# STAGE 1 & 2 REPORTS

**ELDRIDGE/SECTION 21  
REPORT**

**SID RICHARDSON ENERGY SERVICES CO.  
Jal, N.M.**

**SECTION 21&16, TOWNSHIP 19 SOUTH, RANGE 37 EAST  
LEA COUNTY, NEW MEXICO**

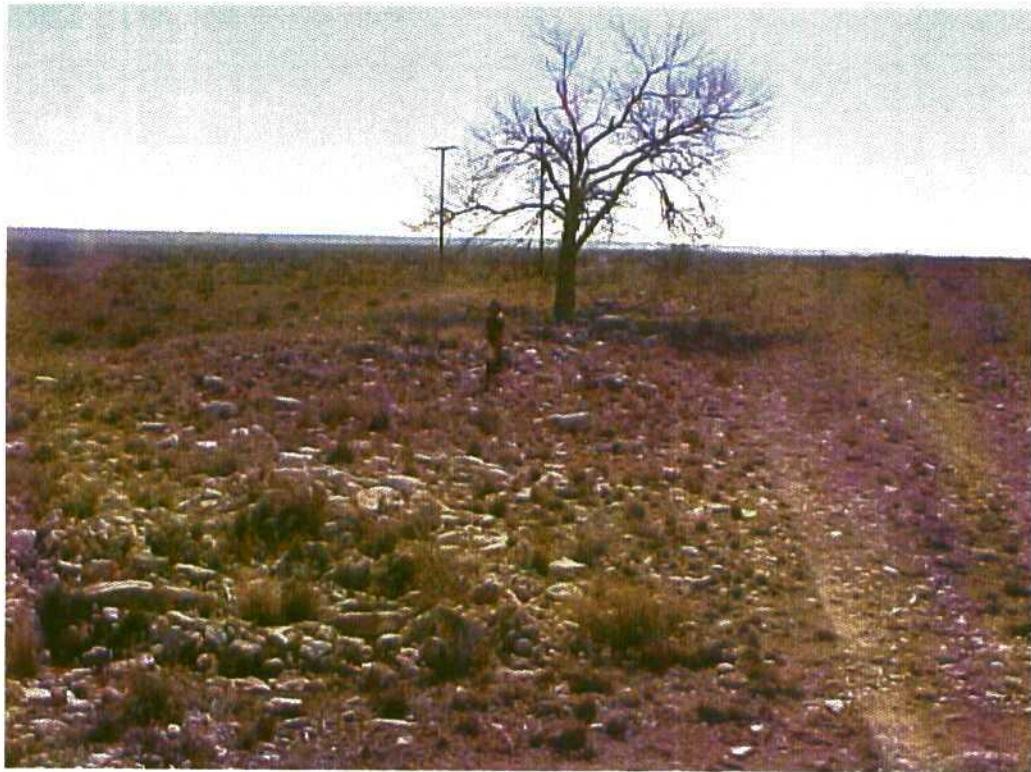
Photo 2995 Looking South at the L-6 To Hobbs 8" Junction 1/19/04

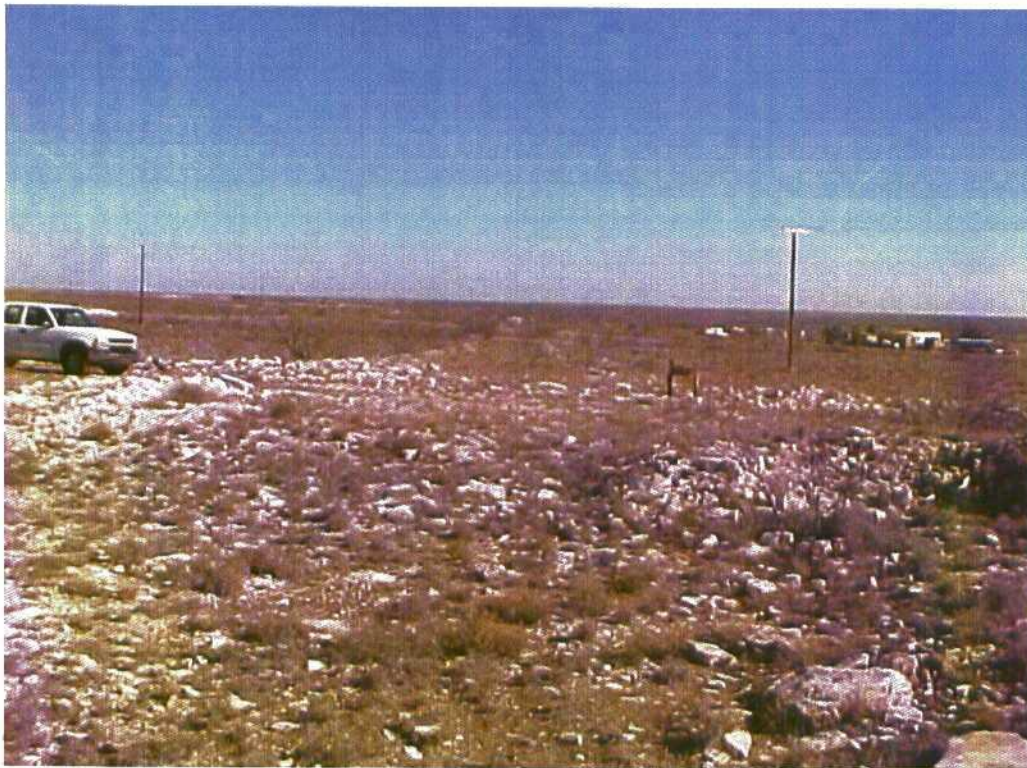
Photo 3005 Looking East at the L-6 To Hobbs 8" Junction 1/19/04

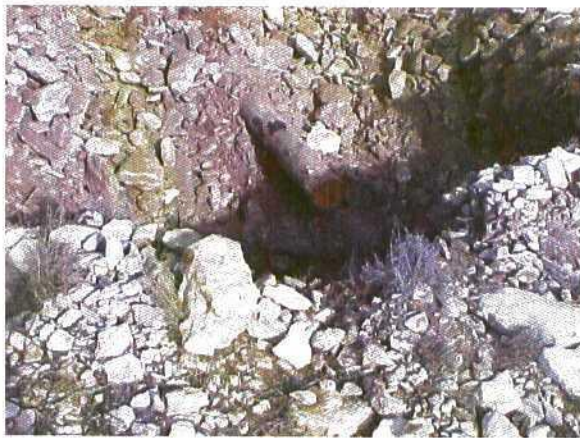
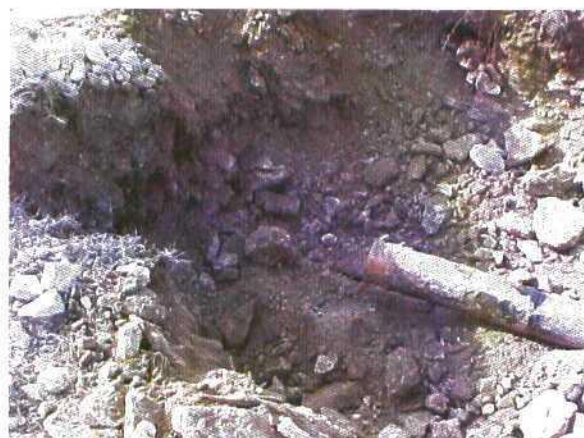
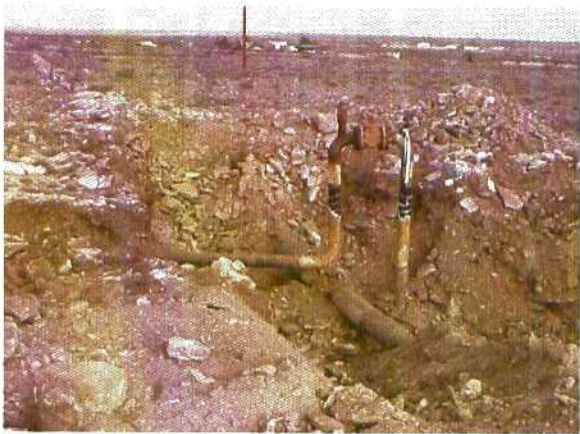
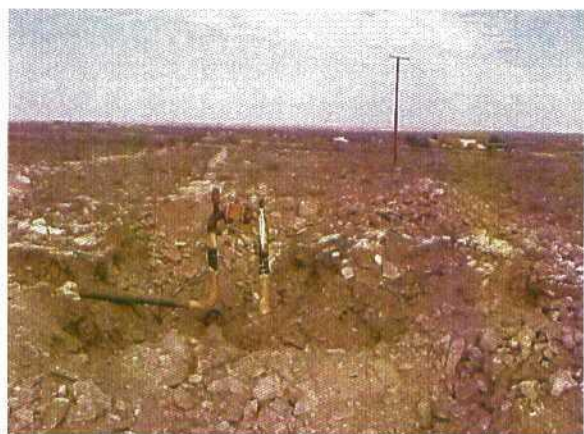
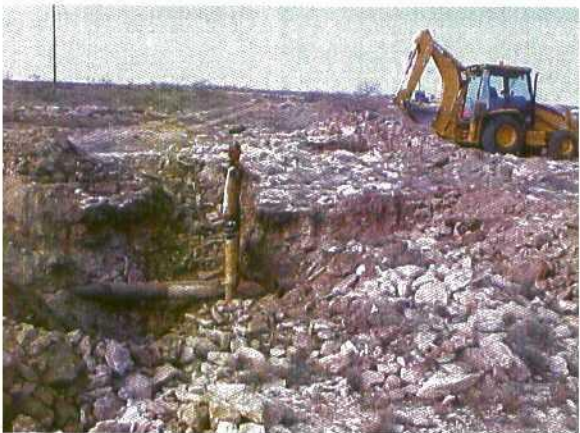
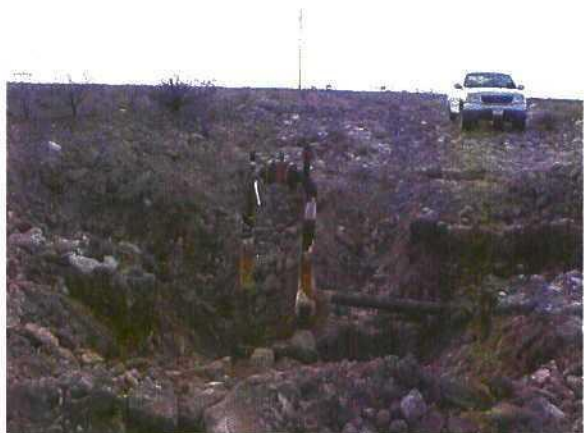
were photographed and the piping was sketched. The results of the excavations showed that both the Hobbs line and the Hobbs loop line had been cut and left open-ended where it crosses into section 21. This area is referenced to as Figure 1 and Figure 2 on the attached pipeline inventory map and the Topo map

Photo 3115 Looking East Hobbs 8"

Photo 3125 Looking North Hobbs 8"

Photo 3145 Looking S.E. Hobbs 8" loop

Photo 3155 Looking East Hobbs 8" Loop

Photo 3165 Looking North Hobbs 8"  
Loop

Photo 3175 Looking West Hobbs 8"  
Loop

Photos taken 1/24/04 With Piping Exposed at the Hobbs 8" Junction to the L-6

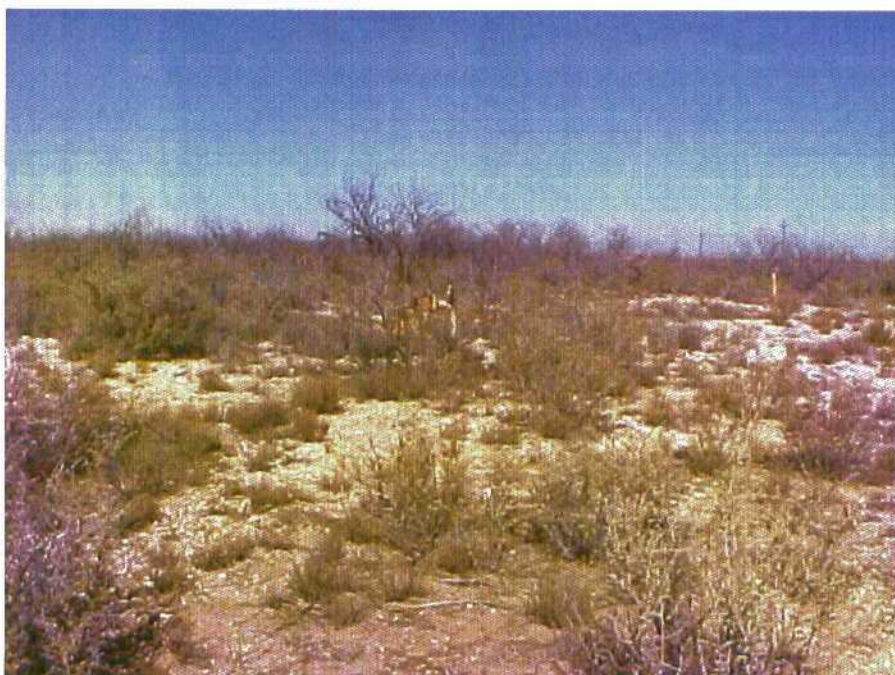
Photo 3045 Looking North at the Hobbs 8" To Monastate 6"  
Junction 1/19/04

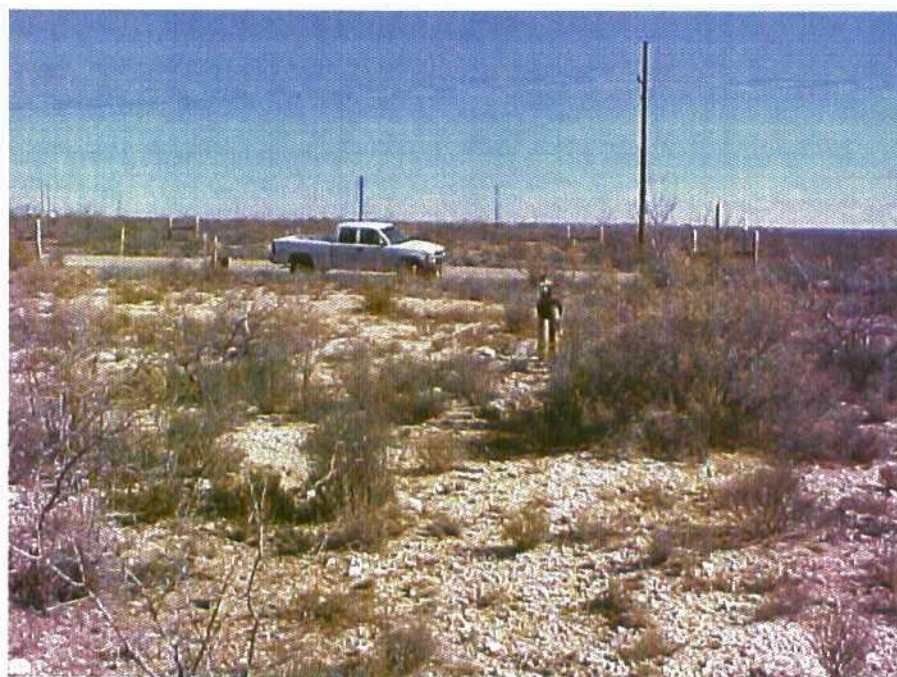
Photo 3055 Looking East at the Hobbs 8" to Monastate 6"  
Junction 1/19/04

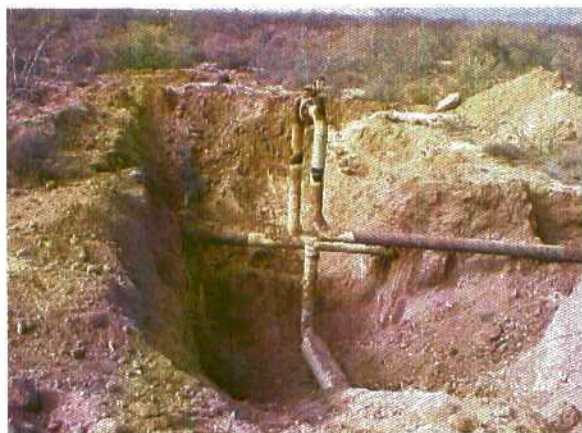
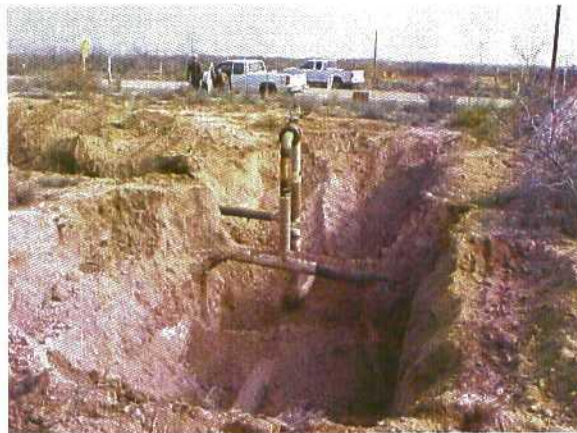
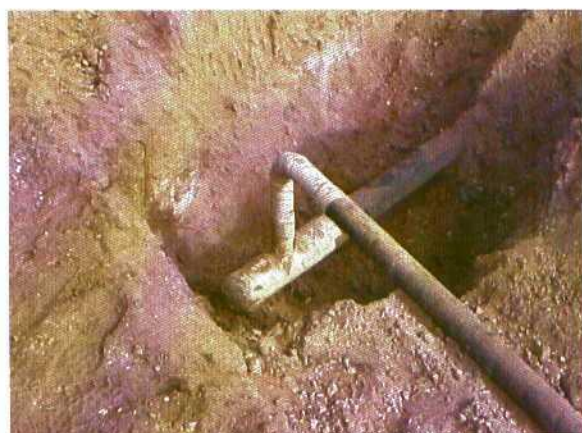
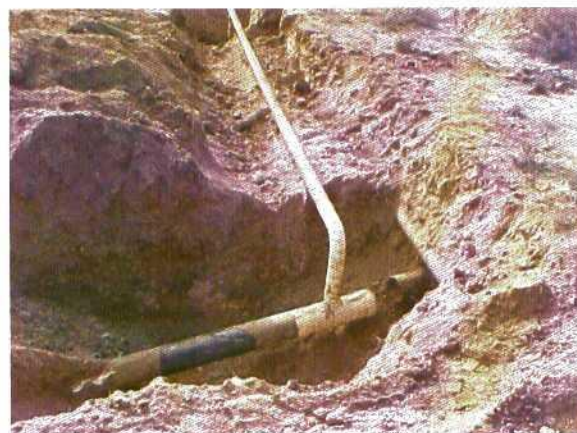
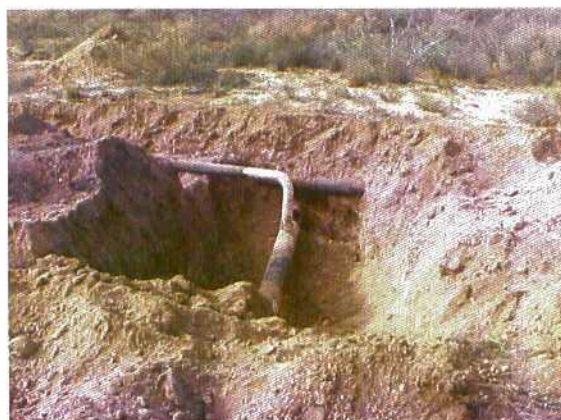
Photo 3065 Looking West 8" Loop

Photo 3075 Looking East 8" loop

Photo 3085 Looking S.E. Hobbs 8"

Photo 3095 Looking South Hobbs 8"

Photo 3105 Looking West Hobbs 8"

Photos taken 1/24/04 With Piping Exposed at the Hobbs 8" Junction to the Monastate 6"

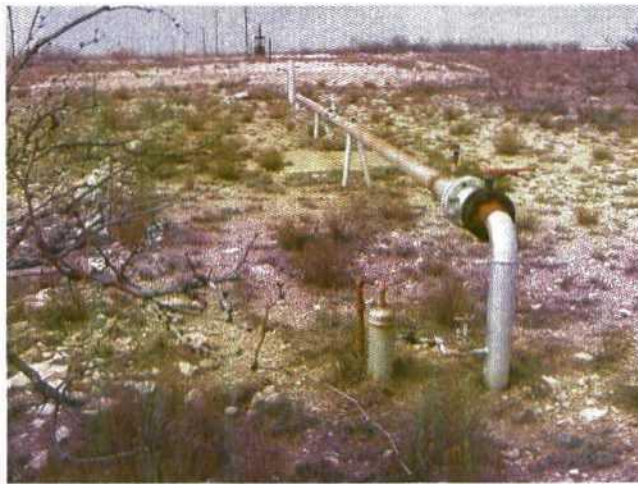
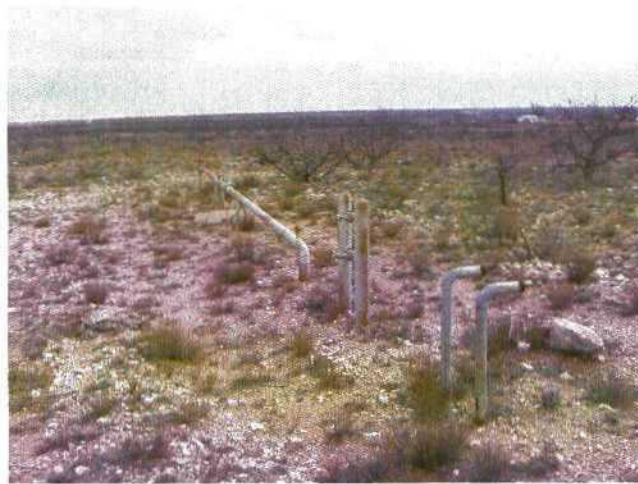
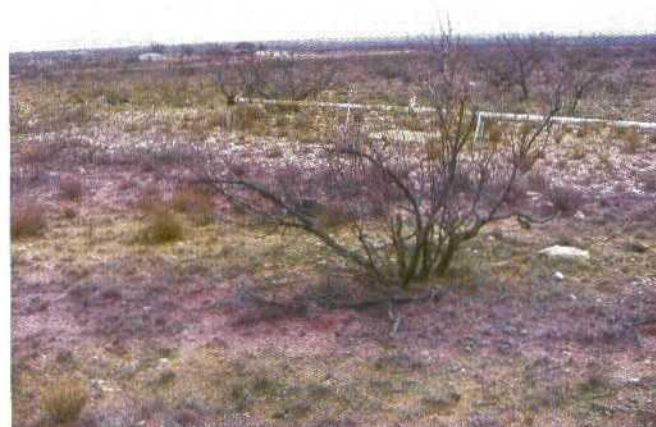
Photo 001 At meter run 60571 looking West

Photo 004 At meter run 60571 looking East

Photo 005 At meter run 60571 looking S.E.

Photos taken 1/23/04 "Out of Service" meter run in Section 21

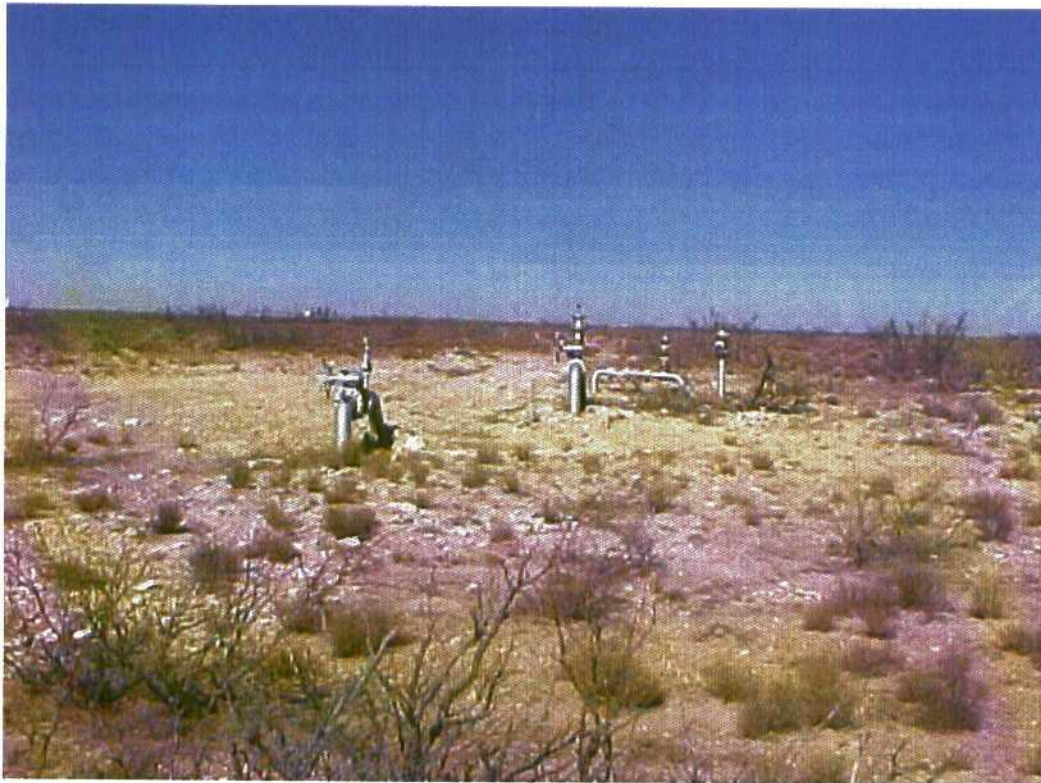
Photo 3025 Looking North at the 4" lateral to L-6 Junction 1/19/04

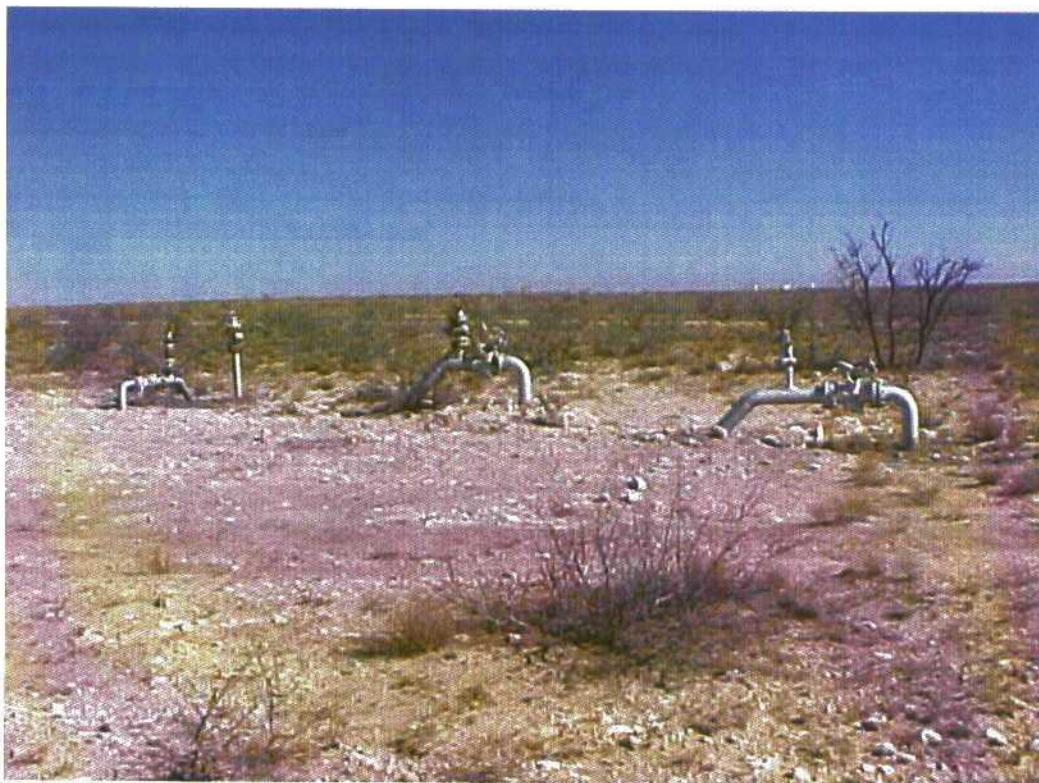
Photo 3035 Looking East at the 4" lateral to L-6 Junction 1/19/04
