**STAGE 1 & 2
REPORTS**

RE: CASE #1R0334
ELDRIDGE RANCH PIPELINE SPILL SITE
MONUMENT, NEW MEXICO

Re: Pipeline Spill Investigation Report, Dynegy Midstream Services, L.P., Unit Letter L (NW/4, SW/4) Section 21, Township 19 South, Range 37 East, Lea County, New Mexico

**DYNEGY MIDSTREAM SERVICES, L.P.
SITE #36, NW/4, SW/4, SEC. 21, T19S, R37E, LEA CO., NM
PHOTOGRAPHS**

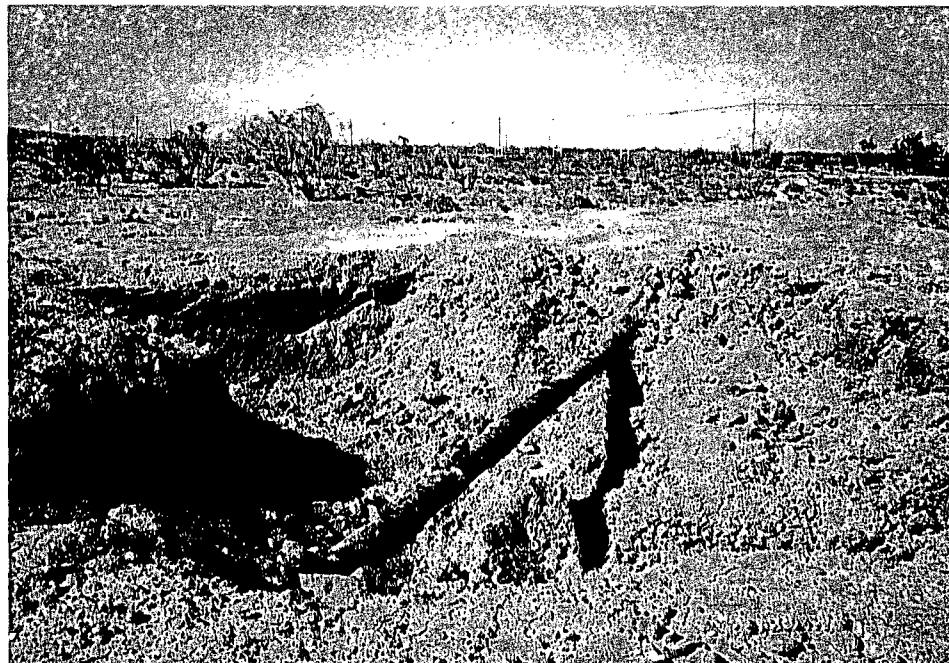
2. View to southwest of final excavation (6/12/03).

Referring to Table 3, final samples obtained from Site #36 were below the RRALs; therefore, the excavation was filled with blended soil. Clean soil was used to fill the remainder of the excavation.
