**STAGE 1 & 2
WORKPLANS**

**Corrective Action Plan for the P-6 Line Leak Site
T20S, R36E, Section 6, Unit Letter P
Lea County, New Mexico**

RE: **CORRECTIVE ACTION PLAN
EME P-6 LINE LEAK
T20S-R37E-Section 6, Unit Letter P
NMOCD CASE # 1R0422**

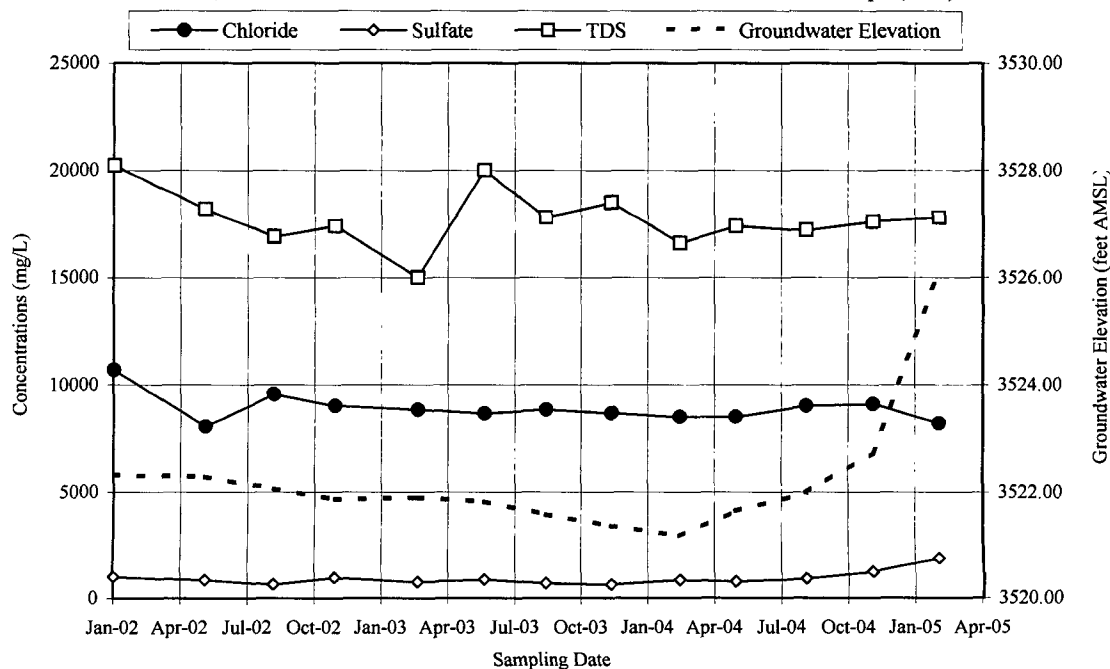
Figure 4
Chloride, Sulfate, TDS, and Groundwater Elevation Values Versus Time Graph (P6-1)

Chloride and TDS concentrations in monitoring wells P6-1, P6-2, and M5-1 have remained relatively stable although some minor fluctuations have occurred. No correlations between chloride/TDS concentrations and changes in groundwater levels are evident at this time.

Continued monitoring of groundwater quality (major ions and TDS) is recommended at a reduced frequency (semi-annually). The next two years of groundwater monitoring will be compared to the three-year trend already documented in which the chloride and TDS levels have not increased as a result of a line leak at this site. Analysis for BTEX concentrations should be suspended, as there has been no indication of dissolved hydrocarbons since the groundwater monitoring program began in January 2002 (13 consecutive quarters).

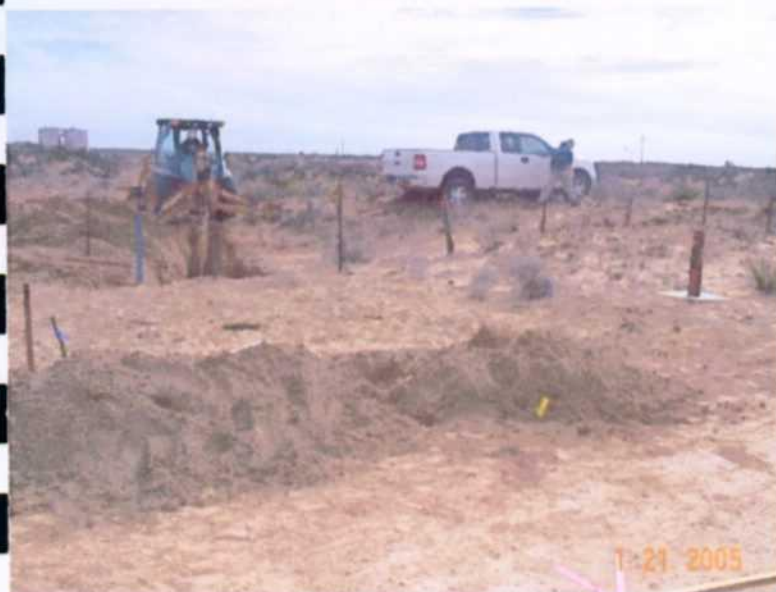
Sampling activity at location "H" approximately 12 feet east of former leak point (center of photo).

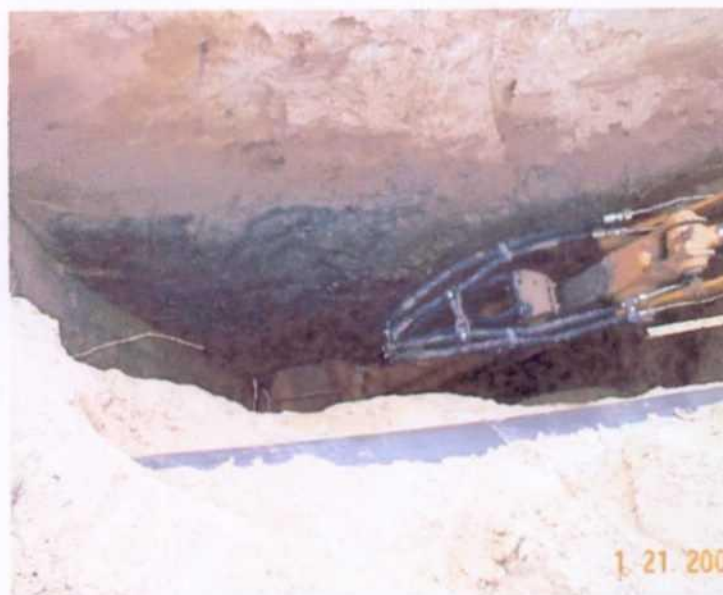
Sample location "J" at 16 ft depth directly below former leak point.

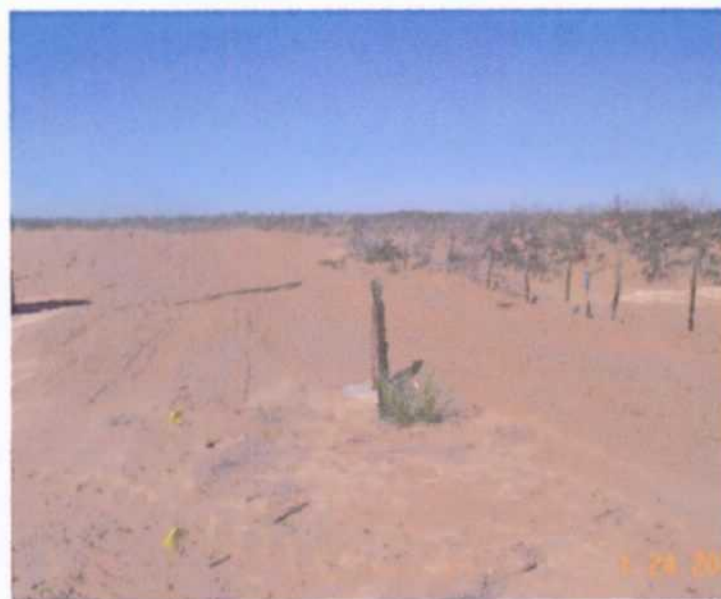
View of P-6 Line Leak Site facing north after completion of backhoe sampling activities.
