STAGE 1 ABATEMENT PLAN

EME K-6 LINE LEAK SITE
T20S, R37E, SECTION 6, UNIT LETTER K
LEA COUNTY, NEW MEXICO

RICE *Operating Company*
122 West Taylor
Hobbs, New Mexico 88240

R. T. HICKS CONSULTANTS, LTD.

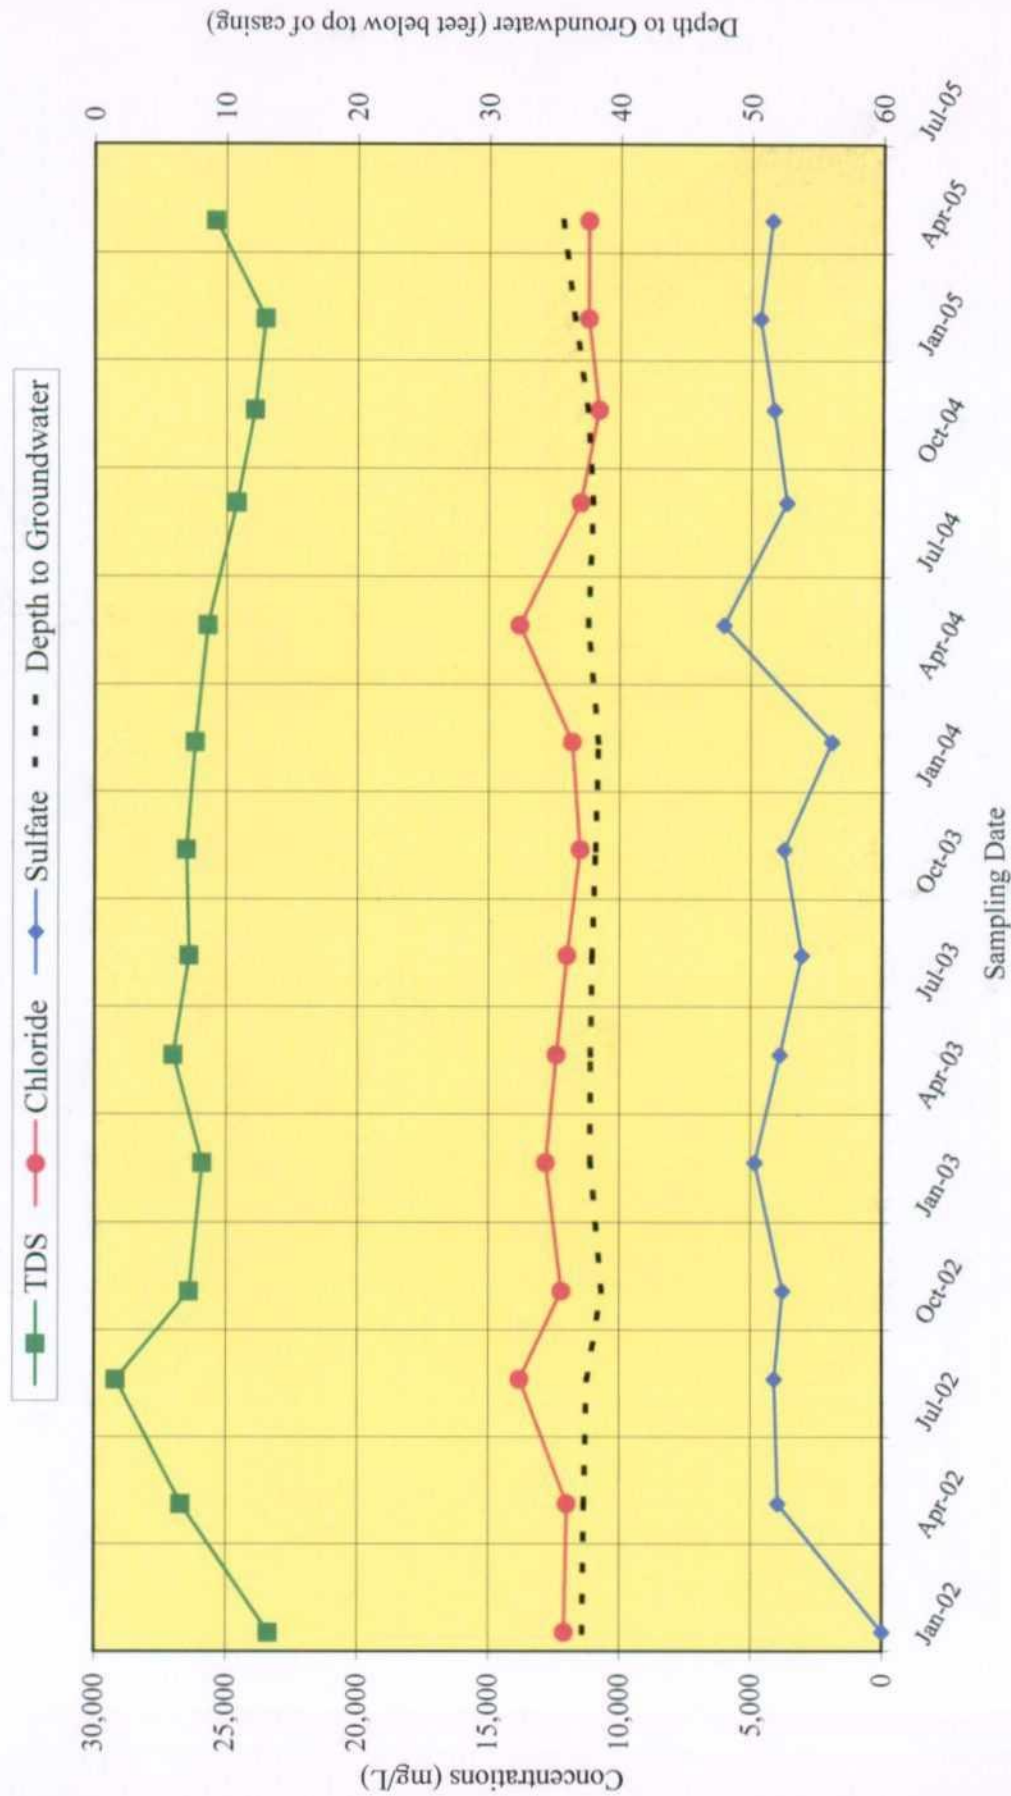
Figure 1
Chloride, Sulfate, TDS, and Depth to Groundwater Values Versus Time Graph (MW-1)

Background and ambient concentrations of these compounds have not been established at this time. Chloride, sulfate, and TDS concentrations in monitoring well MW-1 have remained relatively stable although some minor fluctuations have occurred. No correlations between chloride/sulfate/TDS concentrations and changes in ground water levels are evident.

Monitoring well (MW-1) has been sampled on a quarterly basis for major ions, TDS, and BTEX. A summary of historical analytical results and ground water elevations is listed in Table 1. Analytical results for the most recent sampling event conducted on May 3, 2005, are also depicted in graphical format in Figure 1. A copy of the laboratory analytical report and chain of custody form for the most recent ground water sampling event is included in Appendix C.

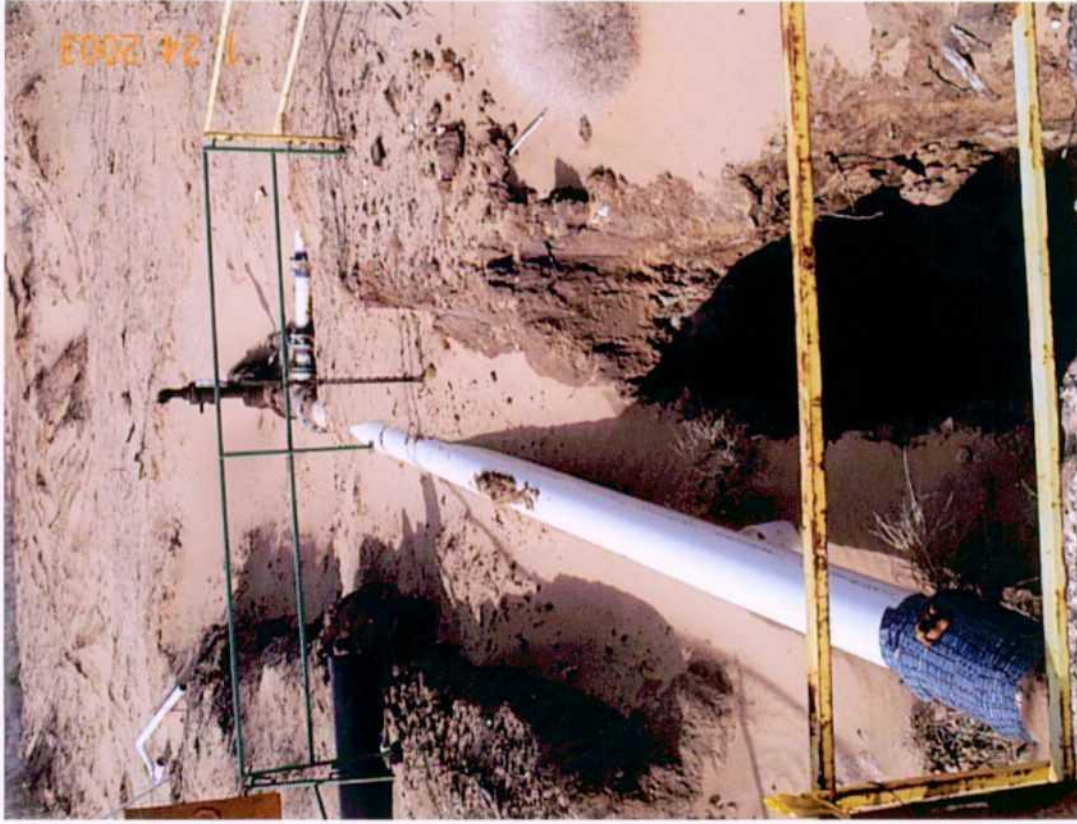
View of K-6 vent site after pipeline upgrade from 10-inch A/C to 6-inch PVC.

inch diameter PVC pipeline, as shown in the attached photographs. Also, 36 cubic yards of hydrocarbon-impacted soils were removed and transported to an NMOCD-approved land farm.

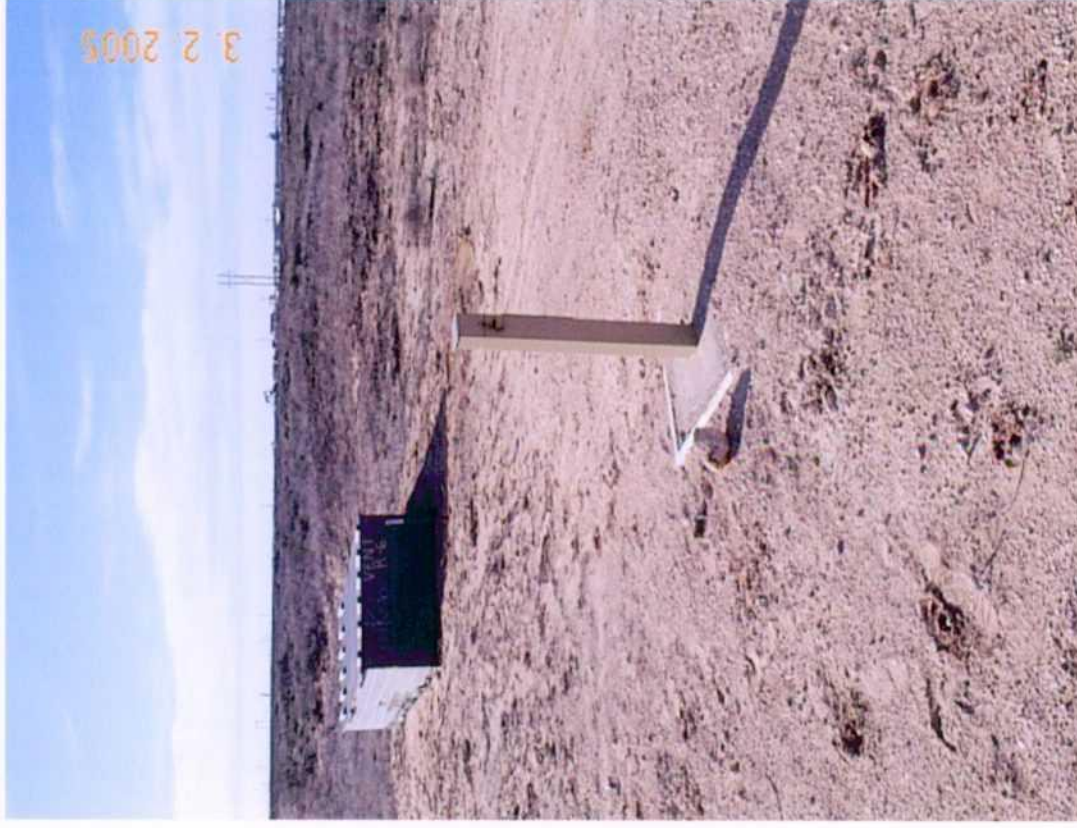
View of K-6 vent junction box (in background) after upgrade to lined watertight plastic junction box. Monitoring Well (MW-1) is shown in foreground.
