**RE: FLORANCE #124 PIT REMEDIATION AND CLOSURE REPORT**

ORIGINAL PIT REMEDIATION AND CLOSURE REPORT

## PIT REMEDIATION AND CLOSURE REPORT

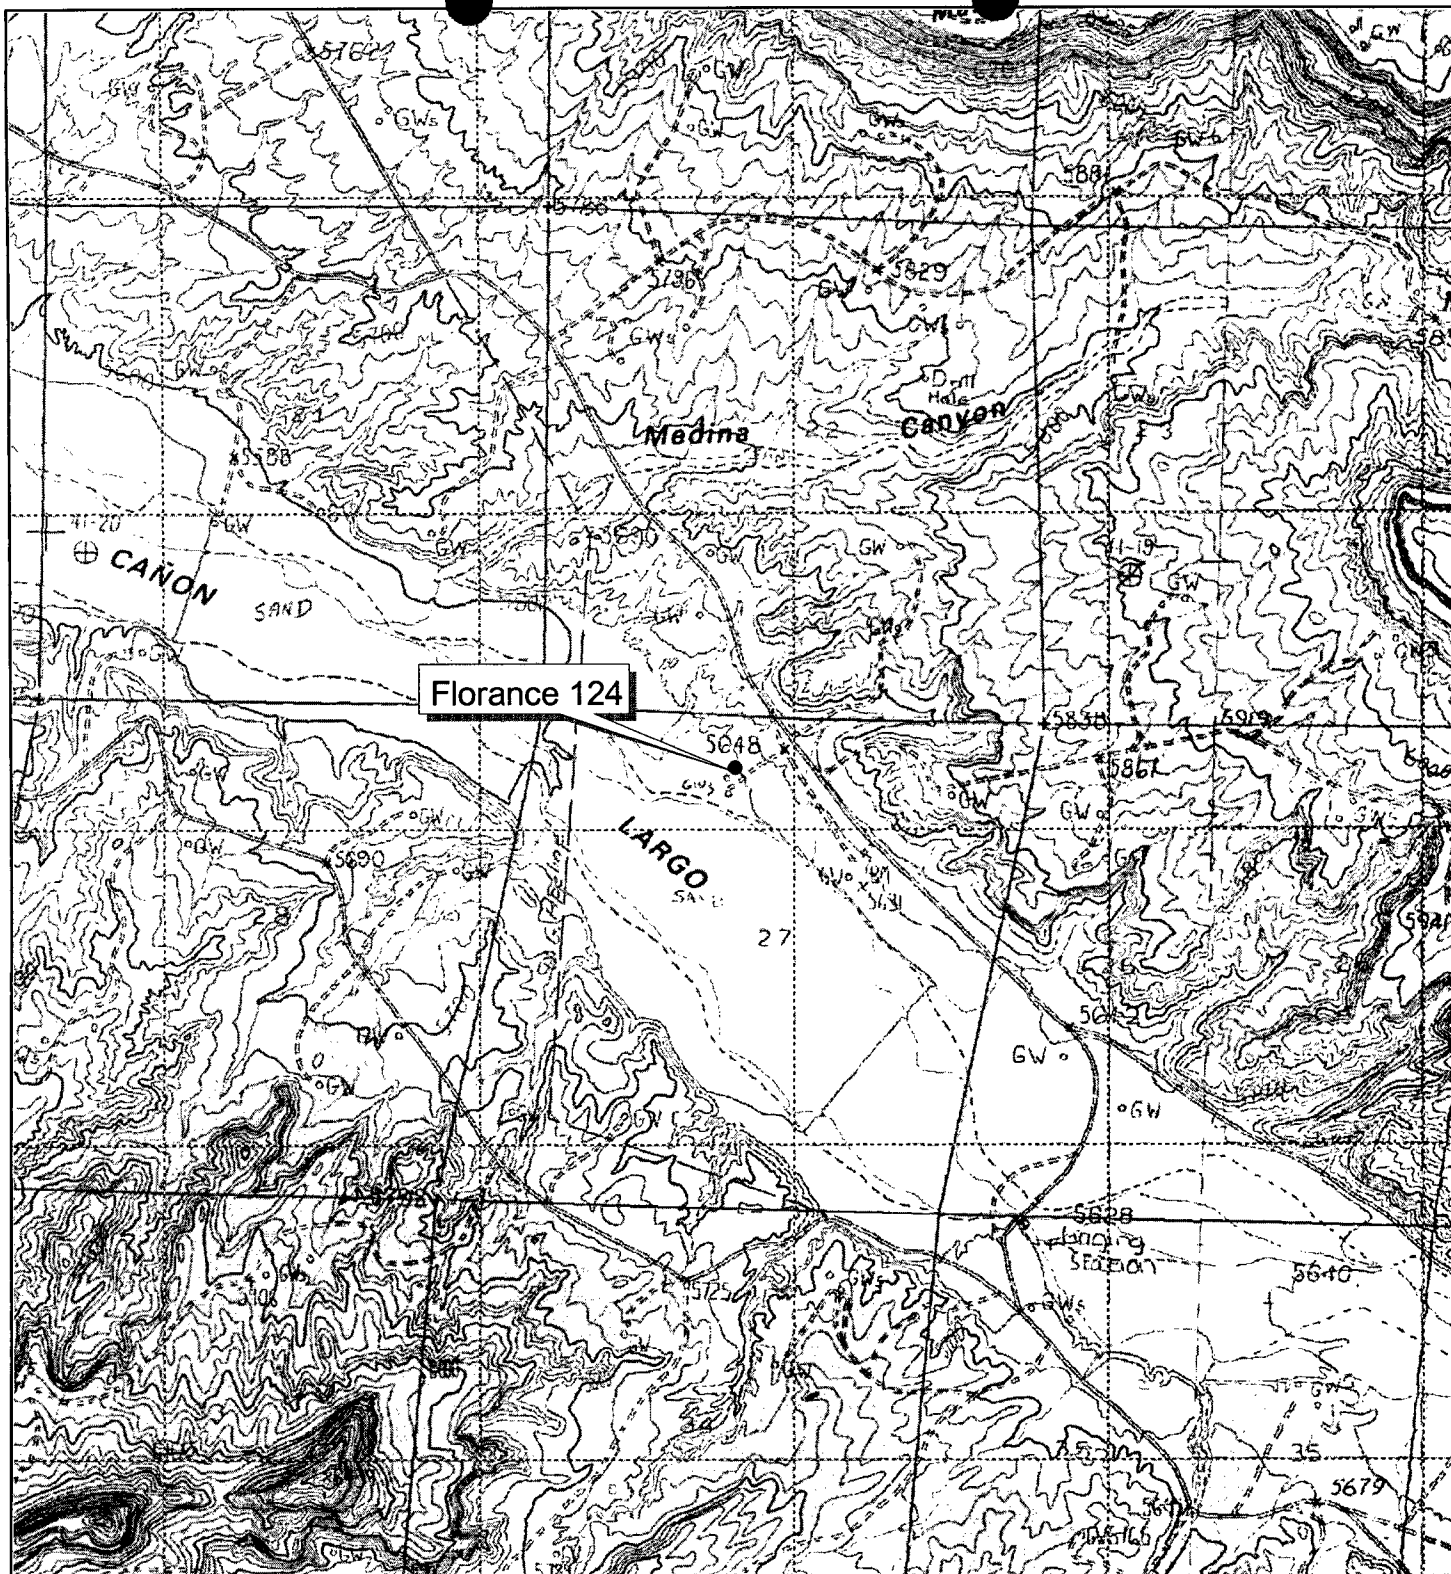
# Figure 1. Site Location Map

The Florance #124 site is located in Unit C, Section 27, Township 29N, Range 9W of San Juan County, New Mexico (Figure 1). The site lies on the northeast edge of Largo Canyon. The alluvial sediments consist primarily of brown, silty sand grading from fine near the surface to coarse at 3-feet below ground surface. At 10-feet the material is primarily gray, coarse sand. Bedrock was encountered in one part of the excavation at a depth of 17-feet below ground surface.

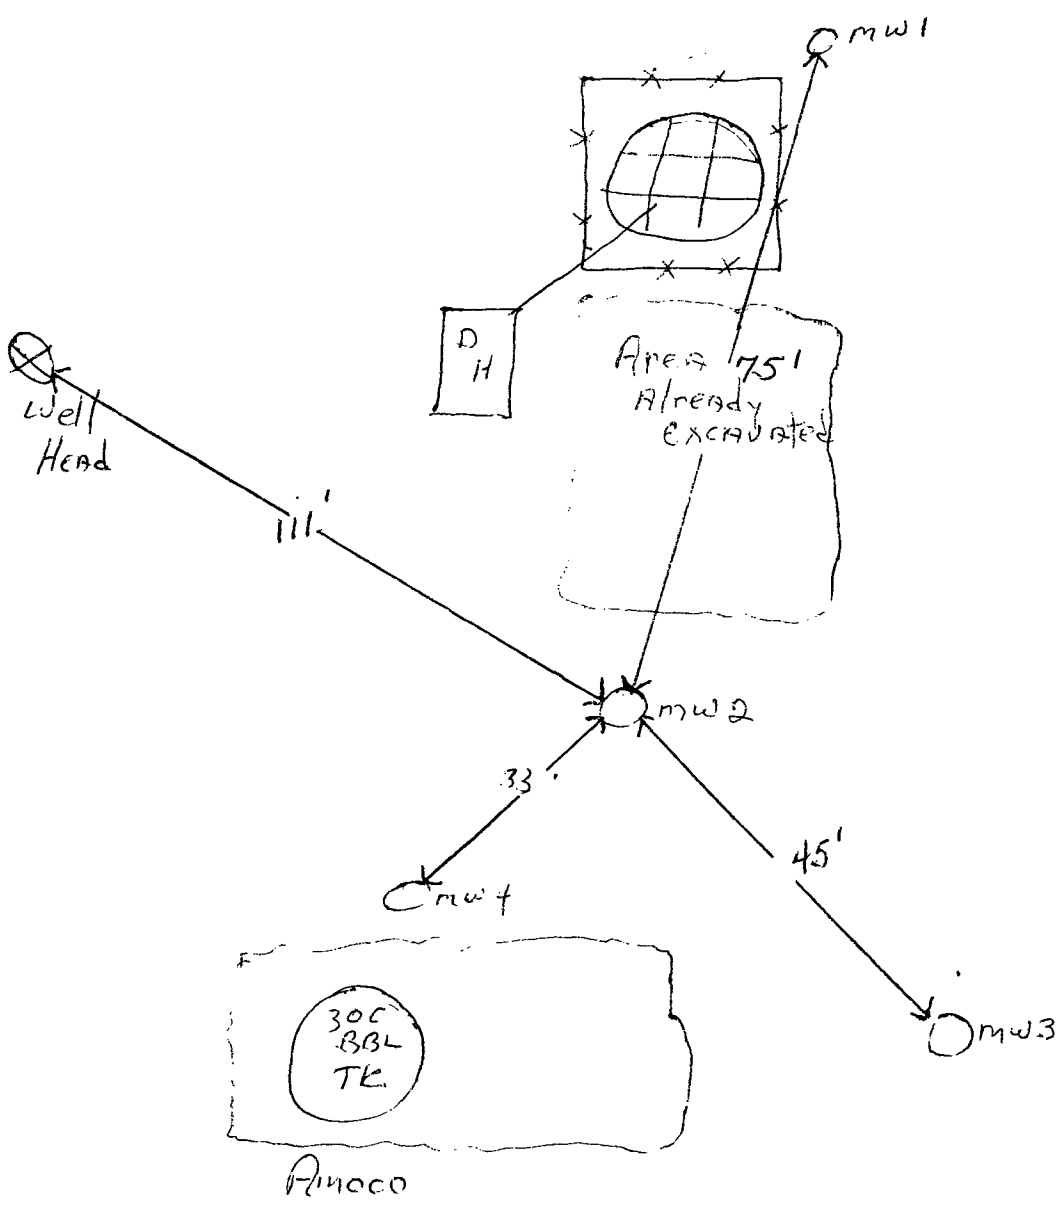
Site Map

Horance 124  
Sec 27 T29N R9W White  
Amoco

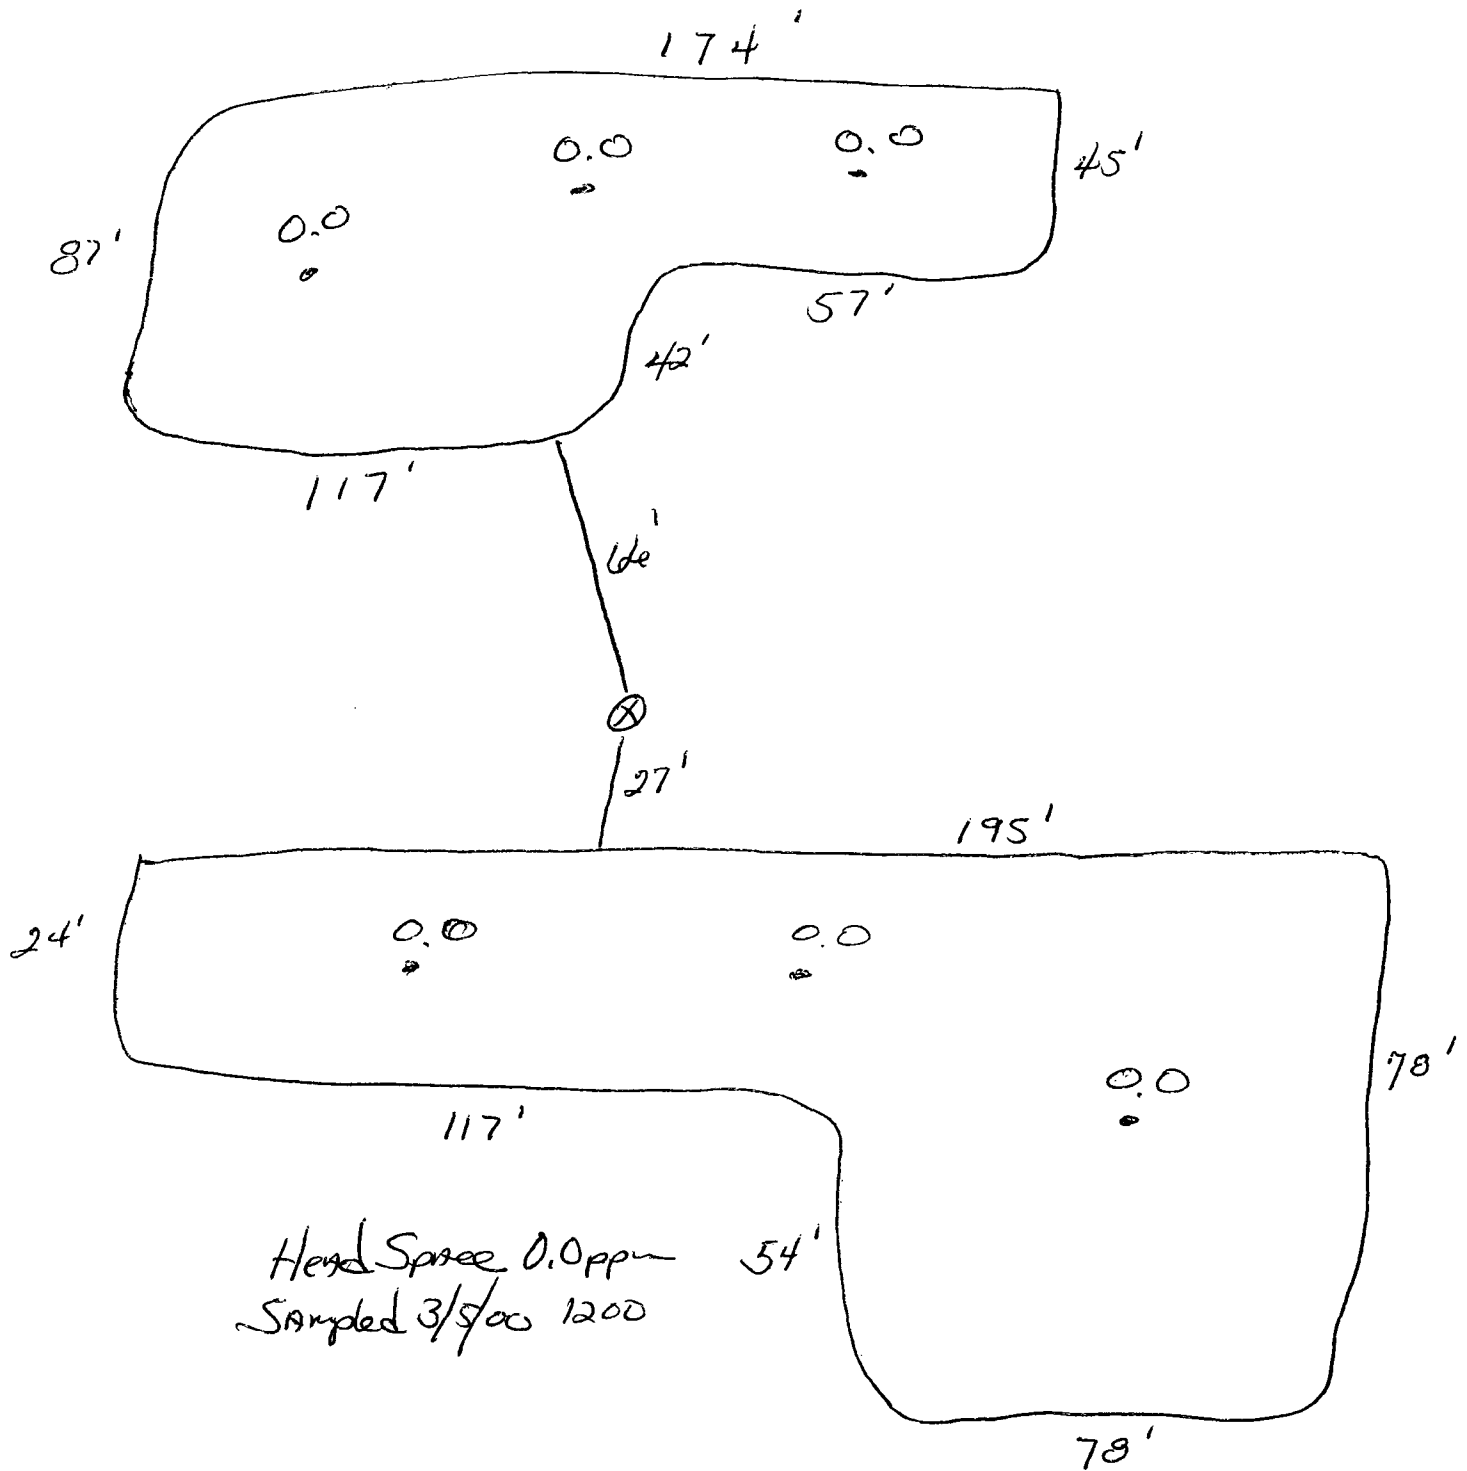
Land farm #1

Land farm located on Florance 27 location  
Sec. 26 T29N R9W Unit L  
Amoco

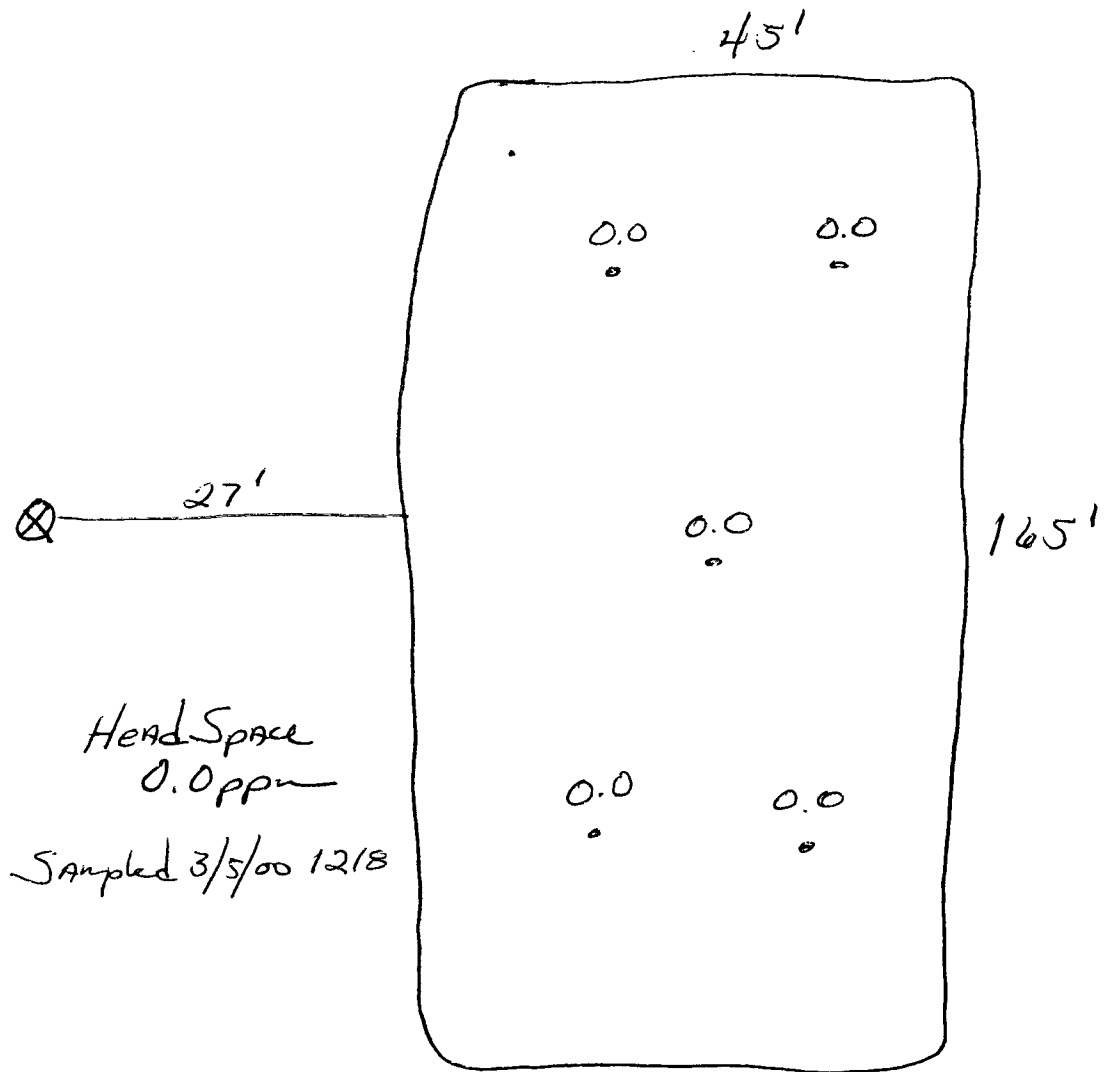
Landfarm #2

Landfarm located on Florence 86 location  
Sec. 26 T29N R9W unit D  
Amoco

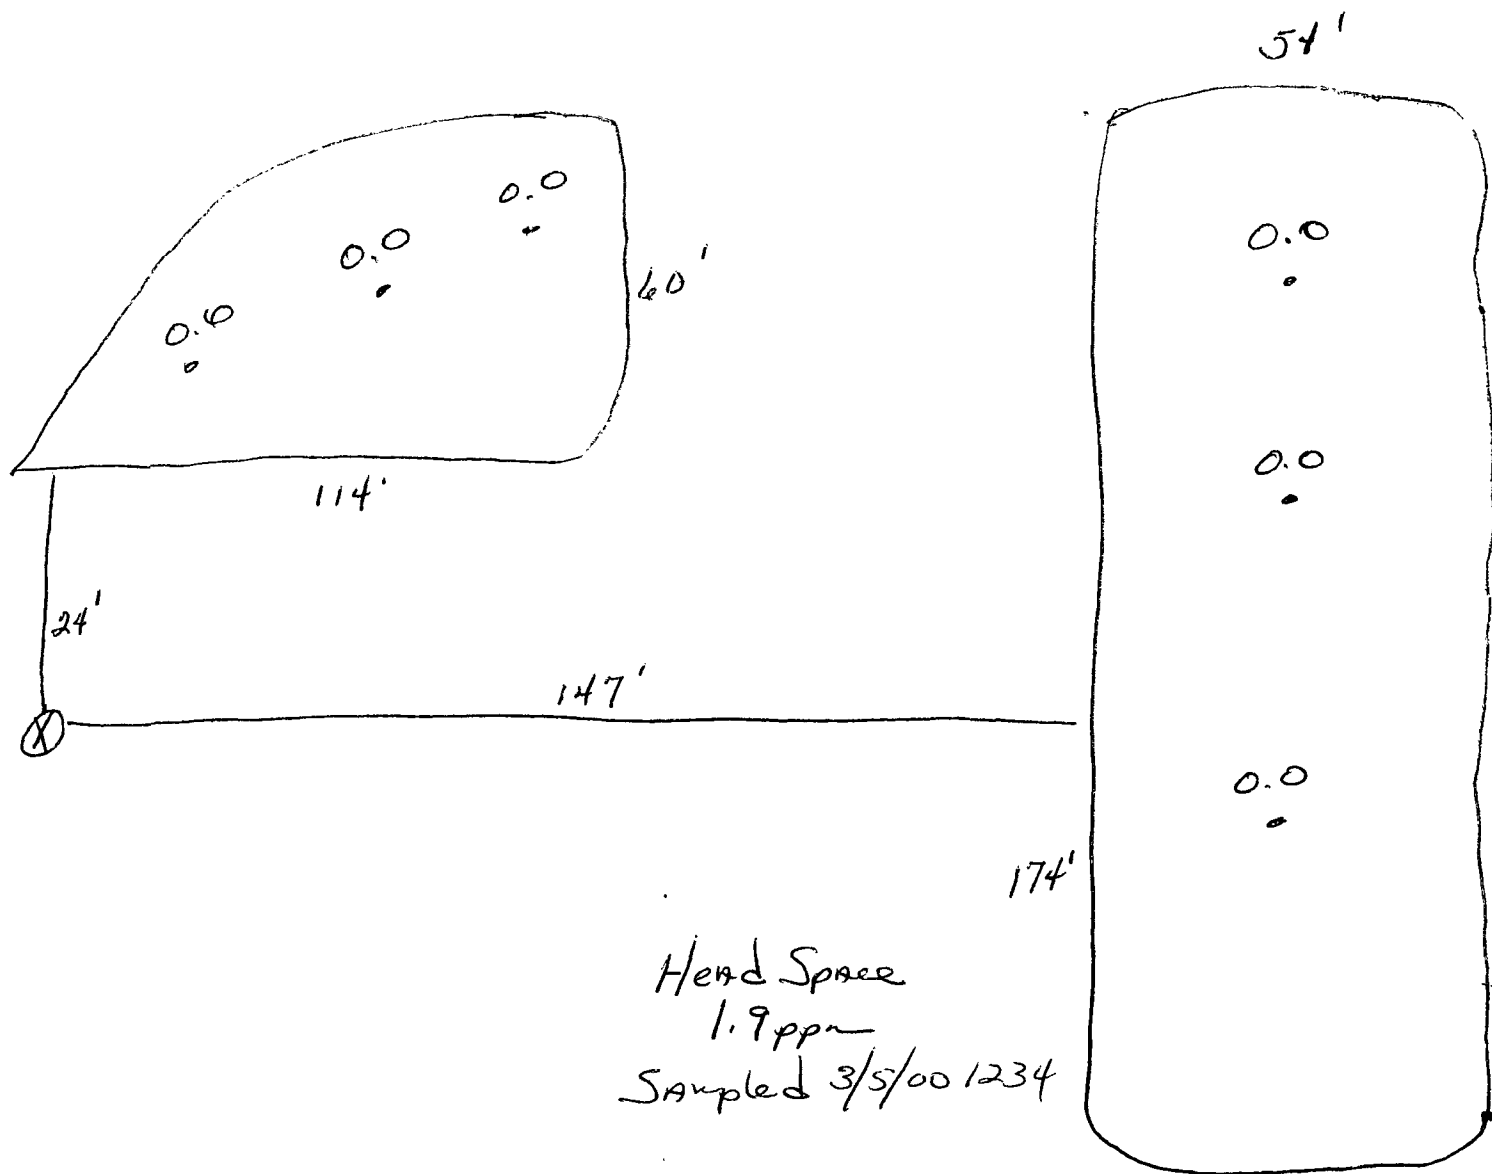
Land farm #3

Land farm located on Florance 124 location

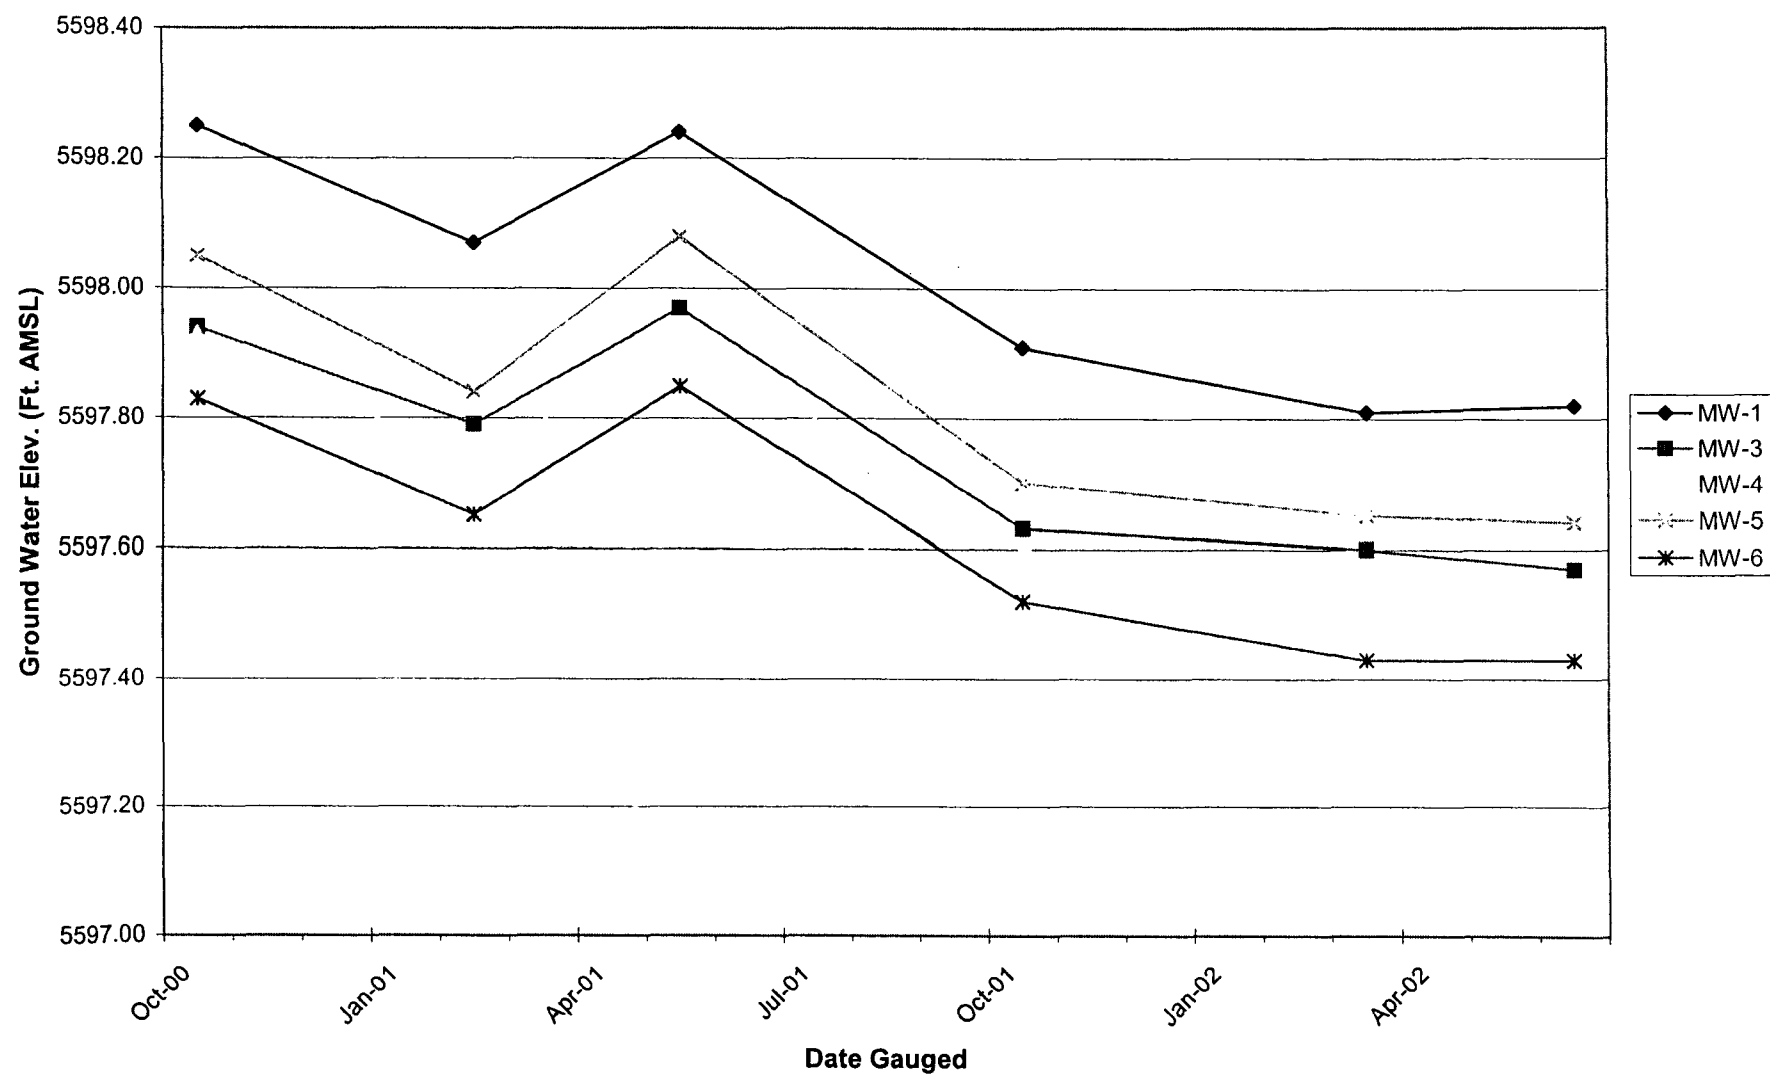
Florance #124 Hydrograph

Ground water in the unconsolidated sediments is unconfined and the depth to ground water is typically around 10-feet below ground level. A hydrograph for the wells is included in Exhibit B. Ground water flows to the southwest toward Largo Canyon. A potentiometric surface map is included in Exhibit B. The average hydraulic gradient across the site is 0.002. Hydraulic conductivities of the sediments are likely on the order of  $10^{-3}$  to  $10^{-1}$  cm/sec.
