Release Notification

Site Name	BELL B FED #2	Site Type	Oil and Gas Well
Date Release Discovered	August 20, 2019	API# (if applicable)	30-025-07066

BELL B FED # 2

Spill Report

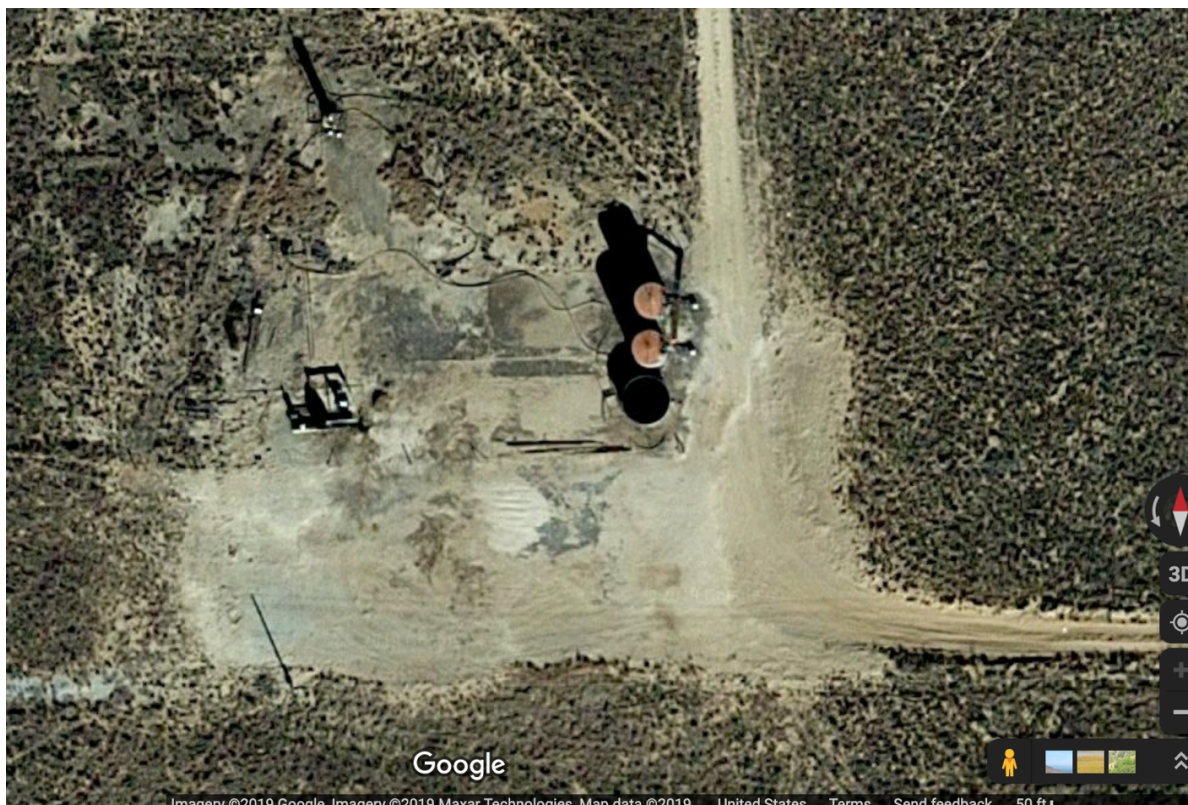
Figure 2: Site map

The sites are located approximately 60 miles North of Hobbs, New Mexico. The legal location for the sites is Unit Letter P, Section 20, Township 9S, Range 38E in Lea County, New Mexico. The GPS Lat/Long for the site is 33.5143356, -103.0648651 NAD83 respectively. Figure 1&2 shows the site location and map.

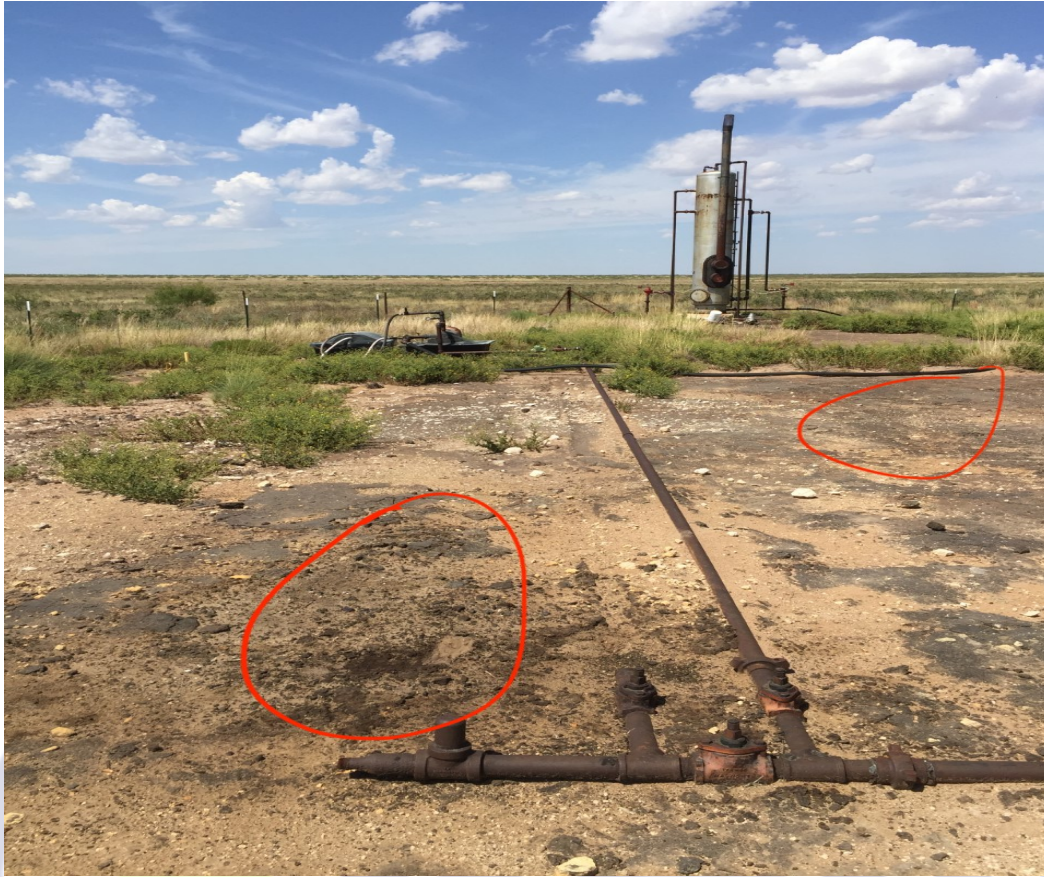
Figure 3: Site map before any clean-up activity.

- On August 20, 2019, it had noticed that there was some Oil&Solid mixture on the surface of Bell-B Fed #2 nearby the battery. KEM was asked to clean up the solid mixture by BLM Inspector. Figure 3 shows a small area of the ground before any clean up activity.

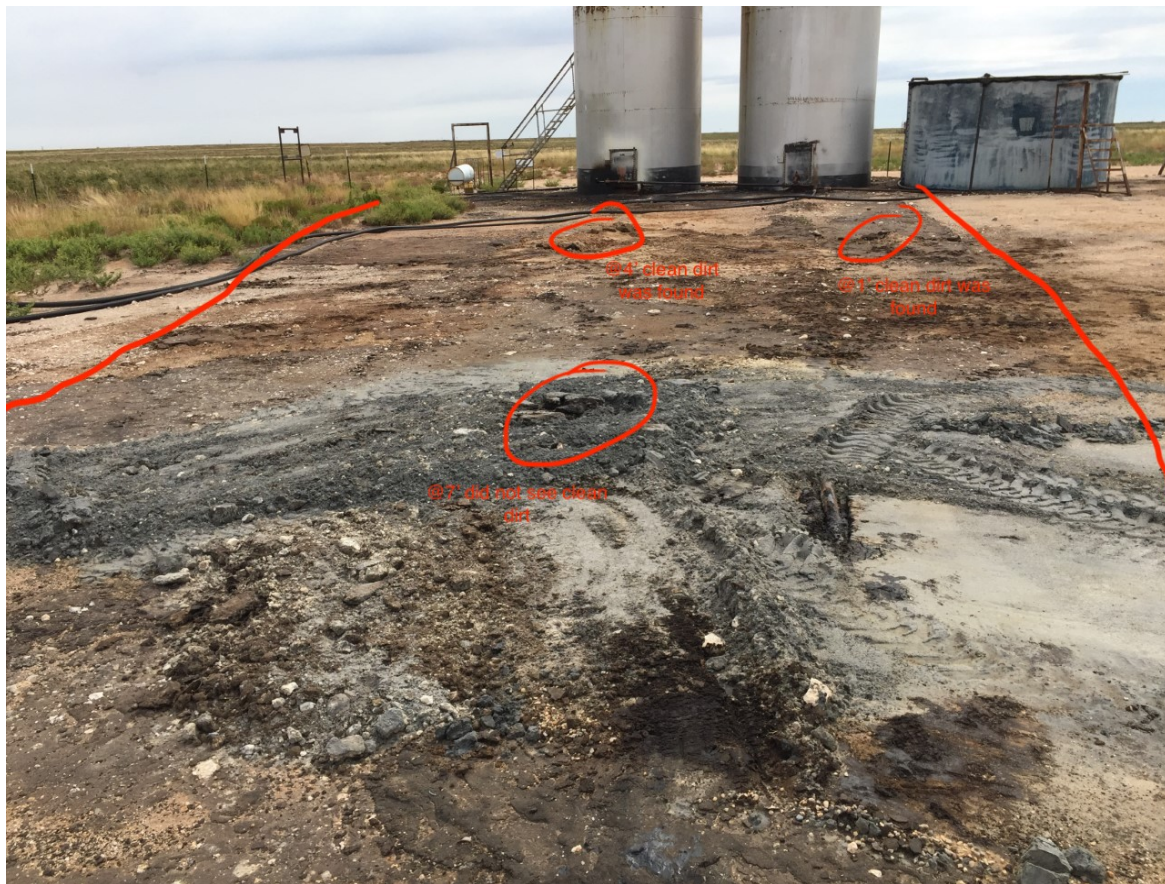
Figure 4: Locations visual assessment were conducted.

- On August 26, 2019, KEM contracted third party company to conduct a visual site assessment in order to identify the depth and scoop of impacted area. At the South of the impacted area, it was dug to about 1 ft where clean soil was found. At the East close to the oil tanks was about 4 ft where clean soil was found. At the west next to the pumping unit, a 7 ft deep hole was dug, but did not reach a possible clean soil. Based on the assessment, a possible 100' by 80' impacted area was identified. Figure 4 shows the spots that had dug.

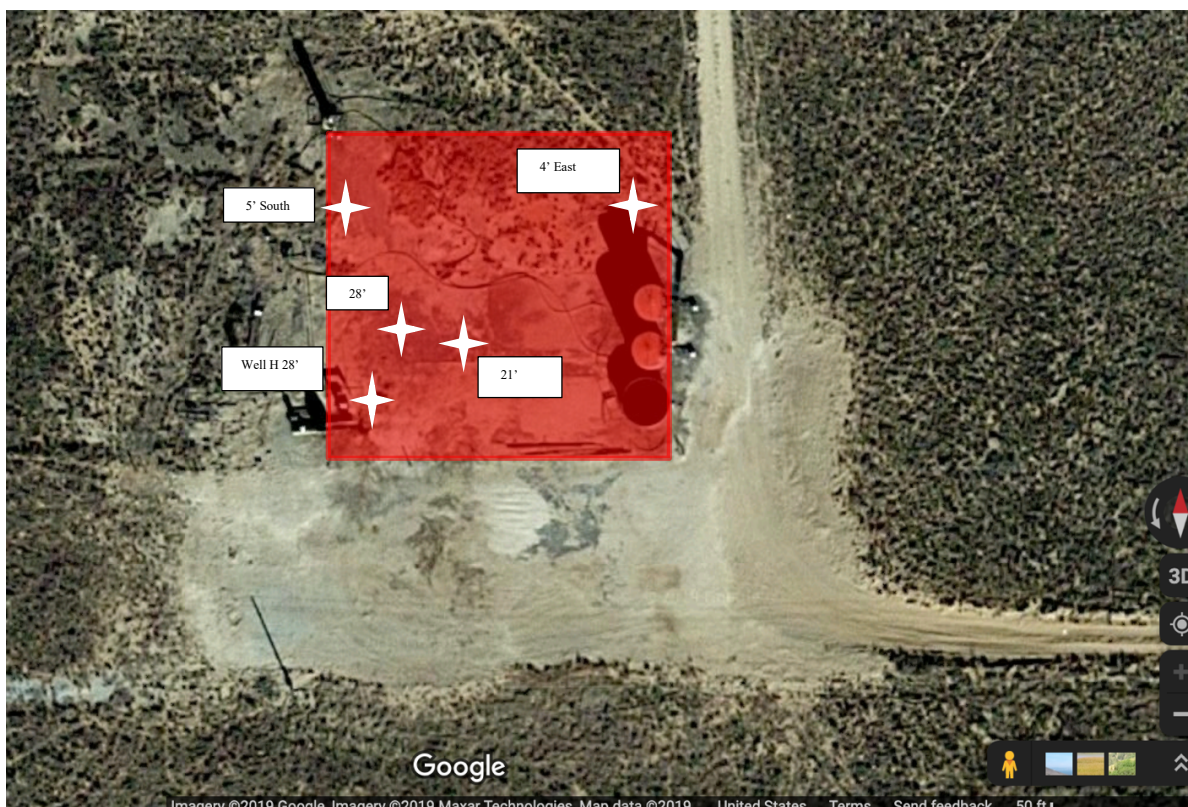
Figure 5: Sampling locations in impacted area.

- From October 28, 2019 to November 19, 2019, KEM had contracted a service company to start cleaning up the impacted area and to facilitate soil sampling when clean soil was visually spotted. In order to identify the maximum horizontal and vertical impacted boundaries, several soil samples were taken to Cardinal Laboratories in Hobbs, New Mexico. Compliance of the regulation, all samples were tested based on EPA protocol. As the results, all samples show Total Petroleum Hydrocarbon (TPH) and BTEX within the range of the regulated limit based on **Table I in 19.15.29.12 NMAC – N, 8/14/2018 and August 13, 1993 New Mexico Oil Conservation Division (NMOCD) Guidelines for Remediation of Leaks, Spills and Release**. At this point, the maximum vertical and horizontal impacted boundaries have been identified, and excavation stopped. Figure 5 shows the locations where the samples were taken. Table 1 summarizes the lab results. All the soil sample analysis results from Cardinal Laboratories shows on Appendix A.

Sample ID	Sampling Date	TPH (mg/kg)	GRO + DRO (mg/kg)	BTEX (mg/kg)	Benzene (mg/kg)	Chloride (mg/kg)
OCD Recommend Values		2,500	1,000	50	10	10,000
5' South	11/12/2019	53	35.4	<0.300	<0.05	48
4' East	11/12/2019	< 10.0	< 10.0	<0.300	<0.05	656
Well H 28'	11/14/2019	< 10.0	< 10.0	<0.300	<0.05	176
21'	11/01/2019	< 10.0	< 10.0	<0.300	<0.05	32
28'	11/01/2019	< 10.0	< 10.0	<0.300	<0.05	96

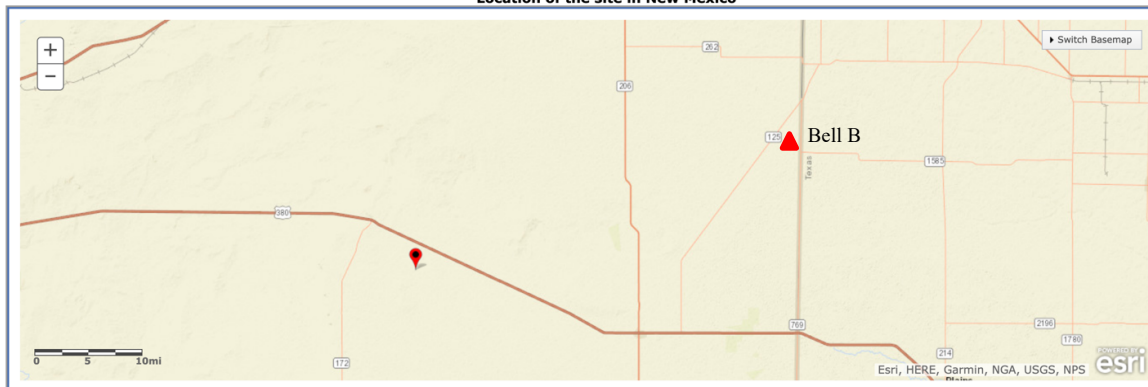
Figure 6: Ground water level reference from USGS database.

Depth to ground water is an estimated 60 feet, according to available information within USGS database. Measurement were conducted from the nearest water wells on record. Figure 6 shows water well information on USGS website. According to the definition of significant watercourse in Subsection P of 19.15.17, there is no such watercourse within ½ mile of the impacted area. Figure 7 shows the topographic map within ½ mile of impacted area.

Lea County, New Mexico
Hydrologic Unit Code 12080004
Latitude 33°21'24.19", Longitude 103°40'40.02" NAD83
Land-surface elevation 4,363 feet above NGVD29
The depth of the well is 110 feet below land surface.
This well is completed in the High Plains aquifer (N100HGHPLN) national aquifer.
This well is completed in the Ogallala Formation (121OGLL) local aquifer.

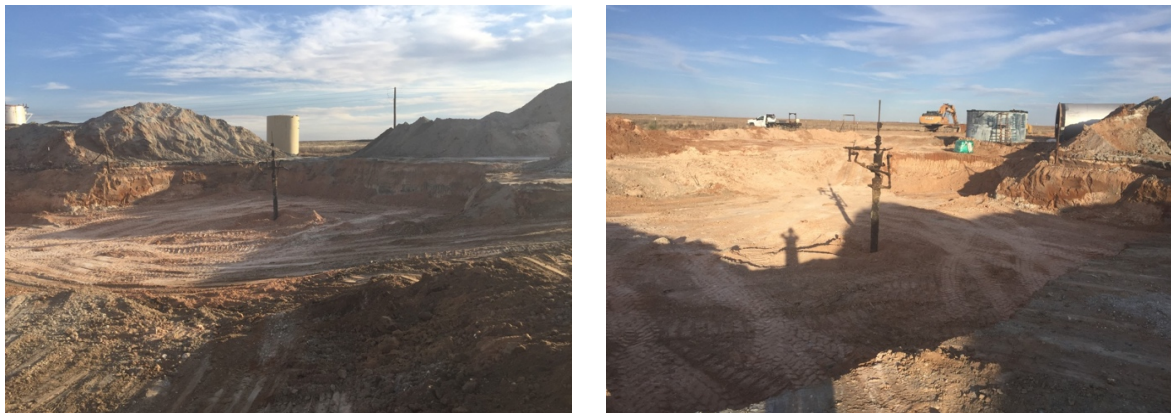
Figure 8: Site maps after excavation

- Excavate until clean sand is spot visually. Sampling the soil for Lab analysis until good samples are found to identify the maximum horizontal and vertical boundaries or depth of impacted area. According to measurement of the area and Lab results, the total amount of dirt came out is about:

- Off-site treatment methods, describing in VI.A.2.b.ii & VI.A.2.b.iii in **GUIDELINES FOR REMEDIATION OF LEAKS, SPILLS AND RELEASE (August 13, 1993)**, including bioremediation and compositing with clean dirt, will be implemented until the concentration is brought down to or meet the level describing within the Table I in 19.15.29.12 NMAC – N, 8/14/2018. The ratio applying for compositing is 1:1, one load contaminated soil to one load clean soil. This remediation has been conducted since 11/25. Sampling procedure for some remediated soil has been conducted. Table 5 demonstrates that all the sampling result from lab analysis are within the requirement showing in Table I in 19.15.29.12 NMAC – N, 8/14/2018. This indicates that the remediation has achieved the closure criteria and ready for backfill. Figure 8 demonstrates the impacted area (site map) after excavation. The lab report will be shown in Appendix B.
