RE: C-141 Notification/Closure Report  
Murchison Oil and Gas, Inc. - Yogi Bear SWD #1 Release  
Unit H, Sec. 12, T17S, R28E, Eddy County

R.T. Hicks Consultants, Ltd 901 Rio Grande Blvd NW Suite F-142 Albuquerque, NM 87104 505-266-5004	Google Earth Image (2016) of Yogi Bear SWD #1 Release Area	Plate 1
	Murchison Oil and Gas, Inc.	December 2019

PHOTOGRAPHS

Yogi Bear SWD #1 Release

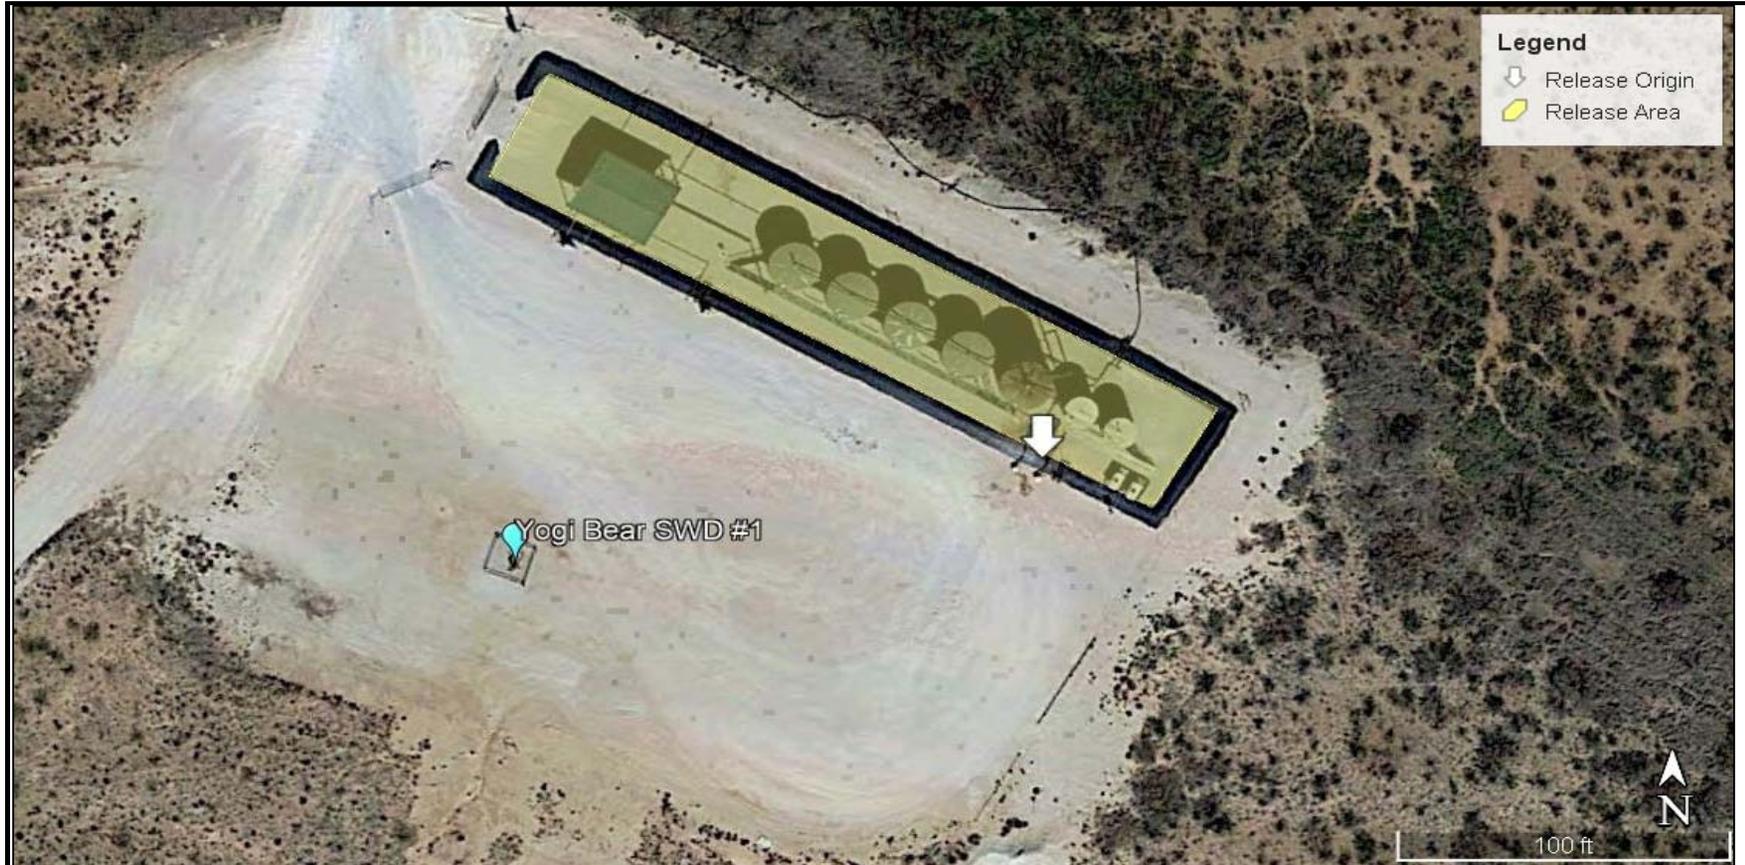
GPS Coordinates: Release Origin 32.85302 -104.123  
(NAD 83)

Release Date  
11/4/2019

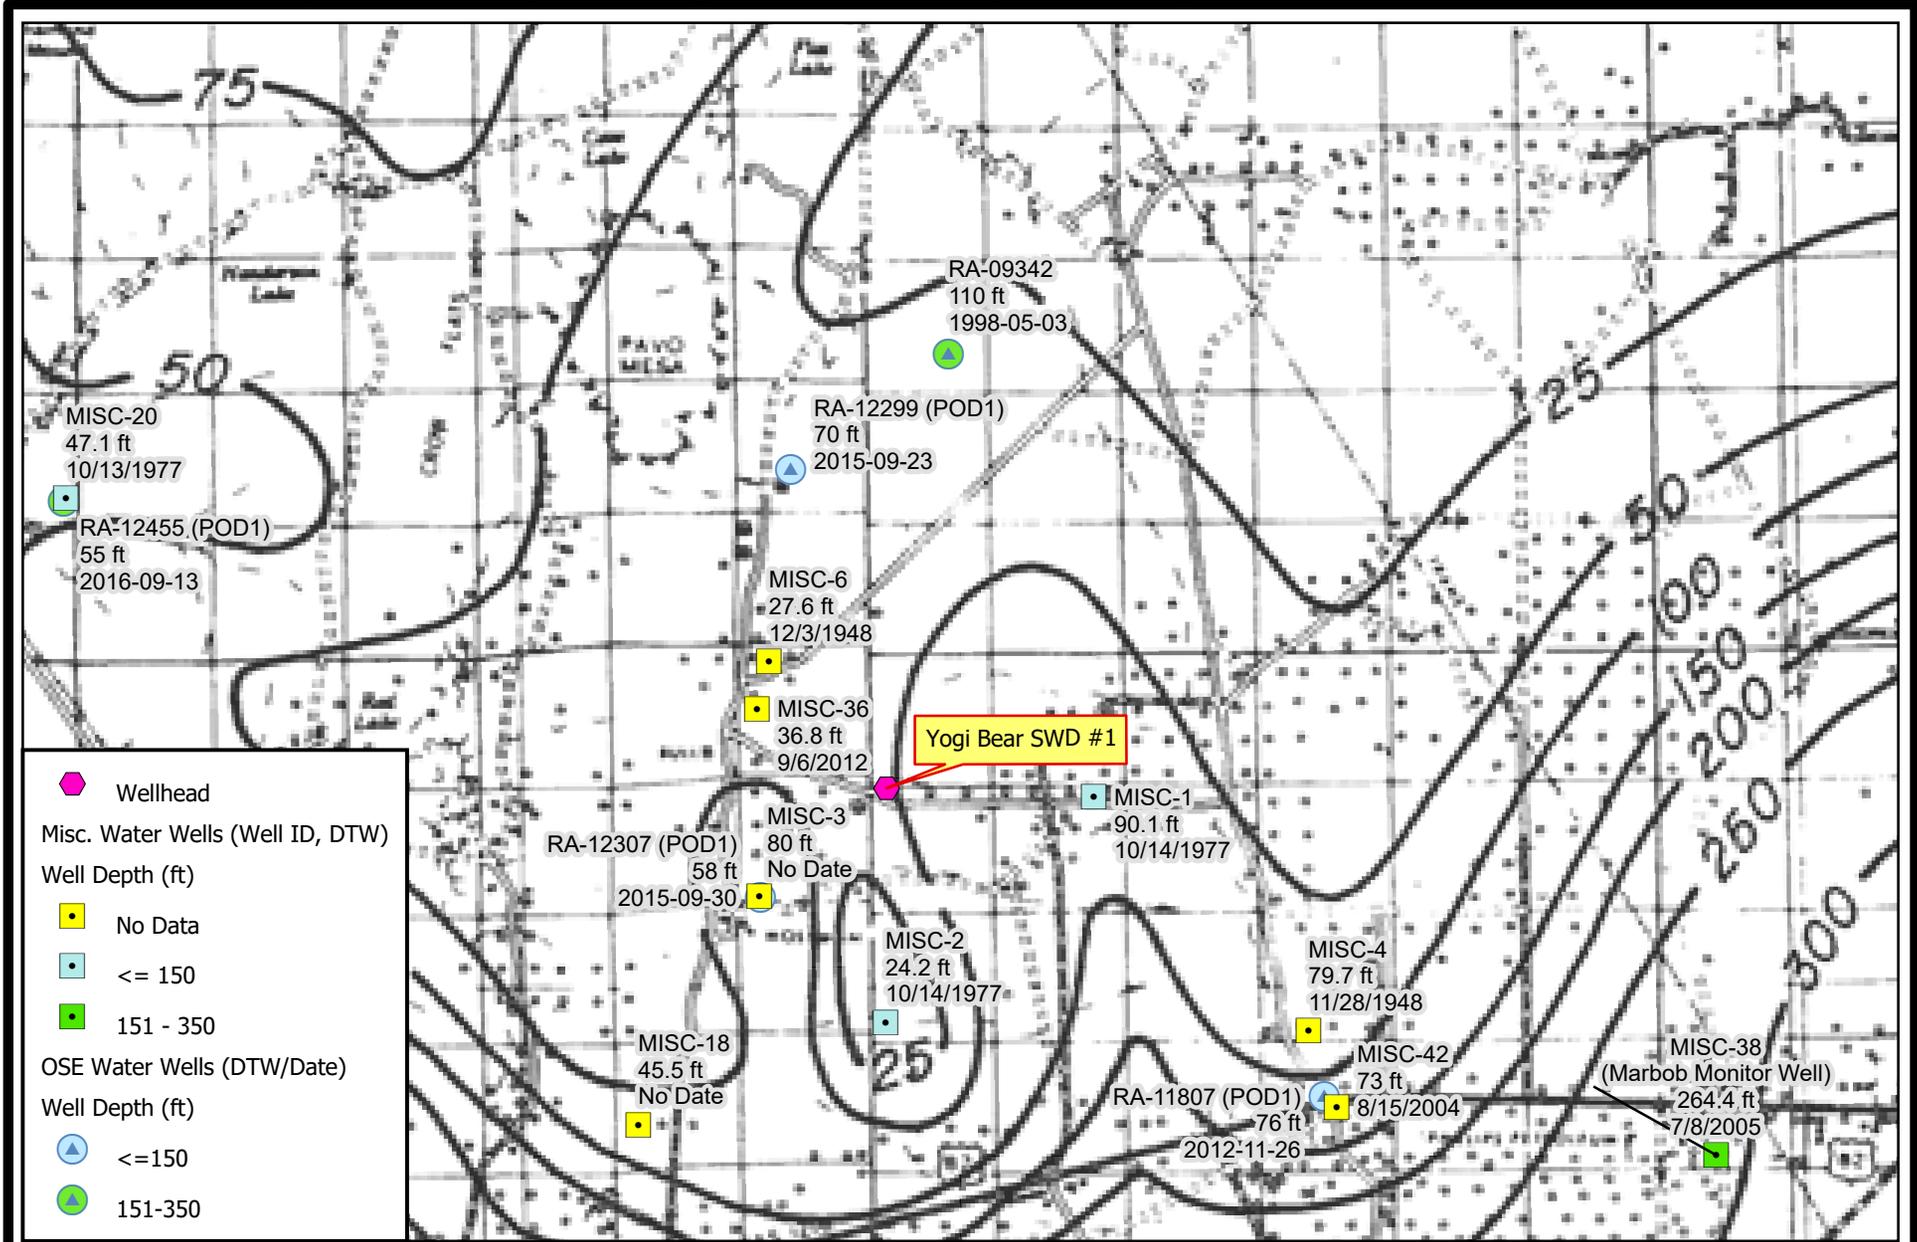
Plate 2  
 Dec. 2019

What is the shallowest depth to groundwater beneath the area affected by the release? <b>Plate 2</b>	48 (ft bgs)
Did this release impact groundwater or surface water?	<input type="checkbox"/> Yes <input checked="" type="checkbox"/> No
Are the lateral extents of the release within 300 feet of a continuously flowing watercourse or any other significant watercourse?	<input type="checkbox"/> Yes <input checked="" type="checkbox"/> No
Are the lateral extents of the release within 200 feet of any lakebed, sinkhole, or playa lake (measured from the ordinary high-water mark)?	<input type="checkbox"/> Yes <input checked="" type="checkbox"/> No
Are the lateral extents of the release within 300 feet of an occupied permanent residence, school, hospital, institution, or church?	<input type="checkbox"/> Yes <input checked="" type="checkbox"/> No
Are the lateral extents of the release within 500 horizontal feet of a spring or a private domestic fresh water well used by less than five households for domestic or stock watering purposes?	<input type="checkbox"/> Yes <input checked="" type="checkbox"/> No

Depth to Water  
 Basemap: USGS OFR-95  
 Murchison Oil & Gas, Inc.  
 Yogi Bear SWD #1

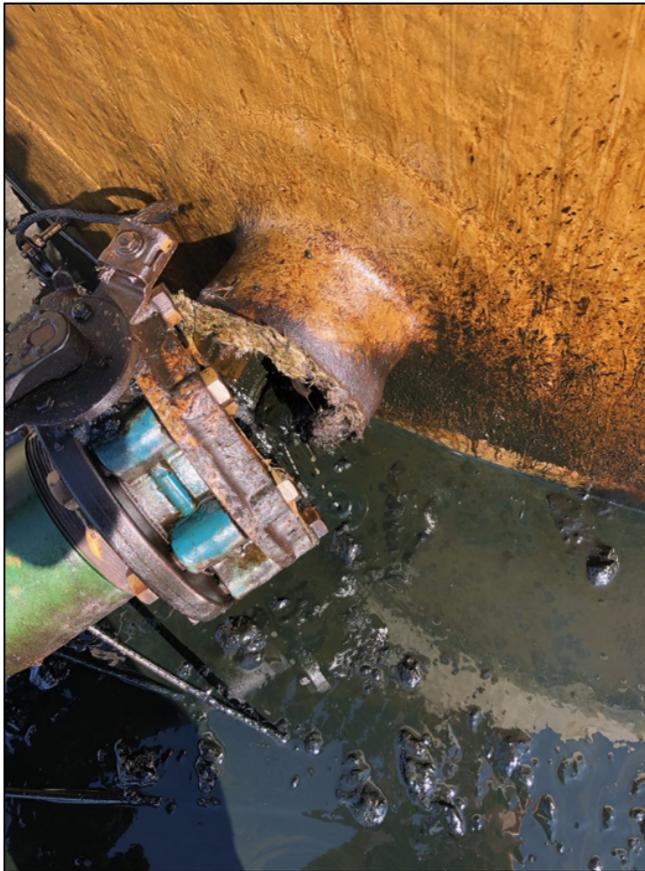
**Figure 1**

Source of release: Broken gun barrel

R.T. Hicks Consultants submits the attached C-141 on the behalf of Murchison Oil and Gas, Inc. (Murchison) for a release that occurred on November 4, 2019 when a water truck driver failed to disconnect the hose of the load line before attempting to leave the Yogi Bear SWD #1 location. The load line broke at the gun barrel of a tank, spilling 650 barrels produced water into the surrounding lined containment.

Murchison responded immediately by shutting in all wells serviced by the Yogi Bear SWD #1 until repairs were made. Murchison dispatched a vacuum truck which recovered approximately 650 barrels from the containment. After all fluids were removed, the gravel was stripped from the containment to inspect the liner which indicated no loss of integrity. Jim Griswold (NMOCD) was notified of the release via a voicemail on November 6, 2019 by R.T. Hicks Consultants.

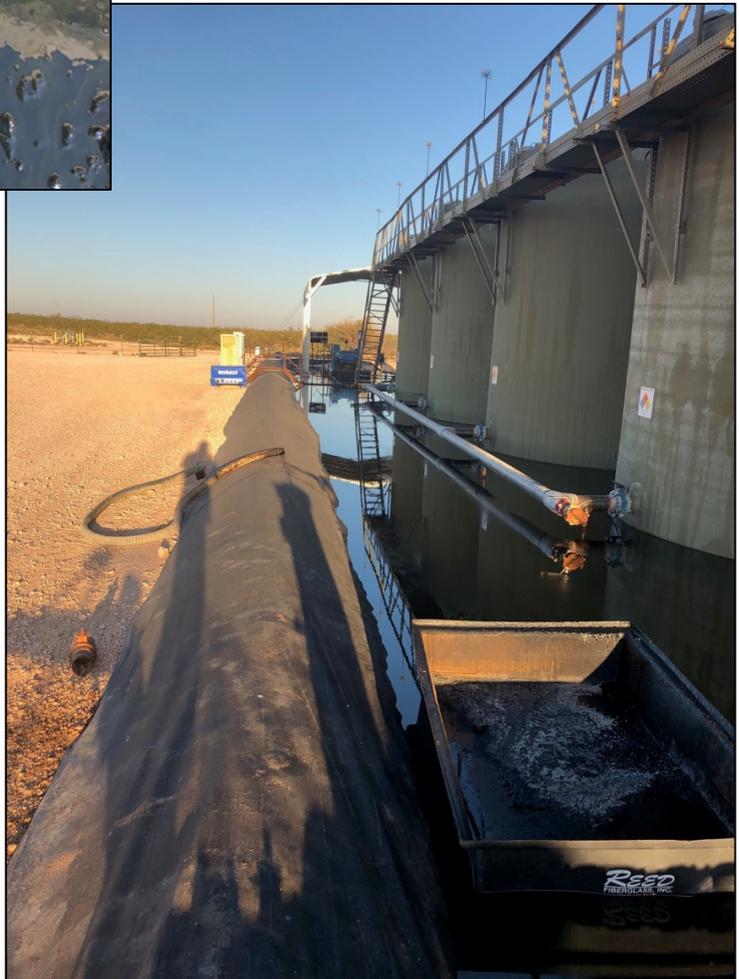
**Figure 2**

Lined containment filled with released fluid

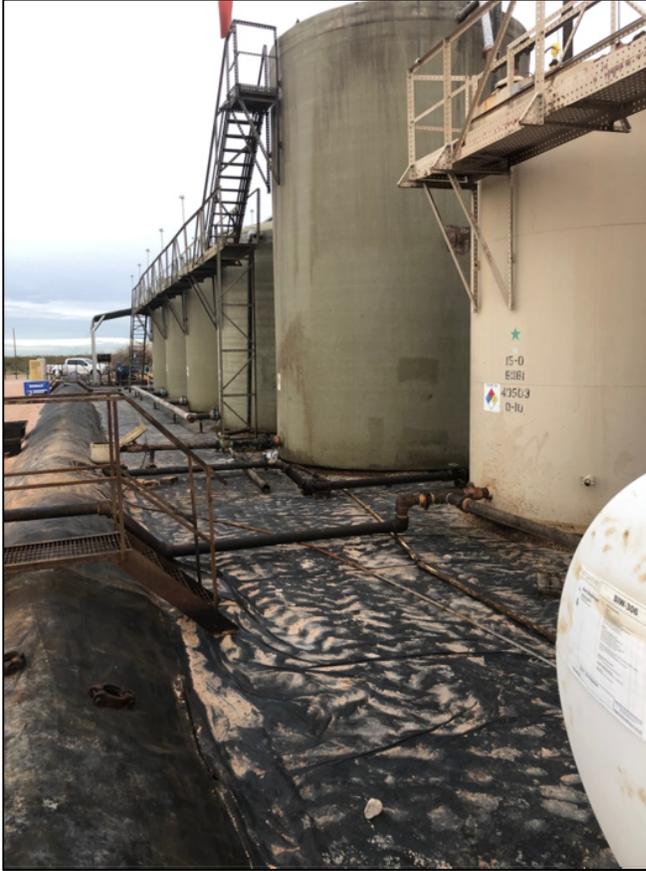
**Figure 3**

Exposed liner near release point

The C-141 including assessment and closure forms is enclosed, as well as a site map with associated photographs, and a map of groundwater depth. Because 100 percent of the released fluid was recovered and the containment liner remained intact, remediation is not warranted and we respectfully request regulatory closure of this release. We also intend this submission as notice that Murchison will replace the gravel over the liner no sooner than 7:00 AM on December 30, 2019. Please contact Murchison to make arrangements to witness this activity or contact me with any questions.

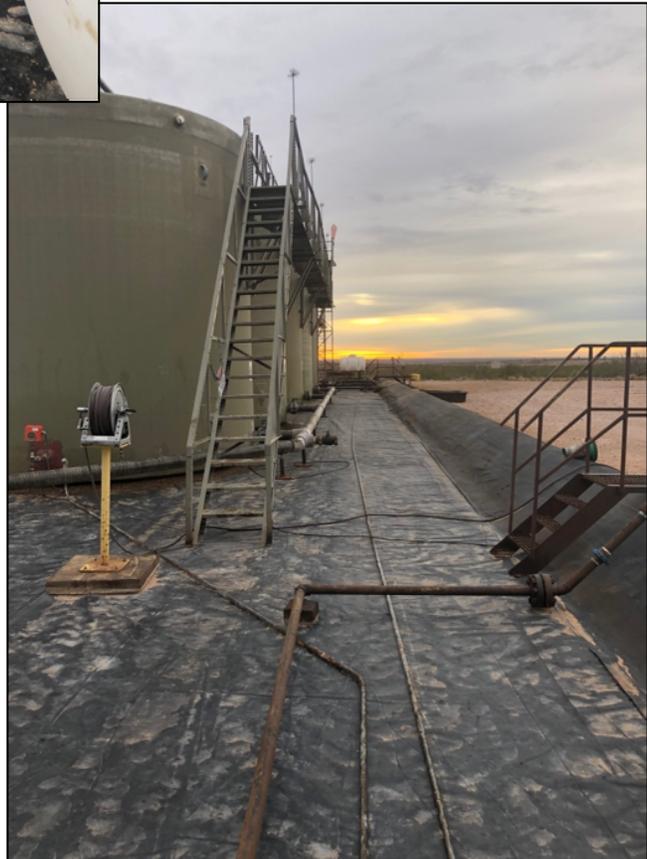
**Figure 4**

Exposed liner
