Revised Remediation Summary and Site Closure Request

**Cabo Wabo 25 Federal Com
#003H (2RP-5473)**

COG Operating, LLC.
600 W Illinois Avenue
Midland, TX 79701

TRC Environmental Corporation
10 Desta Dr. STE 150E
Midland, TX 79705

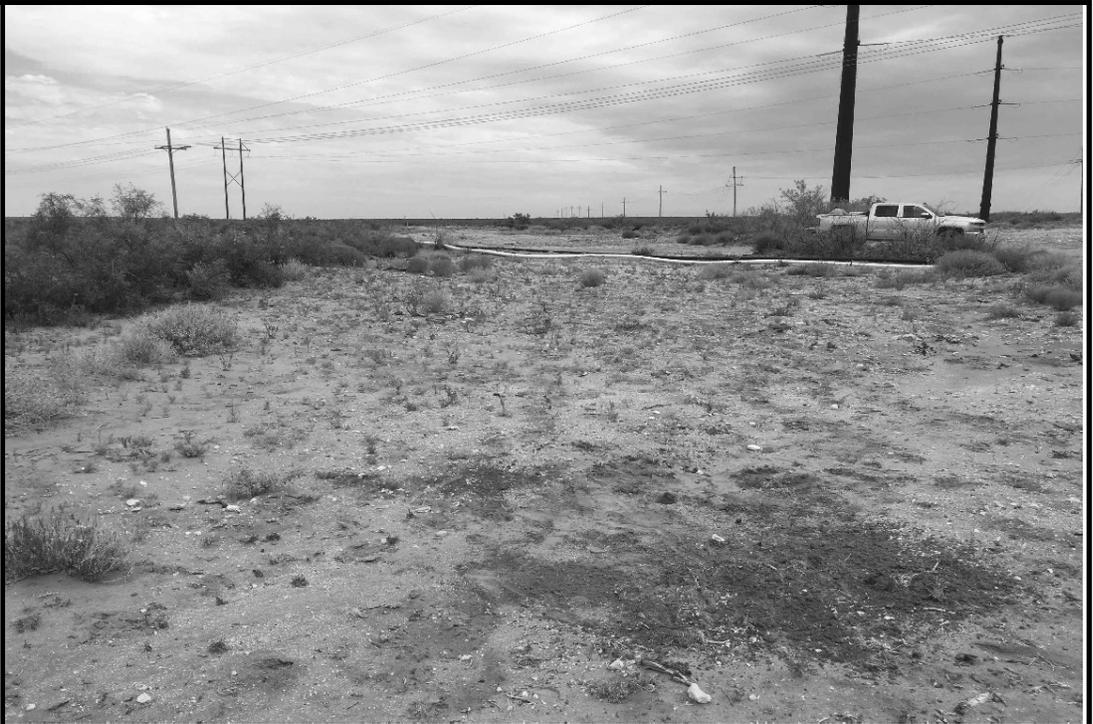
Photograph No. 2

Description:
View of the
impacted area.

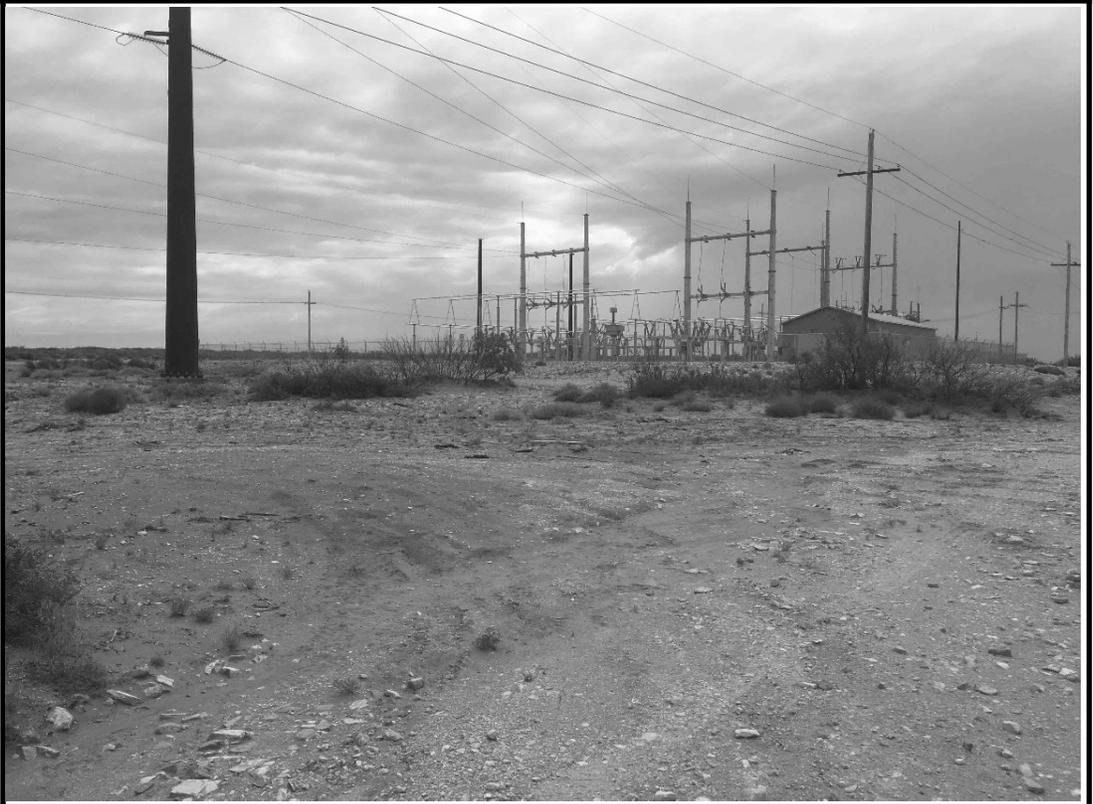
Photograph No. 3

Description: View
of impacted area.

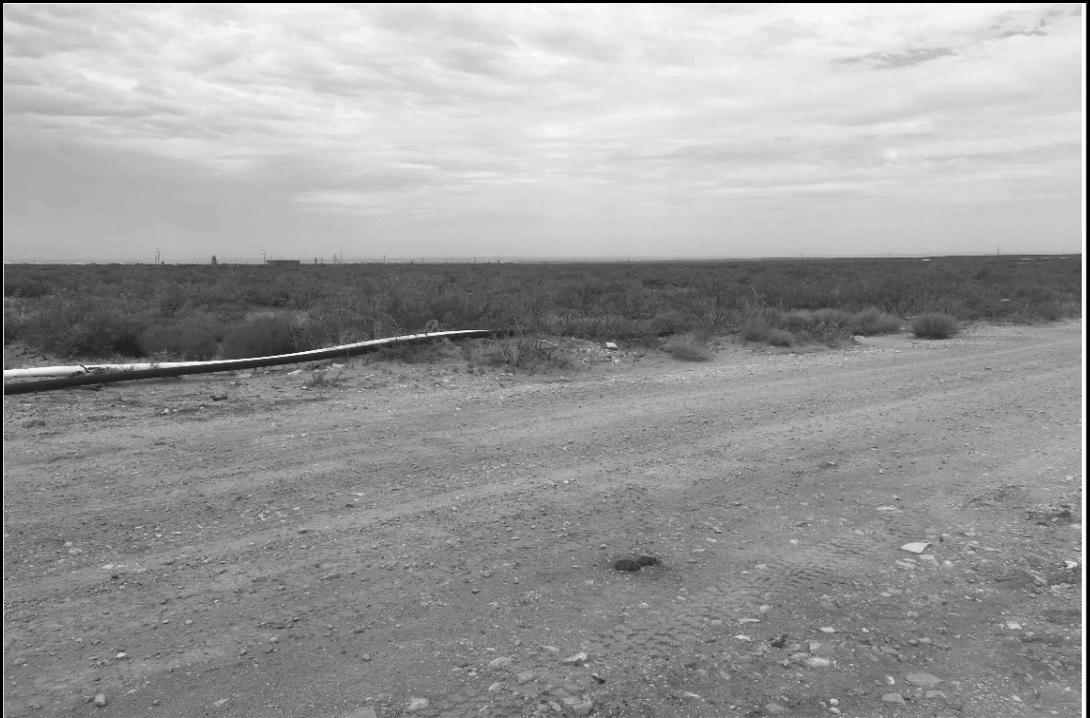
Photograph No. 4

Description: View
of impacted area.

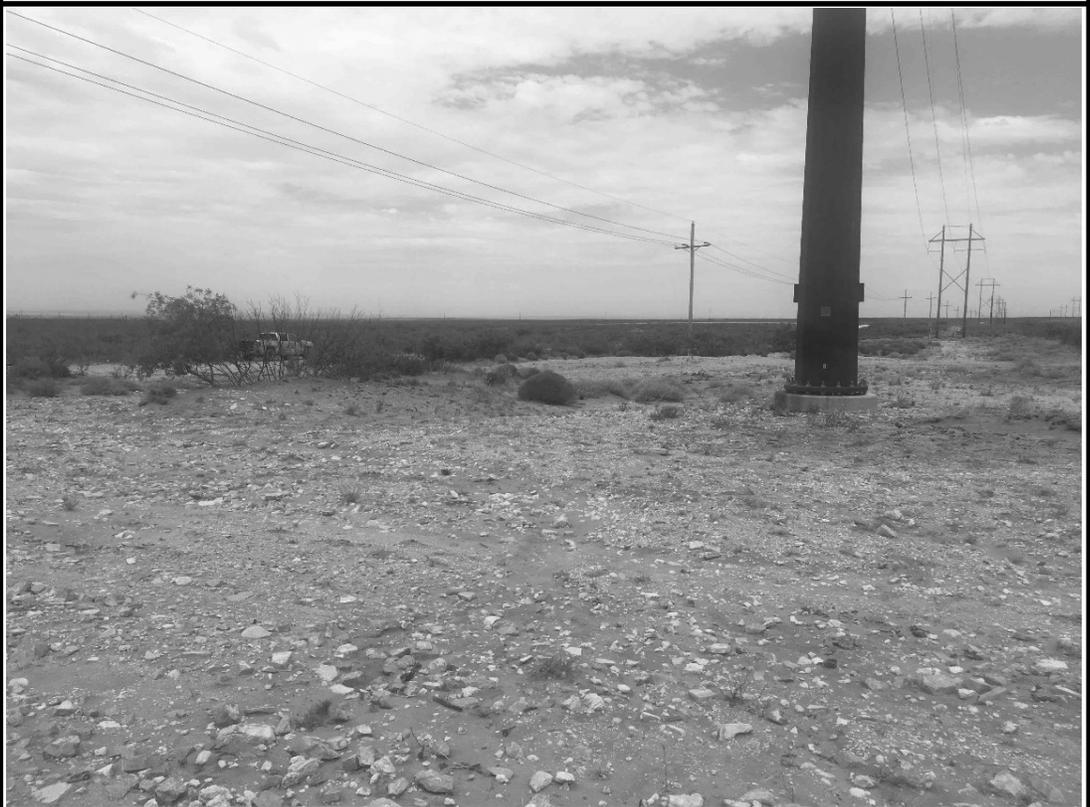
Photograph No. 5

Description:
View of trench delineation.

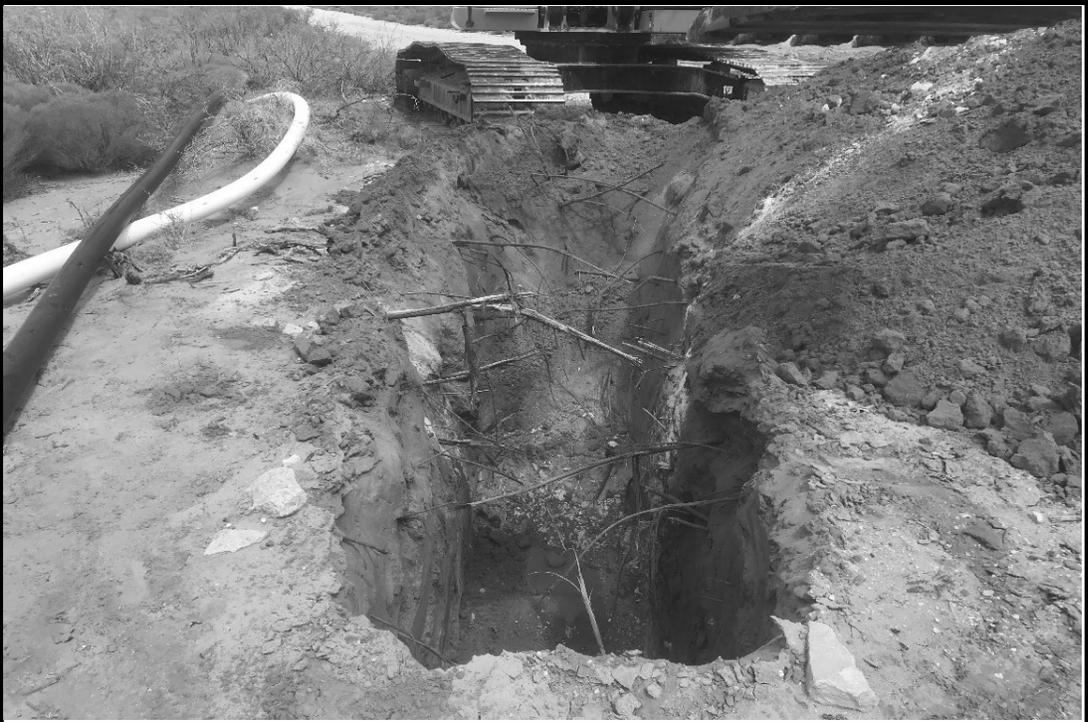
Photograph No. 6

Description:
View of excavation activities.

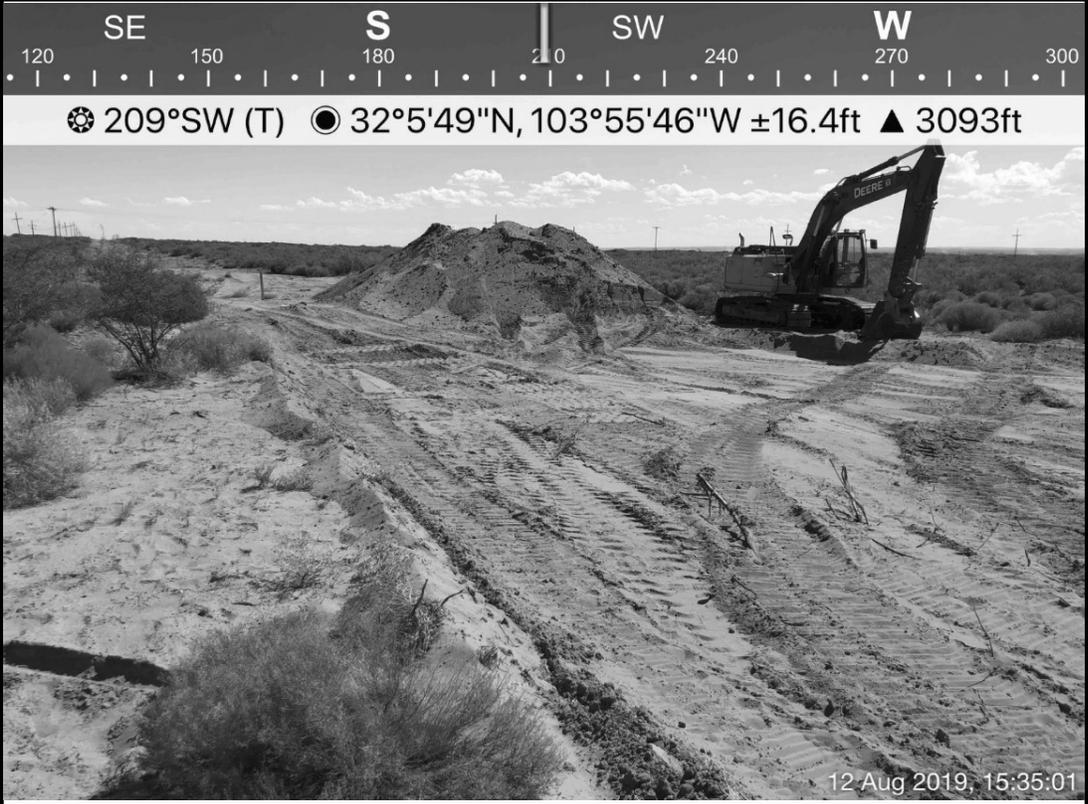
Photograph No. 5

Description:
View of
excavation
activities.

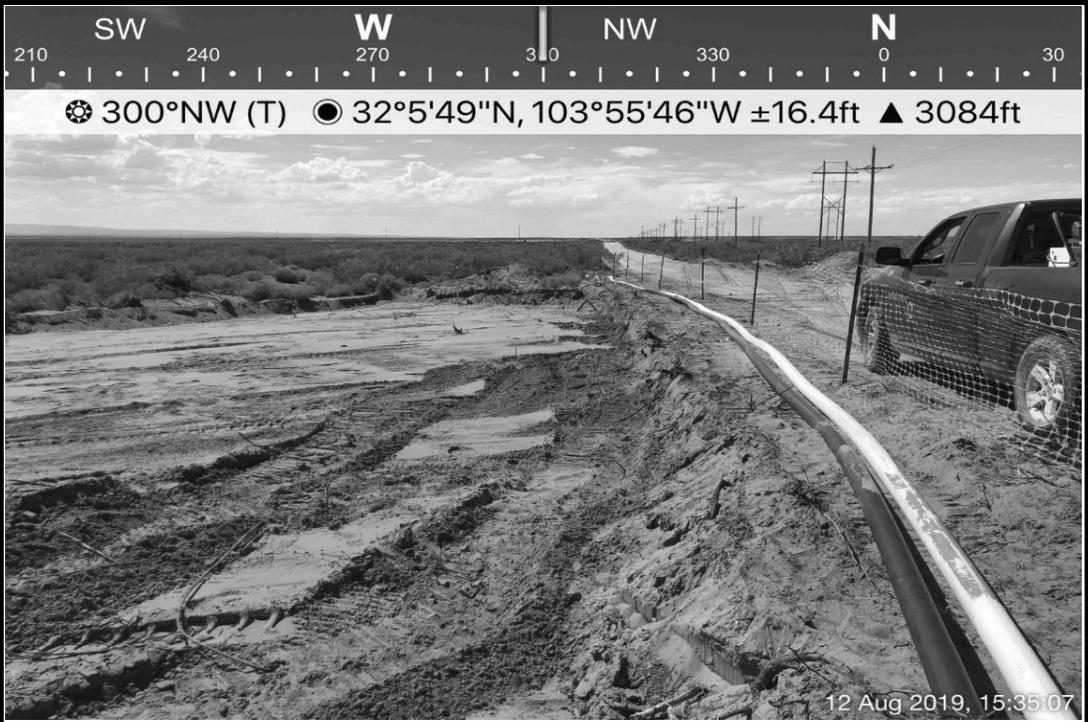
Photograph No. 6

Description:
View of
excavation
activities.

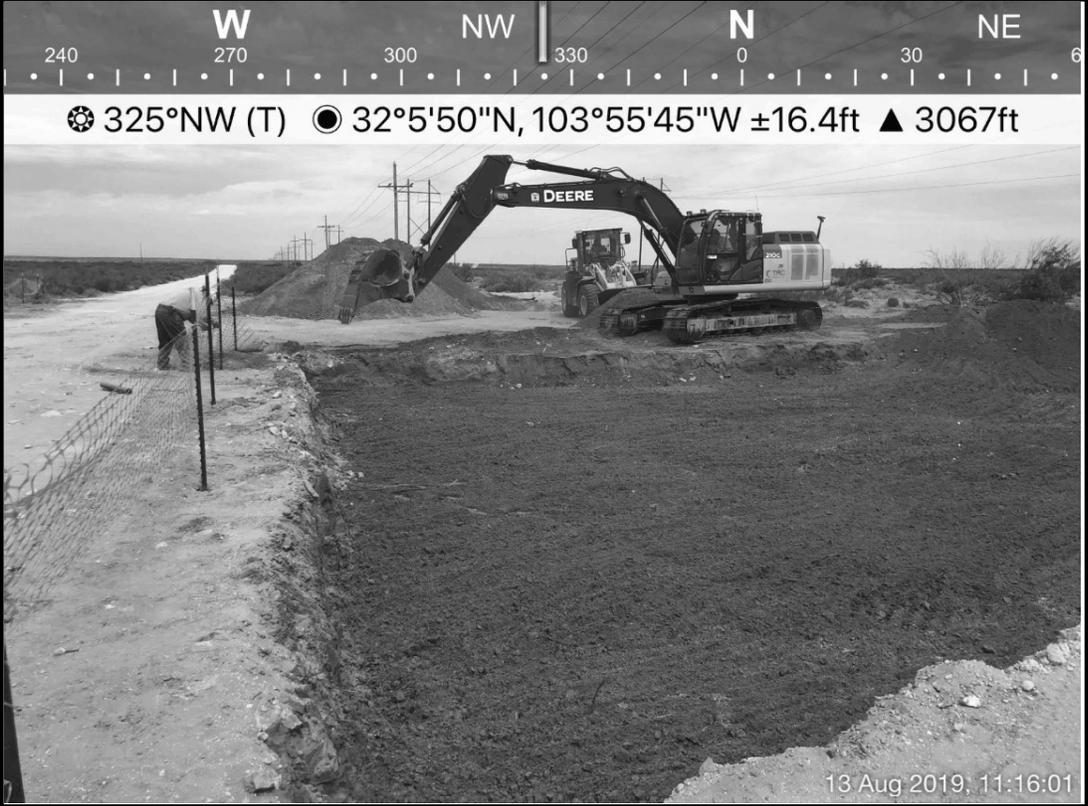
Photograph No. 7

Description:
View of
excavation
activities.

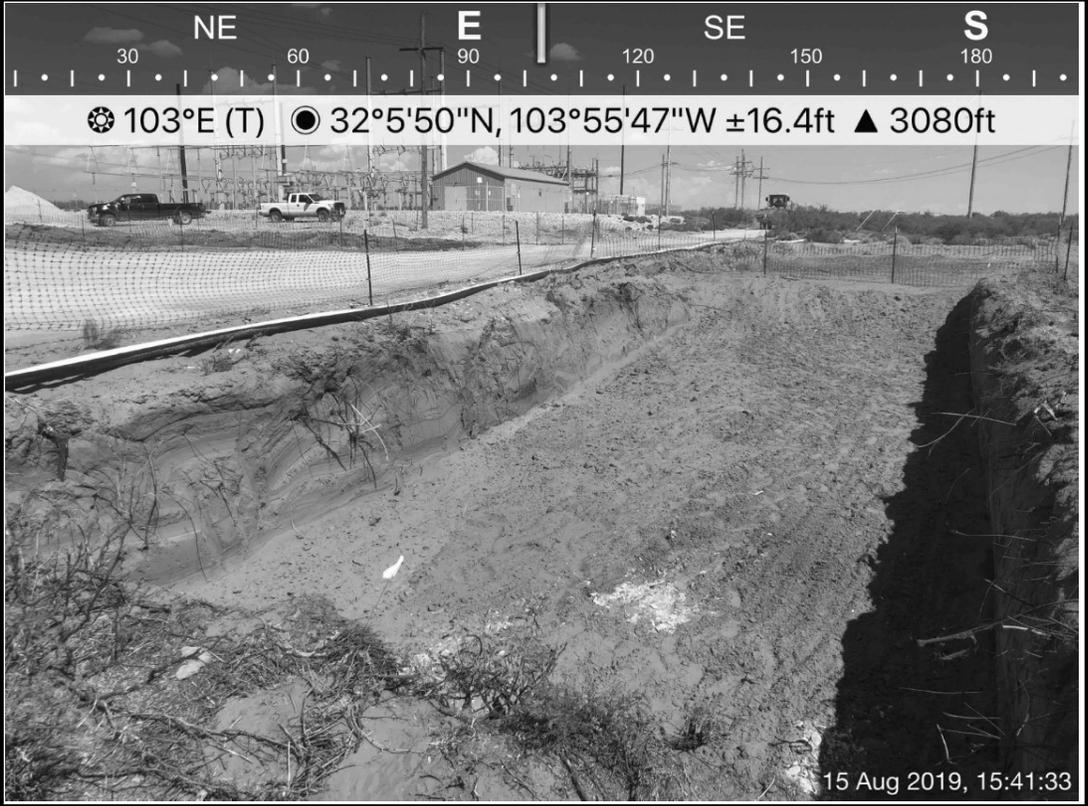
Photograph No. 9

Description:
View of
additional
excavation
activities in
Area A.

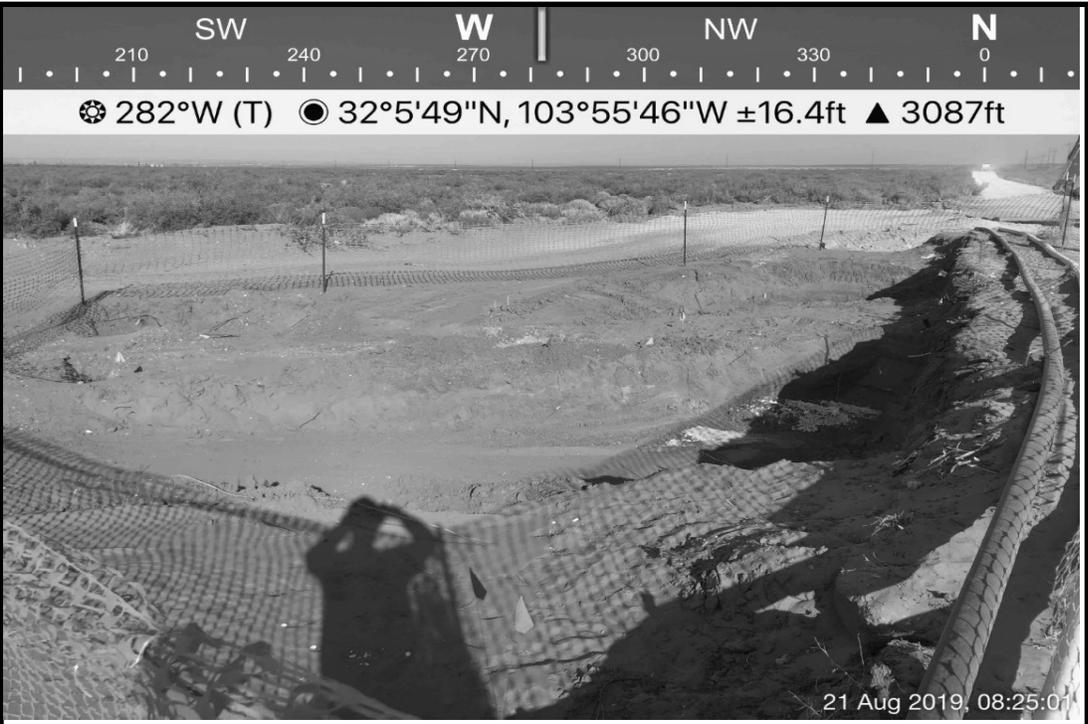
Photograph No. 10

Description:
View of the
Enlink high
pressure
pipeline.

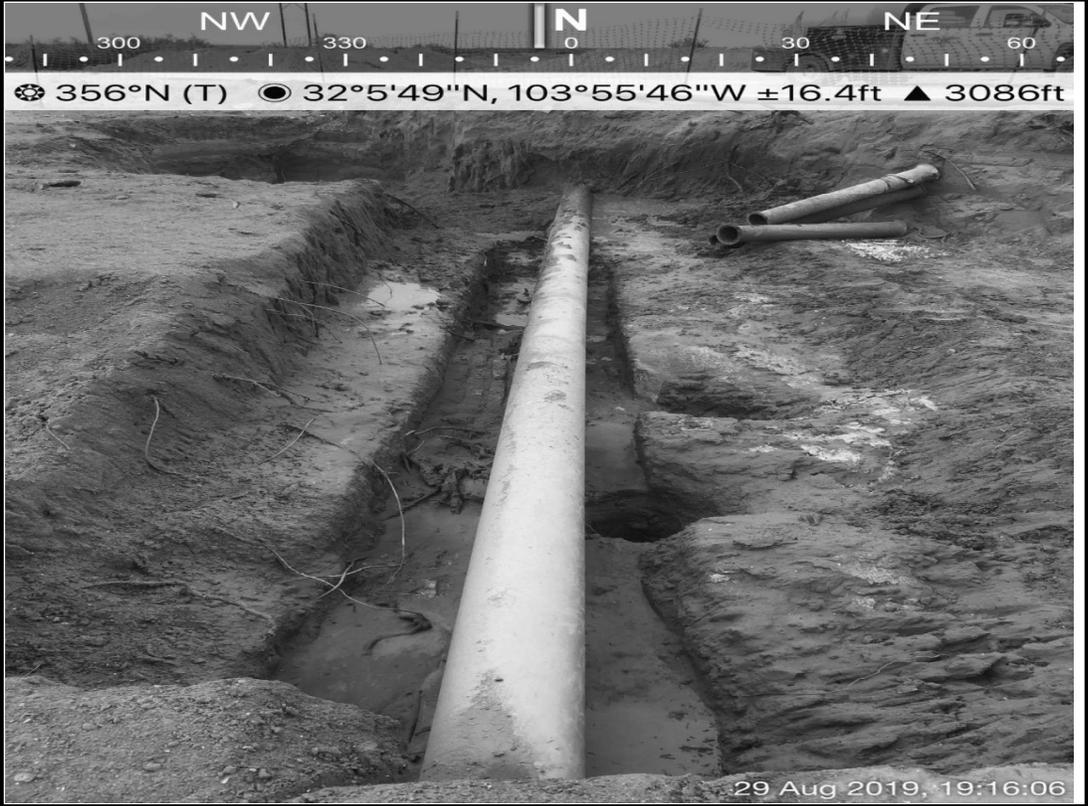
Photograph No.
11

Description:
View of the
Enlink high
pressure
pipeline.

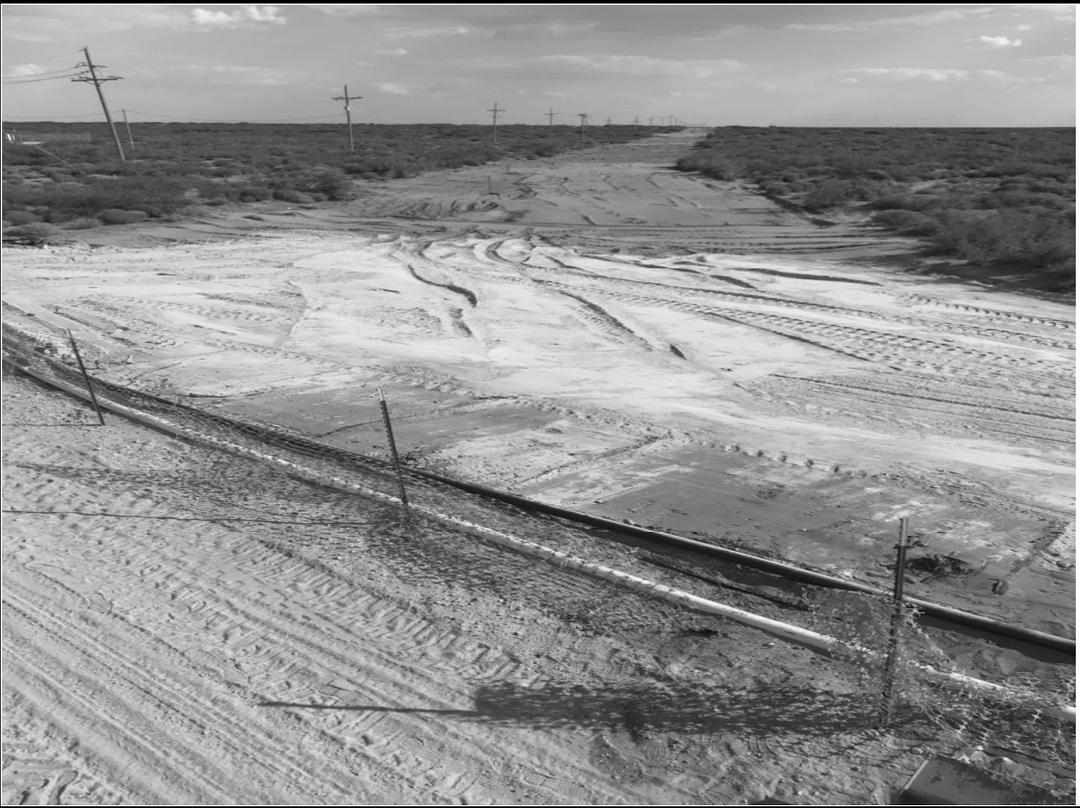
**Photograph No.
13**

**Description:
View of
remediated area
after backfill
activities.**

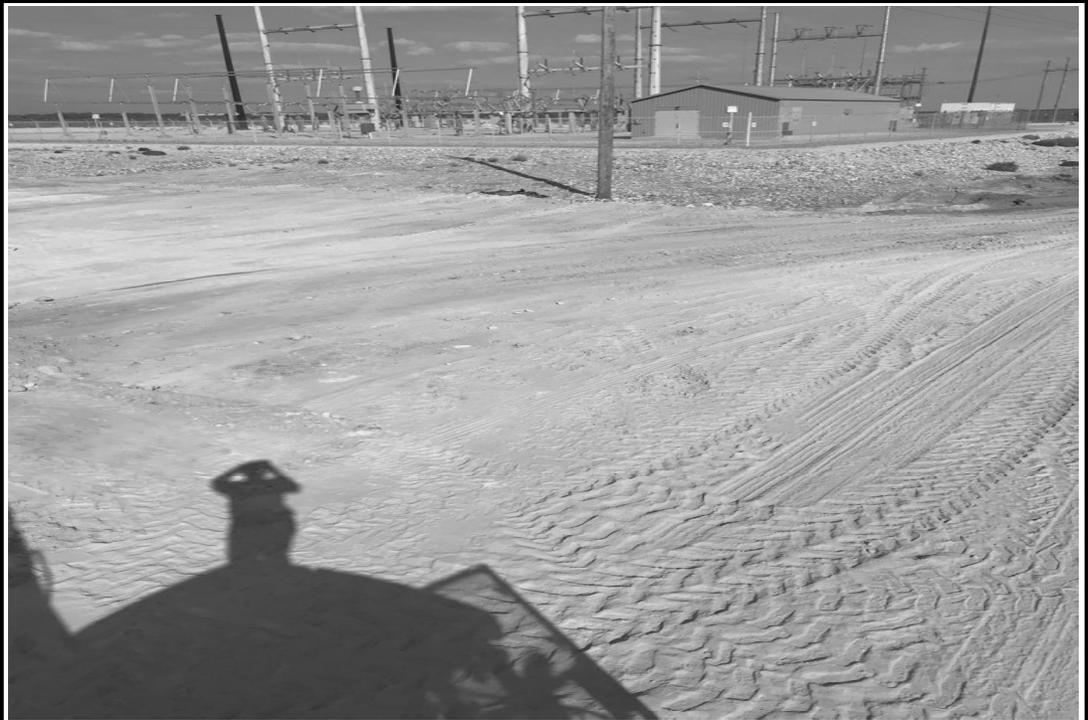
**Photograph No.
14**

**Description:
View of the
remediated area
after backfill
activities.**
