Release Notification

Site Name Denton SWD Trunk Line	Site Type: SWD trunkline
Date Release Discovered 11/4/18	API# (if applicable)

Work Plan: 1RP-5271– Denton Trunkline Spill Workplan

On November 4, 2018 a spill occurred at the Fasken Oil and Ranch (Fasken) Denton Trunkline when an unused meter began leaking due to corrosion. The well location at battery is located at 33.031060°, - 103.180635°. During the spill, an estimated 50 barrels of produced water was released and no crude oil was released. 30 barrels of produced water were recovered according to Fasken operations personnel. The spill occurred in a pasture that is not an active well pad or maintained production site.

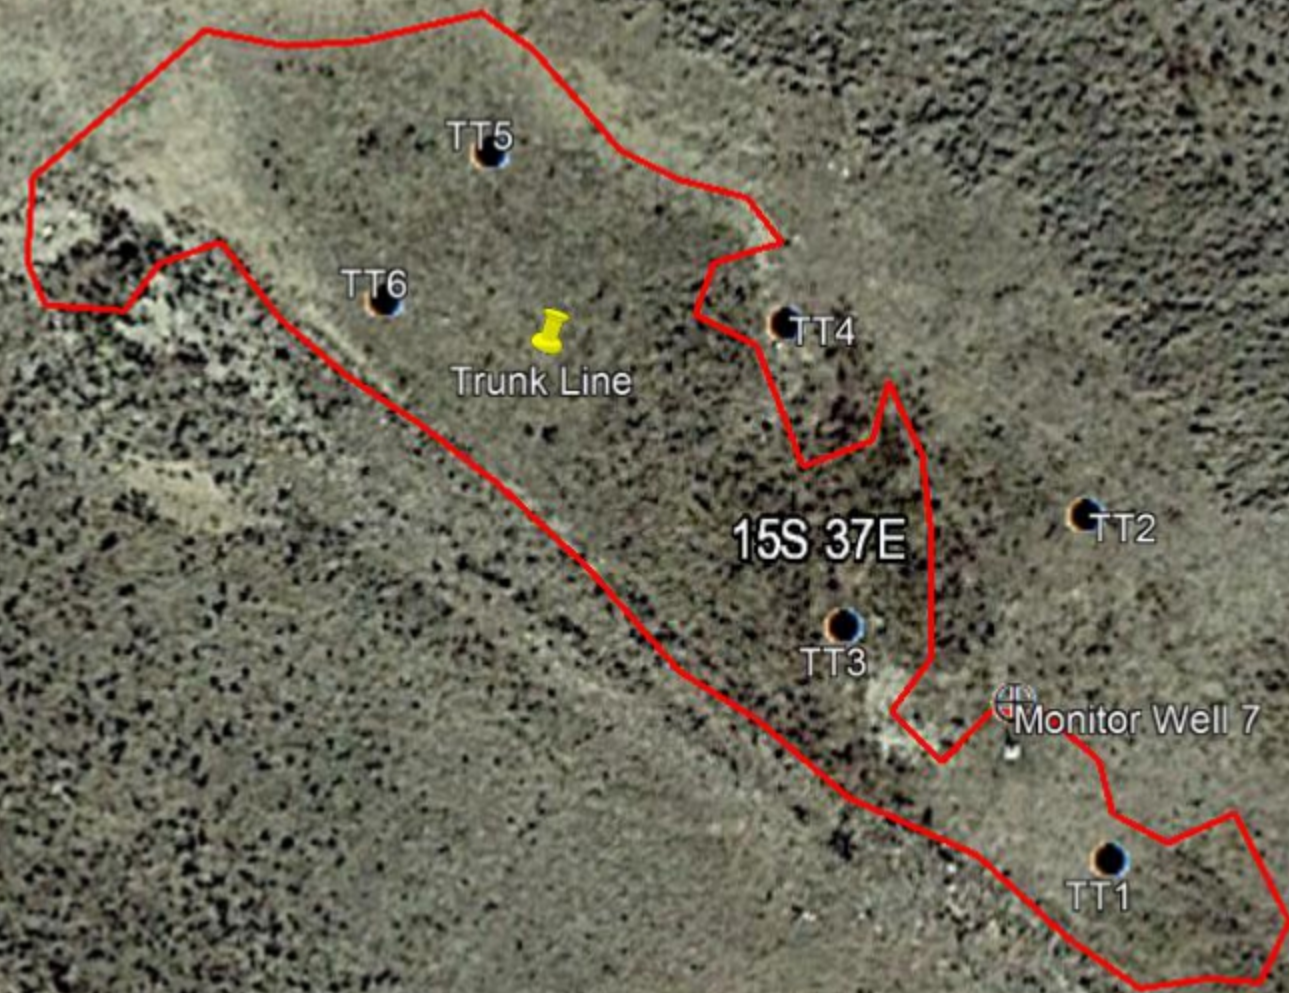
Legend

- Test Trenches
- ⊕ Monitor Well 7
- ⬭ Spill Area 4
- 📌 Trunk Line

On January 30, 2019, six trenches were opened with a backhoe and two samples were collected from each trench: surface and one foot below surface. Laboratory analysis of the samples shows that chloride concentrations are high in the surface samples at TT-1, TT-3, and TT-5, and TT-6. All other sample concentrations are below the NMAC 19.15.29.12, Table 1 concentration of 10,000 mg/kg chloride. A site plan showing these sample locations is included as an attachment.

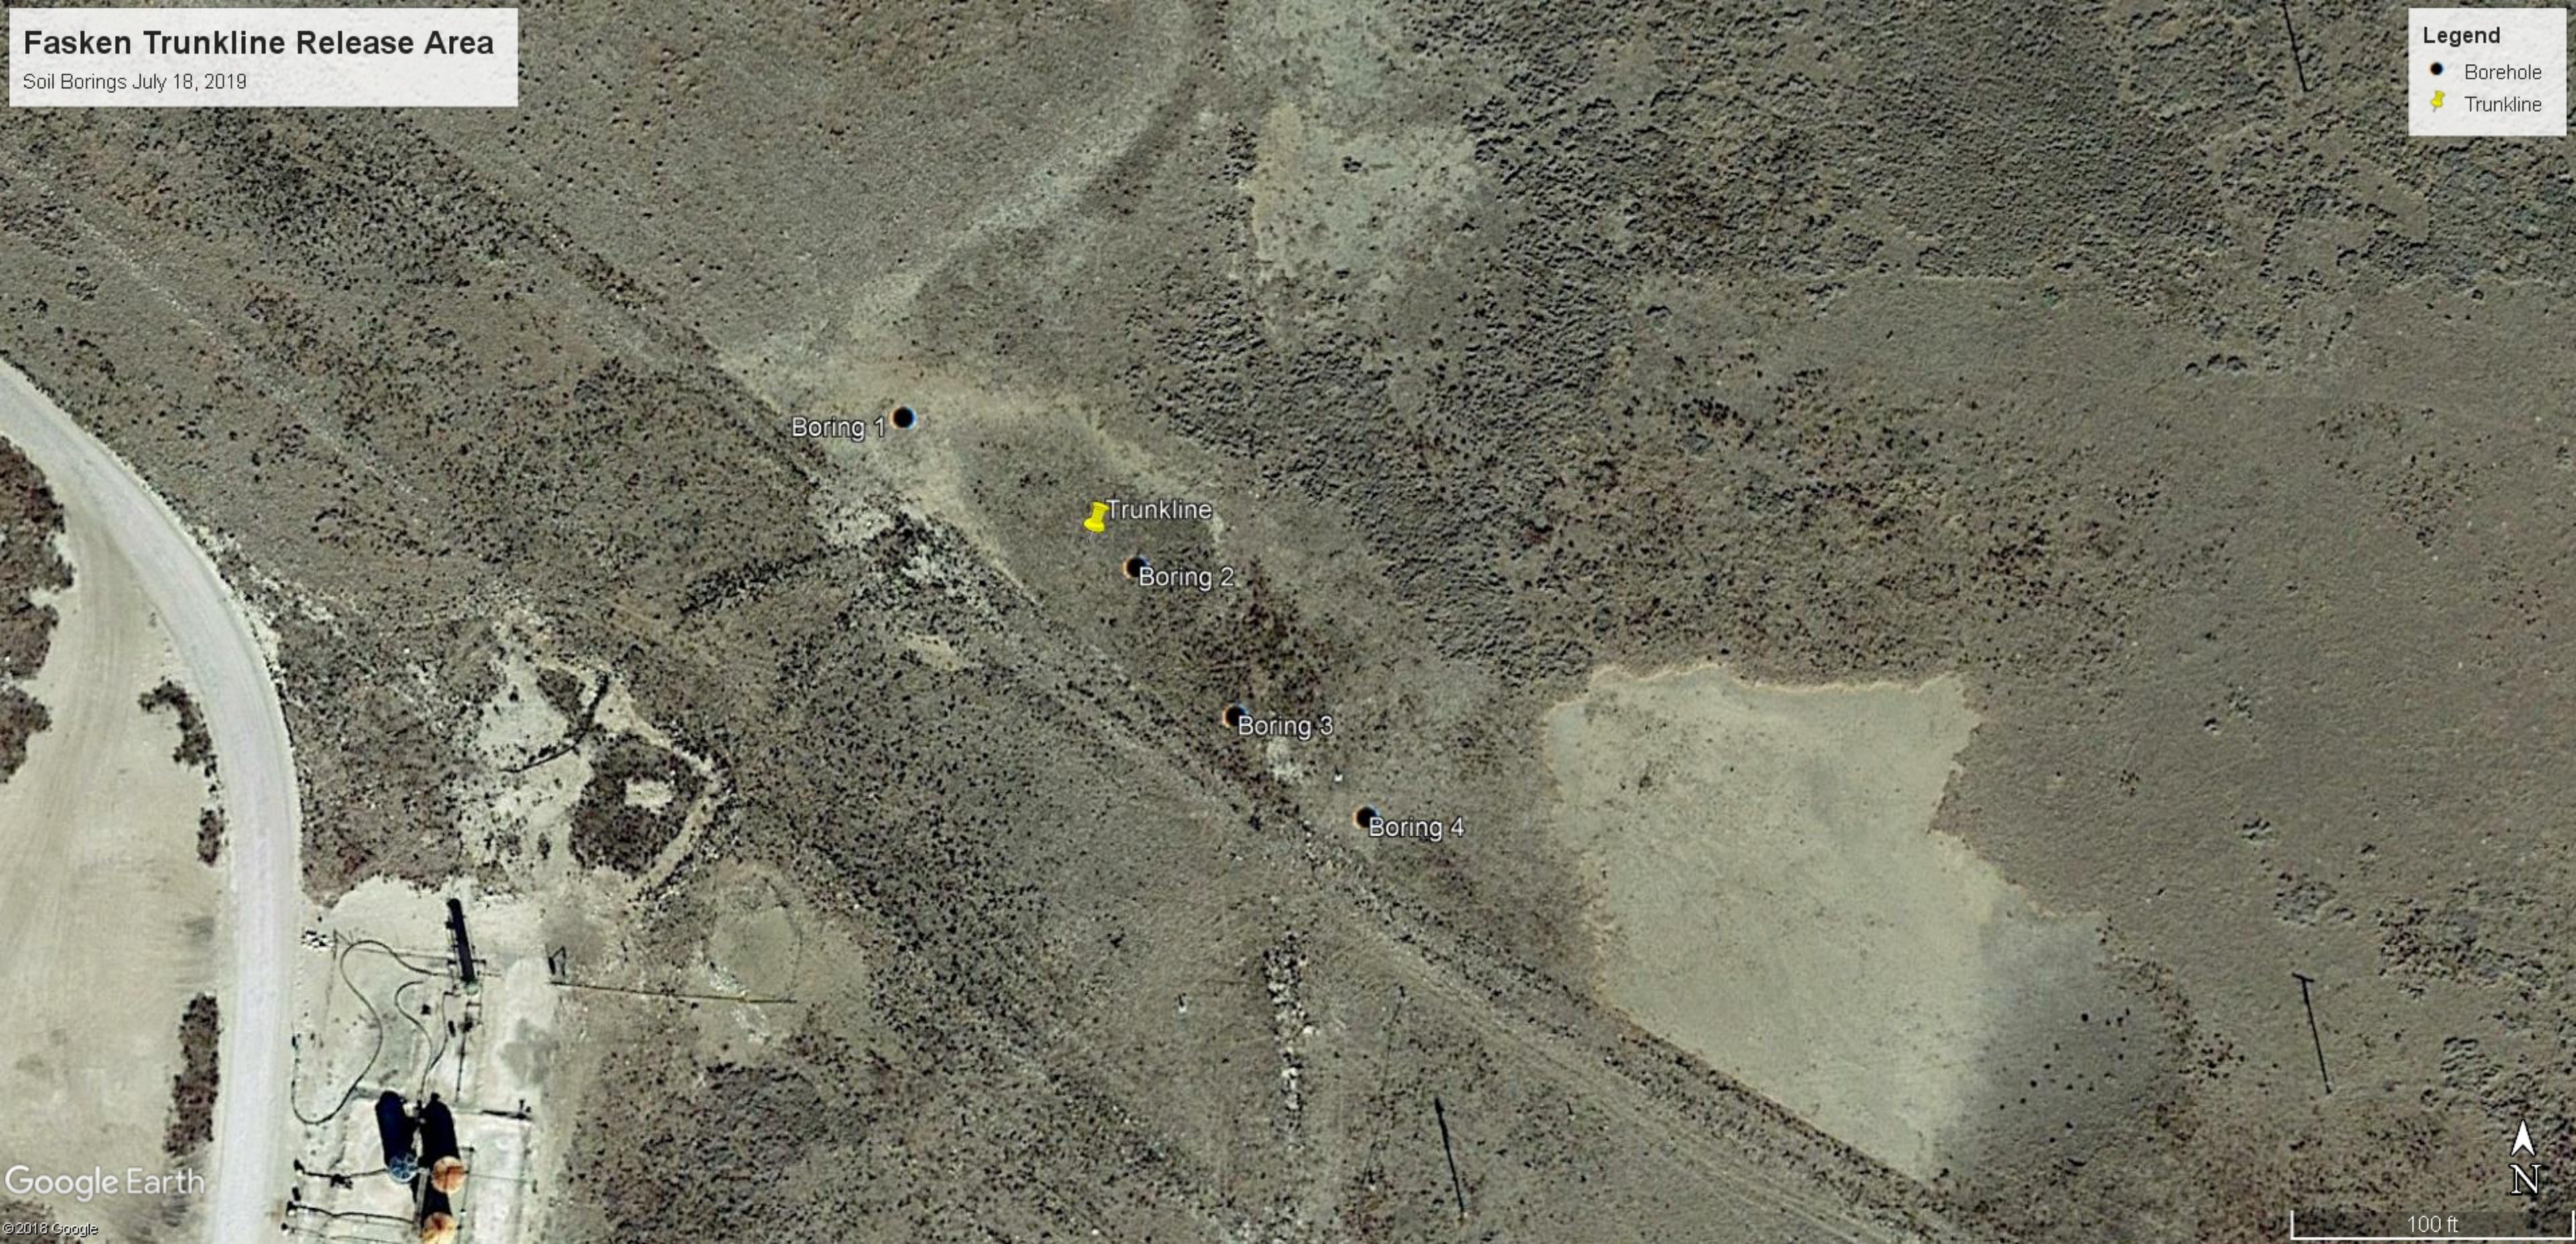
Soil Borings July 18, 2019

Fasken Trunkline Release Area

On July 18, 2019, four borings were advanced with a hollow stem auger mobile drilling machine. Samples were continuously collected by hollow stem auger in two-foot increments. Four samples from each boring were submitted for laboratory analysis, except B-2 where six samples were collected. The maximum concentration for these samples was 4,200 mg/kg chloride in B-2 at 0-2' feet. All other concentrations in all borings were lower, showing a consistent trend of decreasing concentration with depth. Except for B-2, the 20-22' feet sample from each boring was well below 600 mg/kg chloride. At B-2 a concentration of 1,710 was observed at 25 to 27' when the boring was terminated. In accordance with NMAC 19.15.29.11(A)(5)(c) further delineation to 600 mg/kg is not needed. A site plan showing these sample locations is included as an attachment.
