NRM2004831561

Deferment Request

Re: EW Walden Battery
Case # Pending

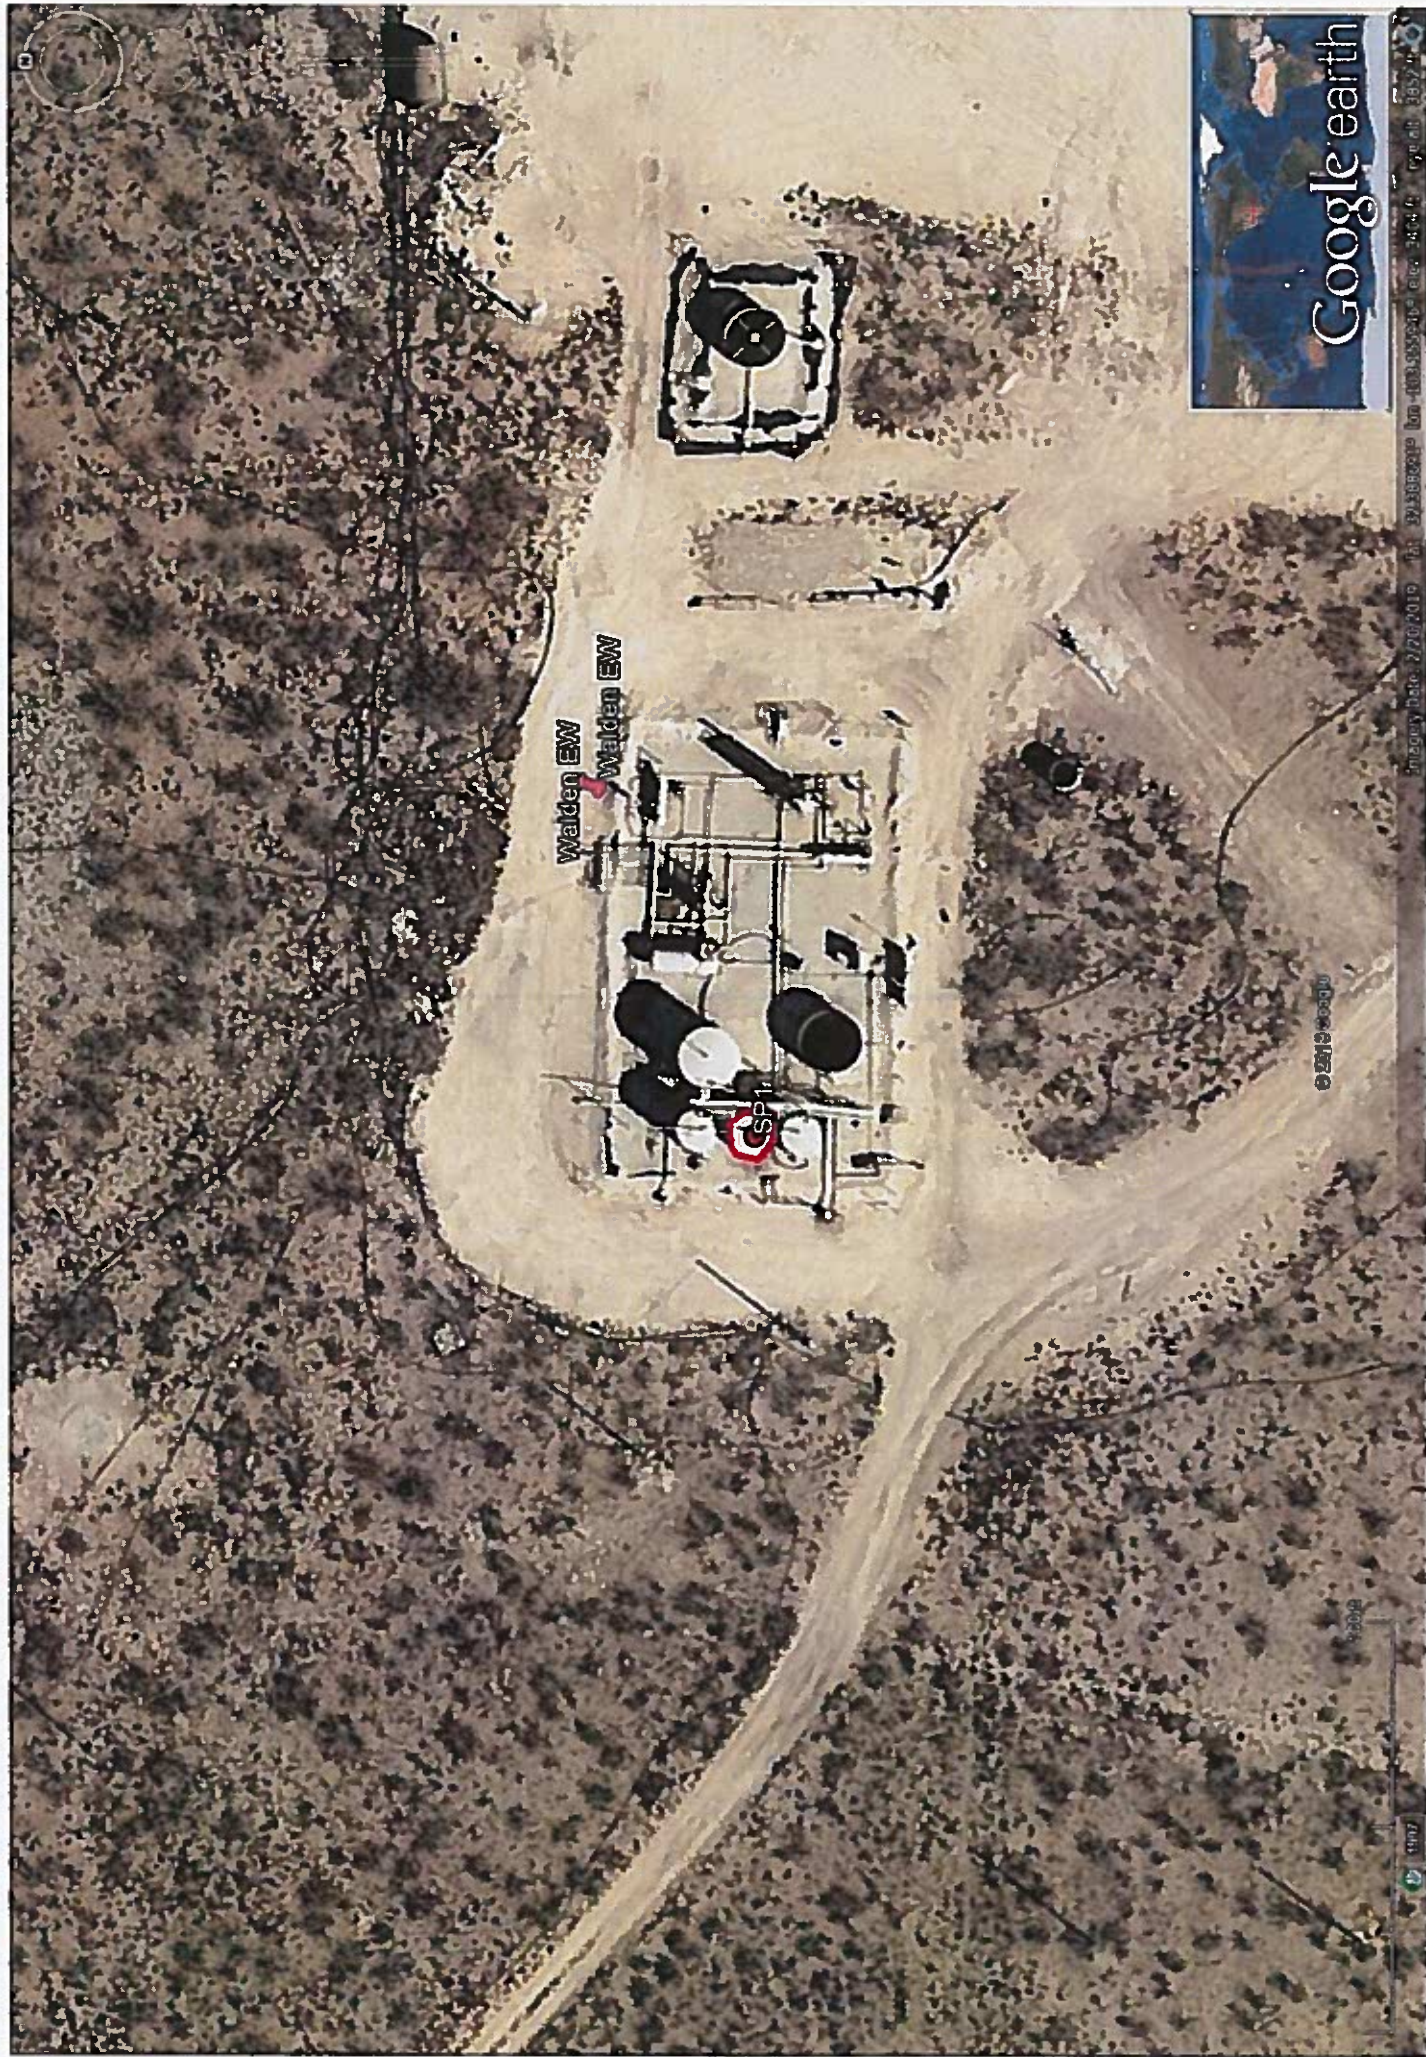
EW WALDEN

Map ID	Sample Date	Sample ID	Depth	Chloride	Benzene	Toulene	Ethybenzene	Total Xylenes	Total BTEX	GRO	DRO	EXT DRO	GPS Coordinates
SP1	12/5/2019	SP1 @ 6"	6"	416	3.24	18.3	18.2	29.5	69.2	922	13800	4130	32.3886649 -103.1560357
SP1	12/18/2019	SP1 @ 2'	2'	N/A	22.2	16.8	119	151	309	5490	12600	2880	
SP1	12/18/2019	SP1 @ 4'	4'	N/A	17	126	87.1	183	413	6290	19400	3760	
SP1	12/18/2019	SP1 @ 6'	6'	N/A	0.071	0.352	0.529	0.948	1.9	28.9	457	173	
SP1	12/18/2019	SP1 @ 7'	7'	N/A	<0.050	<0.050	0.115	<0.150	<0.300	<10.0	109	24.2	
SP1	12/27/2019	SP1 @ 8.5'	8.5'	N/A	<0.050	<0.050	<0.050	<0.150	<0.300	<10.0	44.8	<10.0

A surface sample was not taken due to a Hydrovac being used to excavate the surface area prior to delineation to expose underground electric, gas, and oil lines.

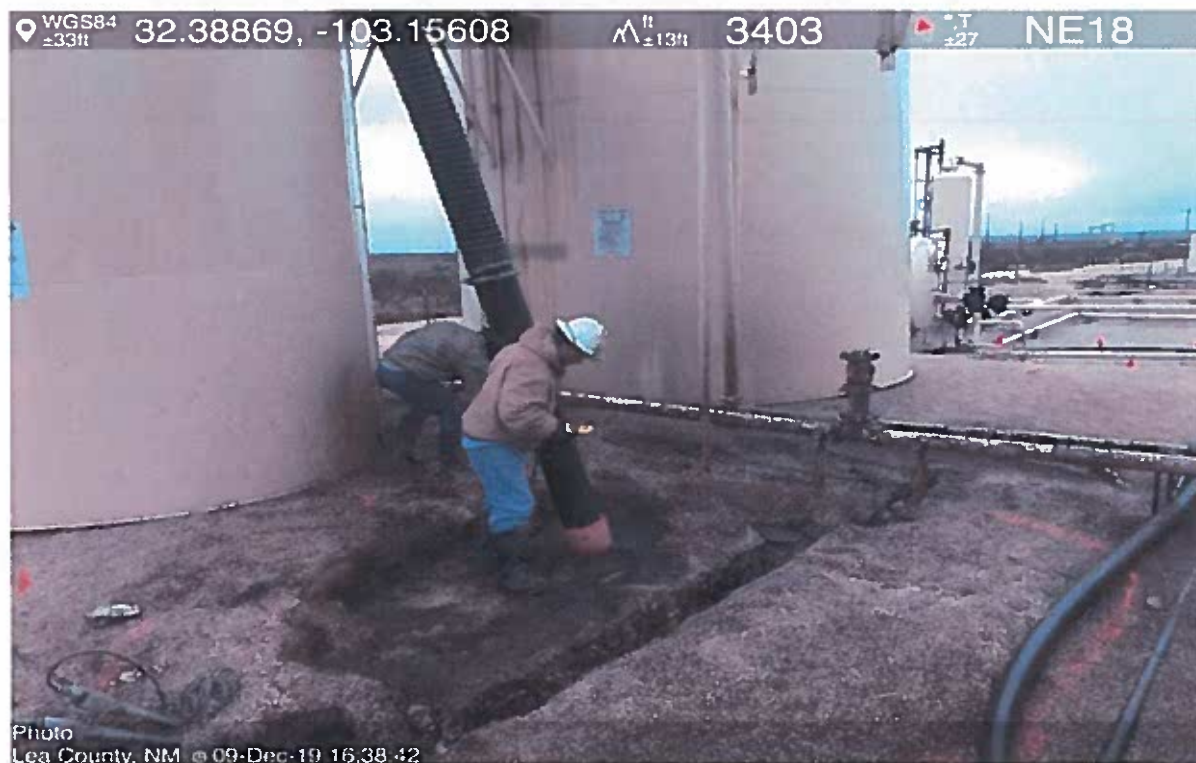
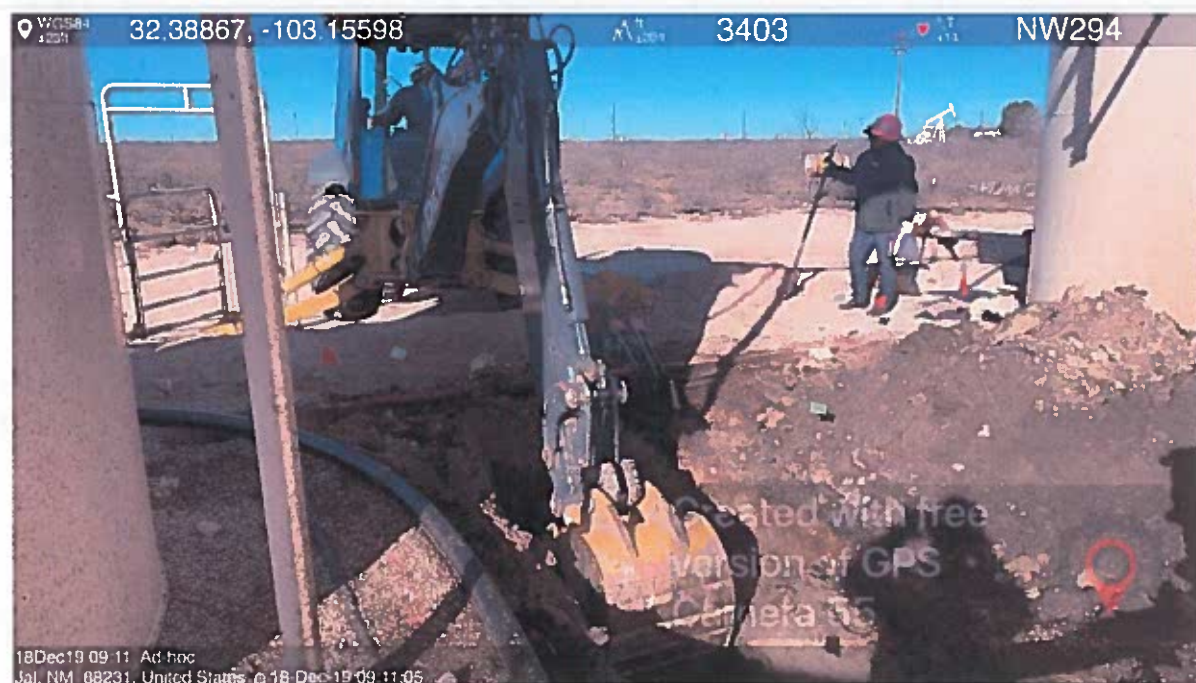
After the tank was removed Apache Corporation excavated approximately 6 inches beneath the tank utilizing a hydro-vac. A bottom sample was collected and submitted to a commercial laboratory for analysis of chloride, TPH, and BTEX. The laboratory results showed TPH levels above table one standards. On December 18, 2019 a vertical was conducted utilizing a backhoe in a depth of 7 feet below ground surface. All samples collected from the vertical were submitted to a commercial laboratory for analysis of TPH, and BTEX. The laboratory results were above table one standards for GRO and DRO. On December 27, 2019 the vertical was advanced an additional 1.5 feet to a depth of 8.5 feet. The 8.5 foot sample was taken to a commercial laboratory for analysis of TPH and BTEX. Laboratory results were below table one standards for TPH and BTEX.

Due to the release being beneath the middle tank inside the battery further excavation could not be conducted. All excavated material (12 cubic yards) was exported to an NMOCD approved disposal facility. The excavation was backfilled with clean imported caliche and a new tank was installed.
