SOIL REMEDIATION ACTIVITIES REPORT AND CLOSURE REQUEST

PLAINS PIPELINE, L.P.

HOBBS TO WASSON 6" PIPELINE RELEASE

NMOCD INCIDENT #: 1RP-5617

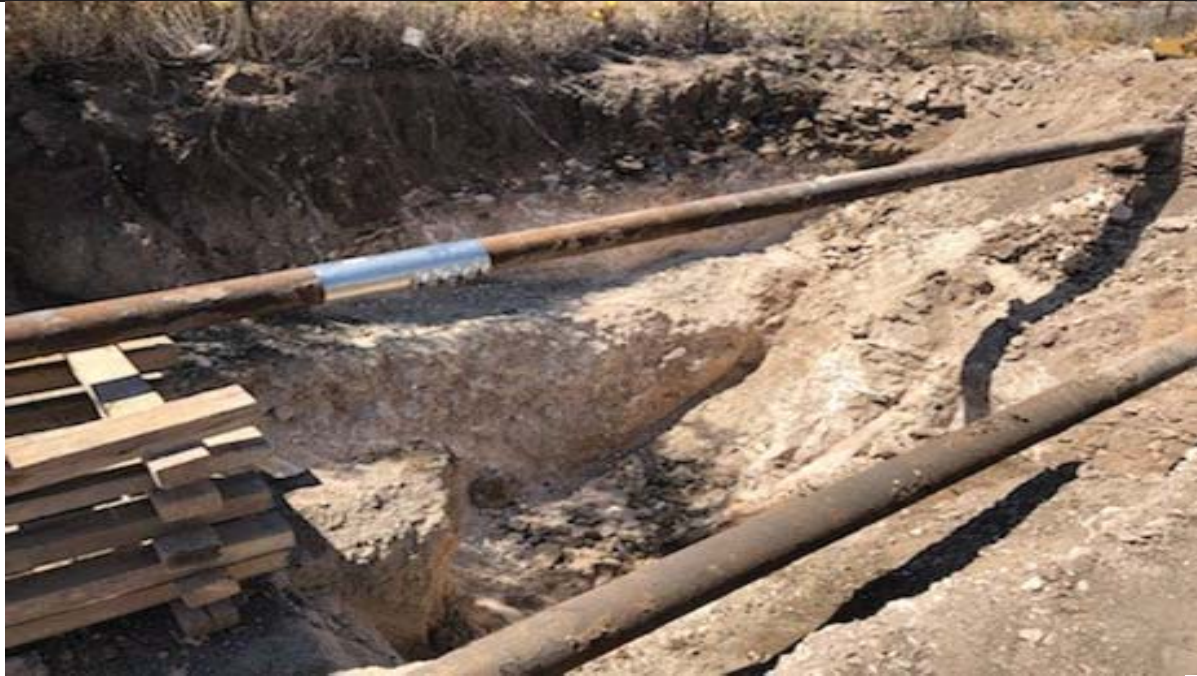
Direction: West

Description: View of release area and excavation.

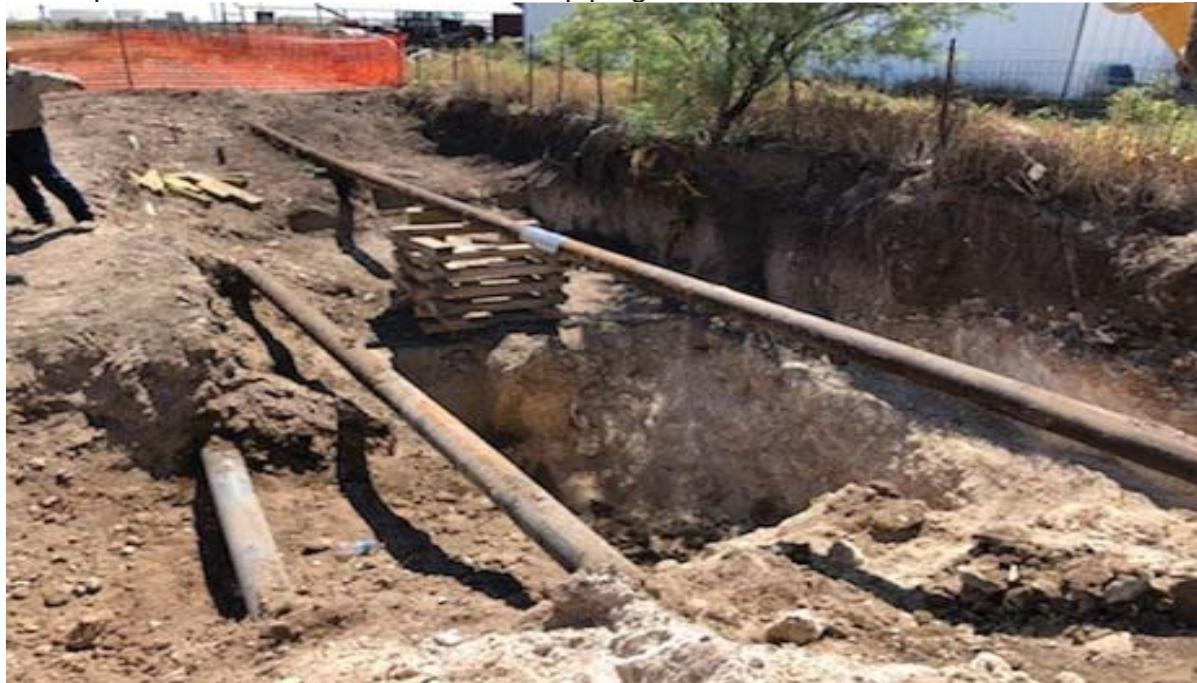
**Photograph No 2.**

Description: View of excavation beneath piping.

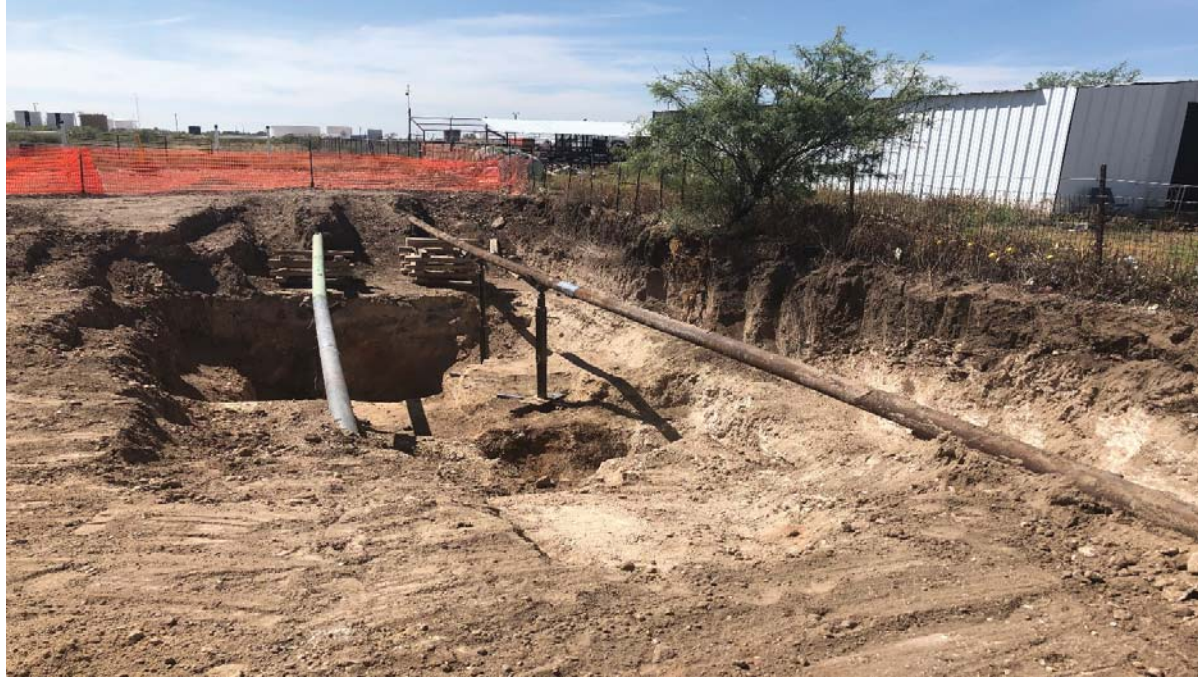
Photograph No 3.

Description: View of excavation beneath piping

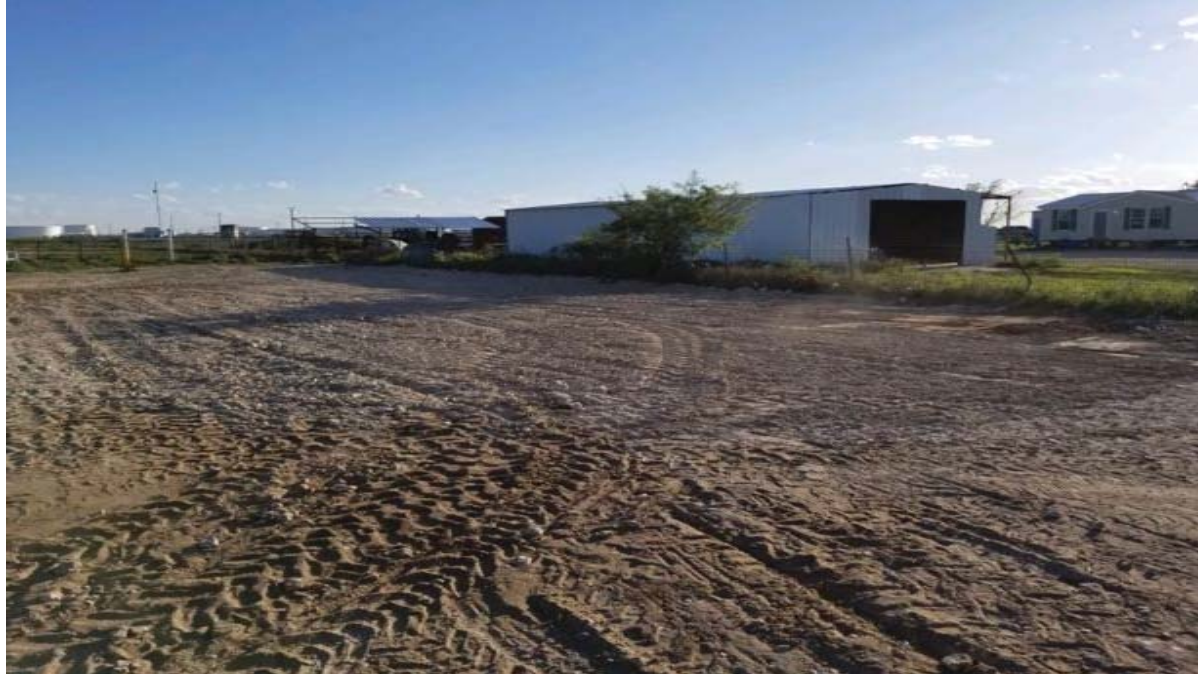
**Photograph No 4.**

Description: View of backfilled excavation in vicinity of trenches V-1 and V-2.

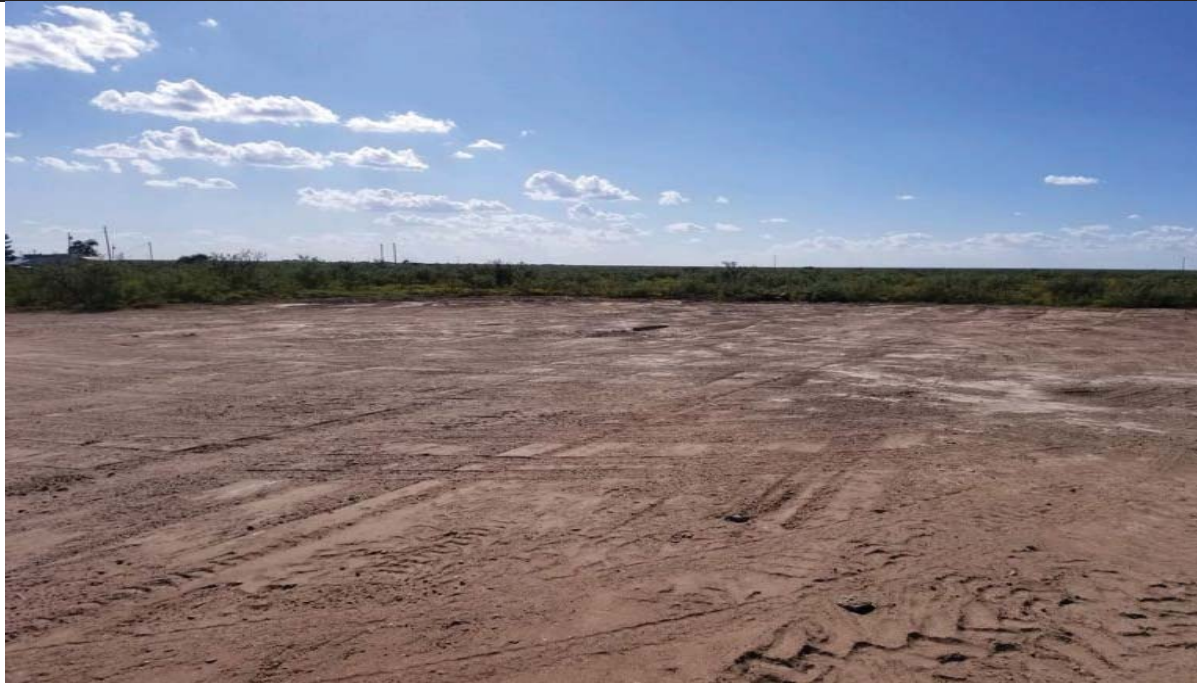
Photograph No 5.

Description: View of backfilled excavation in vicinity of trenches V-3 and V-4.

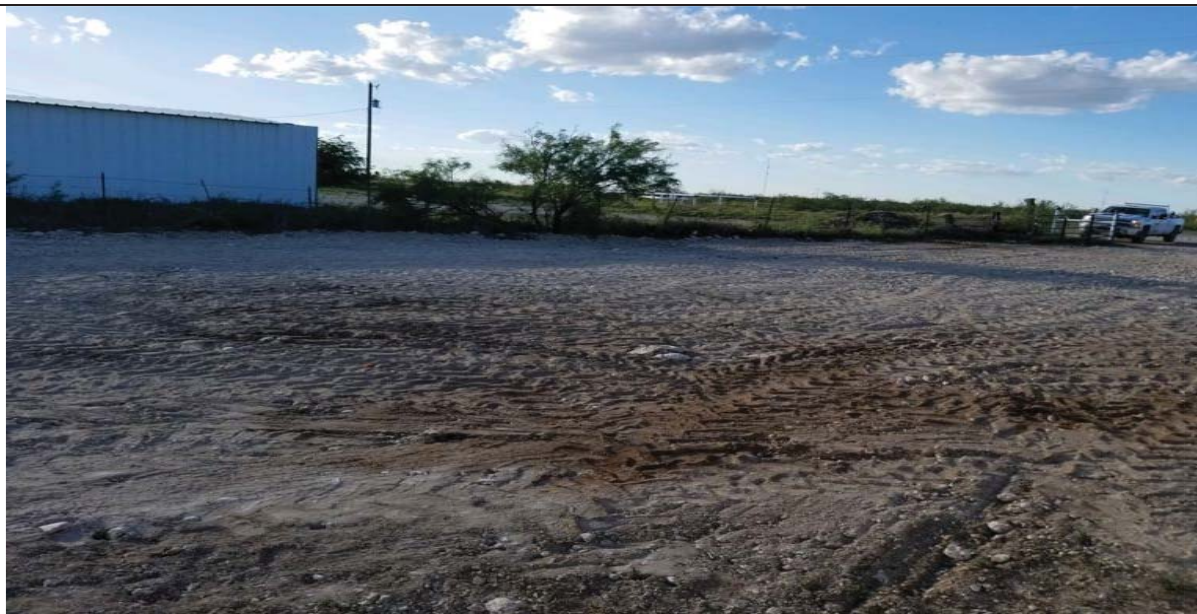
**Photograph No 6.**

Description: View of backfilled excavation in vicinity of trench V-2.
