Release Notification

Site Name PLU 18 Brushy Draw 104H	Site Type Production Well Facility
Date Release Discovered 4/9/2019	API# (if applicable) 30-015-44892

Mr. Mike Bratcher
New Mexico Oil Conservation Division
811 South First Street
Artesia, New Mexico 88210**RE: Closure Request
PLU 18 Brushy Draw 104H
Remediation Permit Number 2RP-5395
Incident Number NAB1912738712
Eddy County, New Mexico**

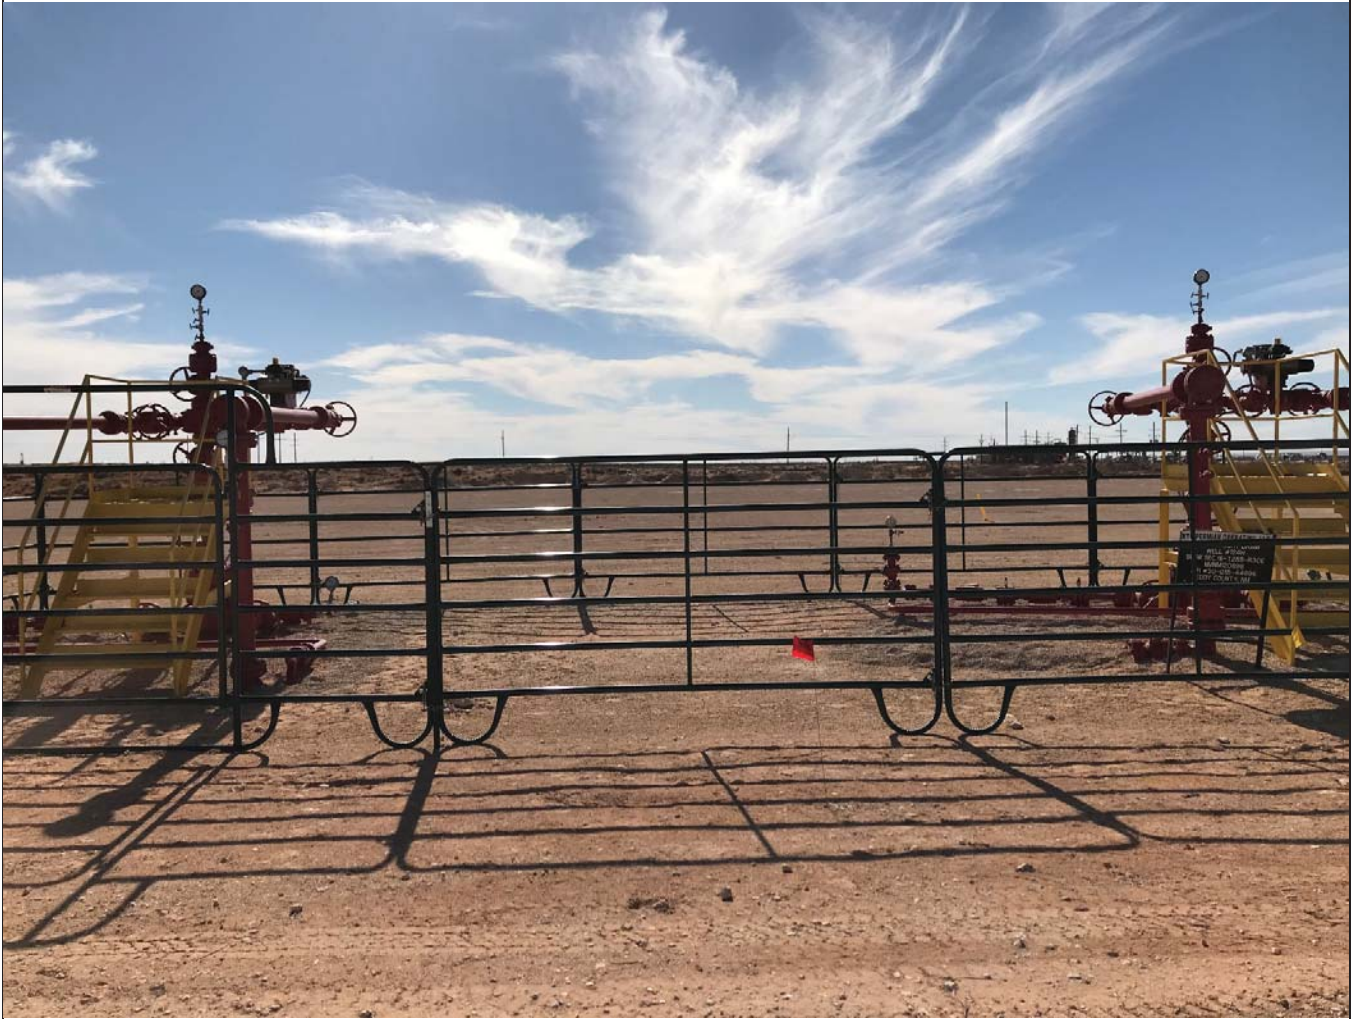
Northern view of release area during delineation soil sampling activities.

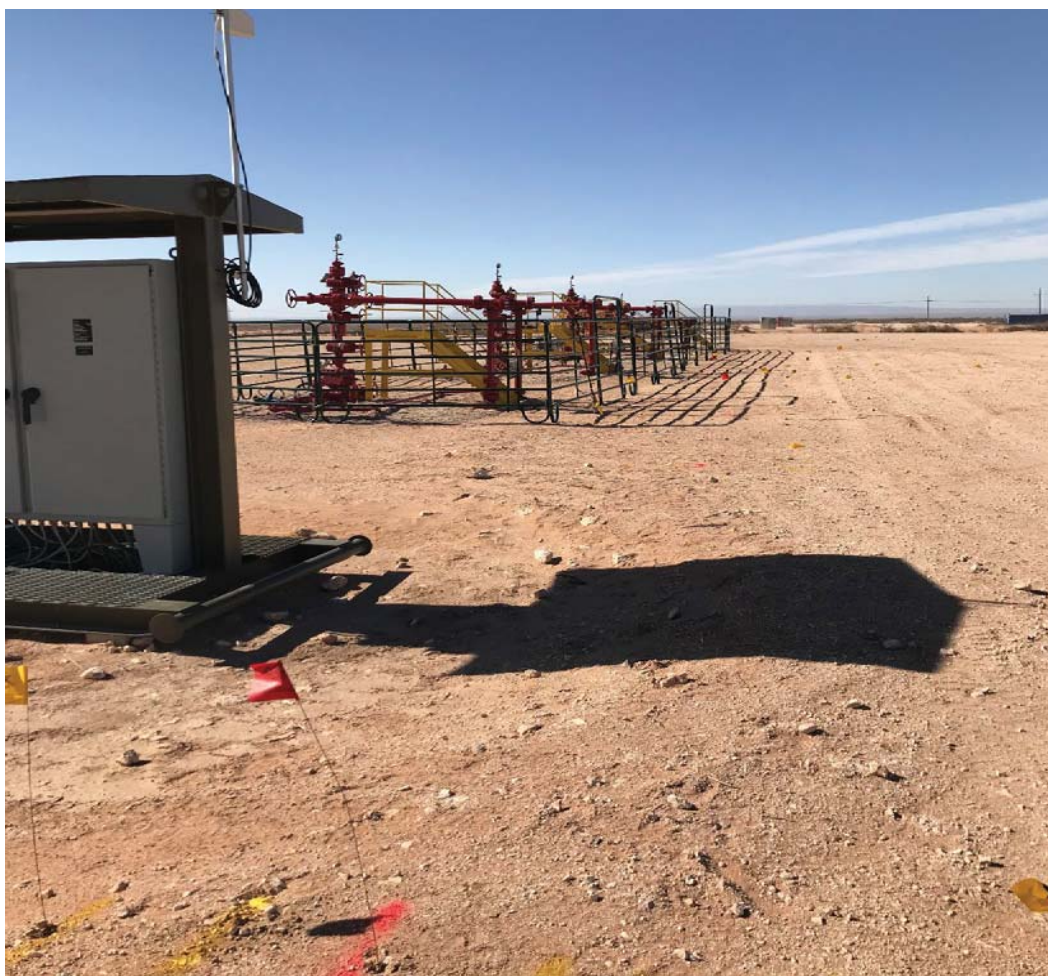
Southern view of release area during delineation soil sampling activities.
