Site Name PLU Big Sinks 14-25-30 Battery	Site Type Bulk Storage and Separation Facility
Date Release Discovered 09/11/2019	API# (if applicable) 30-015-39508

**RE: Closure Request
Poker Lake Unit Big Sinks 14-25-30 Battery
Remediation Permit Number 2RP-5663
Eddy County, New Mexico**

FIGURE 1
SITE LOCATION MAP
 POKER LAKE UNIT BIG SINKS 14-25-30 BATTERY
 UNIT N SEC 14 T25S R30E
 EDDY COUNTY, NEW MEXICO
 XTO ENERGY, INC.

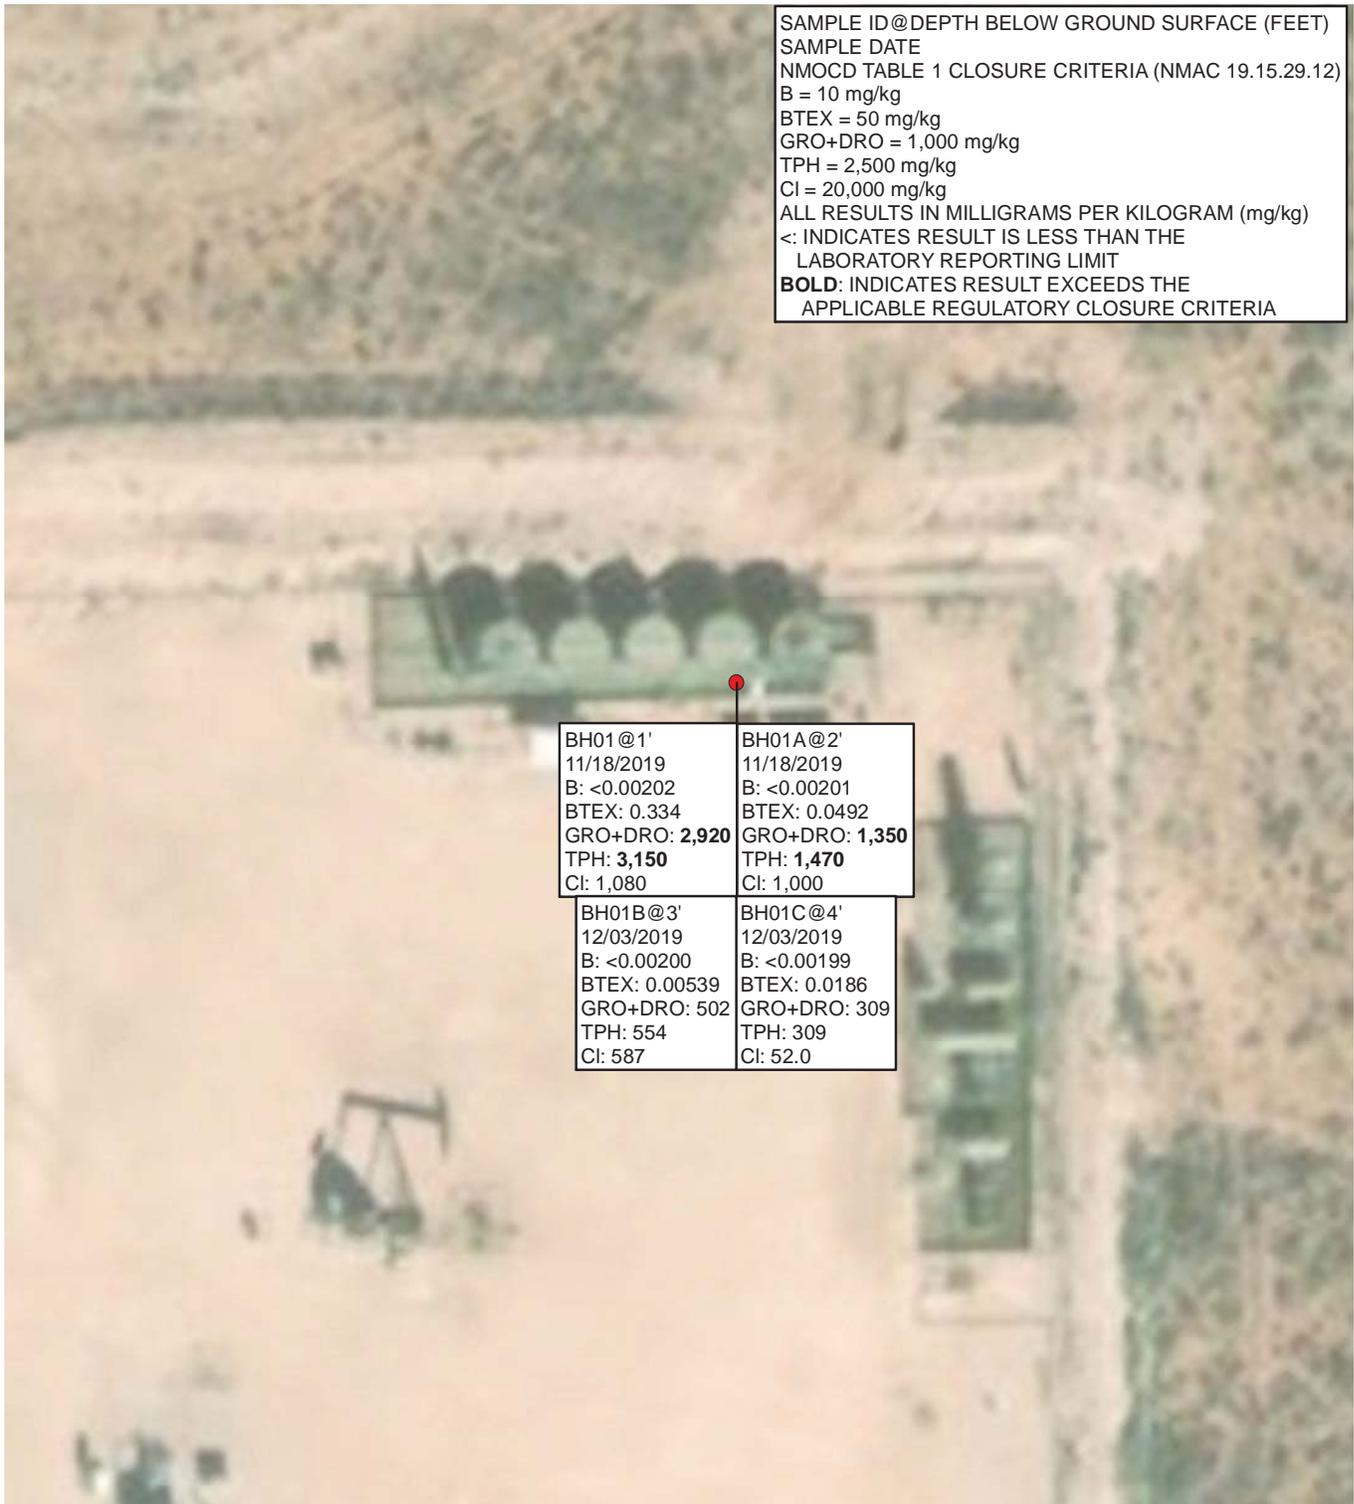
FIGURE 2
 SOIL SAMPLE LOCATIONS
 POKER LAKE UNIT BIG SINKS 14-25-30 BATTERY
 UNIT N SEC 14 T25S R30E
 EDDY COUNTY, NEW MEXICO
 XTO ENERGY, INC.

On November 18 and December 3, 2019, LTE evaluated the release extent based on information provided on the Form C-141 and visual observations. LTE personnel advanced a borehole via hand-auger at the location of the hole found during the liner integrity inspection conducted by XTO. The hole was within the lined tank battery containment on the northern edge of the caliche well pad. Four soil samples were collected for vertical delineation at depths ranging from 1 foot to 4 feet bgs (BH01/BH01A/BH01B/BH01C). No soil staining was observed during the site visit. Soil from the borehole was field screened for volatile aromatic hydrocarbons and chloride utilizing a calibrated photo-ionization detector (PID) and Hach® chloride QuanTab® test strips, respectively. Field screening results and observations for each sample were documented on a lithologic/soil sample log and are included as Attachment 2. The borehole was backfilled with the soil removed and XTO repaired the liner. The borehole and vertical delineation soil sample location is depicted on Figure 2.

BH01@1' 11/18/2019 B: <0.00202 BTEX: 0.334 GRO+DRO: 2,920 TPH: 3,150 Cl: 1,080	BH01A@2' 11/18/2019 B: <0.00201 BTEX: 0.0492 GRO+DRO: 1,350 TPH: 1,470 Cl: 1,000
BH01B@3' 12/03/2019 B: <0.00200 BTEX: 0.00539 GRO+DRO: 502 TPH: 554 Cl: 587	BH01C@4' 12/03/2019 B: <0.00199 BTEX: 0.0186 GRO+DRO: 309 TPH: 309 Cl: 52.0

Laboratory analytical results indicated benzene, BTEX, GRO and DRO, TPH, and chloride concentrations were compliant with the Closure Criteria in soil samples BH01B and BH01C at depths of approximately 3 feet and 4 feet bgs, respectively.

Laboratory analytical results indicated that GRO and DRO and TPH concentrations exceeded the Closure Criteria in soil samples BH01 and BH01A, collected at depths of 1 foot and 2 feet bgs.

Laboratory analytical results are presented on Figure 2, and summarized in Table 1. The complete laboratory analytical reports are included as Attachment 4.

The impacted soil remaining in place in the area of soil samples BH01 and BH01A is delineated vertically by soil sample BH01B, collected at a depth of 3 feet bgs. The lateral extent of impacted soil remaining in place is defined by the lined tank battery containment. An estimated 410 cubic yards of impacted soil remains in place surrounding borehole BH01 and beneath the lined tank battery containment, assuming a maximum 3-foot depth based on sample BH01B collected at a depth of 3 feet bgs that was compliant with the Closure Criteria.

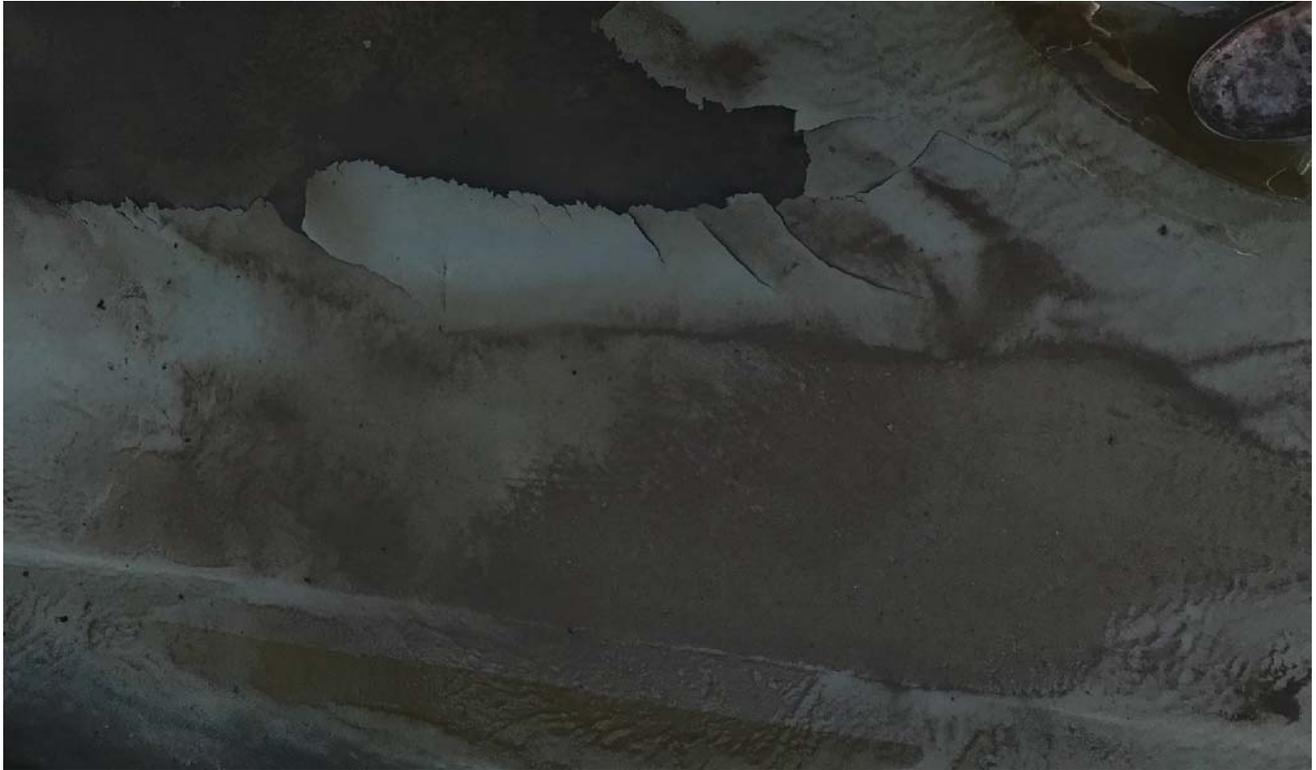
Discharge line from transfer pumps had a pin hole leak due to corrosion. 10 bbls of produced water was released inside the containment and recovered by vacuum truck. A 48-hour advance notice of liner inspection was provided by email to NMOCD District 2. The liner was visually inspected and determined to be inadequate. Liner is scheduled for repair and returned to impervious condition. XTO requests deferral of potential impacts under liner until facility upgrades or is abandoned. It is XTO safety policy to restrict disturbance to within 3 feet of equipment. The containment is congested by lines, tanks, and equipment making access for vertical delineation via heavy equipment or drilling rig problematic.

View of hole in the tank battery containment liner identified during the liner integrity inspection.

Following the failed liner integrity inspection, LTE personnel advanced a borehole in the location of the hole in the compromised liner. Laboratory analytical results indicated that GRO and DRO concentrations exceeded the Closure Criteria in soil samples BH01 and BH01A, collected at 1 foot and 2 feet bgs. Laboratory analytical results indicated that benzene, BTEX, GRO and DRO, TPH, and chloride concentrations were compliant with the Closure Criteria in soil samples BH01B and BH01C, collected at 3 feet and 4 feet bgs. Residual impacted soil in the area of BH01 and BH01A was left in place for compliance because full remediation of soil around and beneath the equipment would require major facility and pad deconstruction.

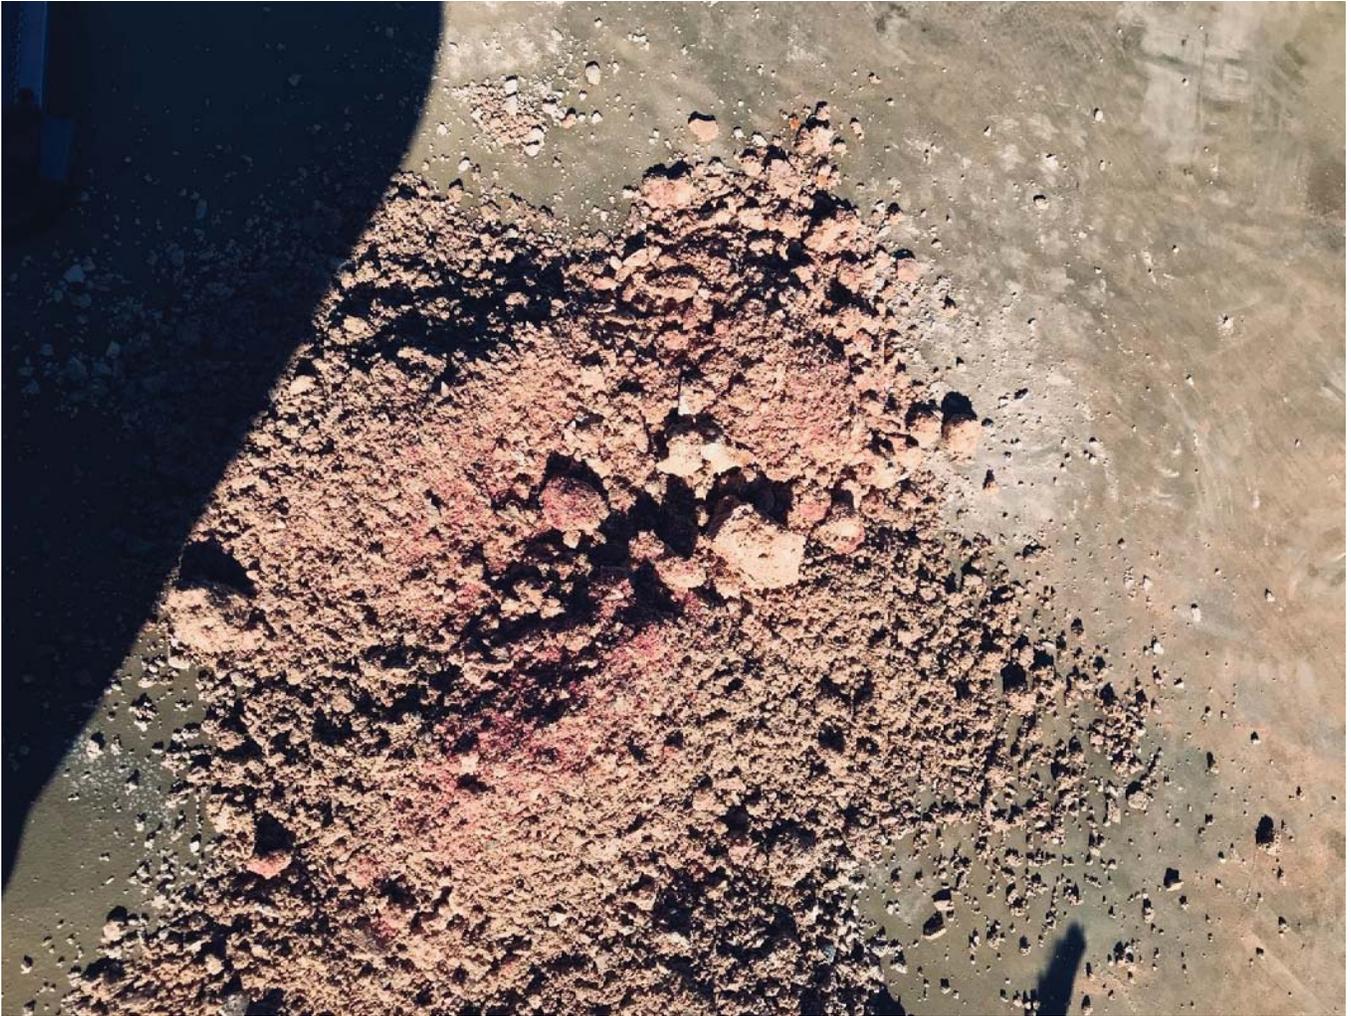
View of tank battery containment liner and borehole location during delineation soil sampling activities.
