May 7, 2019

**RE: Closure Request
BEU-DI-5 #004H
Remediation Permit Number 2RP-3013
Eddy County, New Mexico**

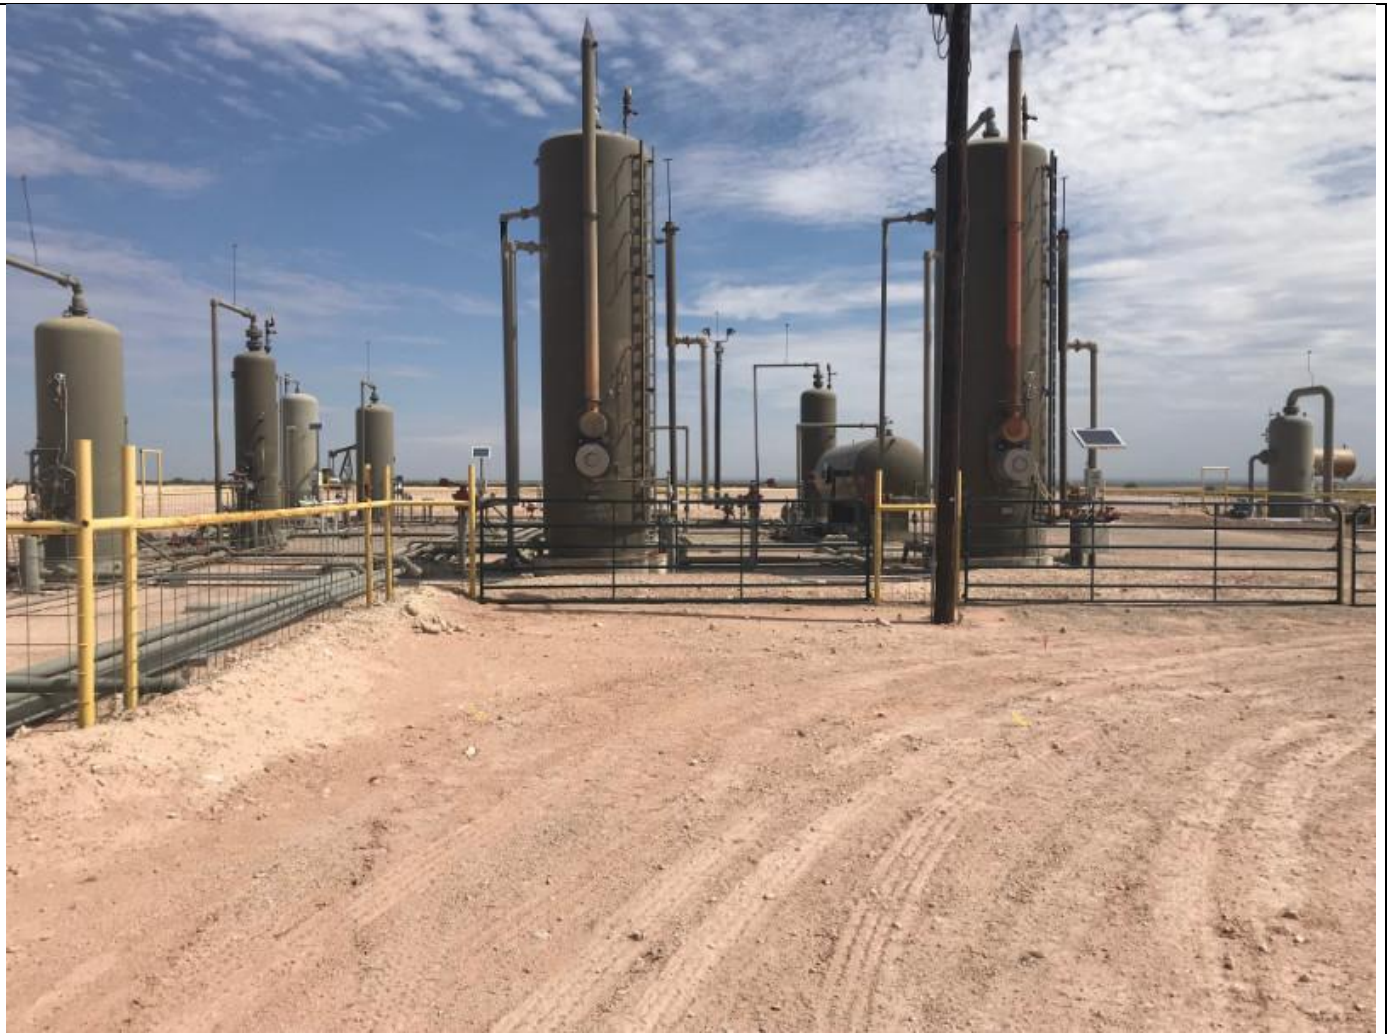
Western view of the release area prior to excavation activities.

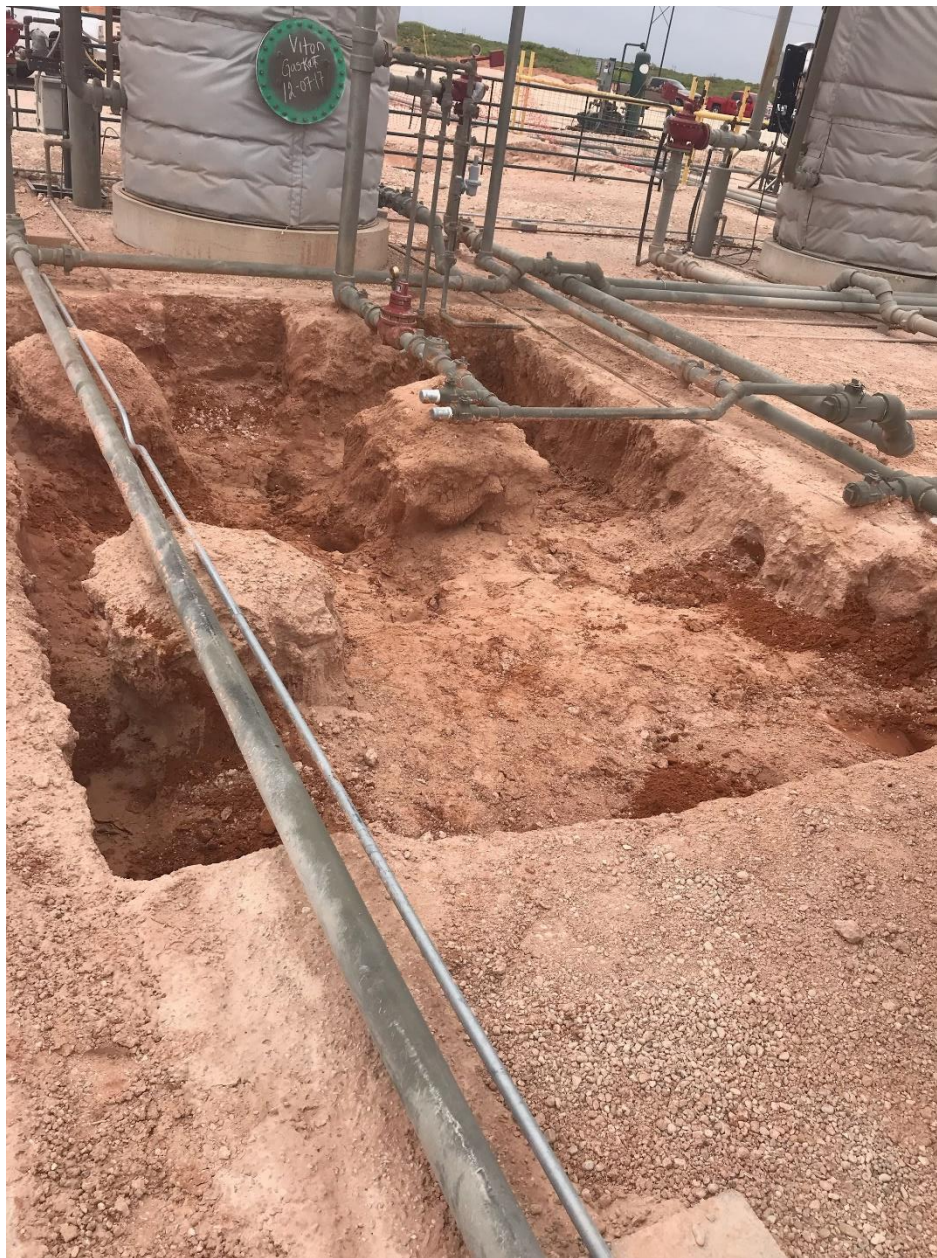
Western view of the southern excavation extent.

The southern excavation measured approximately 180 square feet in area and was completed to a depth of 2 feet bgs. Composite soil sample SW04 was collected from the sidewalls of the excavation from depths ranging from 0 feet bgs to 2 feet bgs. Composite soil sample FS04 was collected from the floor of the excavation from a depth of 2 feet bgs.

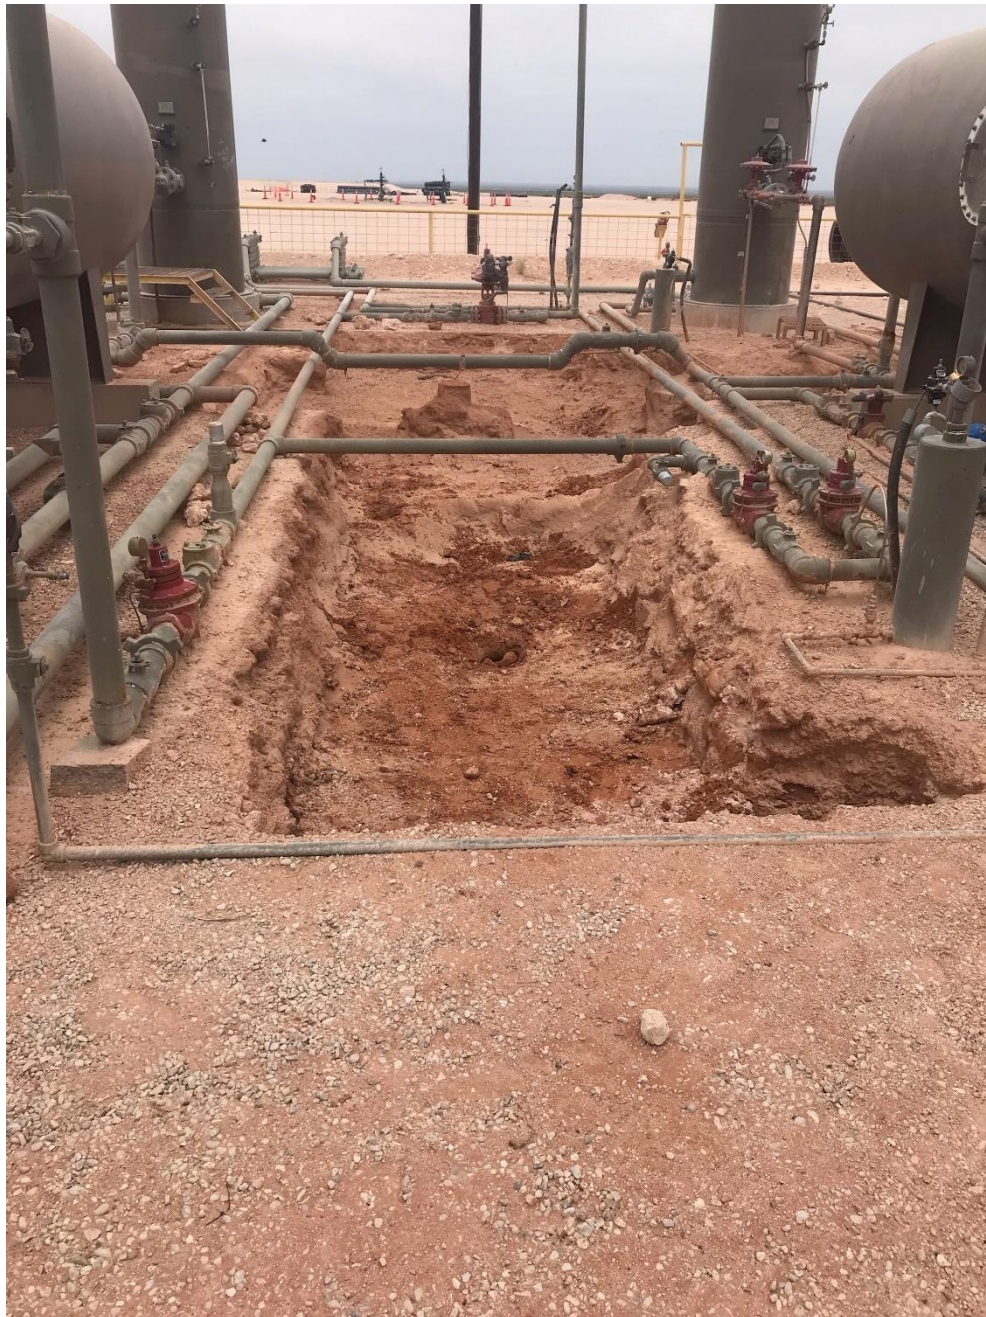
Western view of the northern excavation extent.

The northern excavation measured approximately 390 square feet in area with depths ranging from 1.5 feet to 2 feet bgs. Composite soil samples SW01 through SW03 were collected from the sidewalls of the excavation from depths ranging from the surface to 1.5 feet to 2 feet bgs.
