**2RP-3875**  
**REMEDIATION REPORT**  
**Nash Draw Tank Battery #24**  
**Eddy County, New Mexico**

LAI Project No. 16-0108-05

March 23, 2017

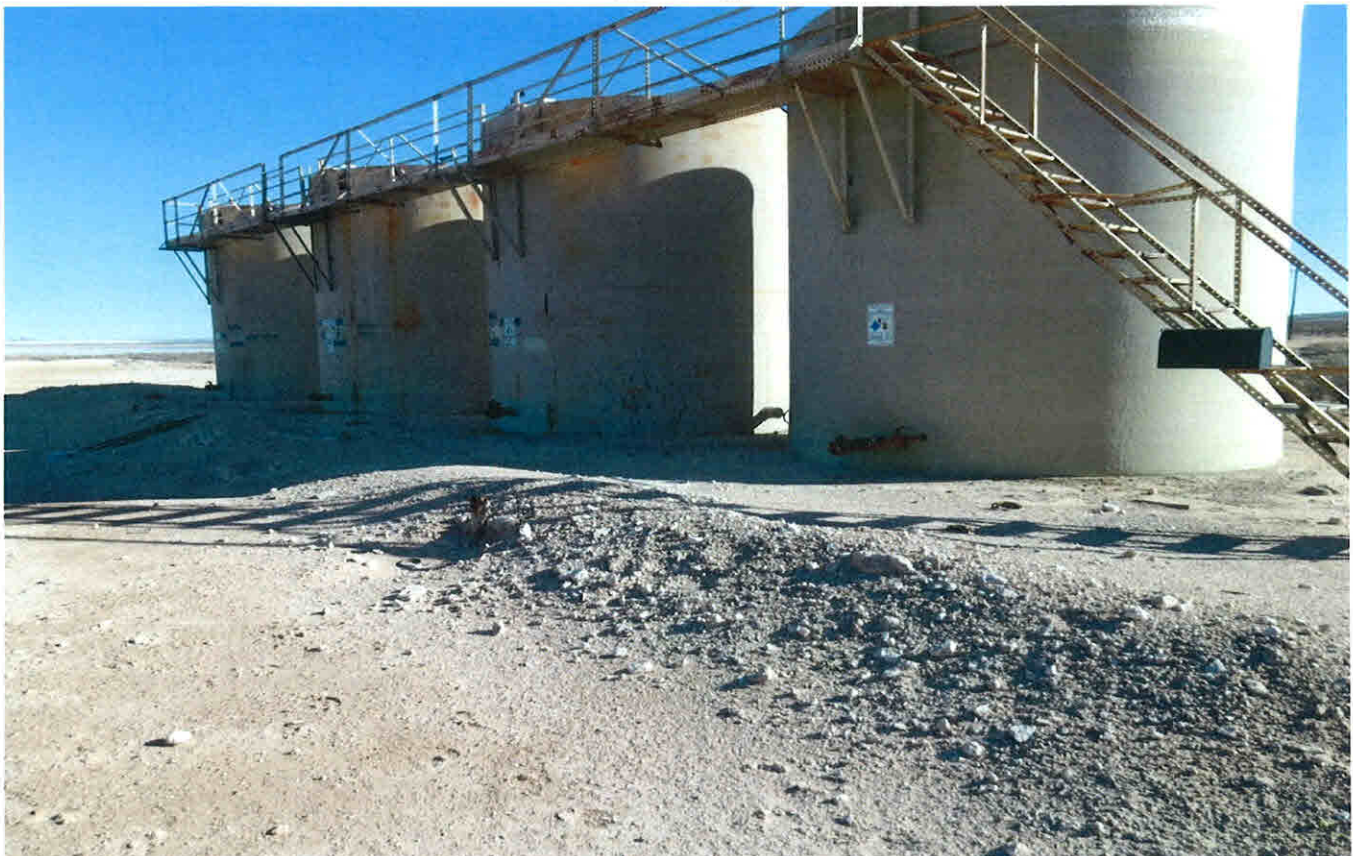
Location Viewing Northeast Prior to Remediation, February 3, 2016

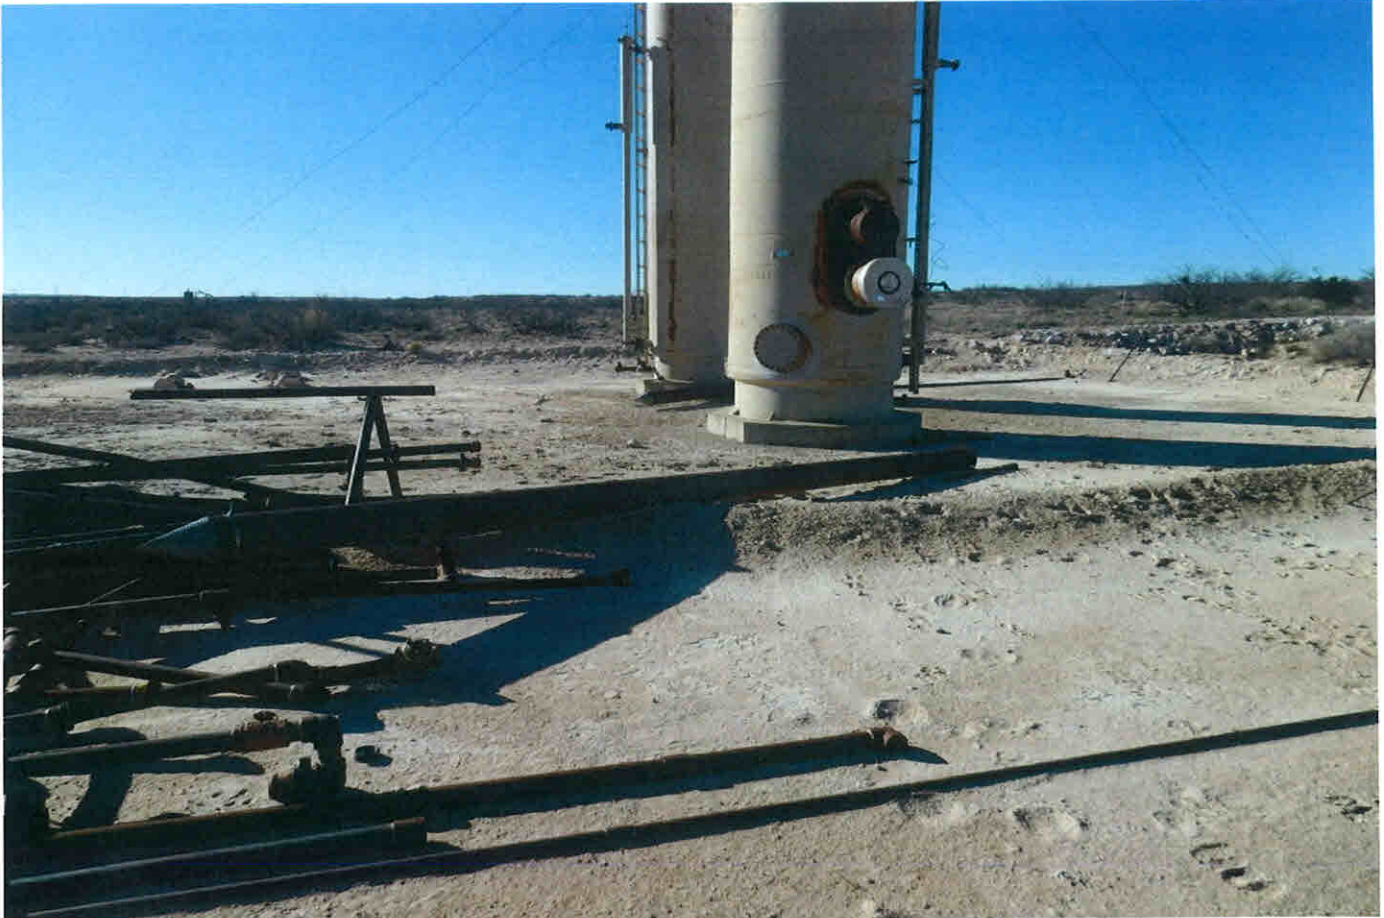
Location Viewing South Prior to Remediation, February 3, 2016

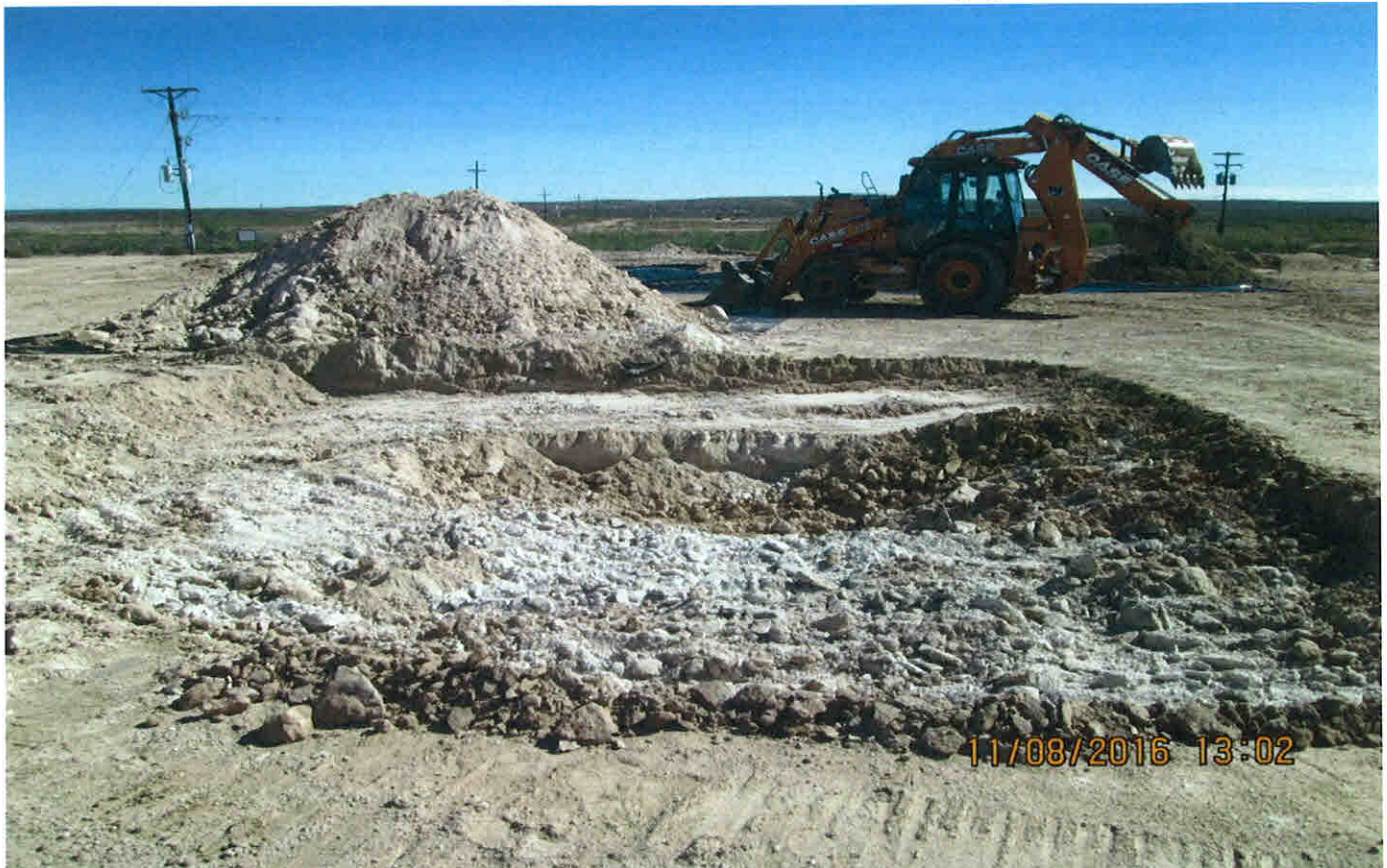
Excavation at DP-05-01 Viewing East, November 8, 2016

On November 11, 2016, SDR excavated soil from the area of DP-05-01 measuring about 25 x 25 feet to about 3 feet bgs. SDR excavated soil from the area of DP-05-02 measuring about 15 x 15 feet and DP-05-03 over an area measuring about 25 x 25 feet to about 2 feet bgs. Soil was excavated from the area of DP-05-05 over an area measuring approximately 25 x 25 feet to about 3 feet bgs. The excavations were filled with caliche.

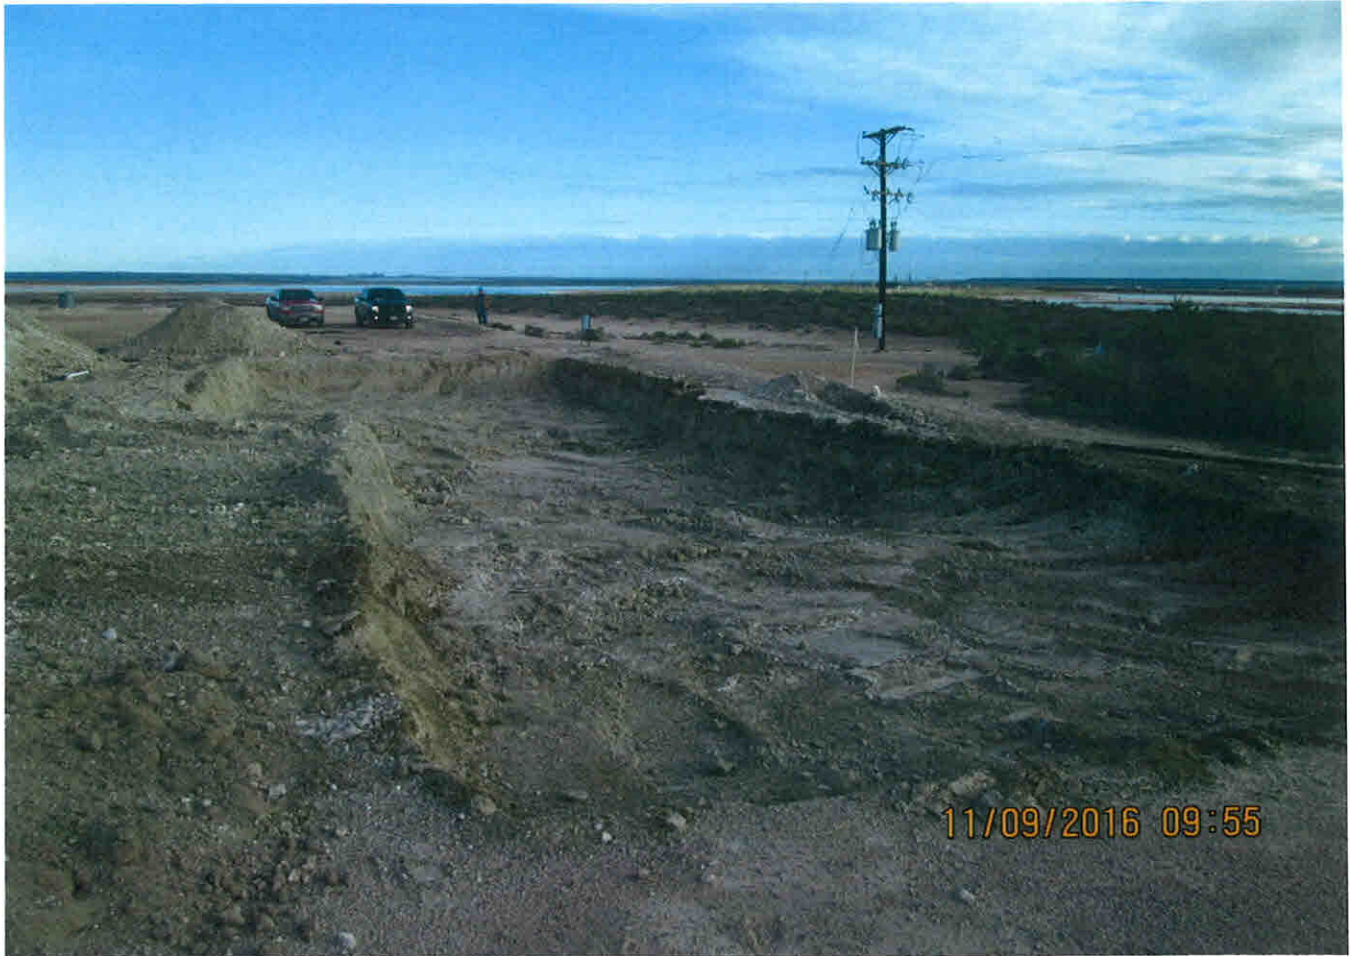
Excavation DP-05-03, DP-05-04, and DP-05-05 Viewing Northeast, November 9, 2016

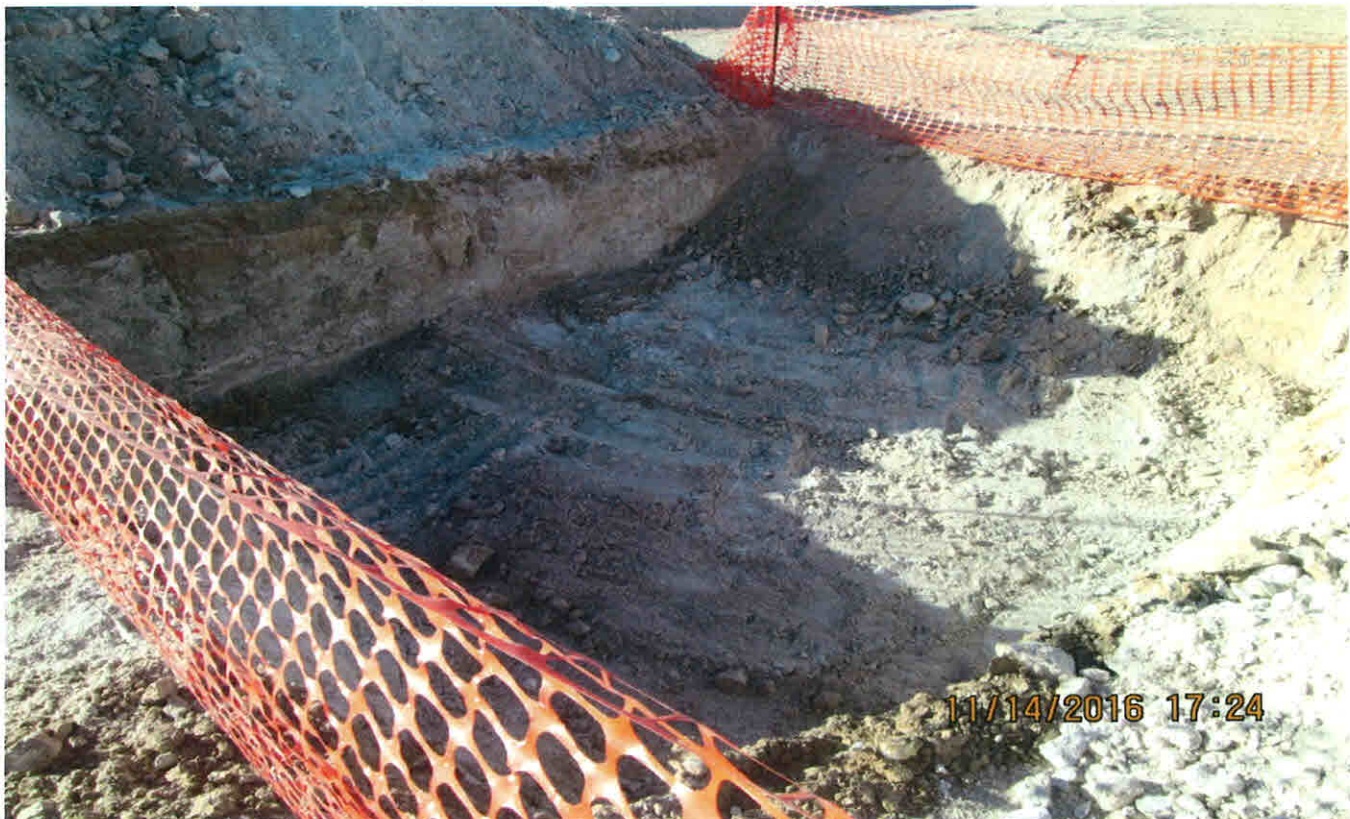
Excavation at DP-05-02 Viewing Northwest, November 14, 2016

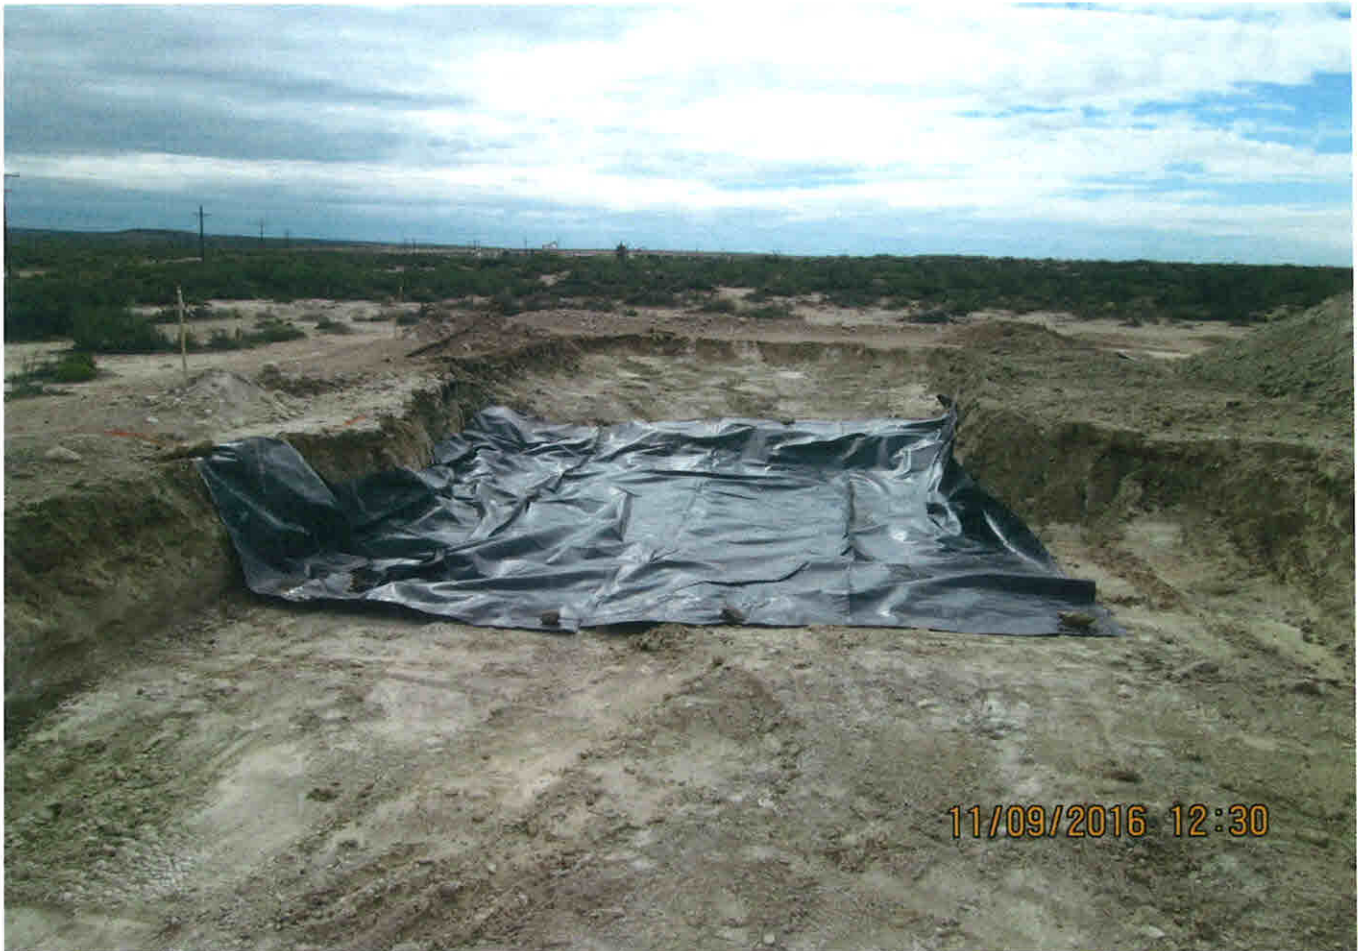
Liner Installed in Excavation (4 feet) DP-05-04 Viewing South, November 9, 2016

Soil was excavated from the area of DP-05-04 over an area measuring about 25 x 30 feet to about 4 feet bgs where a 20 mil thickness polyethylene liner was installed in the bottom of the excavation. The excavation above the liner was filled with caliche to ground surface.

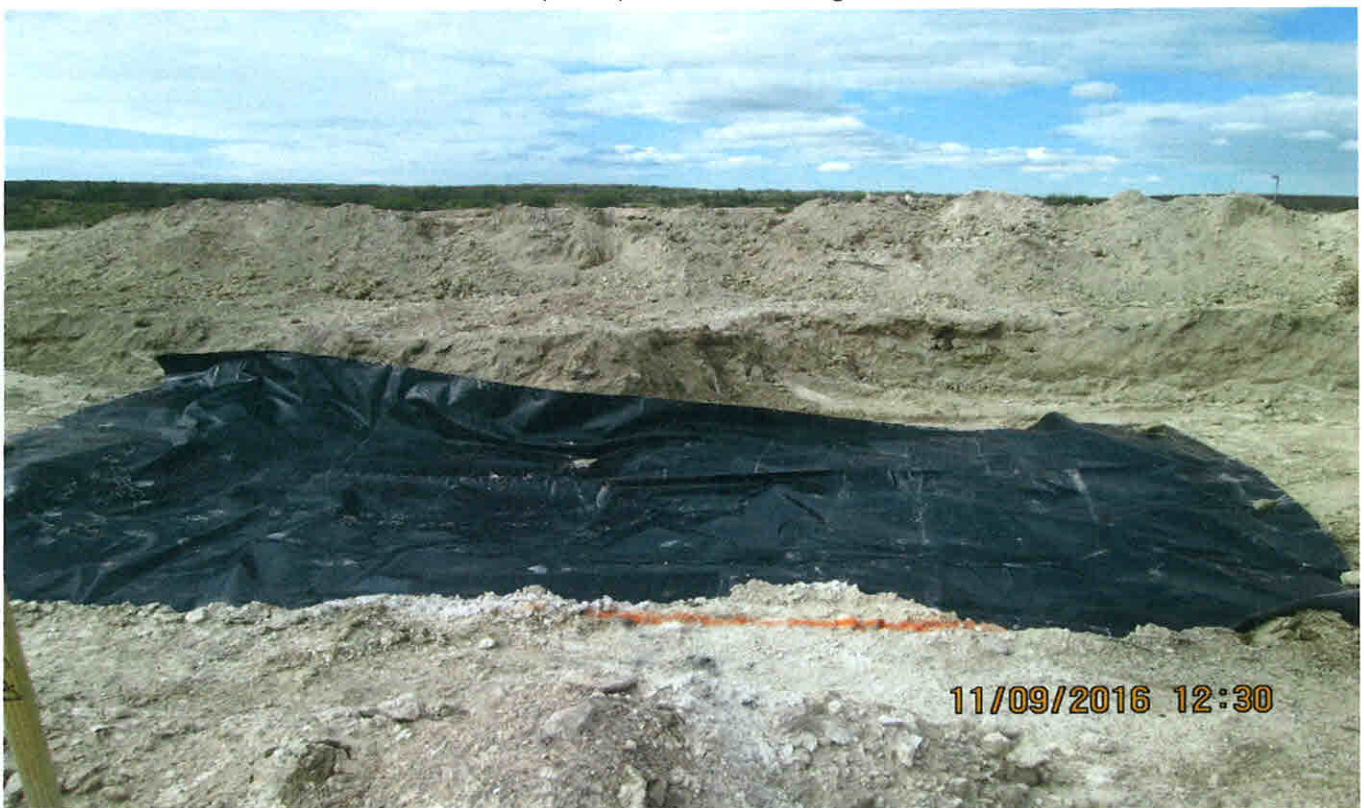
Liner Installed in Excavation (4 feet) DP-05-04 Viewing West, November 9, 2016

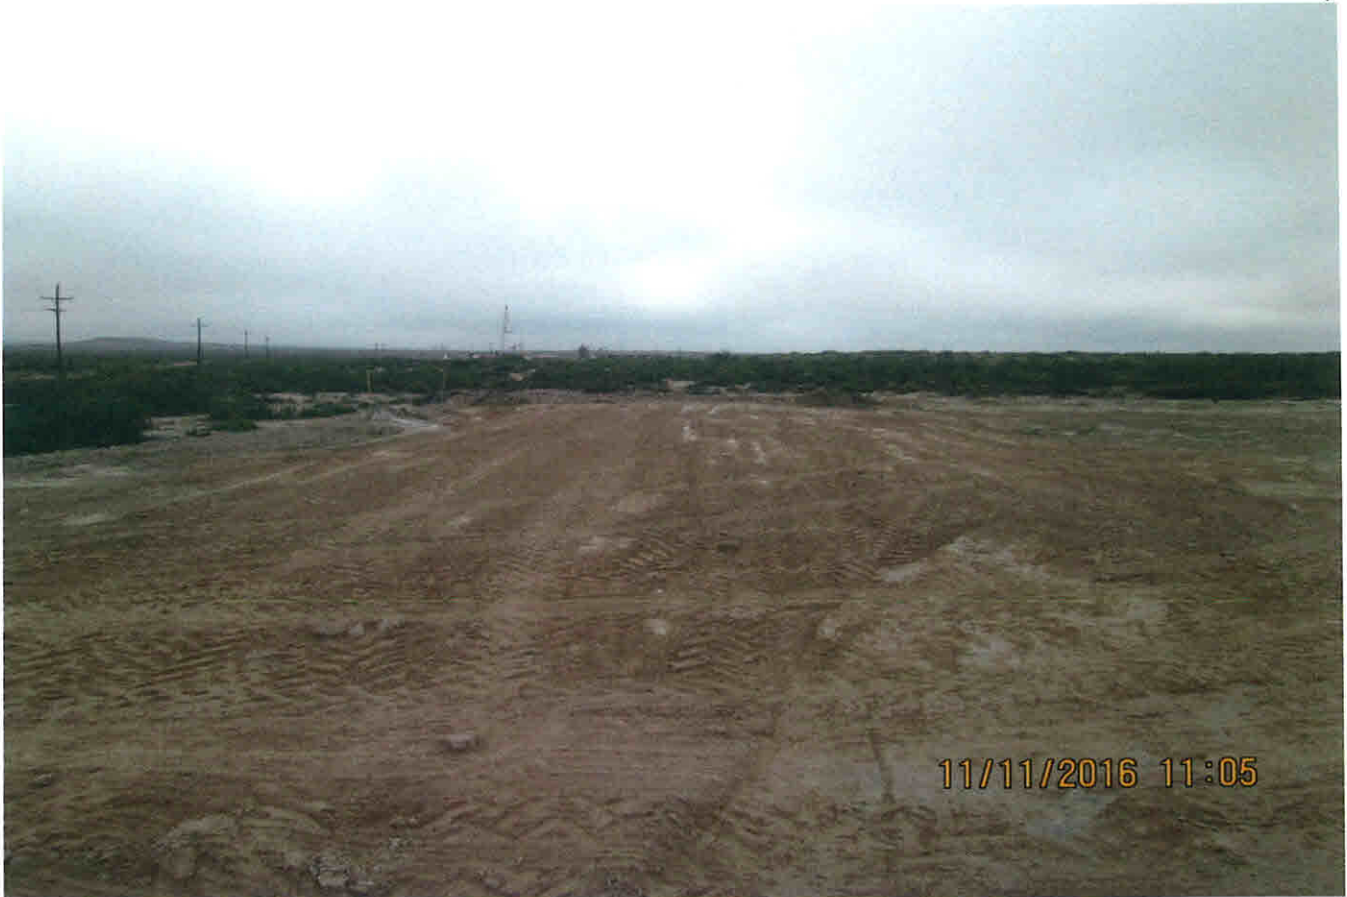
Completed Remediation at Excavation DP-05-03, DP-05-04, DP-05-05 Viewing South, November 11, 2016

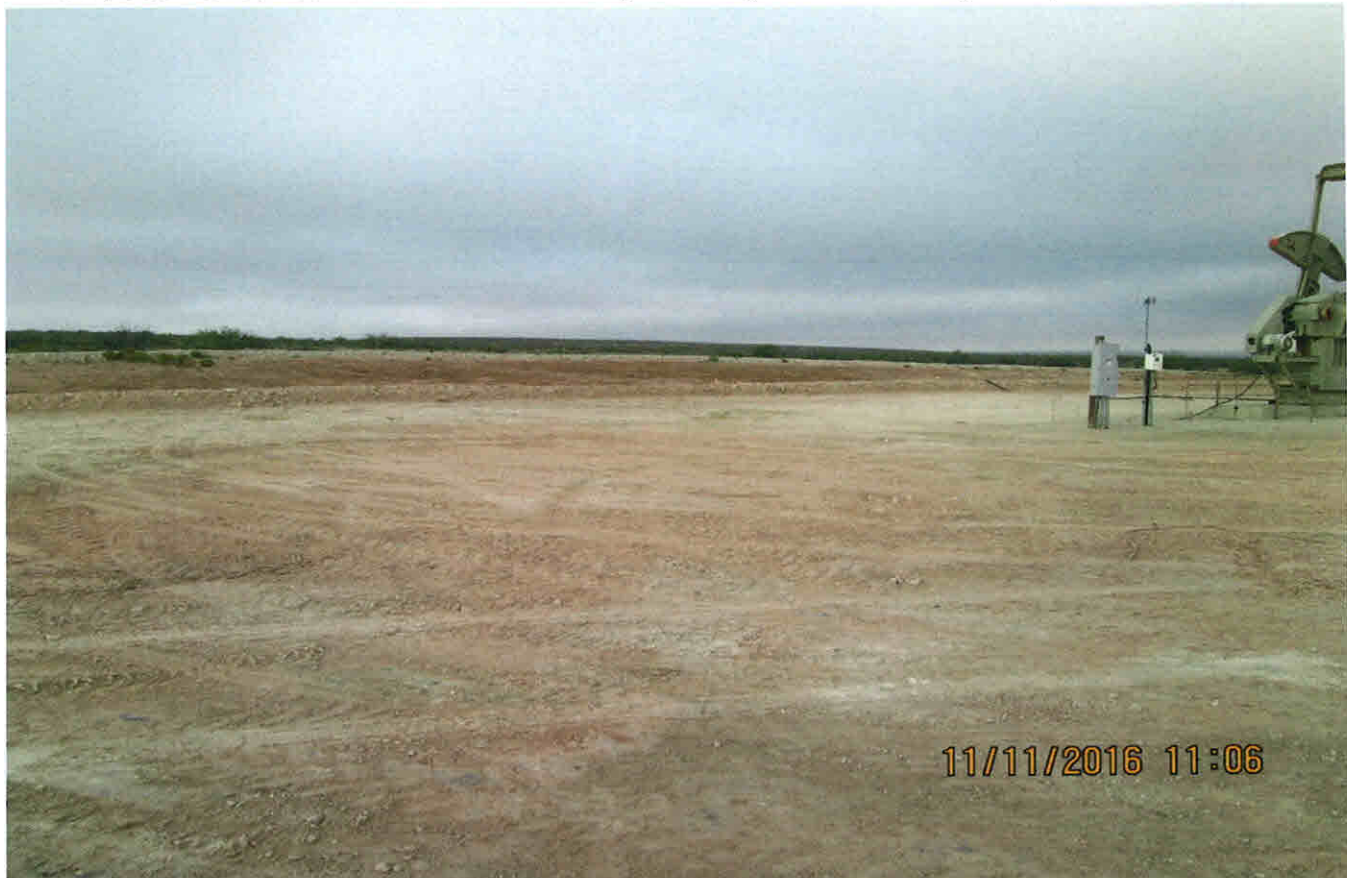
Completed Remediation at Excavation DP-05-01 Viewing West, November 11, 2016

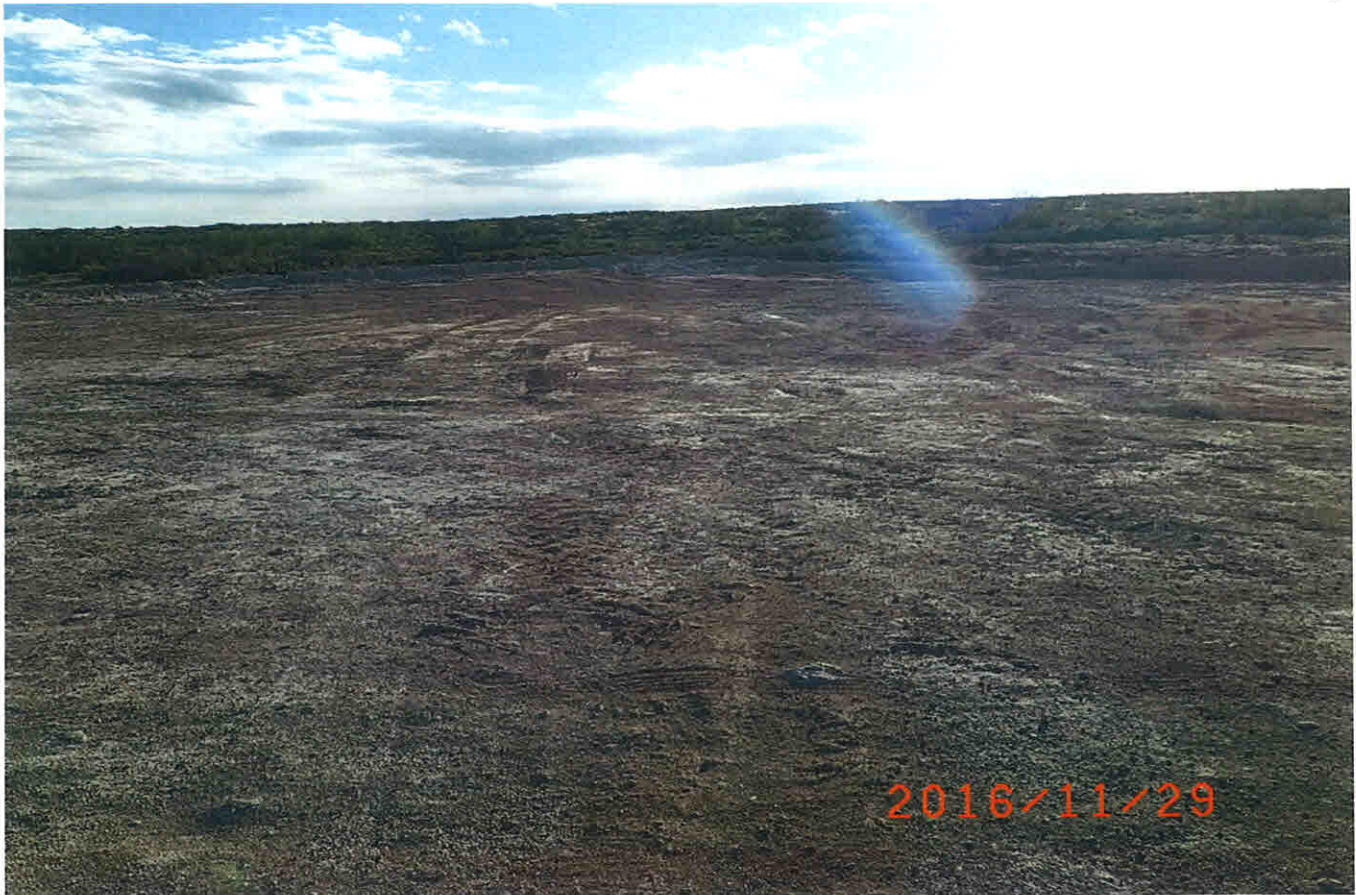
Completed Remediation at Excavation DP-05-02 Viewing Southeast, November 11, 2016
