CLOSURE REPORT

**BOPCO, L.P.
PLU #347H
Eddy County, New Mexico
Unit Letter "C", Section 11, Township 25 South, Range 30 East
Latitude 32.150845 North, Longitude 103.855589 West
NMOCD Reference #2RP-3931**

RE: Final Closure Report
Bopco, L.P. – PLU #347H
UL-C, Section 11, Township 25 South, Range 30 East
Eddy County, New Mexico
NMOCD Reference #'s 2RP 3931

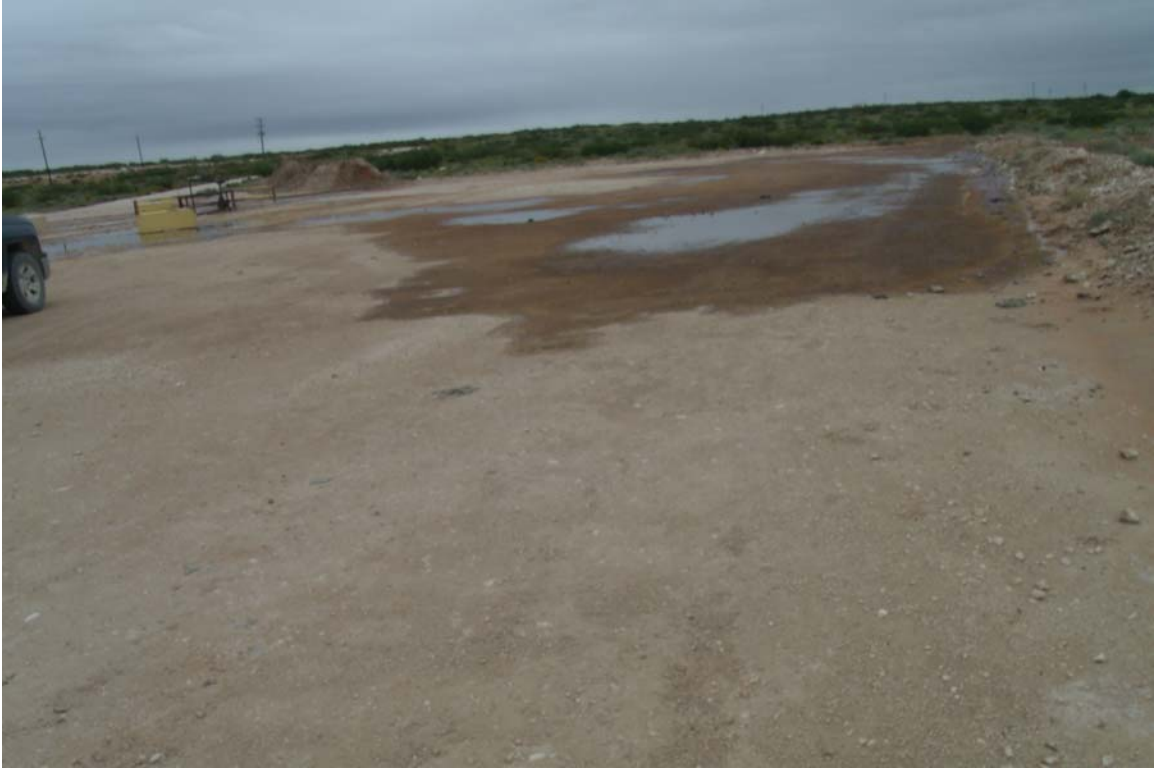
The lease operator arrived on location and found the release was caused by corrosion on the nipple that connects the tubing gauge to the Baird BPV, the nipple broke off causing the release. Vacuum trucks were called to the location and were able to recover 230 barrels of fluid from the location. All fluid remained on the well pad.

Photograph #1 – View across release area

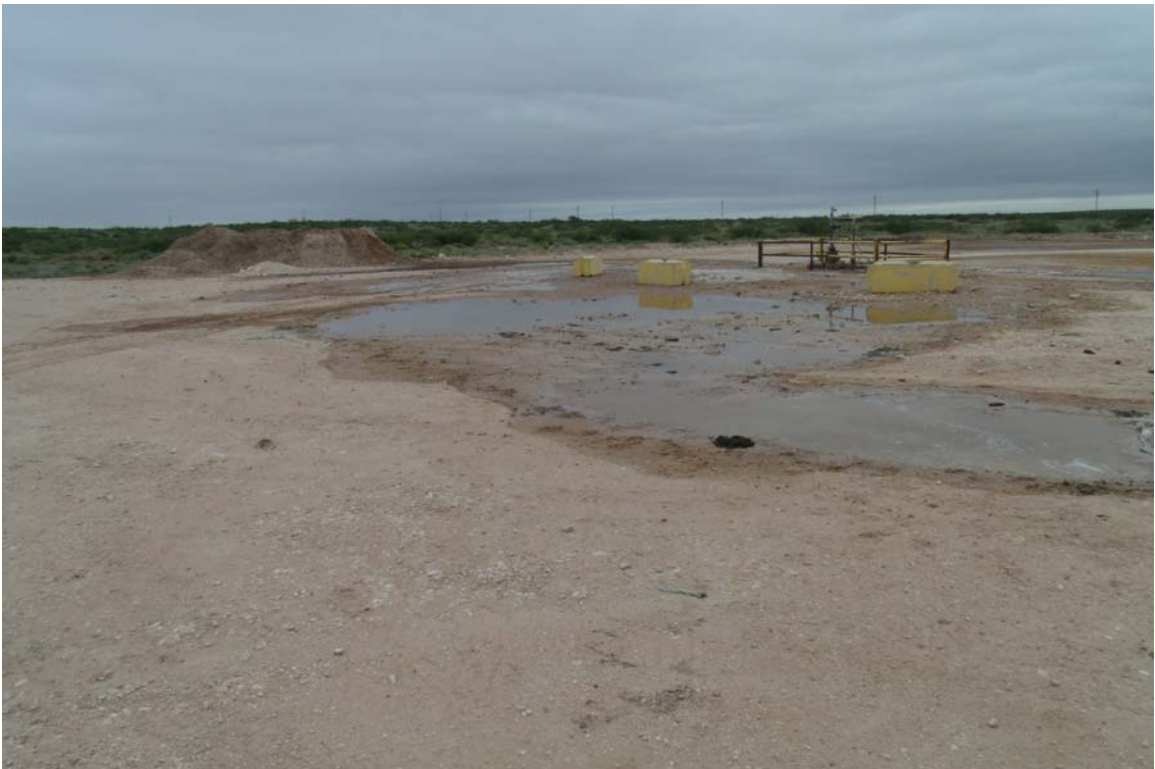
Photograph #2 – View across release area

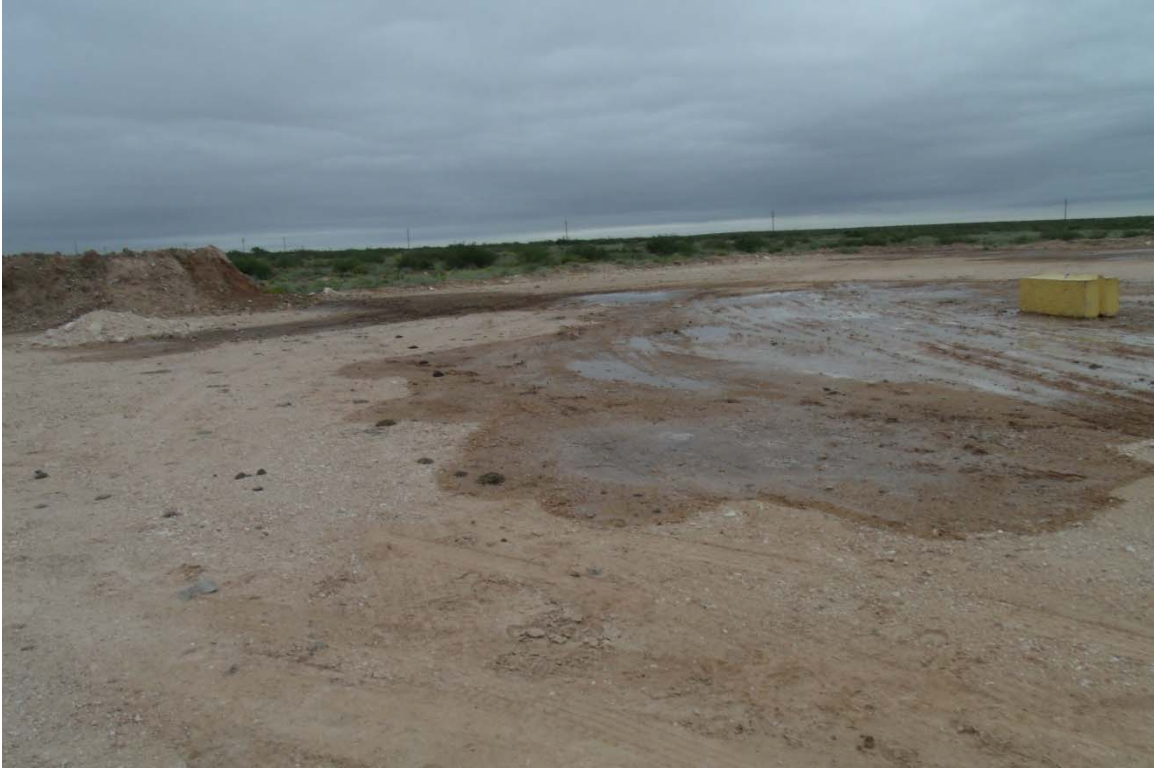
Photograph #3 – View across release area

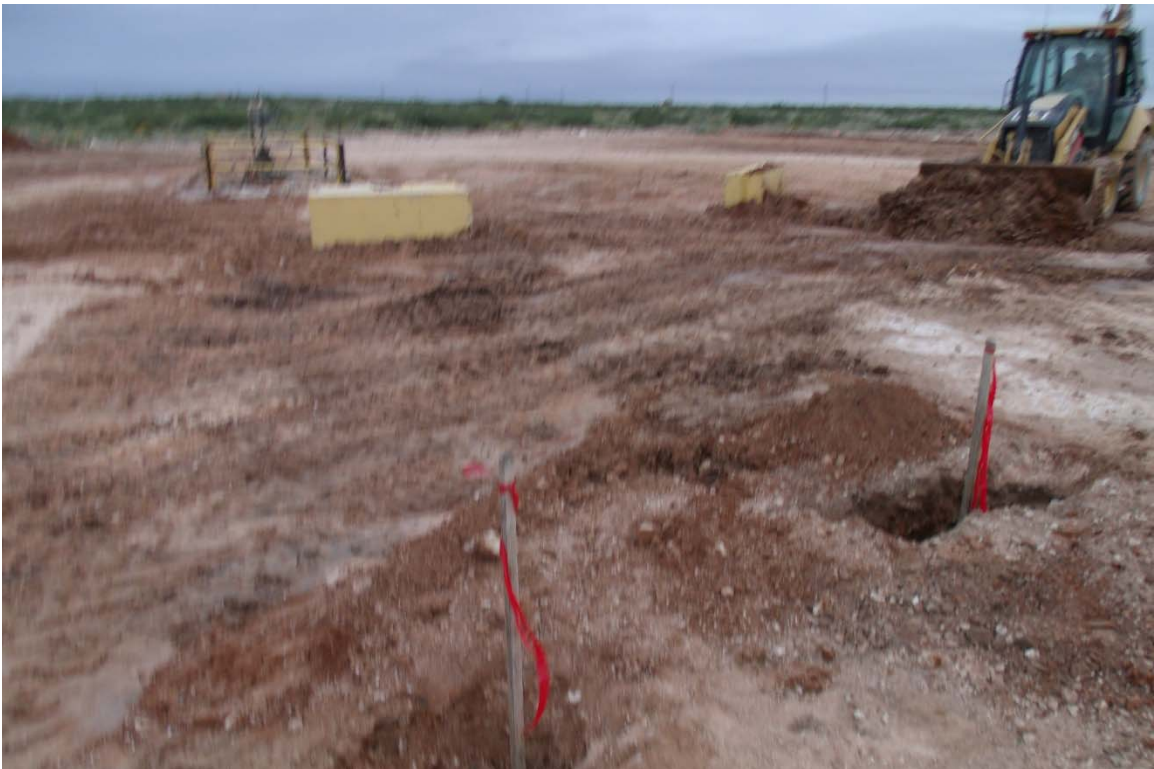
Photograph #4 – Surface scraped

The release area was surface scraped approximately three (3) – four (4) inches deep. Approximately 147 tons of contaminated soil was excavated and hauled to a state approved facility for disposal.

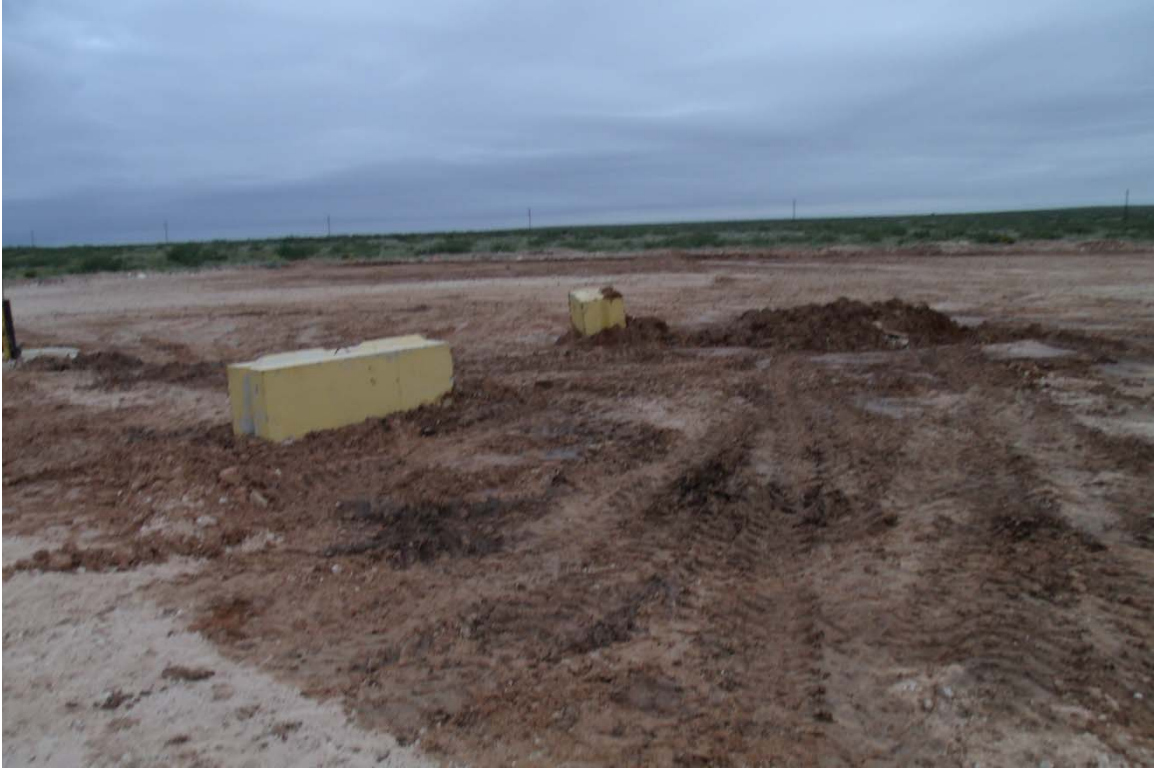
Photograph #5 – Surface scraped

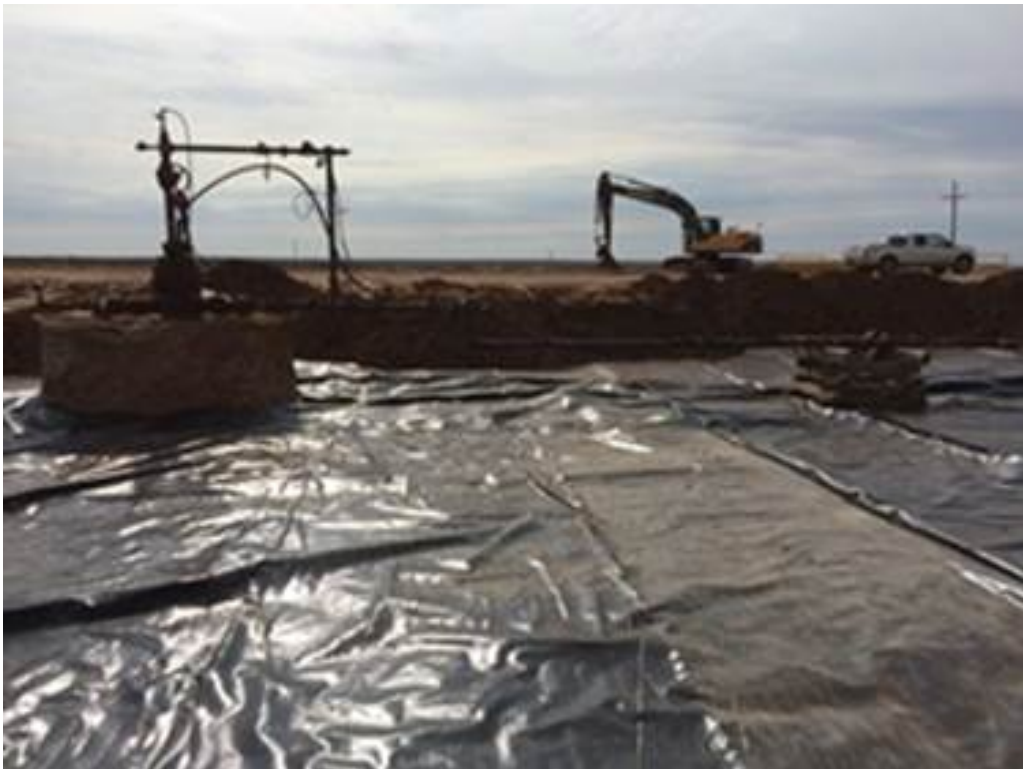
Photograph #6 – Liner installation during remediation of previous release

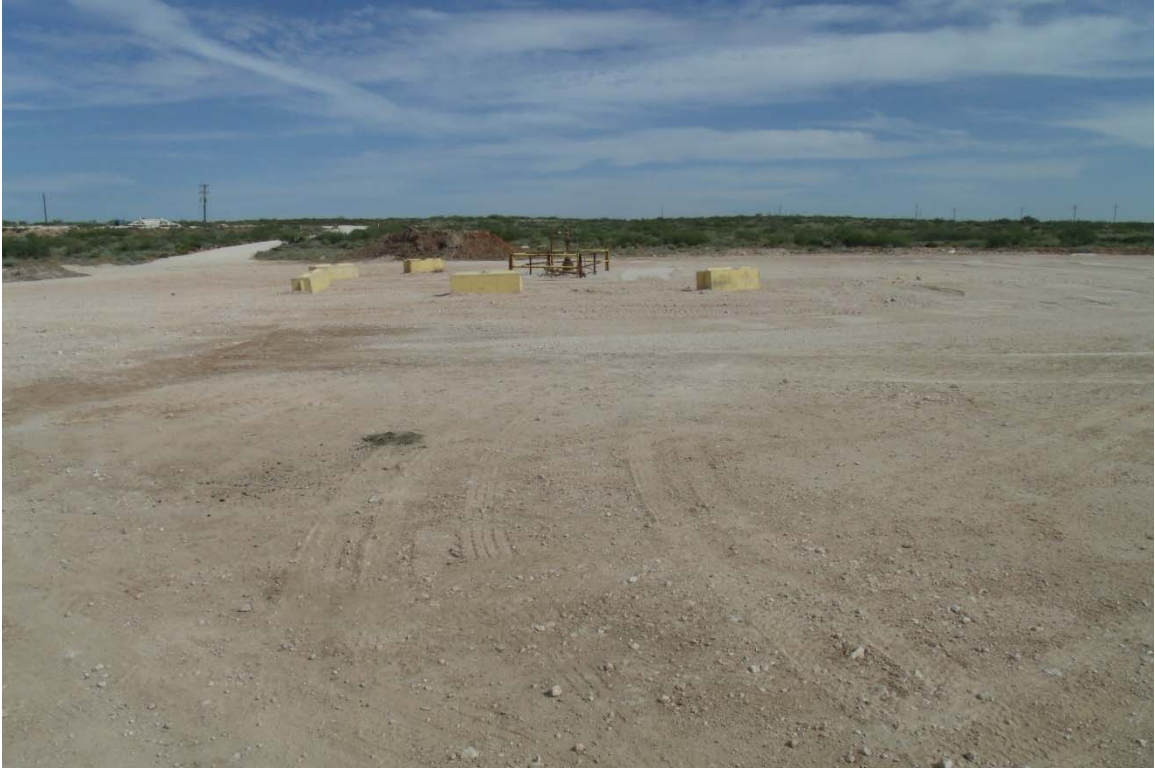
Photograph #7 – Backfilled

Based on laboratory analytical data and NMOCD approval, the excavation was backfilled with approximately 147 tons of clean soil. The entire disturbed area was then contoured to blend with existing pad area and protected against wind/water erosion.

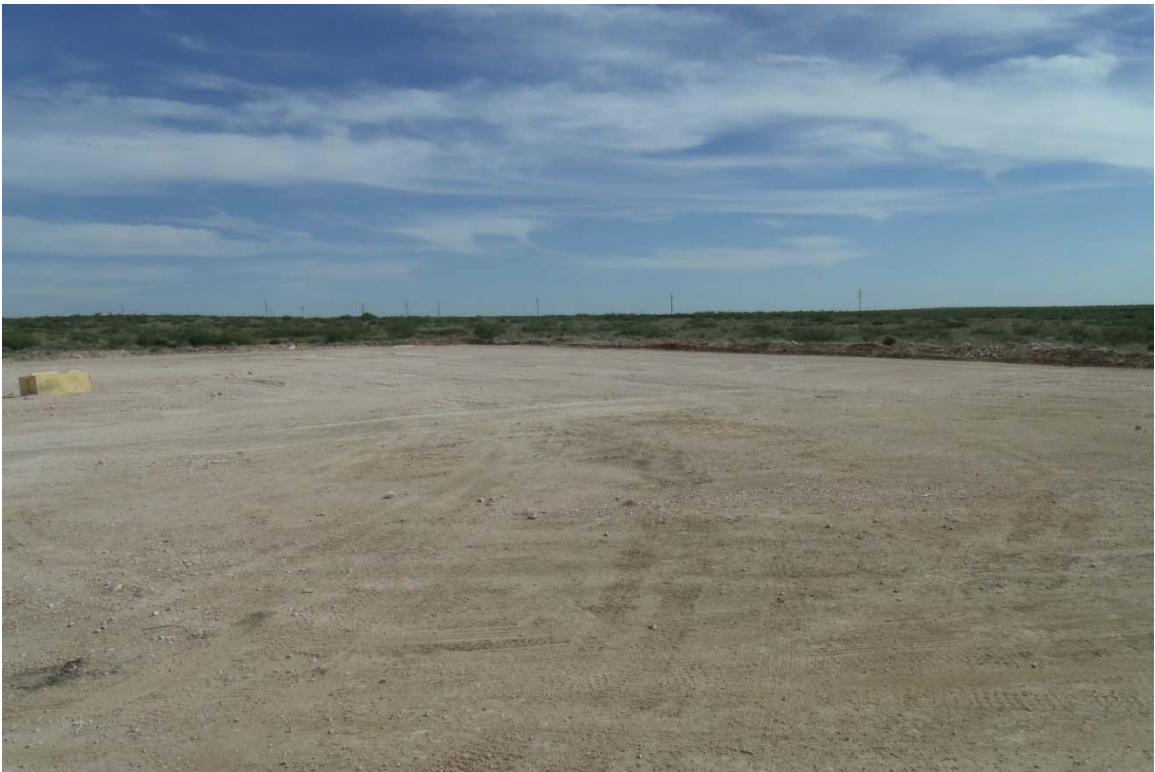
Photograph #8 – Backfilled
