**RE: Closure Request  
Poker Lake Unit Ross Ranch 33-25-30 USA Battery  
Remediation Permit Number 2RP-4450  
Eddy County, New Mexico**

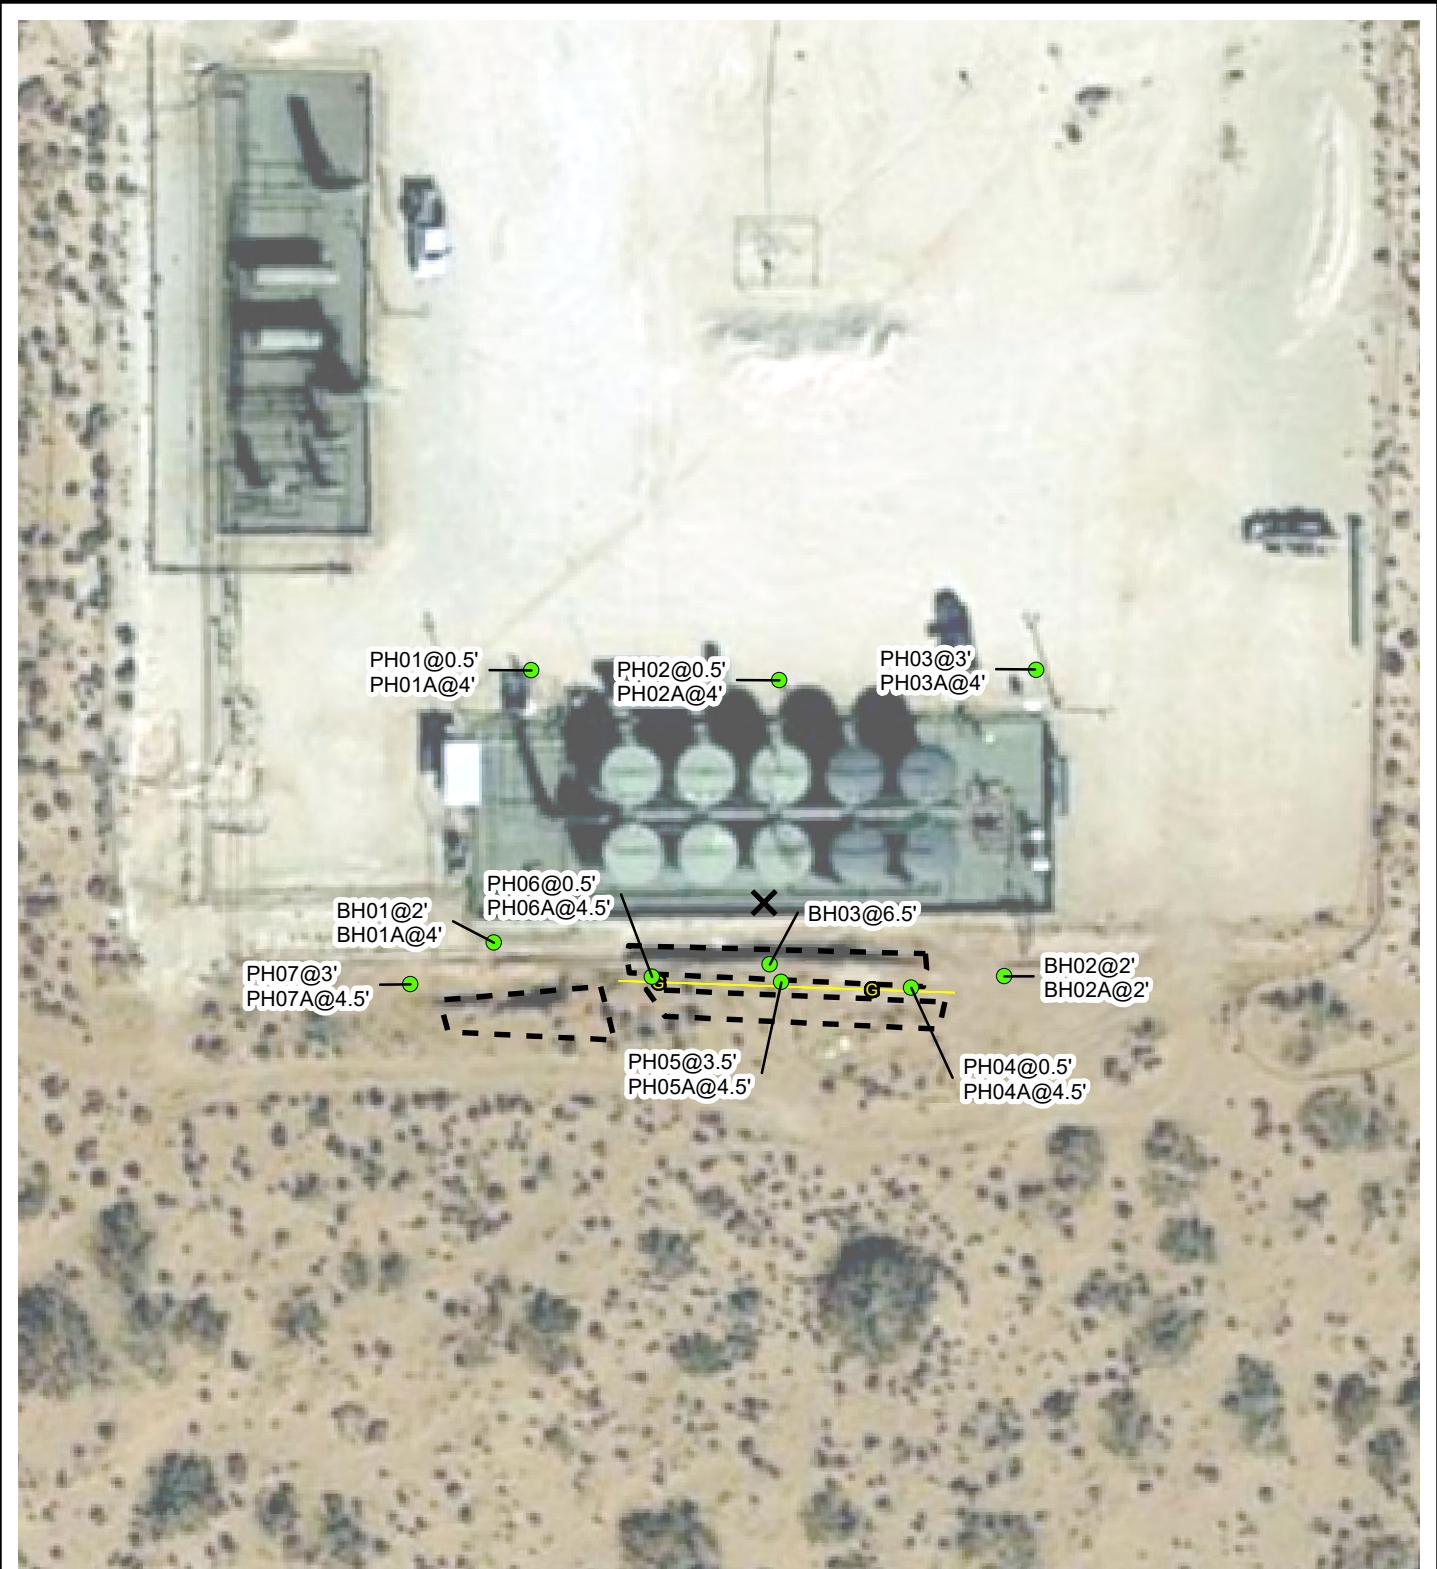
FIGURE 2  
DELINEATION SOIL SAMPLE LOCATIONS  
POKER LAKE UNIT  
ROSS RANCH 33-25-30 USA BATTERY  
UNIT D SEC 33 T25S R30E  
EDDY COUNTY, NEW MEXICO  
**XTO ENERGY, INC.**

- ✖ RELEASE LOCATION
- DELINEATION SOIL SAMPLE IN COMPLIANCE WITH APPLICABLE STANDARDS
- GAS LINE
- [---] EXCAVATION EXTENT

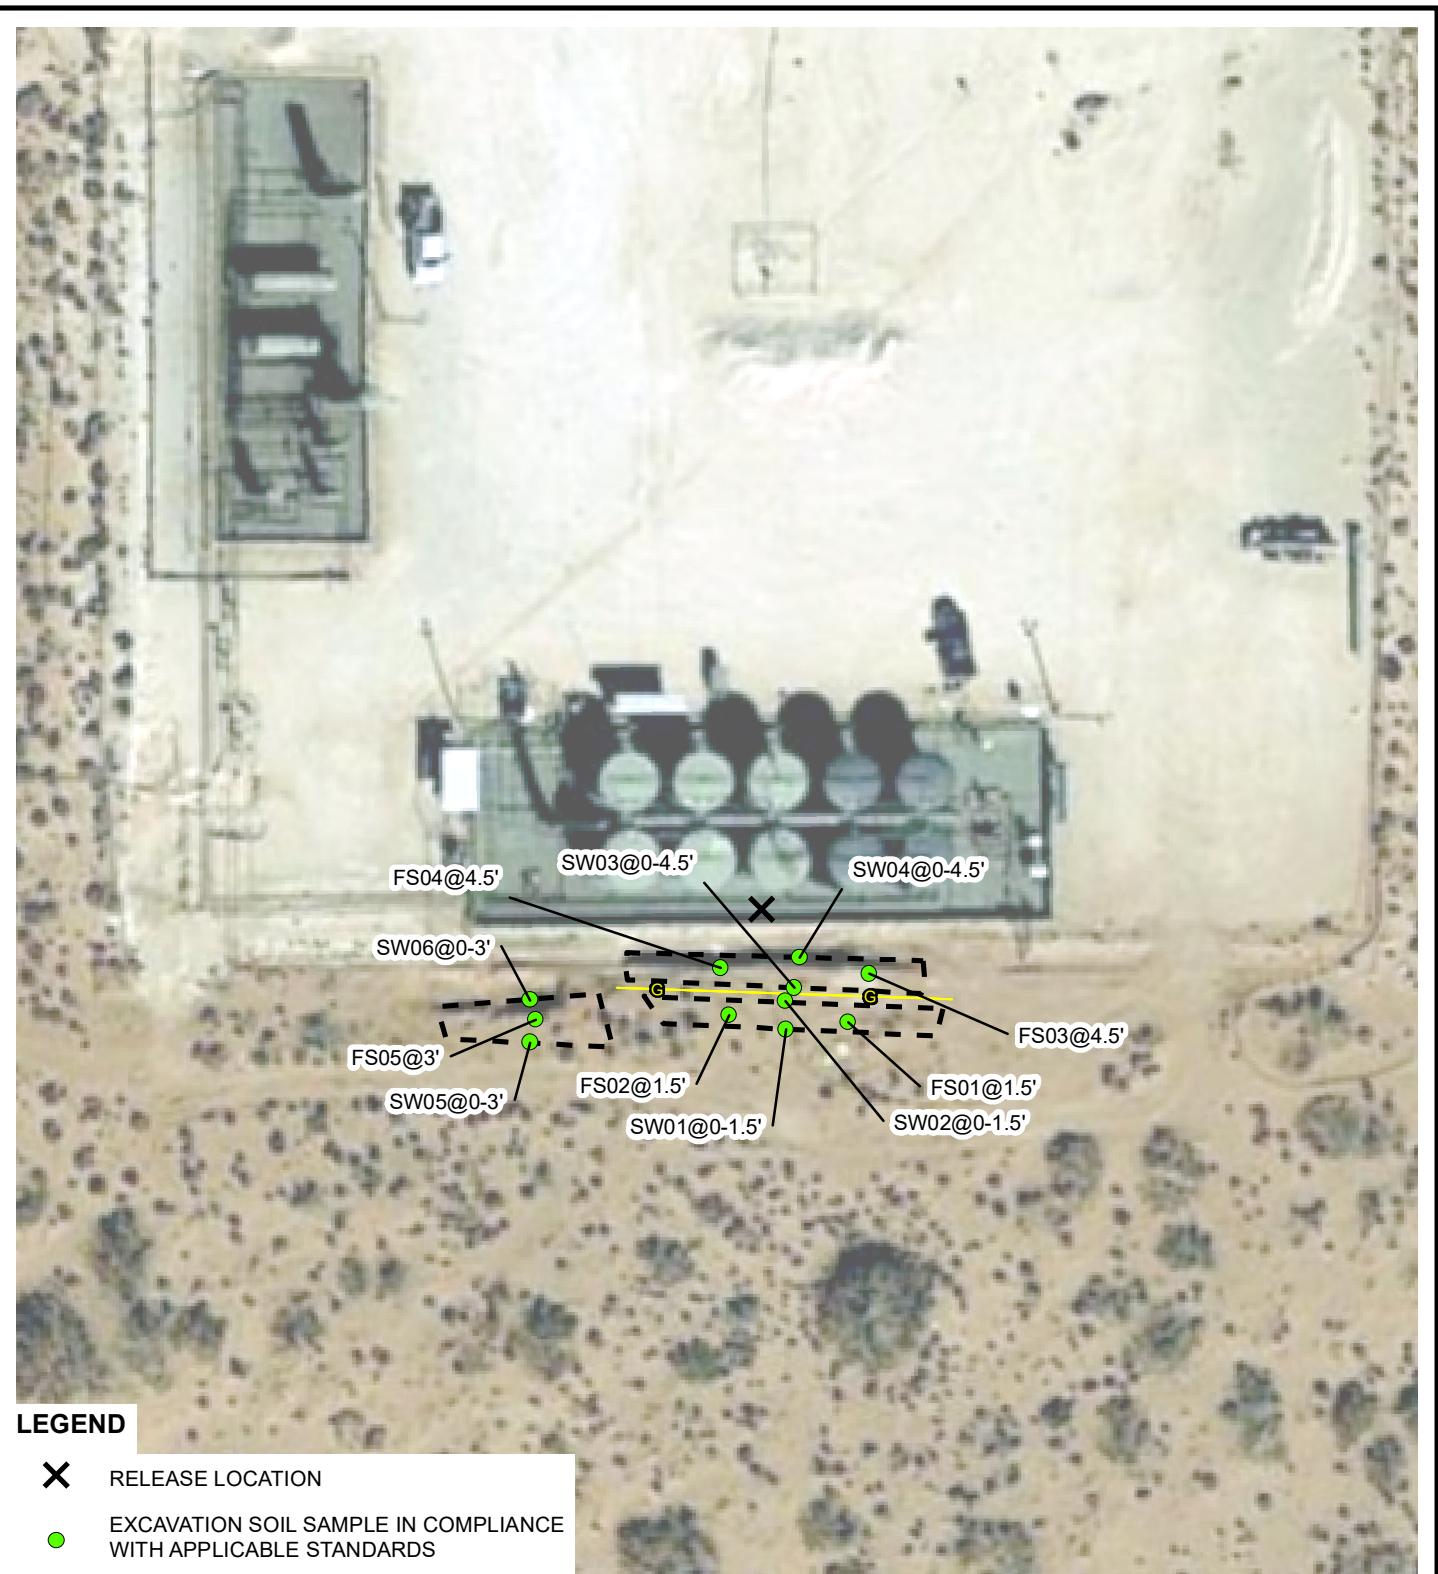
Based on field screening results and visual staining, soil was excavated from the three excavations to depths ranging from approximately 1.5 feet to 4.5 feet bgs. Following removal of impacted soil, LTE collected 5-point composite soil samples every 200 square feet from the sidewalls and floor of the excavations. The 5-point composite soil samples were collected by depositing five aliquots of soil into a 1-gallon, resealable plastic bag and homogenizing the samples by thoroughly mixing. The following composite floor soil samples were collected on April 26, 2019:

- RELEASE LOCATION
- EXCAVATION SOIL SAMPLE IN COMPLIANCE WITH APPLICABLE STANDARDS
- GAS LINE
- EXCAVATION EXTENT

The northern excavation extent was limited to the north by the existing metal containment berm and to the south by the existing active gas pipeline. XTO safety policy restricts soil disturbing activities to a 2-foot radius of any on-site storage tanks or process equipment. This safety policy is established to protect workers and to reduce the likelihood of compromising the foundation of the storage tanks and/or process equipment. This policy had to be enforced along the northern and southern sidewalls of the northern excavation extent.

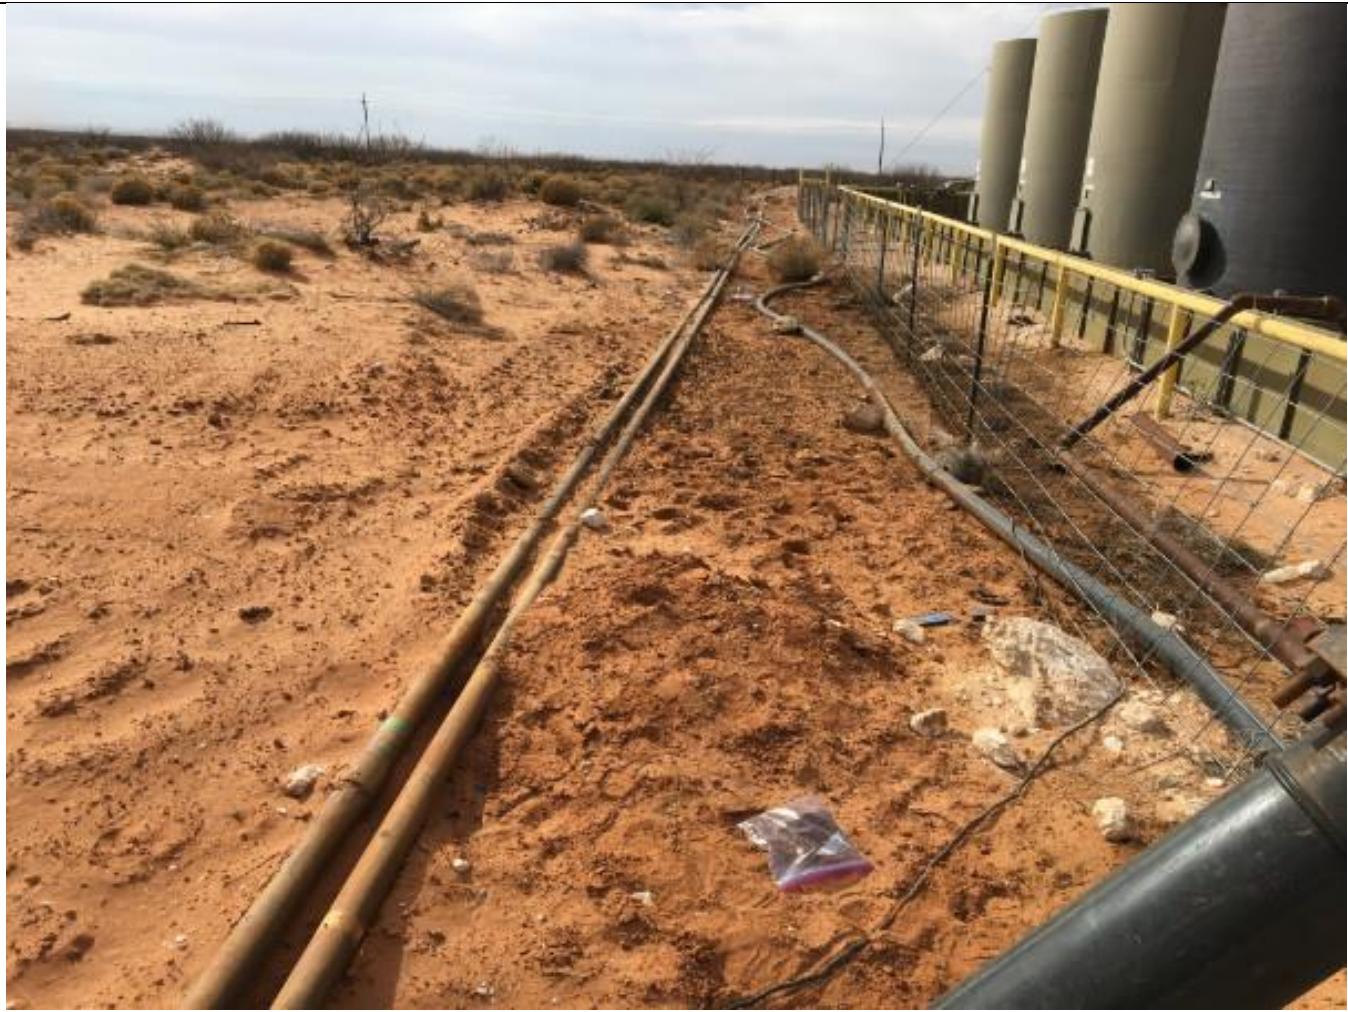
**Western view of the soil impacts on pad (right side of center gas lines) and off pad on pasture (left of center gas lines) during delineation activities.**

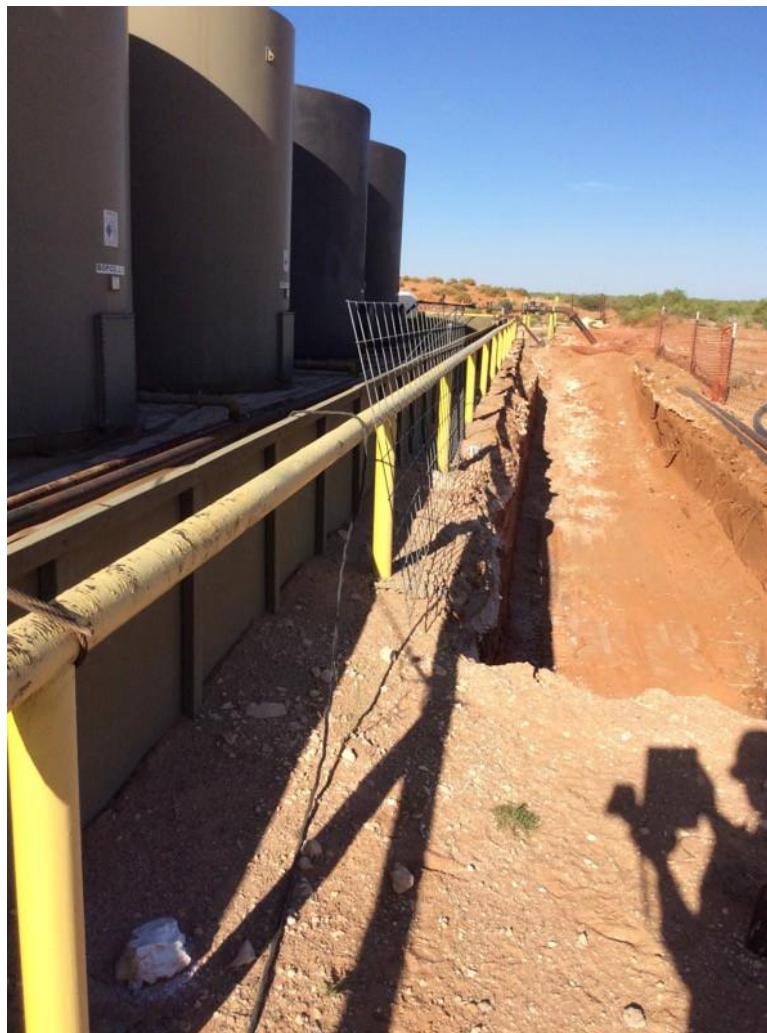
**Eastern view of the northern excavation extent during excavation activities.**
