BTA OIL PRODUCERS

Site Activities

Closure Request

1RP-5295

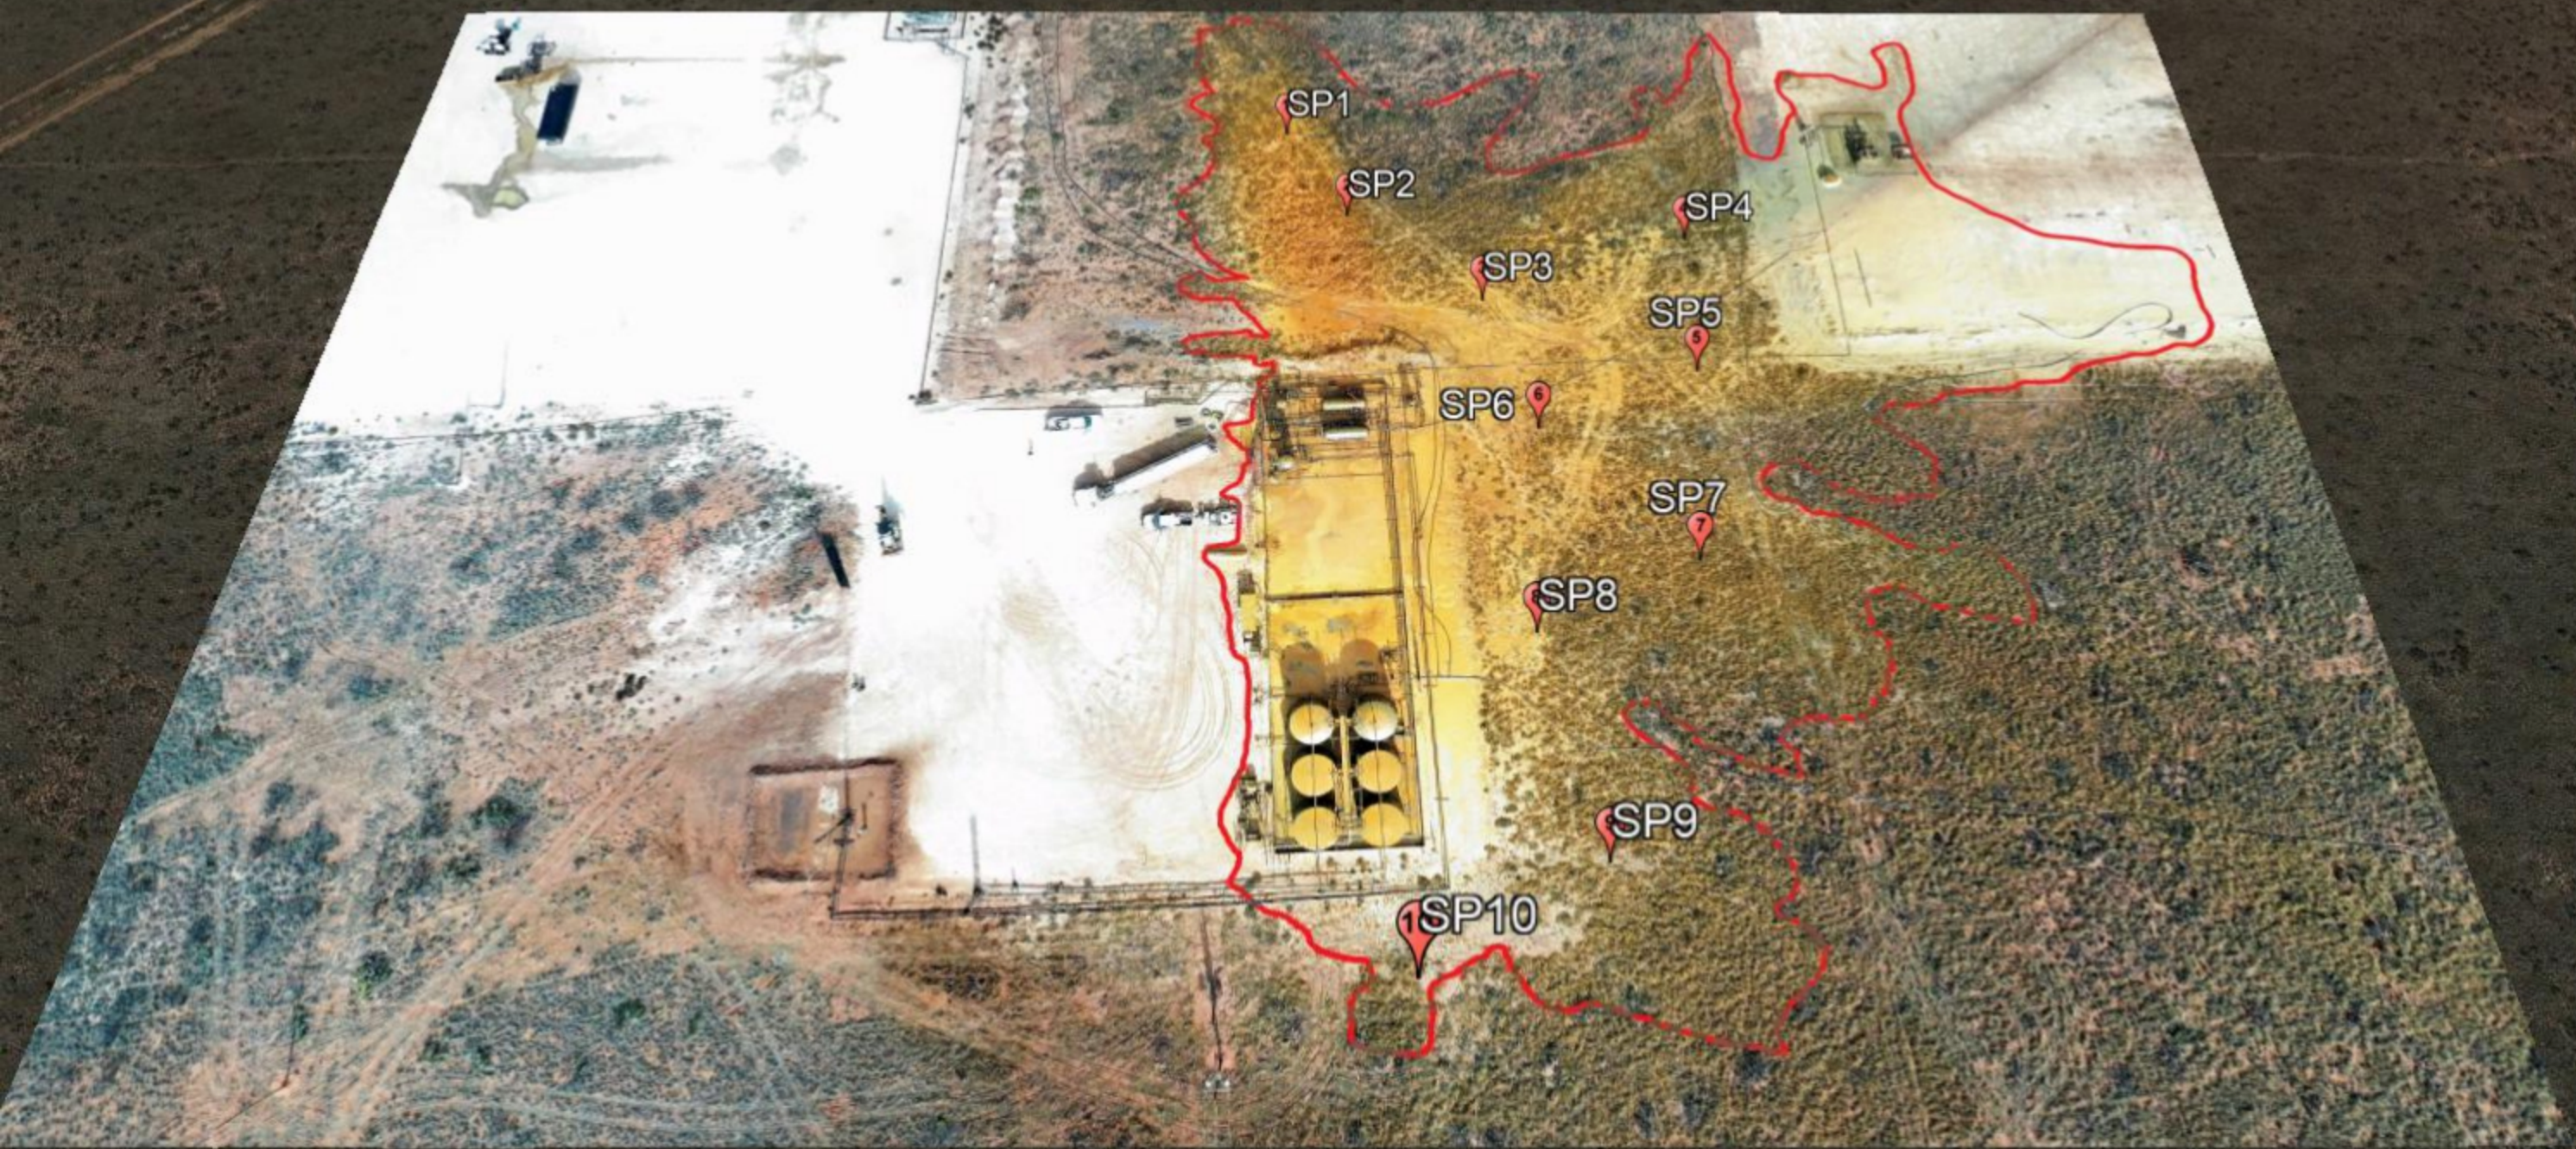
Appendix I -Site Map

Rojo AE 7811 JV-P Federal 001H
Tank Battery
D-Sec, 27-T25S, R33E
Lea County
API 30-025-43476
659,861 Sq Ft.

Expert Environmental, on behalf of BTA Oil Producers, respectfully request acceptance of this closure report on the release detailed herein. A site map is attached before the Appendices and pictures have been included to provide additional information about the release and the scope of the emergency response activities and backfill.

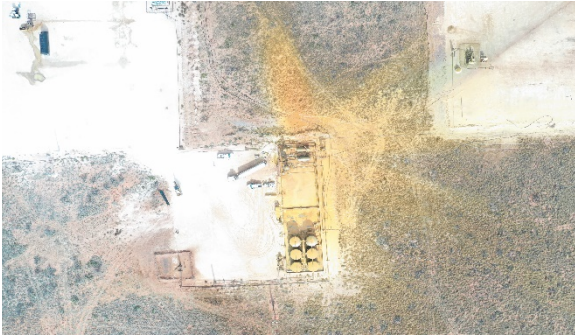
Ariel Image of entire spill

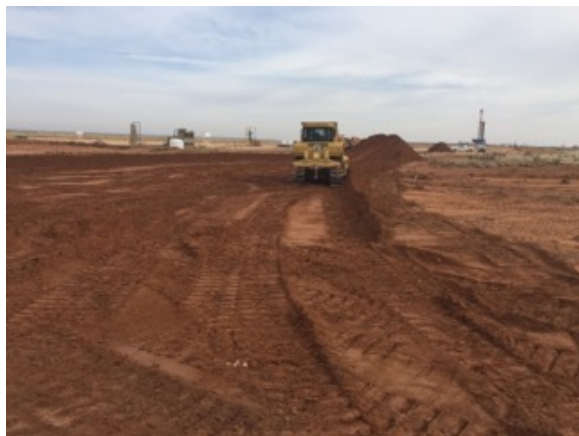
Excavating 2'BGS

After the initial scraping of 1' of obviously impacted soil in the vicinity of sample locations 3 – 10, the soil was excavated another 1' for a total of 2' BGS depth excavated from those portions of the spill area. Sample locations 1 & 2 were left as is, due to field results and confirmed with lab analysis. The tanks were washed as was the interior of the secondary containment. All waste water was taken to a BTA SWD for proper disposal. All impacted soil

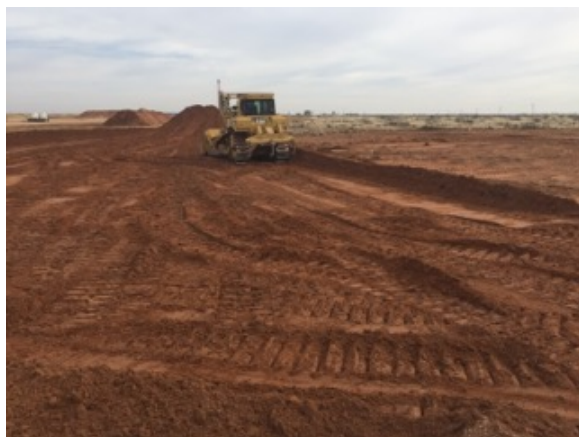
Excavating 2'BGS

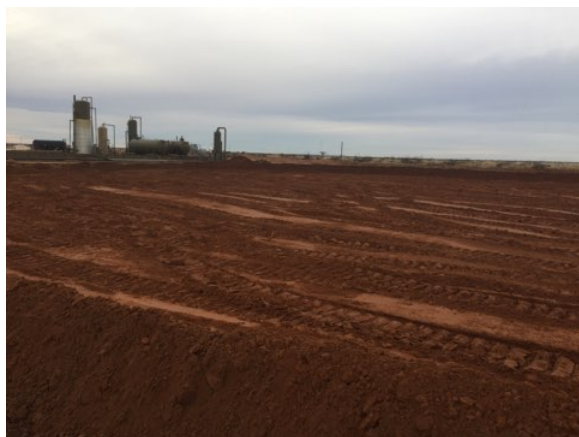
Site excavated

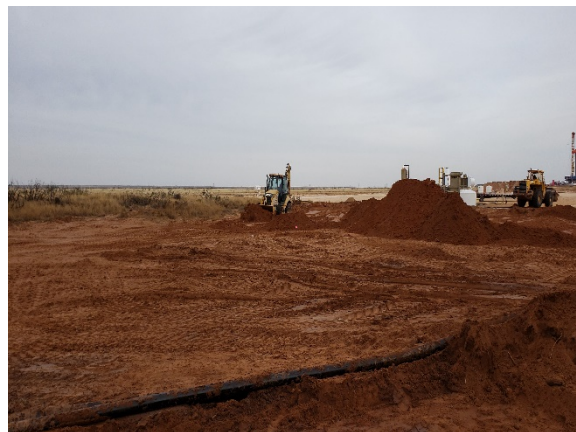
Excavating around lines

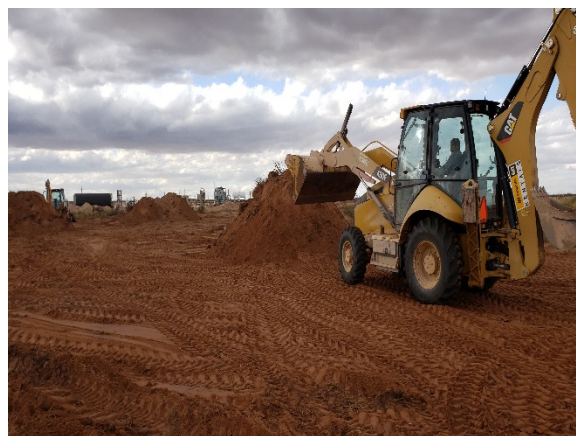
Continuing to excavate around lines

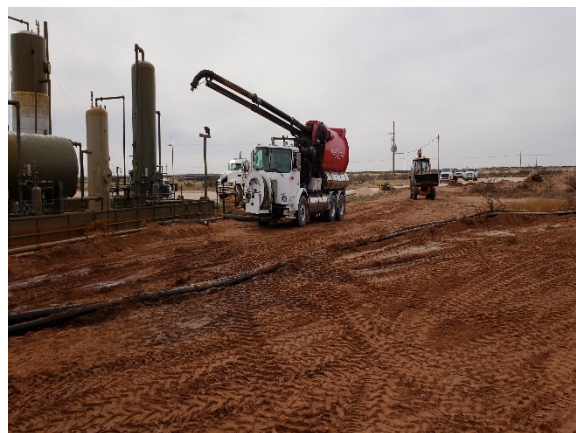
Hydro-vac around gas lines at battery

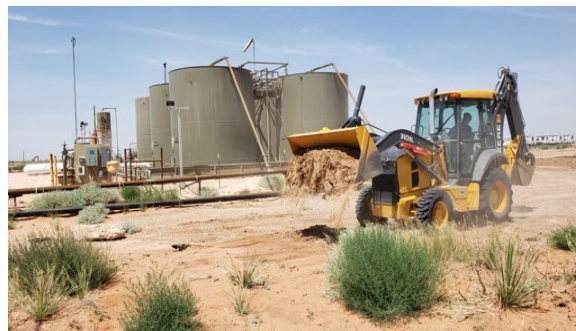
Continuing to backfill

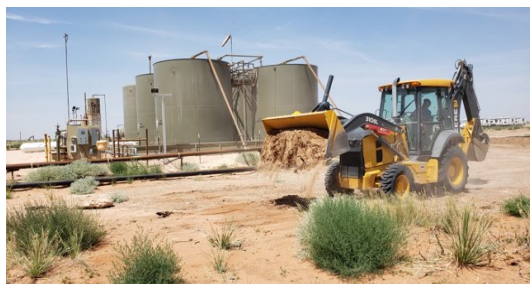
Backfilling location

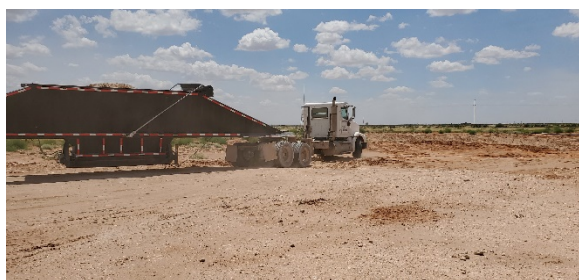
Hauling in topsoil

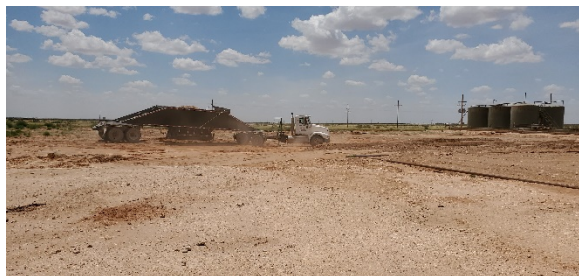
Hauling in topsoil
