Remediation Plan

January 17, 2020

Re: WBDU 46
API# 30-025-37020
Case # 1RP-5793

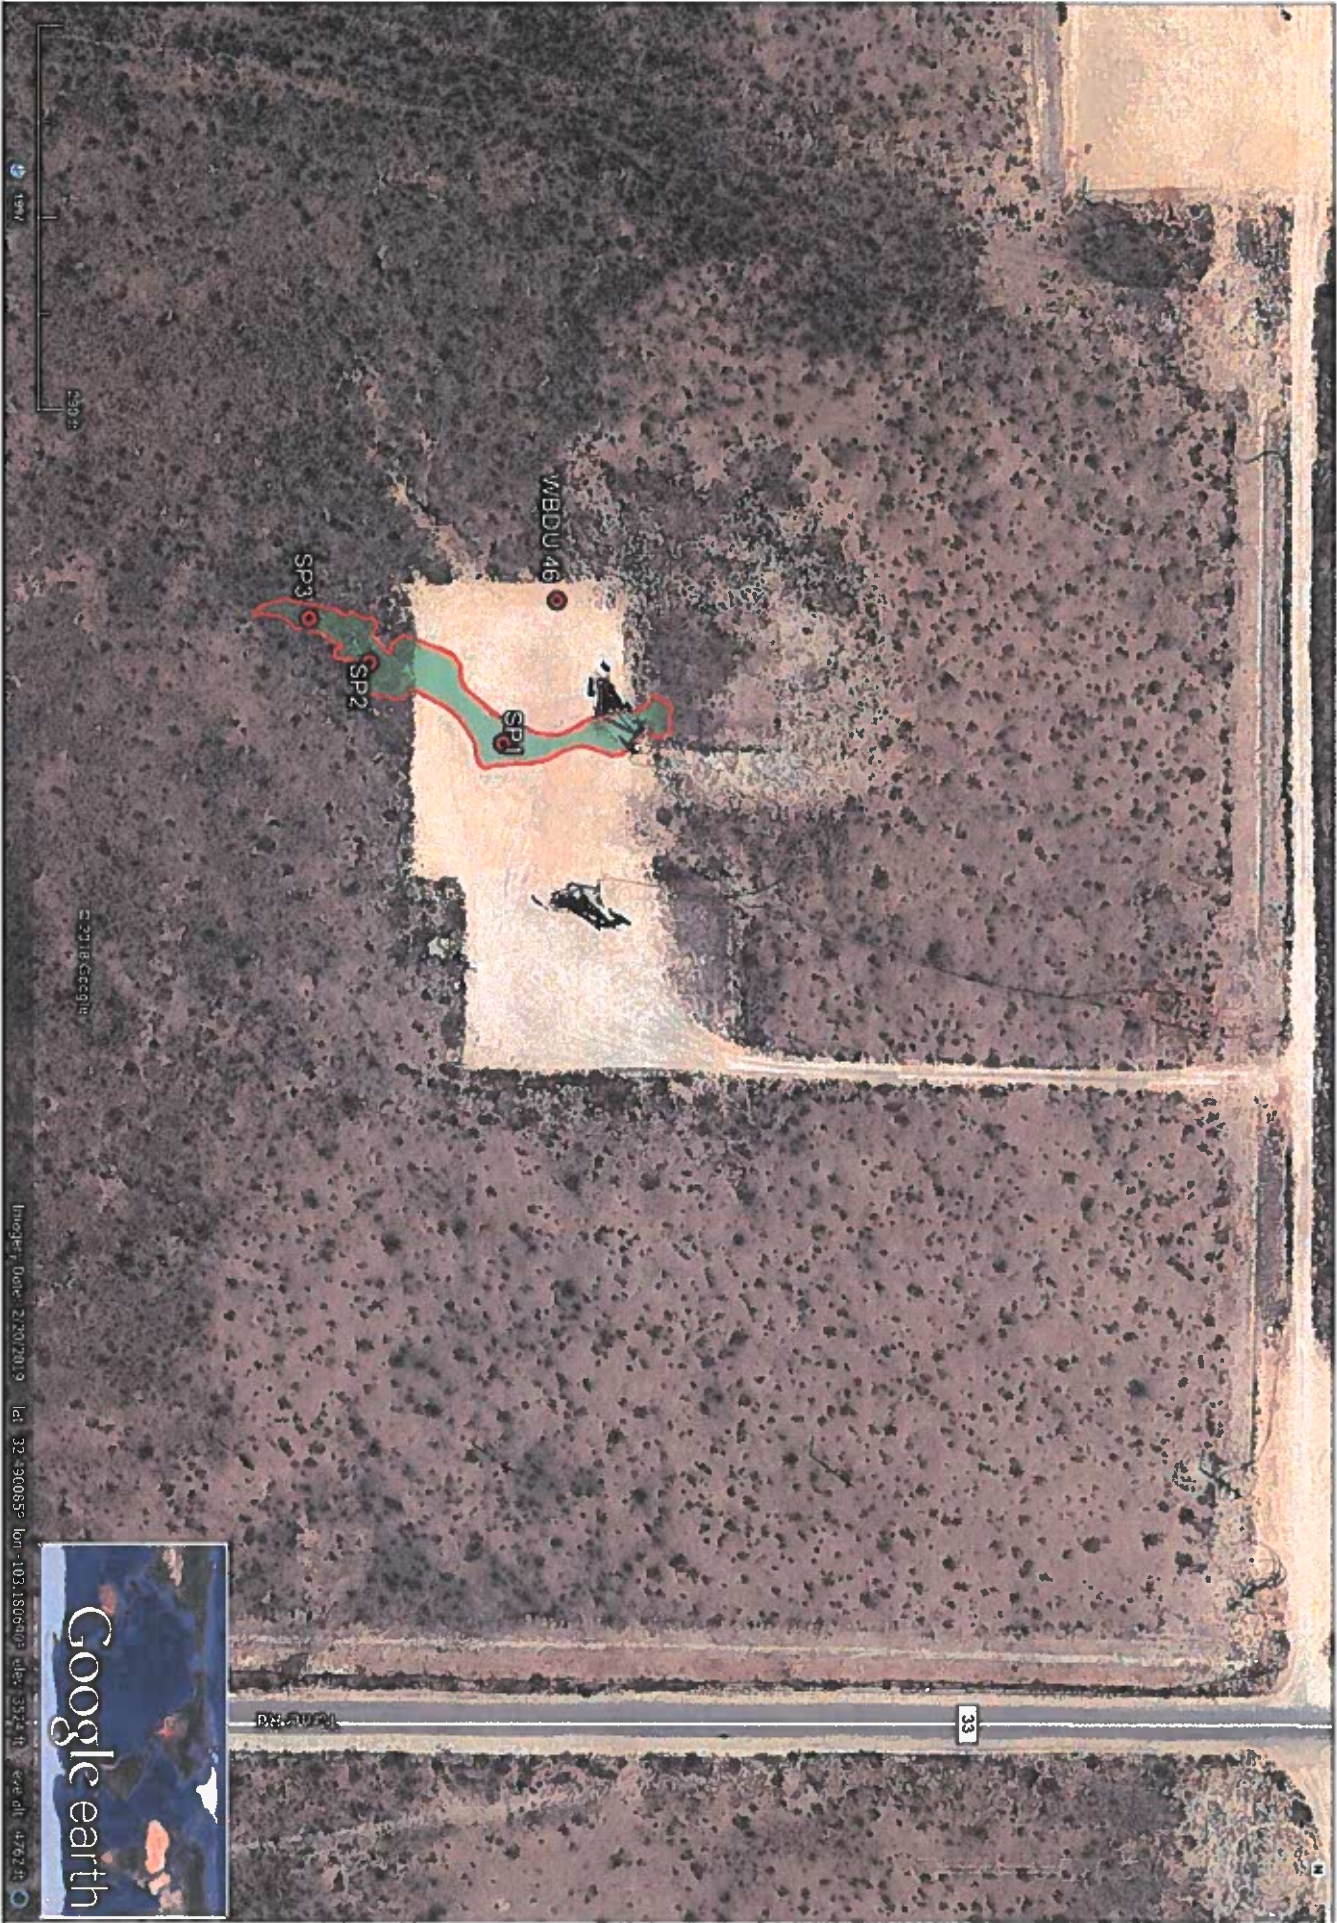
WBDU 46 Delineation

Map ID	Sample Date	Sample ID	Depth	Chloride	Benzene	Toulene	Ethylbenzene	Total Xylenes	Total BTEX	GRO	DRO	EXT DRO	GPS Coordinates
SP1	11/25/2019	SP1 @ Surface	5	19200	<0.050	<0.050	<0.050	<0.150	<0.300	<10.0	154	26.5	32.489613, -103.181143
	11/25/2019	SP1 @ 1'	1'	6000	<0.050	<0.050	<0.050	<0.150	<0.300	<10.0	<10.0	<10.0	
SP2	11/25/2019	SP2 @ Surface	5	2800	<0.050	<0.050	0.658	3.77	4.42	560	21100	3700	32.489377, -103.181328
	11/25/2019	SP2 @ 2'	2'	3080	<0.050	<0.050	<0.050	<0.150	<0.300	<10.0	<10.0	<10.0	
	11/25/2019	SP2 @ 4'	4'	5120	<0.050	<0.050	<0.050	<0.150	<0.300	<10.0	25.5	<10.0	
SP3	11/25/2019	SP3 @ Surface	5	304	<0.050	<0.050	0.694	2.75	3.45	251	5930	872	32.489356, -103.181450
	11/25/2019	SP3 @ 2'	2'	288	<0.050	<0.050	<0.050	<0.150	<0.300	<10.0	16.3	<10.0	
	11/25/2019	SP3 @ 4'	4'	272	<0.050	<0.050	0.327	1.24	1.57	80.2	1080	126	
	12/3/2019	SP3 @ 5'	5'	N/A	<0.050	<0.050	<0.050	<0.150	<0.300	<10.0	<10.0	<10.0

Apache proposes that the release area located on the lease pad (SP 1) be excavated to a depth of 1'. Apache proposes that the area of SP 2 be excavated to a depth 4 feet and the area of SP 3 be excavated to a depth of 5 feet. Once the excavations are complete Apache proposes that final 5 point bottom and wall composite samples be collected not to exceed 500 square feet. If chloride values at the proposed excavation depths in the pasture exceed 1,000 mg/kg than a 20 mil reinforce liner will be installed.
