Release Notification

Site Name: WLU Remote Battery 1	Site Type: Tank Battery
Date Release Discovered: 2/28/2020	API# (if applicable) NA

Enduring Resources, LLC
WLU Remote Battery 1 Compressor Fire

Xact Incident Number 13474

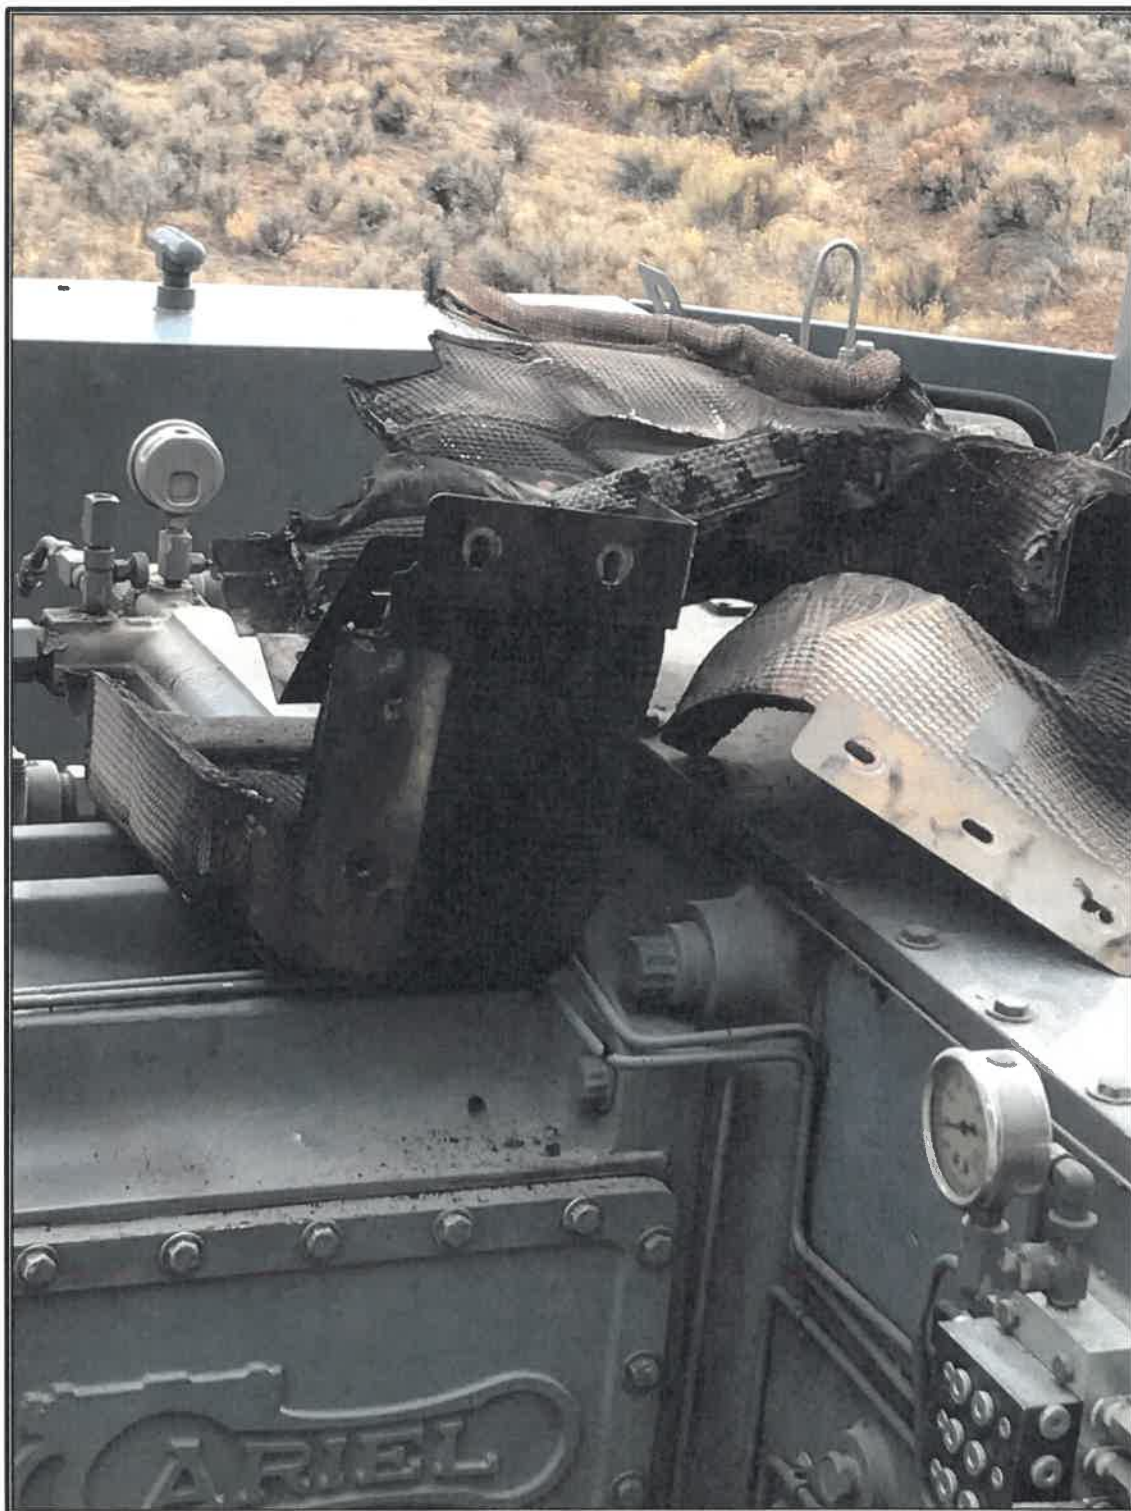
PHOTO 2: View of Damaged Insulation after Being Removed from Turbo Booster

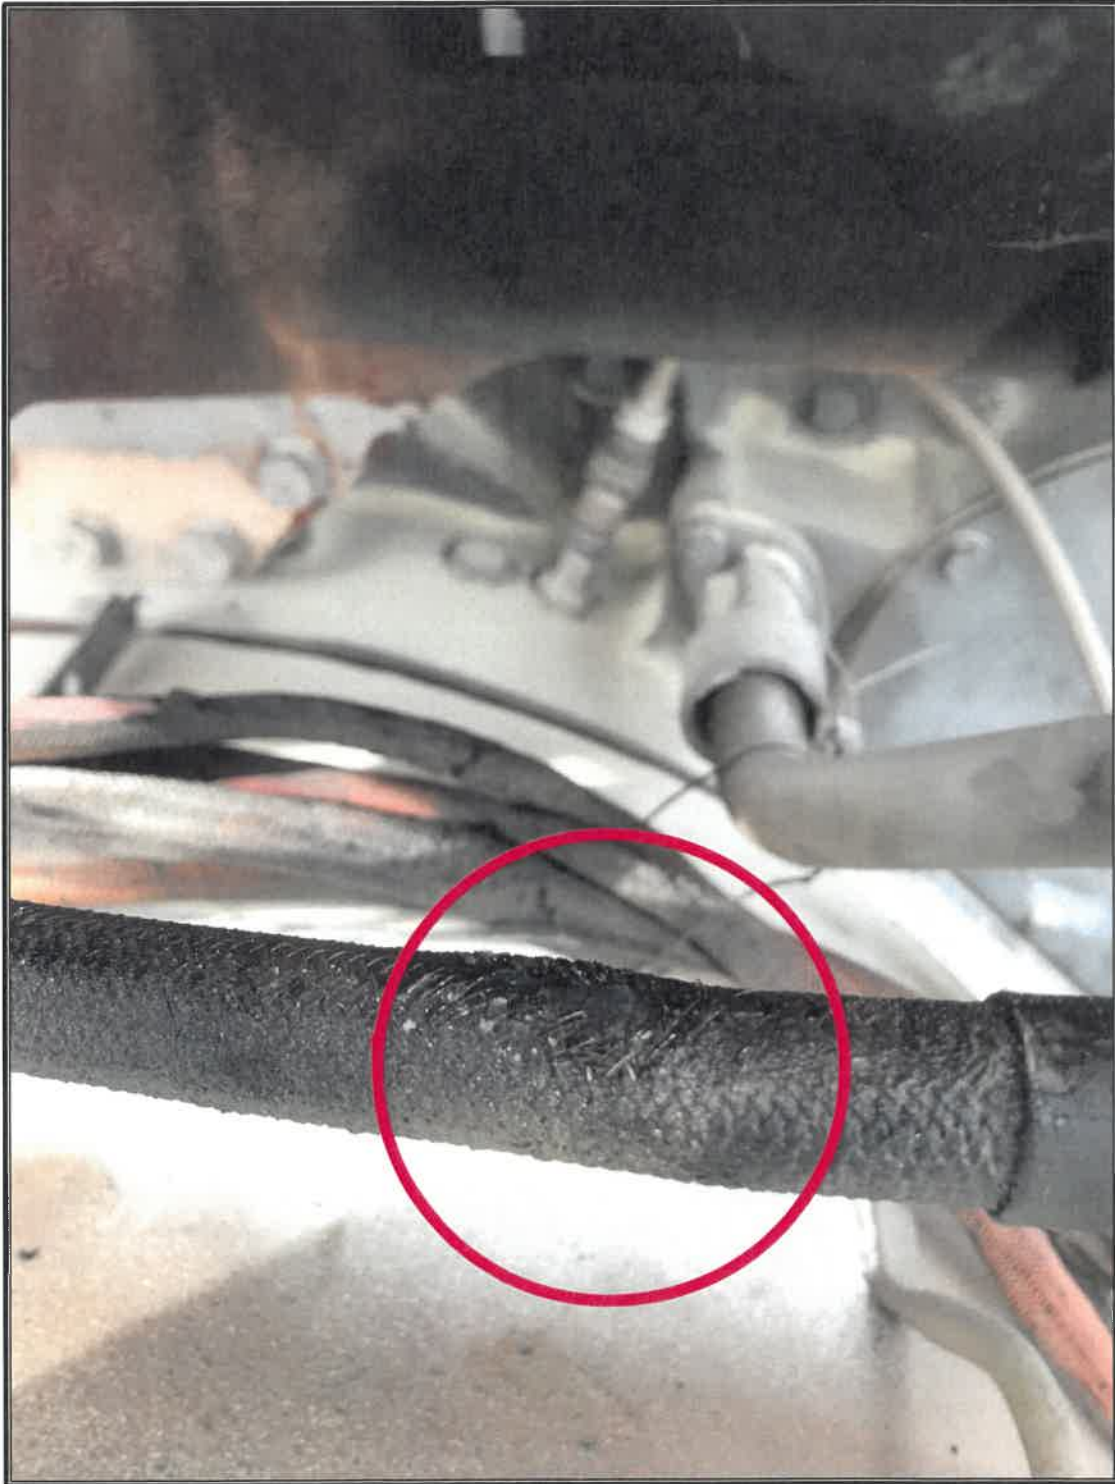
As detailed on the voicemail I left you, Enduring had a small fire occur at the WLU Remote Battery #1 today at approximately 1:00 PM. The fire occurred on the back side of the gas lift compressor due to a leak in the oil hose that sprayed oil onto the turbo boosters, catching the insulation covering the hose on fire. The fire was put out using a fire extinguisher. No damage occurred to well equipment, or the surrounding area. All damage was contained to the insulation around the compressor turbo boosters. A small amount of compressor oil dripped onto the compressor skid, but did not leave the skid. There is no API for this facility, as it is a centralized battery, but the GPS and an Aerial photo is below. Please don't hesitate to contact me with any questions.

PHOTO 3: Close Up of Leaking Oil Hose

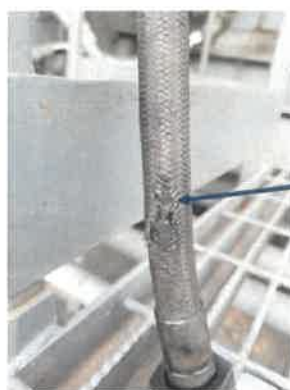
Split oil line

- Oil return line vibrated against metal mesh heat blanket causing the hose to split.

Action	Date to be Completed	Employee Responsible	Status
Repair unit, Installed New Cat Hose	2.29.2020	Archrock FST's	Completed
Replaced old style CAT metal mesh heat blanket with CAT new style soft blanket	2.29.2020	Archrock FST's	Completed

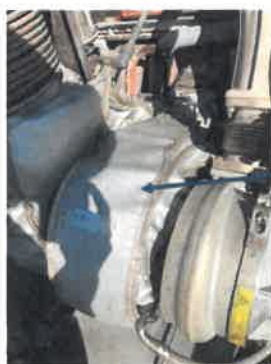
CAT new style soft heat blanket installed

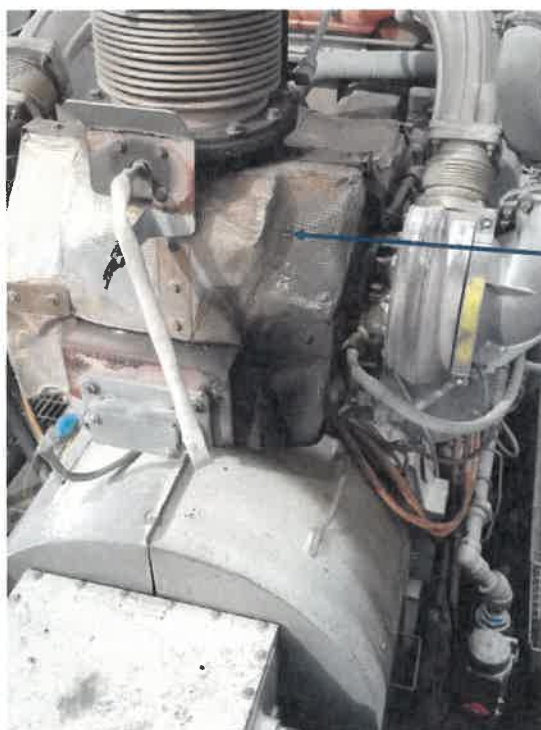
Old style metal mesh heat blanket
