Incident ID	nAB1926639738
District RP	
Facility ID	
Application ID

Site Assessment/Characterization

Closure

Cause of Release and Affected Area:

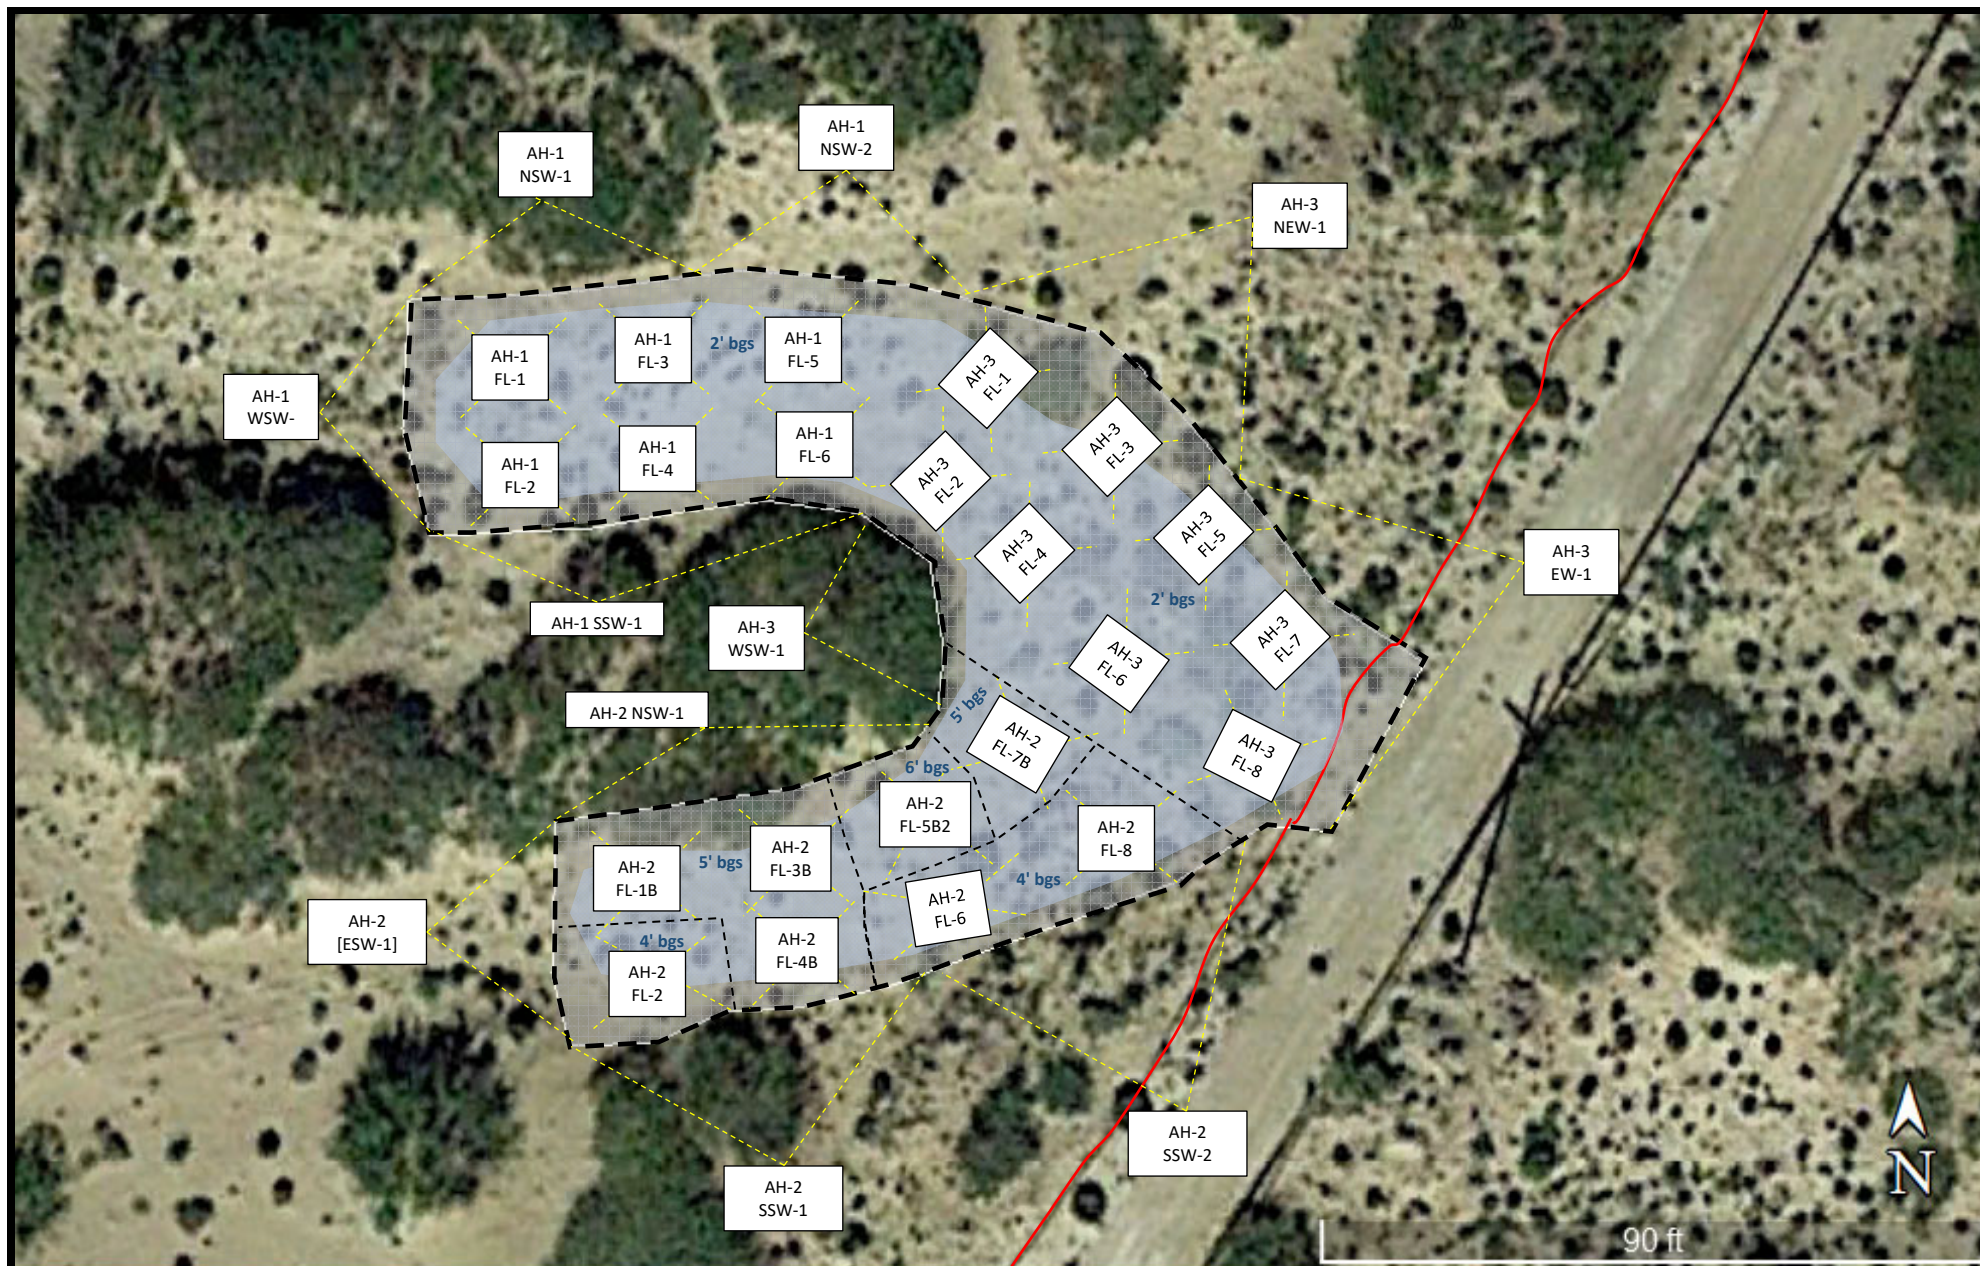
Figure 3
Site and Sample Location Map

The release was attributed to the failure of a flowline. Impacts from the release affected an area within the pasture measuring approximately 4,600 sq. ft.

- Sample Point
- Affected Area
- Poly Flowline
- Excavated Area
