Re : Chevron Special Projects – NM State AN 5 (RP# 3254)

Please find enclosed for your records, a copy of the final report documenting the assessment activities at the New Mexico State AN No. 5 (RP # 3254).

VACUUM/LOVINGTON FUNCTIONAL MANAGEMENT TEAM UNITS
LEA COUNTY, NEW MEXICO
SITE ASSESSMENT REPORT

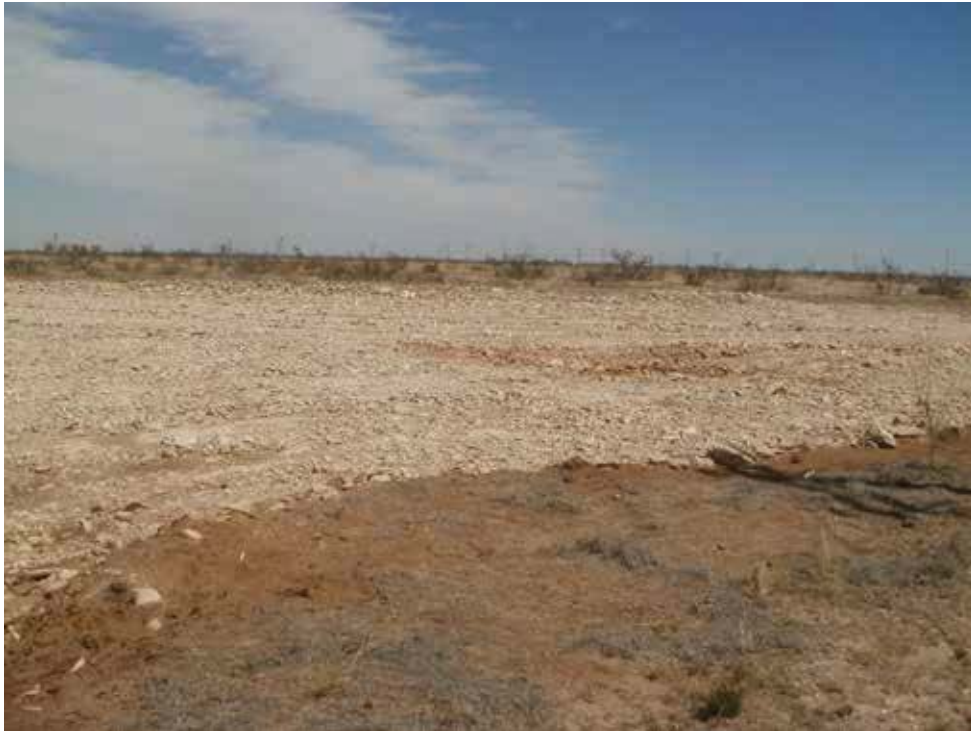
Photograph 1 – State AN 5 release area; Facing Northeast

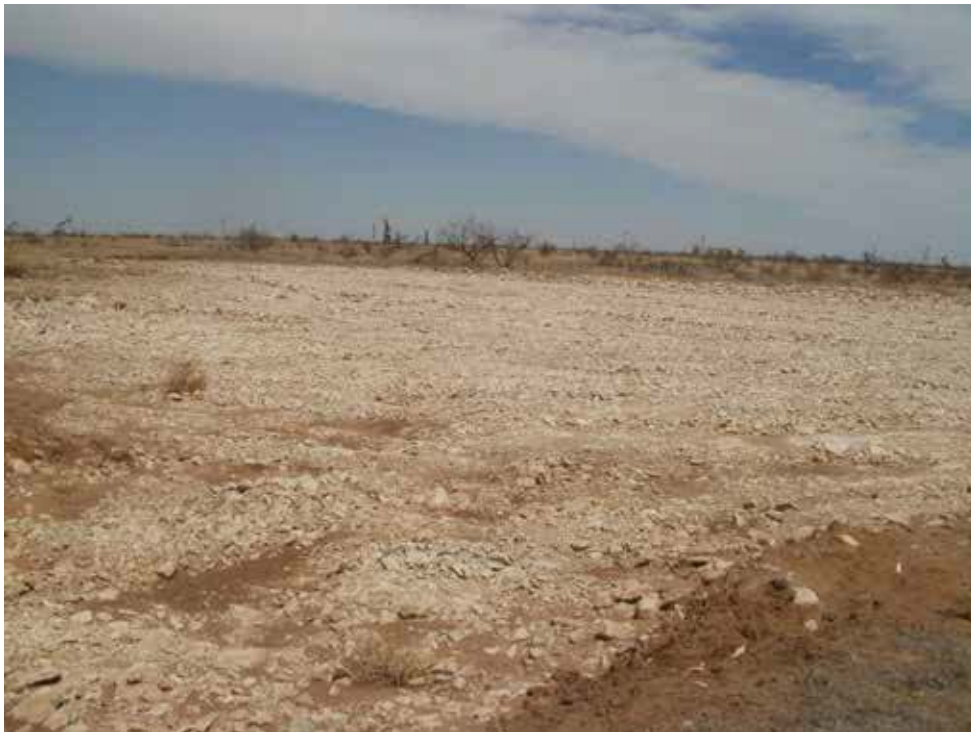
Photograph 2 – State AN 5 release area; Facing North

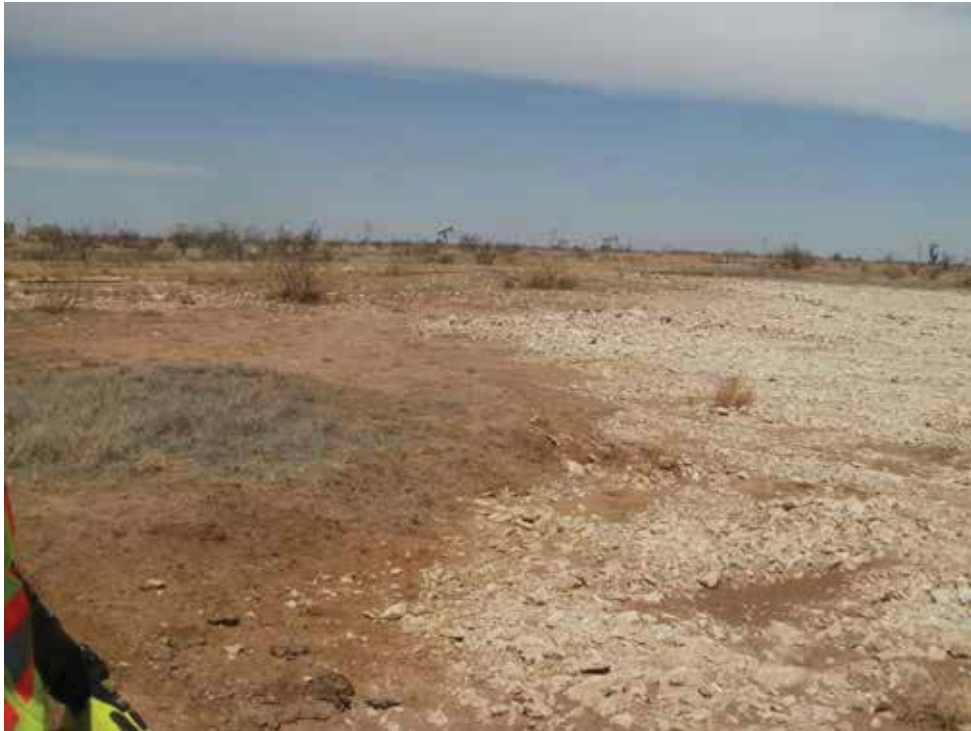
Photograph 3 – State AN 5
release area; Facing
Northwest

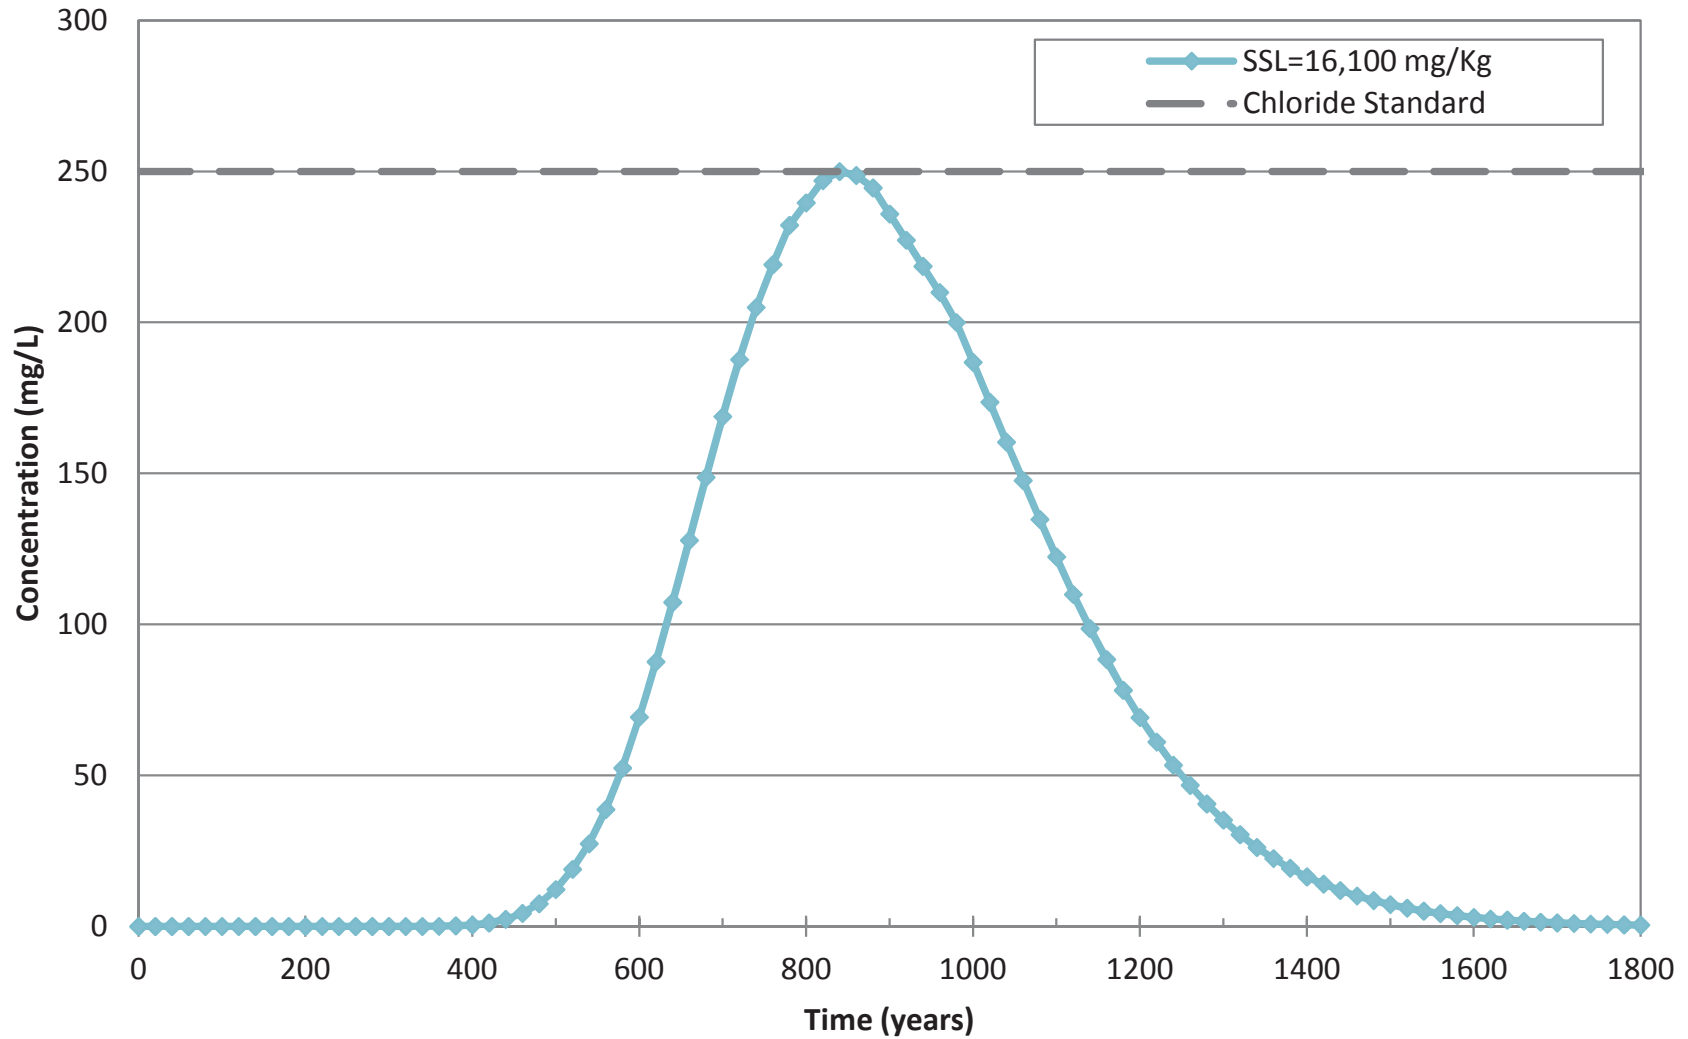
Figure 8

**MULTIMED Simulated Chloride Concentration Vs Time in Groundwater
(Source = 45m, Chloride 0-3m, & Depth to Groundwater = 30.5m)**
