Chevron Special
Projects

VGSAU 15

Re : Chevron Special Projects – VGSAU 15 (RP# 3255)

VACUUM/LOVINGTON FUNCTIONAL MANAGEMENT TEAM UNITS
LEA COUNTY, NEW MEXICO
SITE ASSESSMENT REPORT

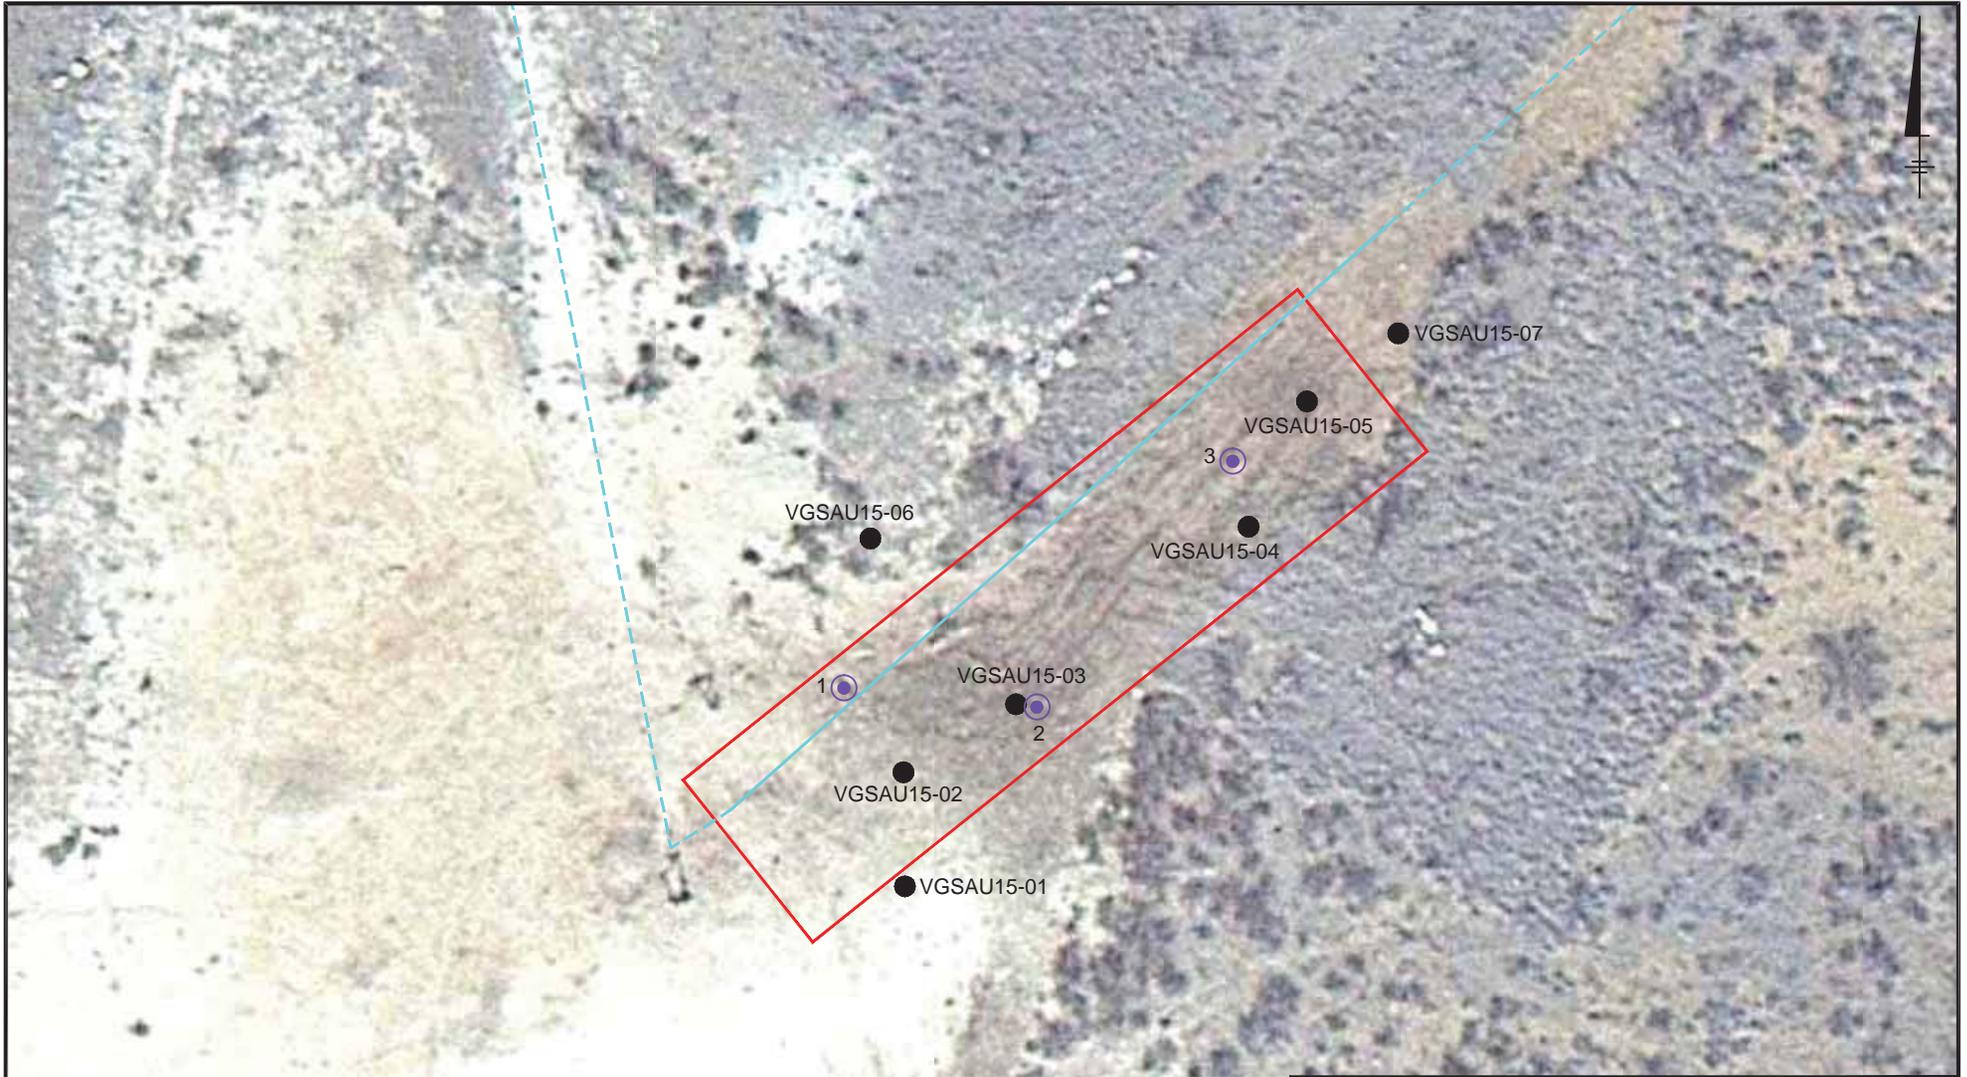
- MAY 2013 ASSESSMENT SOIL SAMPLING LOCATION
- 1 ○ OCTOBER 2011 CONFIRMATION SOIL SAMPLING LOCATION
- - - - POTENTIAL UNDERGROUND UTILITY LINE NOT DETECTED BY THIRD PARTY SURVEYOR
- UNDERGROUND UTILITY LINE
- APPROXIMATE EXTENT OF SPILL

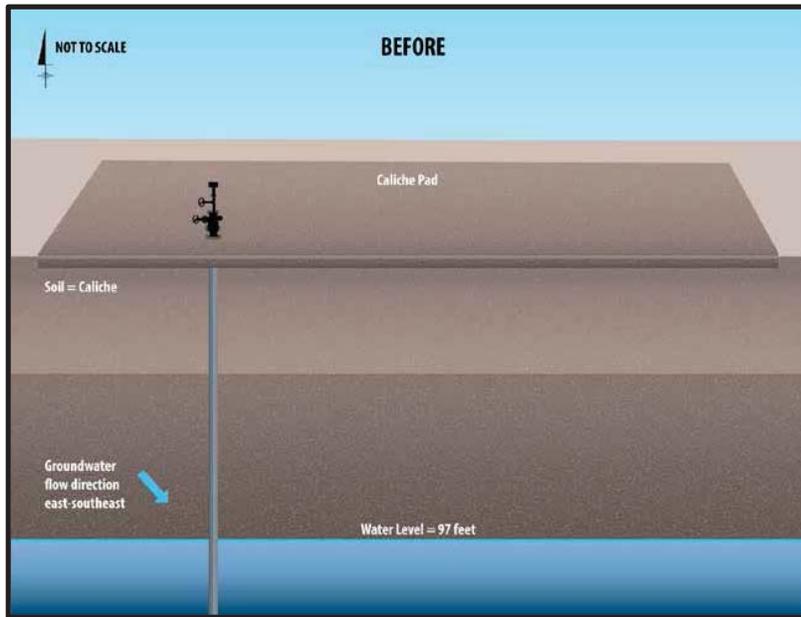
The site is located in the western edge of the Permian Basin with Lovington (the closest town) located approximately 14 miles northeast of the site. Due to the arid climate, the site experiences low precipitation and high evapotranspiration rates. According to information obtained from the NMOSE online database, groundwater near the site is encountered at a depth of approximately 97 feet bgs.

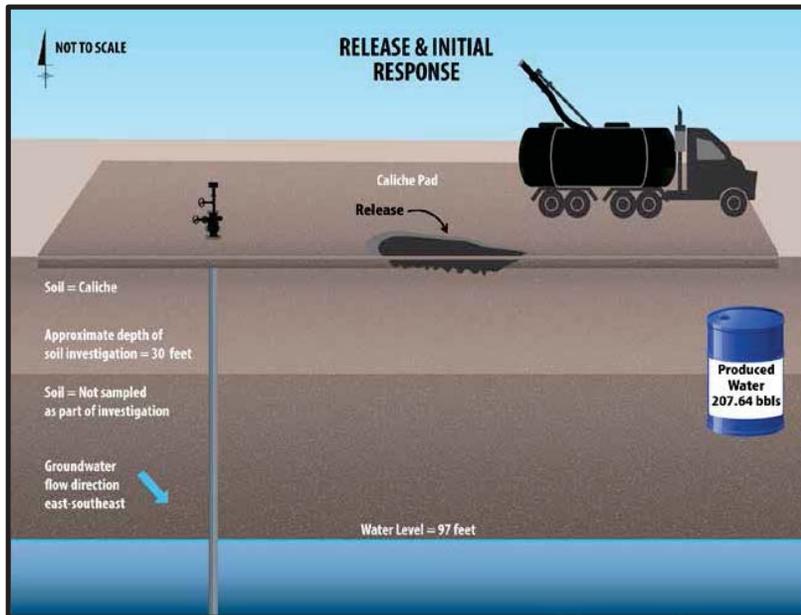
A release of approximately 207.64 bbls of produced water occurred at the site on August 14, 2011 due to the failure of a corroded well head nipple. Chevron personnel from the Mid-Continent Business Unit (MCBU) stopped the release and recovered approximately 65 bbls of fluids using a vacuum truck. Chevron MCBU personnel excavated visually impacted soil in the area to a depth of approximately 2 feet bgs and collected three discrete confirmation soil samples from the base of the excavation on October 13, 2011. After collecting the soil samples, the excavated area was reportedly backfilled with imported soil. Analyte concentrations in one or more confirmation soil samples were above regulatory criteria, which prompted additional site assessment activities.

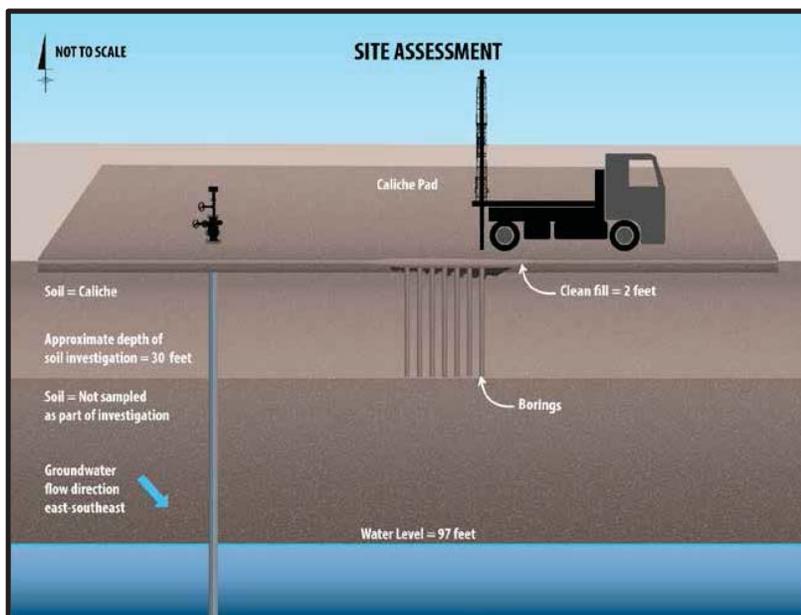
In May 2013, ARCADIS conducted site assessment activities to characterize the lateral and vertical extents of soil impacts at the site. Soil boring locations were selected based on the results of confirmation soil sampling completed at the site in October 2011, locations of pipelines and other equipment at the site, and the extent of the release as documented by Chevron MCBU personnel during the initial response activities. Analyte concentrations in samples collected during the 2013 assessment were reported below site-specific criteria. Site assessment activities demonstrate that remaining soil concentrations associated with the release do not pose significant risk to groundwater resources or other receptors.

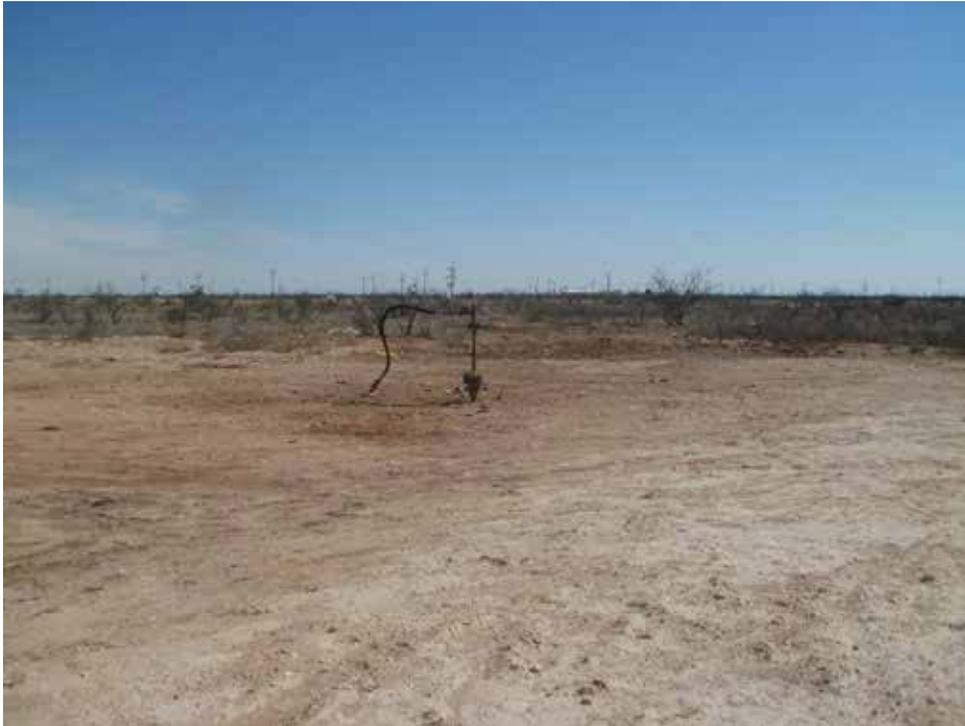
Photograph 1 – Vacuum Grayburg San Andres Unit Well #15; Facing Northeast

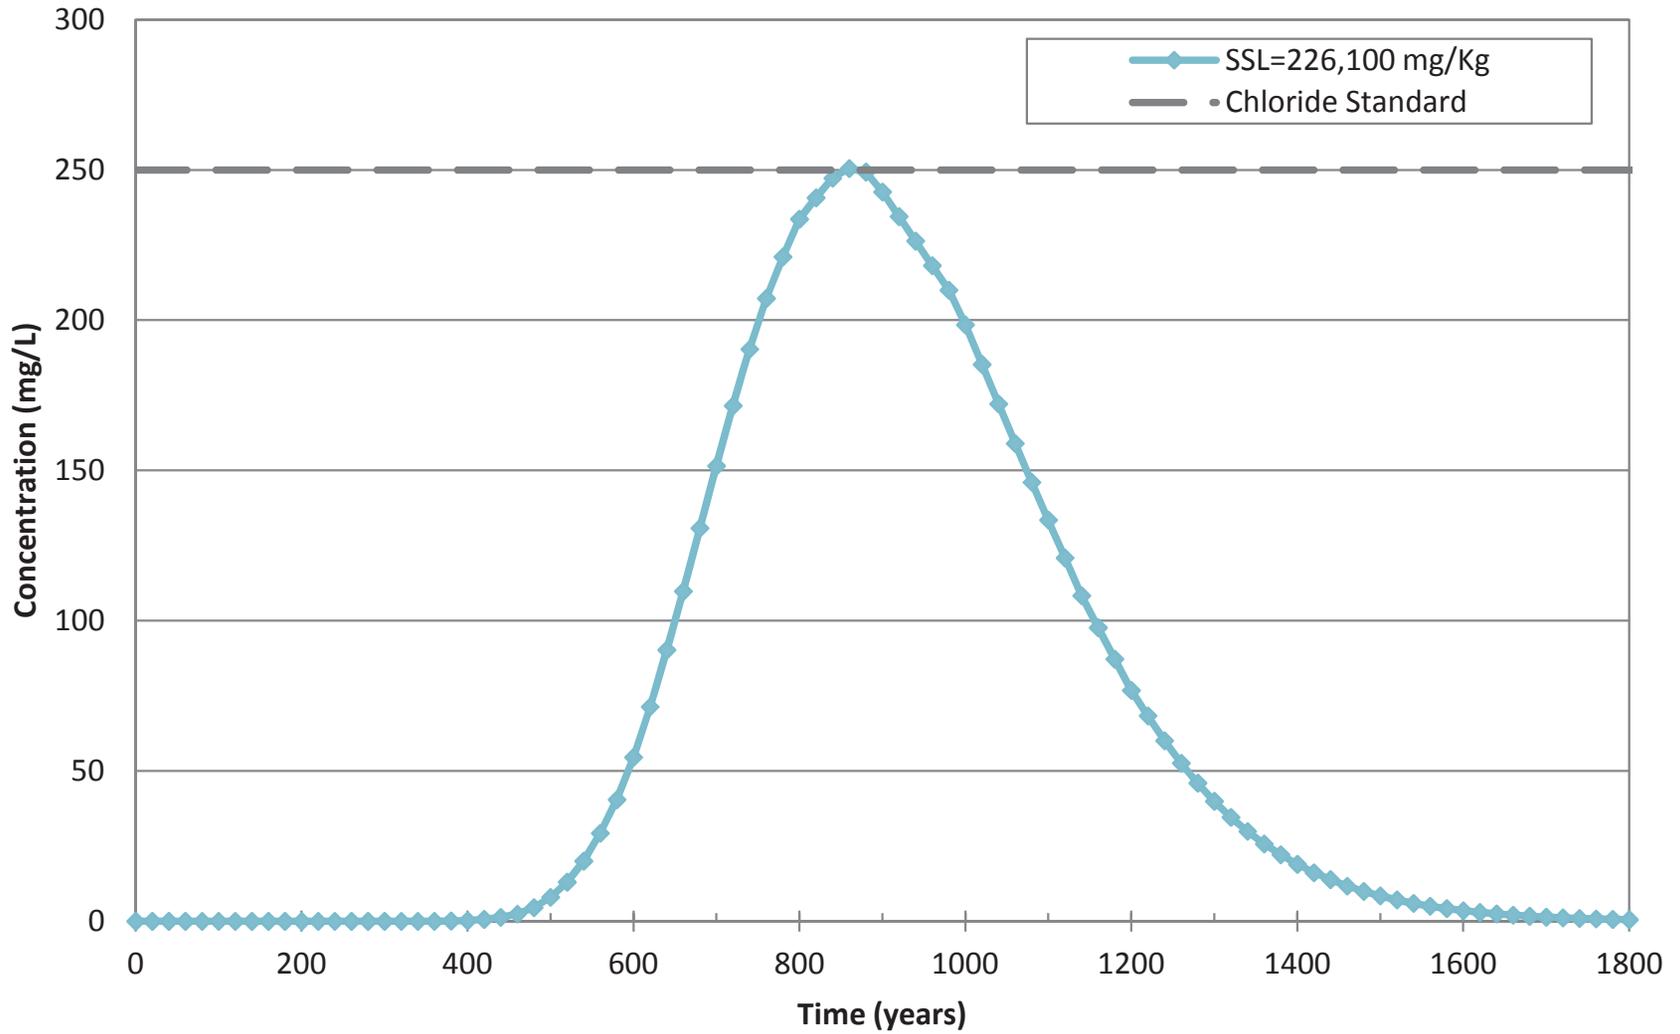
Figure 2
MULTIMED Simulated Chloride Concentration Vs Time in Groundwater
(Source = 20m, Chloride 0-1m, & Depth to Groundwater = 30.5m)

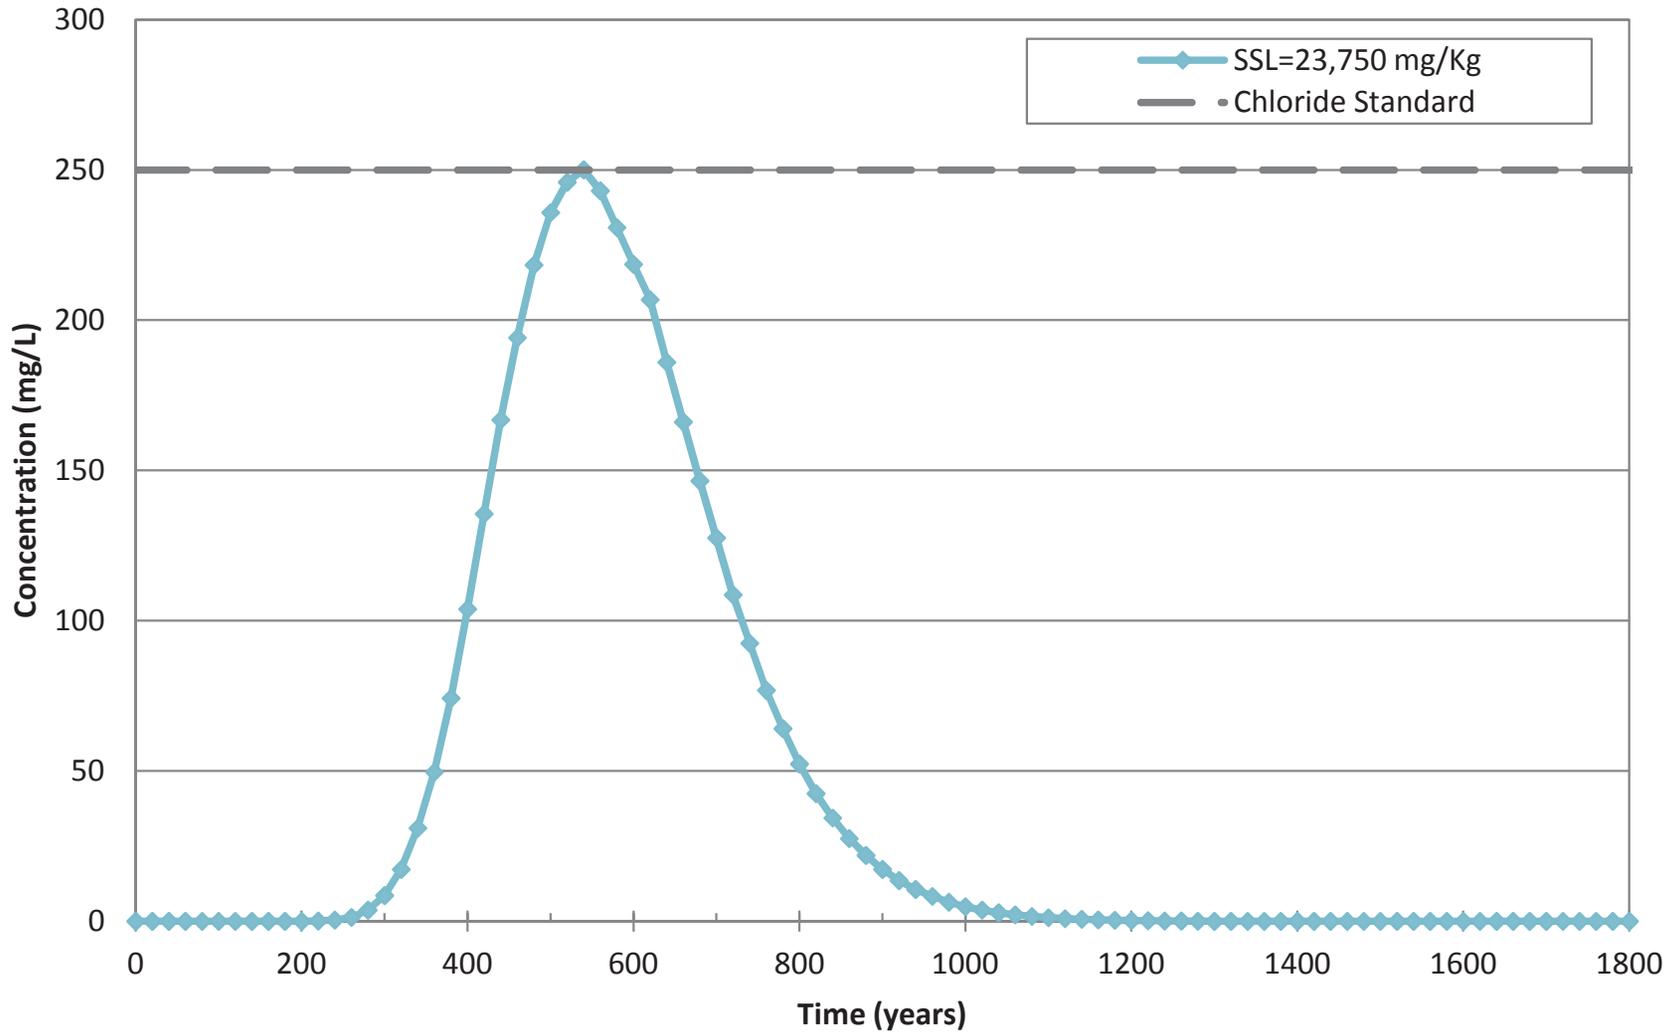
Figure 3
MULTIMED Simulated Chloride Concentration Vs Time in Groundwater
(Source = 20m, Chloride 0-3m, & Depth to Groundwater = 20m)

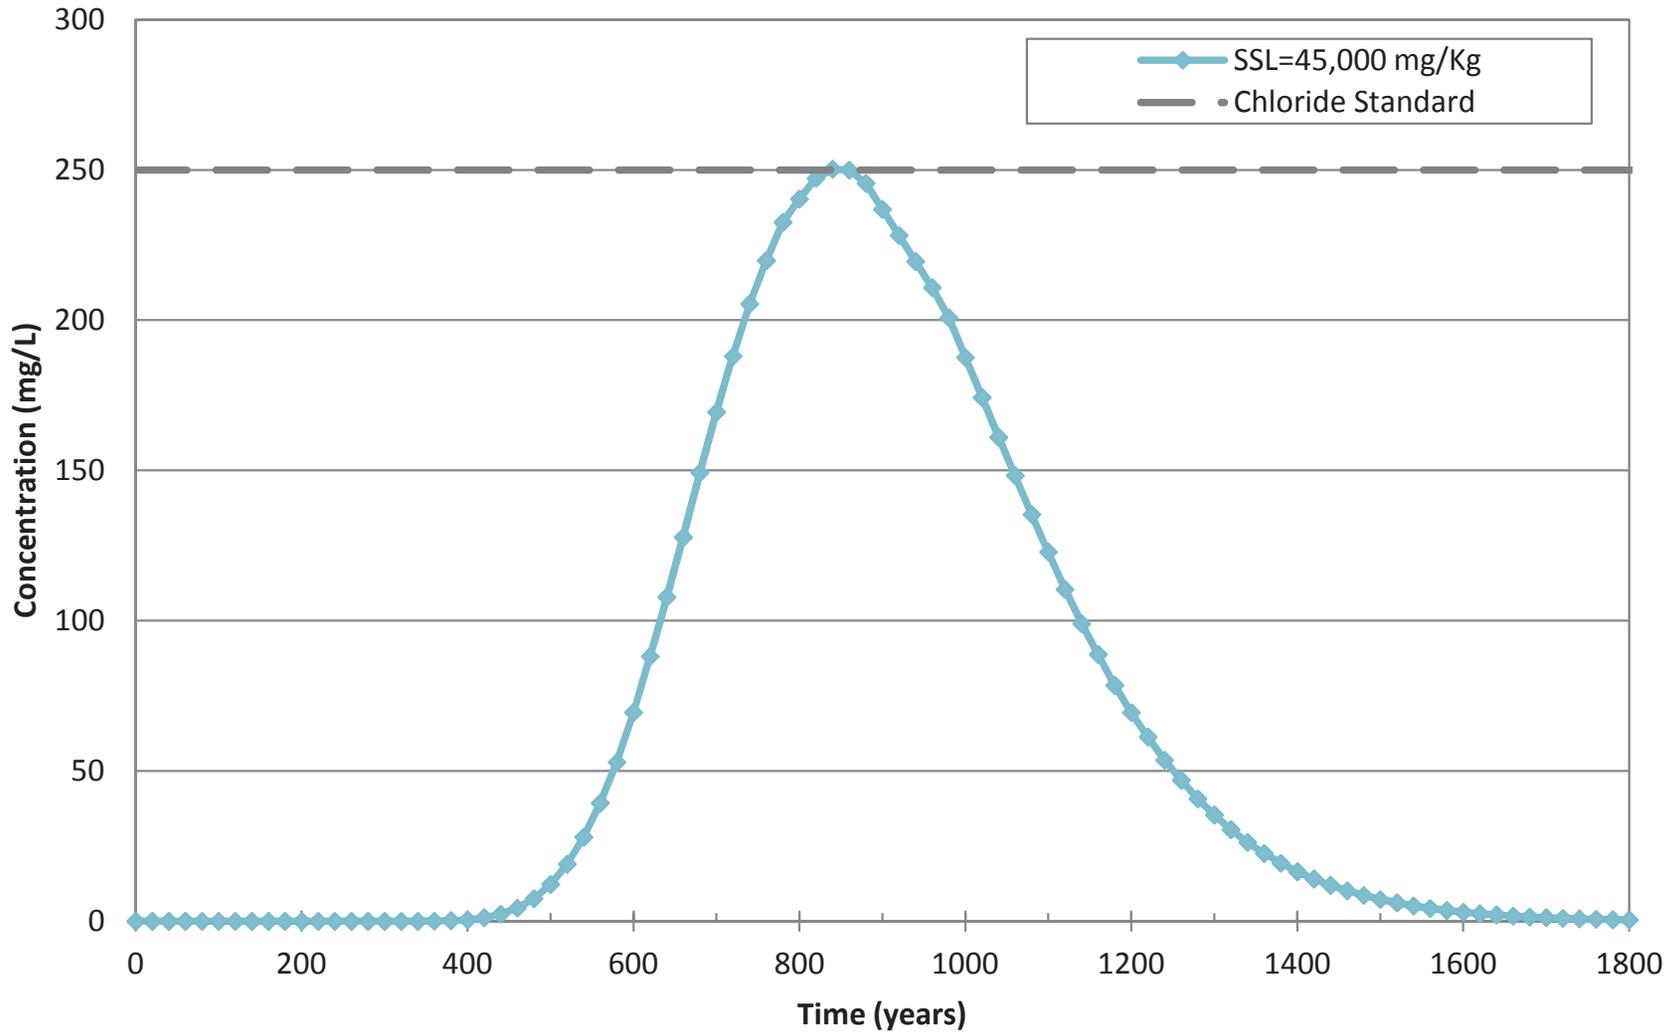
Figure 4
MULTIMED Simulated Chloride Concentration Vs Time in Groundwater
(Source = 20m, Chloride 0-3m, & Depth to Groundwater = 30.5m)

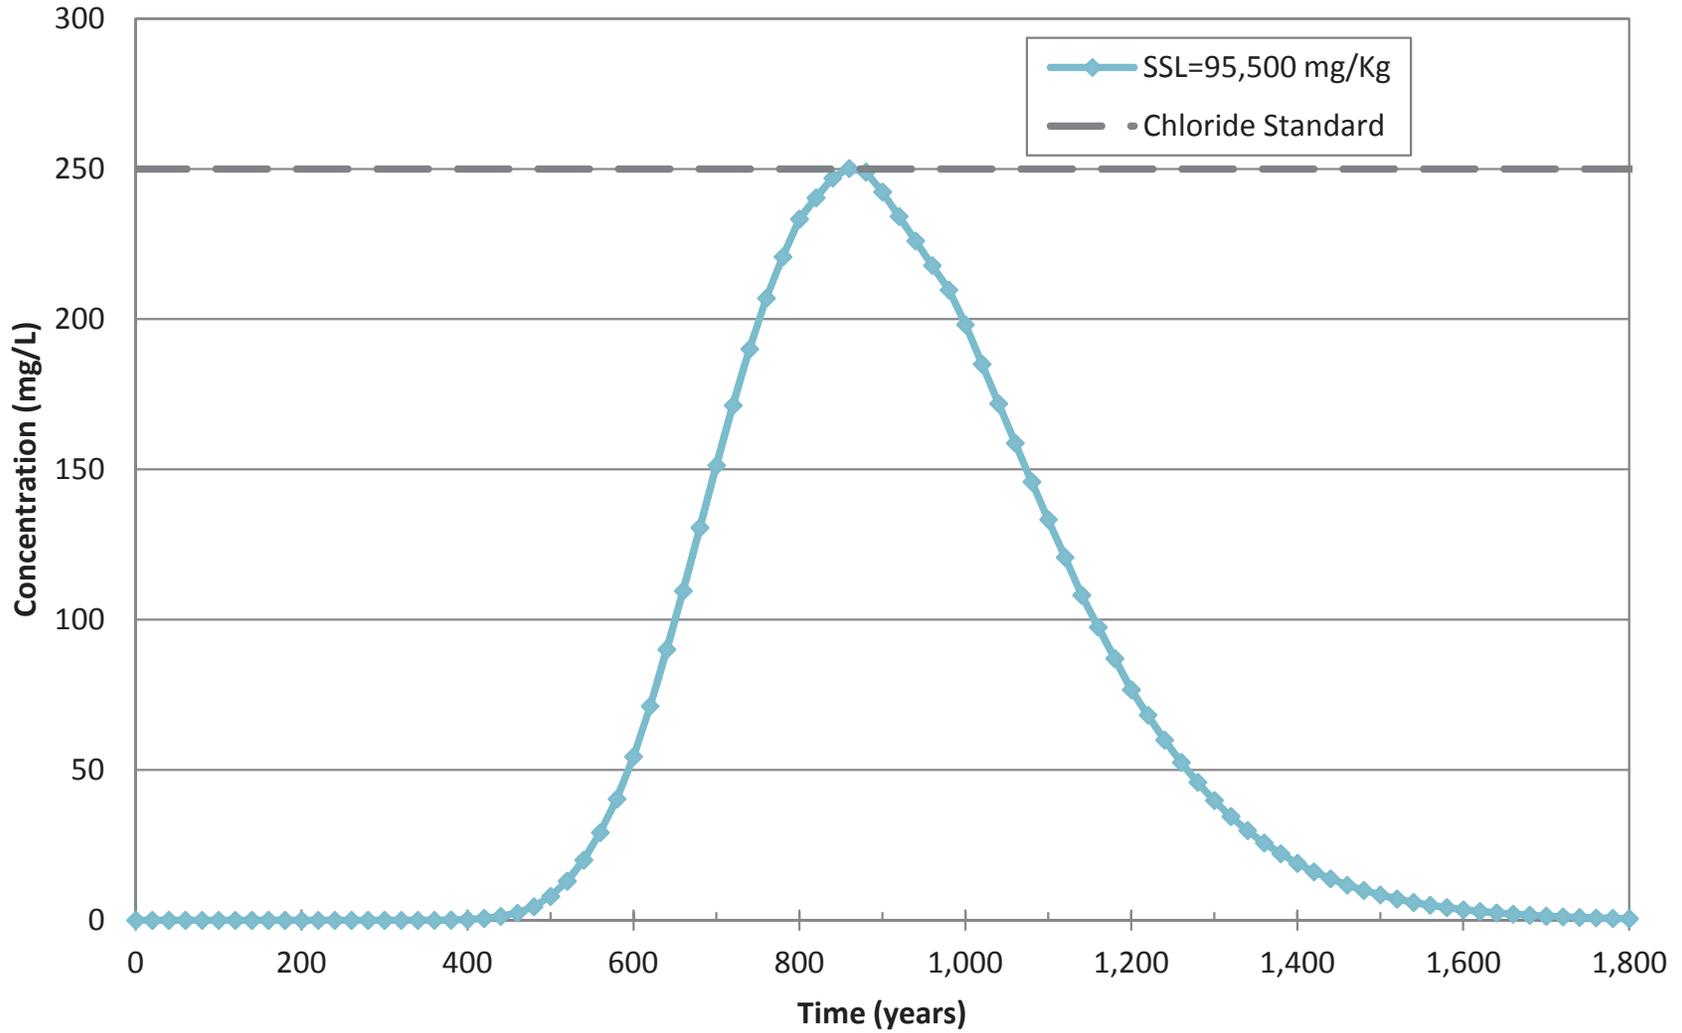
Figure 6
MULTIMED Simulated Chloride Concentration Vs Time in Groundwater
(Source = 45m, Chloride 0-1m, & Depth to Groundwater = 30.5m)

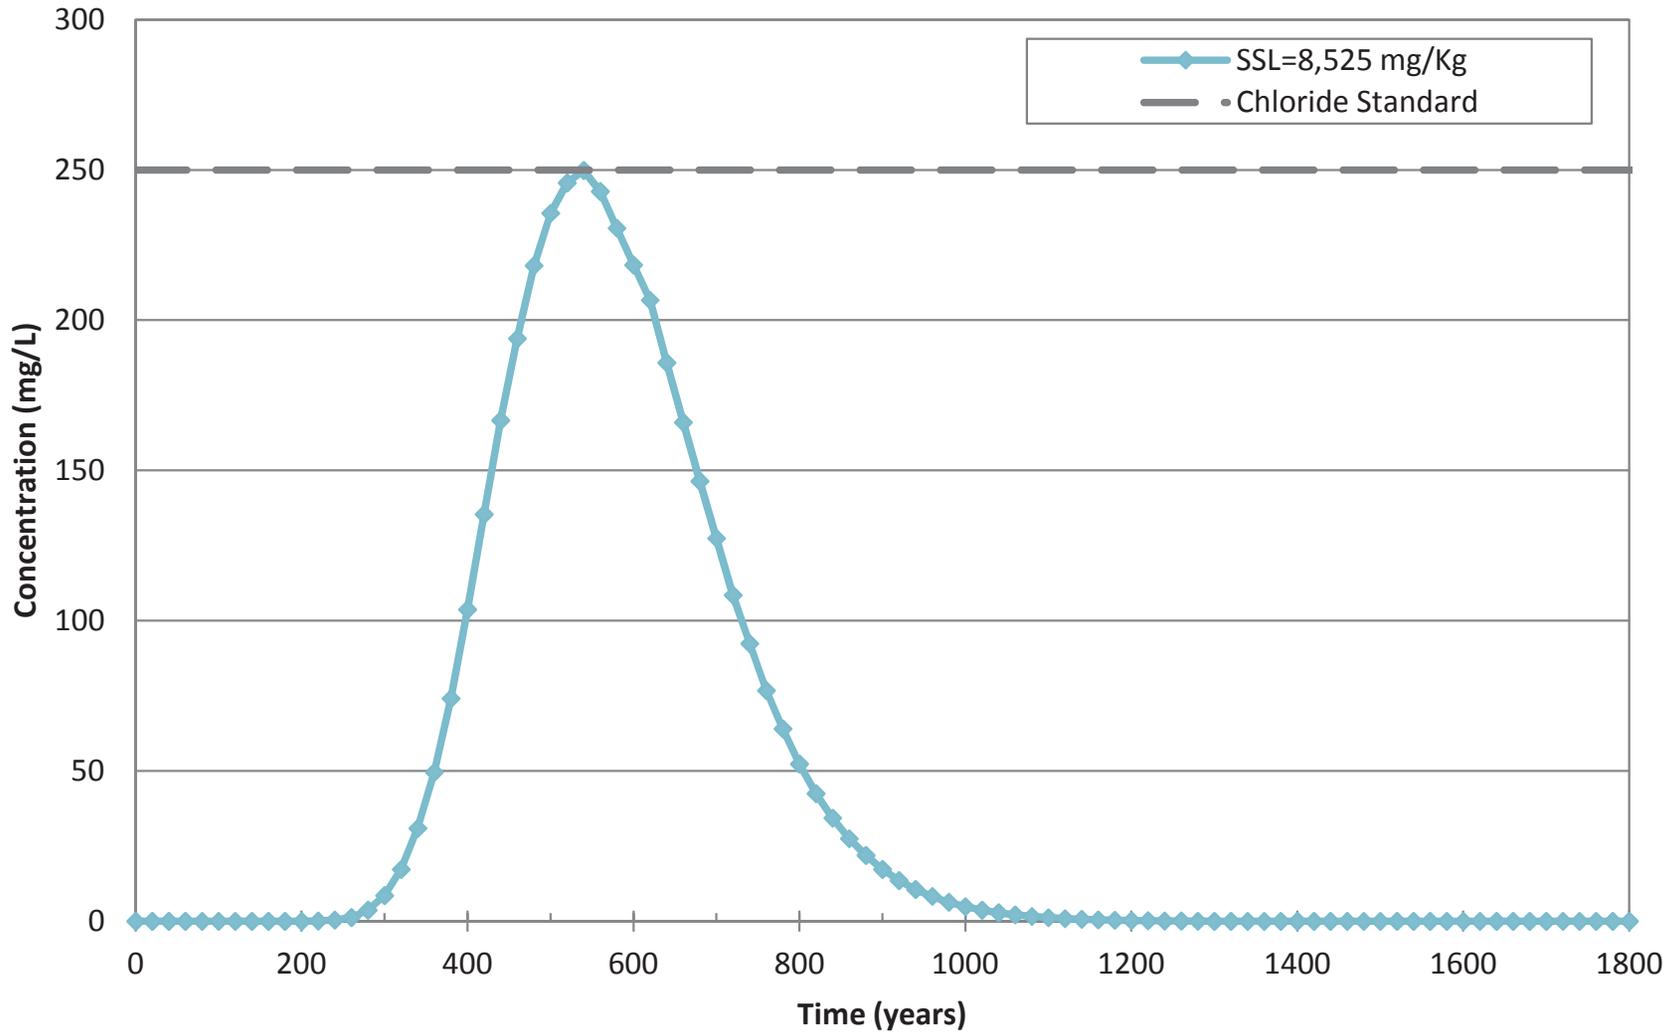
Figure 7
MULTIMED Simulated Chloride Concentration Vs Time in Groundwater
(Source = 45m, Chloride 0-3m, & Depth to Groundwater = 20m)
