Re : Chevron Special Projects – VGSAU Satellite 4 (RP# 3258)

Please find enclosed for your records, a copy of the final report documenting the final closure activities at the Vacuum Grayburg San Andres Unit Satellite No. 4 (RP #3258).

Release Notification and Corrective Action

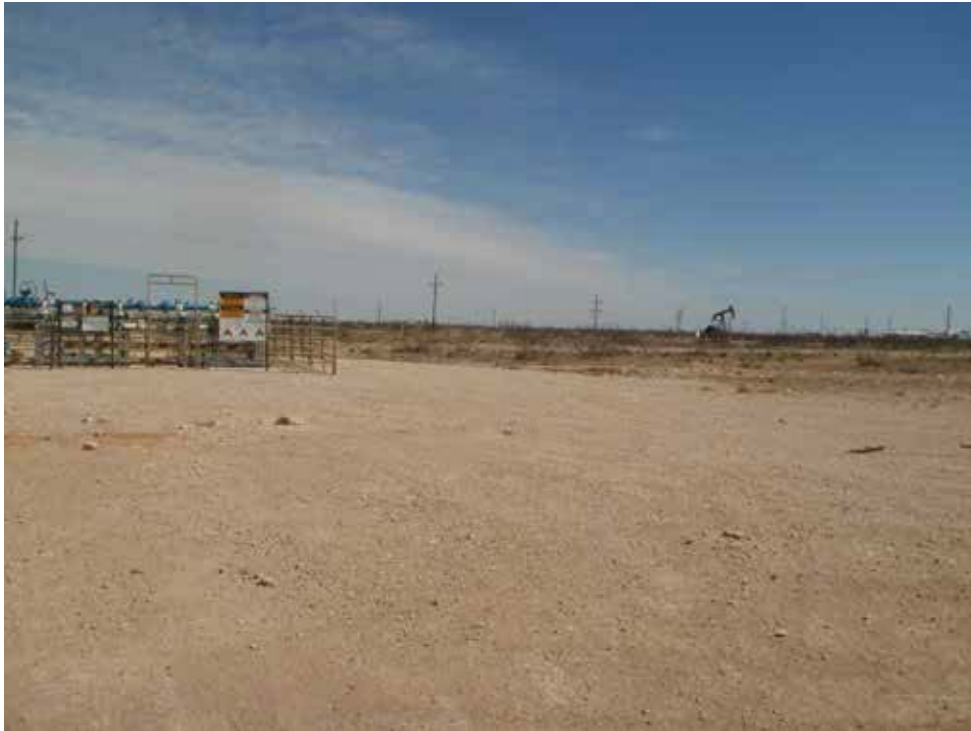
Photograph 1 – Vacuum Grayburg San Andres Unit Sat. 4 release area ; Facing North

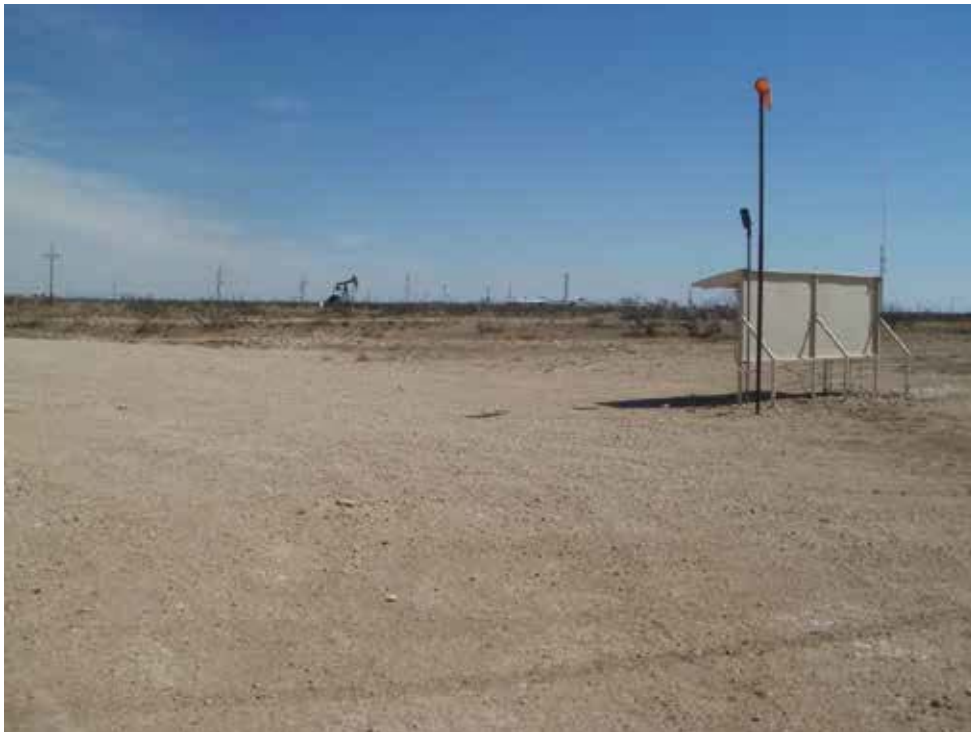
Photograph 2 – Vacuum Grayburg San Andres Unit Sat. 4 release area; Facing Northeast

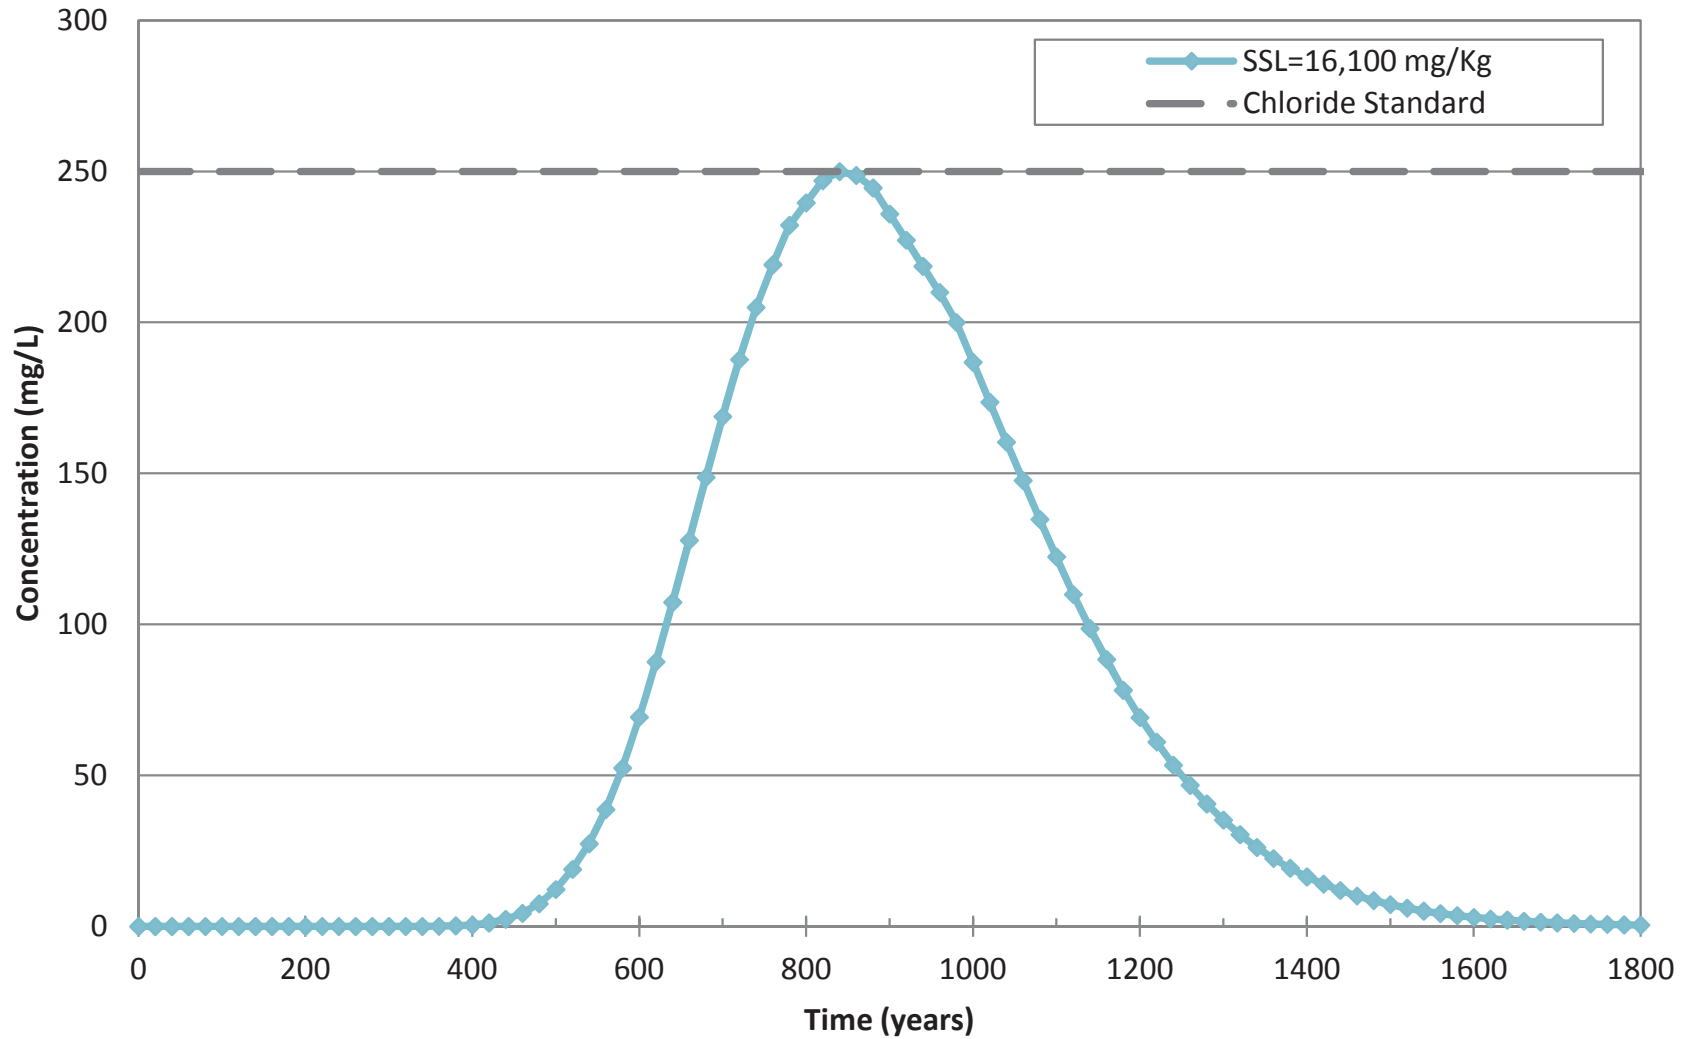
Figure 8

**MULTIMED Simulated Chloride Concentration Vs Time in Groundwater
(Source = 45m, Chloride 0-3m, & Depth to Groundwater = 30.5m)**
