Release Notification

Site Name: Northeast Blanco Unit 426A Waterline	Site Type: Water Transfer System
Date Release Discovered: April 14, 2020	API#: No API assigned to ROW

Release of produced water from a produced water transfer pipeline failure. Root cause was determined to be internal corrosion. No BTEX or TPH detected above the remedial action level. Flow path has been sampled for baseline chloride concentrations. Approximately 100 lbs of gypsum was applied to the surface and raked in to the flowpath on 4/27/20.

Northeast Blanco Unit 426A

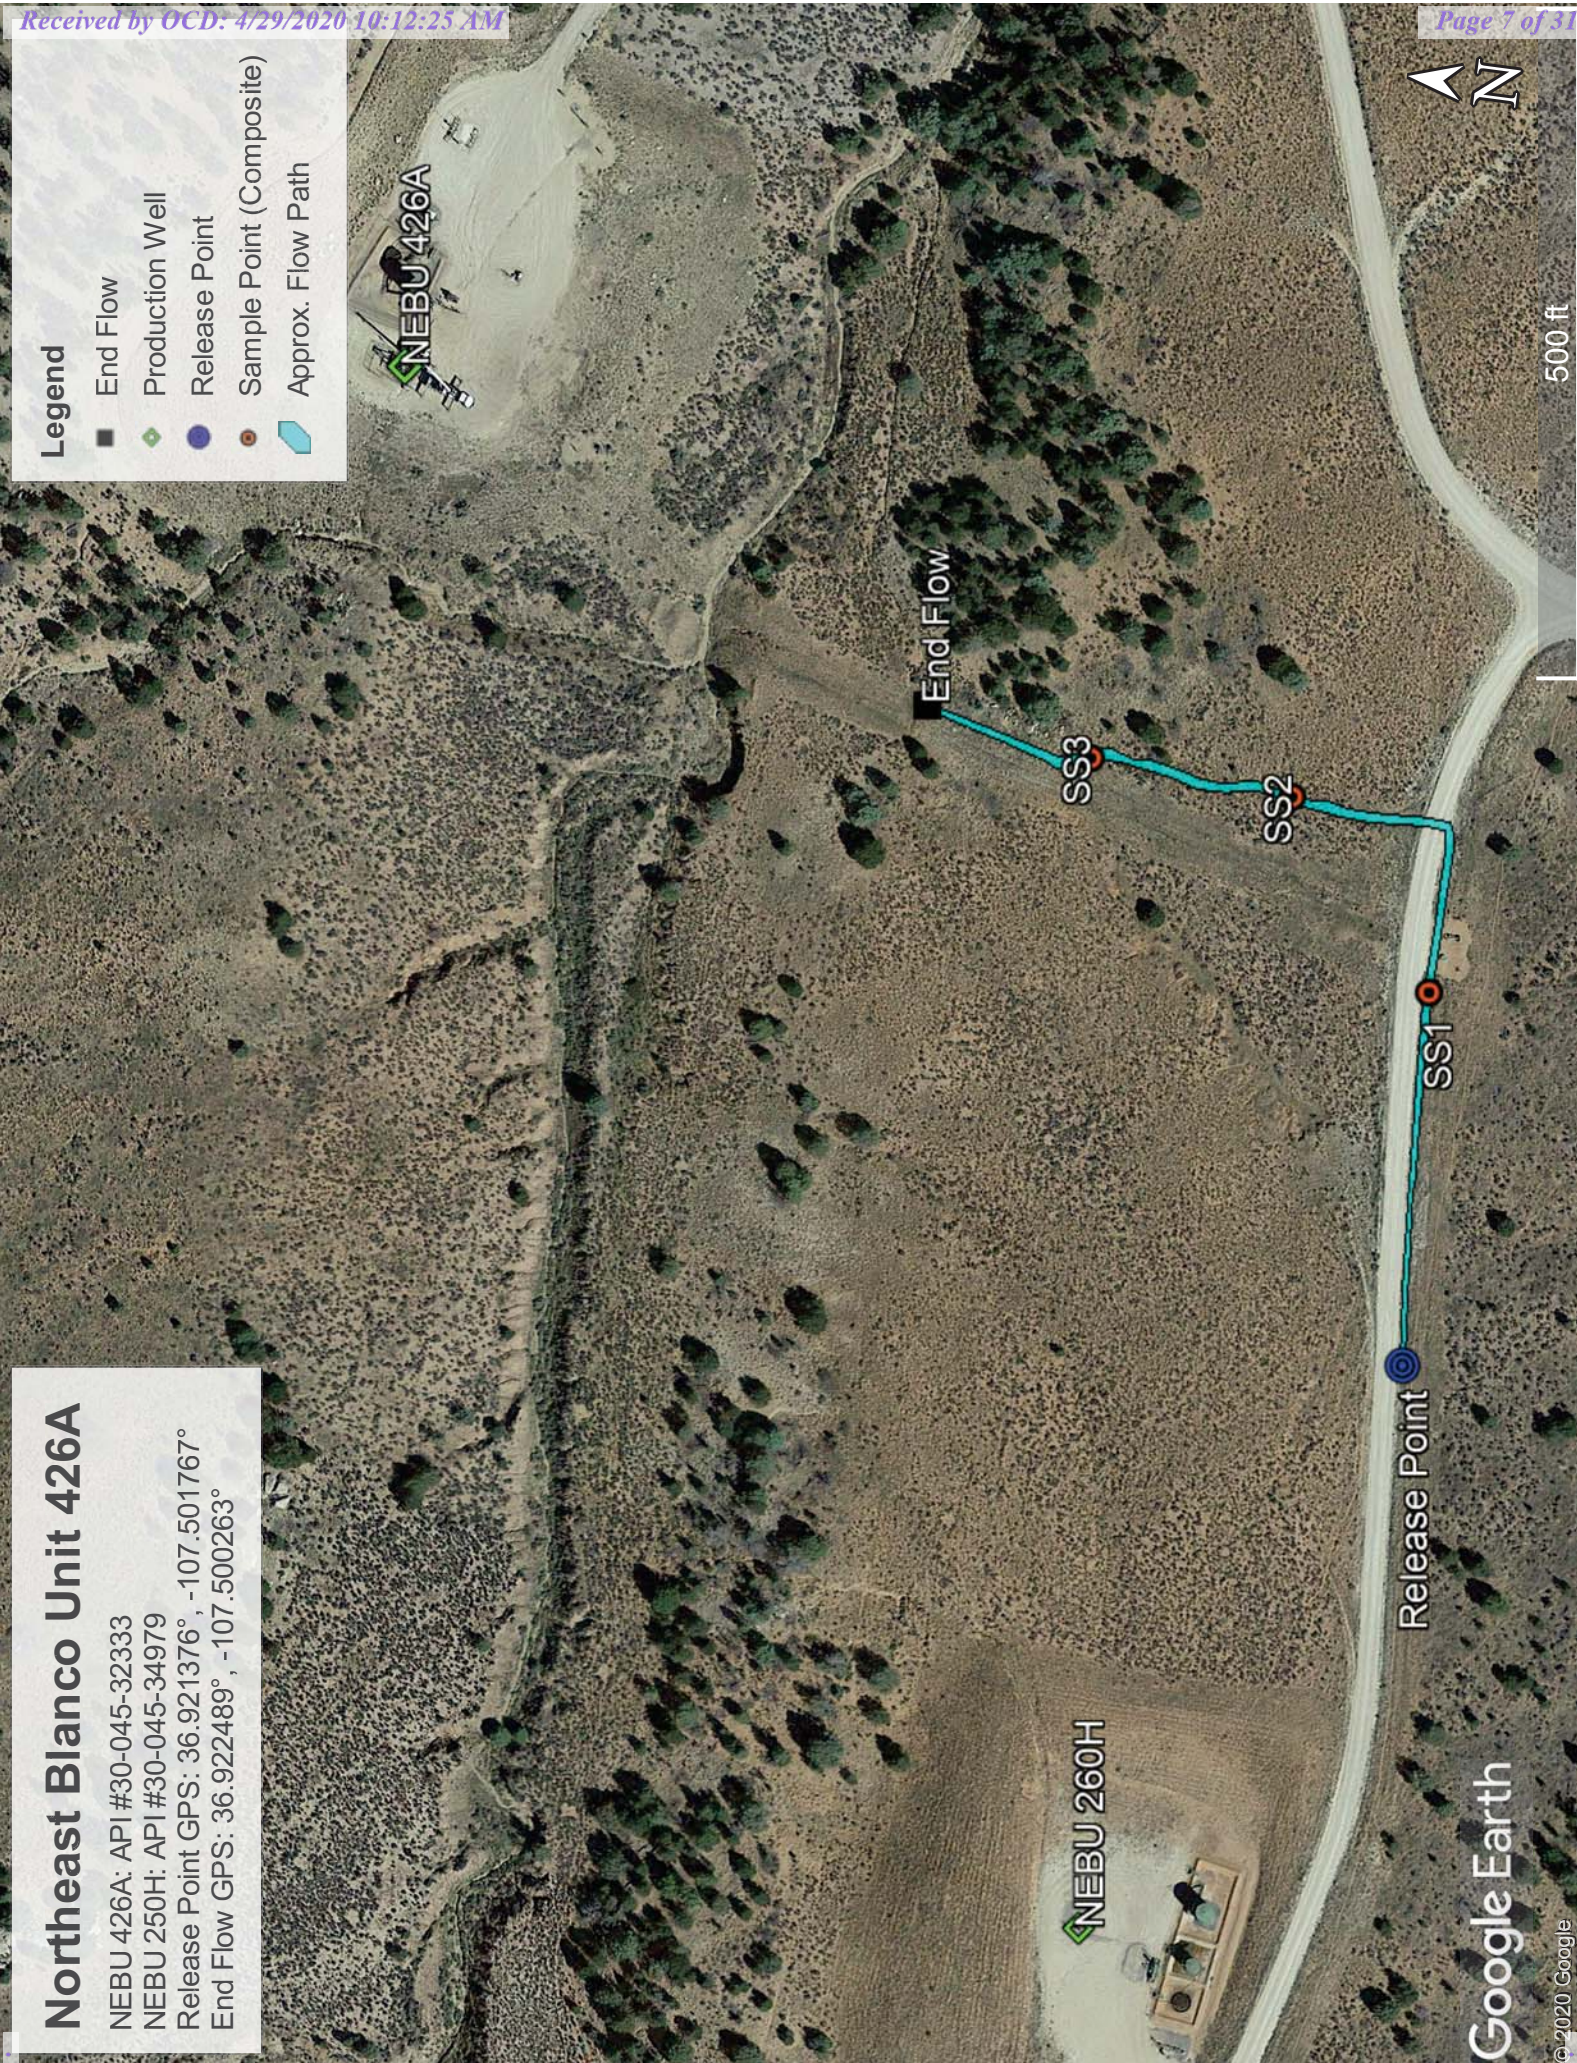
Release Point GPS: 36.921376°, -107.501767°

End Flow GPS: 36.922489°, -107.500263°

- End Flow
- Production Well
- Release Point
- Sample Point (Composite)
- Approx. Flow Path
