**Tracking #: nRM2000354631
Dagger Lake Battery Oct 30 2019
Remediation/Workplan**

**Prepared for
Advance Energy Partners Hat Mesa LLC
Houston, Texas**

**Prepared by
R.T. Hicks Consultants, Ltd.
Albuquerque, New Mexico**

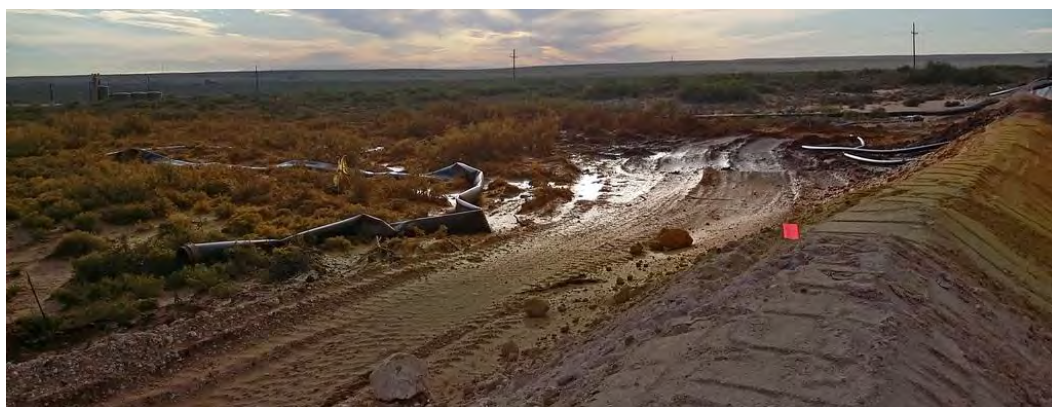
- An area of saturation immediately south of the well pad and extending south approximately 28-feet into an area of prior disturbance caused by the construction of the well pad (Figure 1).
- An area of surface spray. Windy conditions at the time of the release caused oil to spray approximately 650-feet south-southwest. Oil spray was limited to the vegetation and surface soils. Visual observations suggested that impact to sub-surface soils did not occur.

Figure 1: Photo of release area viewing west-southwest. The south edge production pad berm is visible photo right. The area of saturation is visible photo center. The pastureland exhibits oil surface spray, background center and left.

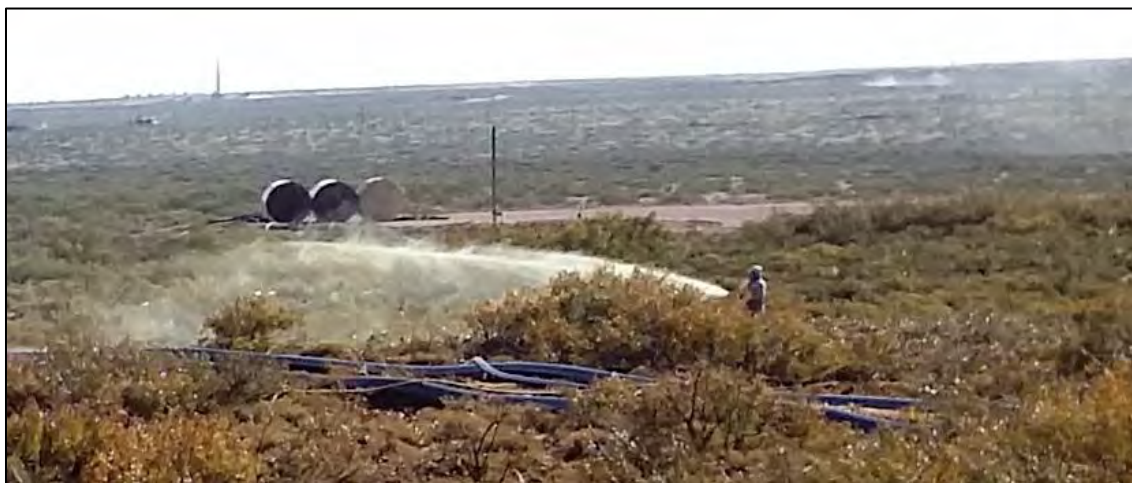
Figure 2: Microblaze application in the oil spray area in pastureland.

On Nov. 1st, 2019 archeologists determined the release area was not within the nearby archeological area. Therefore, on Nov. 4th, 2019 the release area was treated with Microblaze (Figure 2) to begin the biodegradation process of hydrocarbons.

Shortly after the application of Microblaze, cooler temperatures prevented the microbial process to occur and cause biodegradation of hydrocarbons. It is anticipated that upon return of warmer temperatures this spring, the microbial activity of the Microblaze will resume the natural bioremediation process of hydrocarbons.

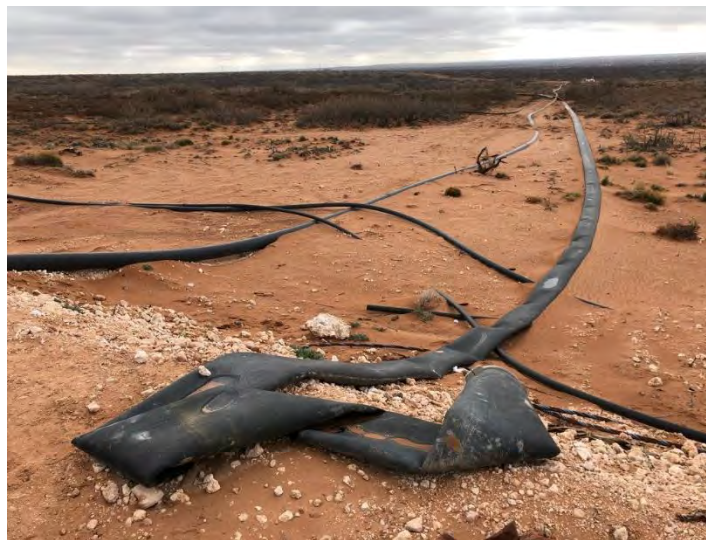
Figure 3: Surface flow lines within remediation area. The layflat in the foreground can be removed prior to remedial activities.

1. Remove surface lines no longer in-use (Figure 3).
