## Release Notification RP96G-190814-C-1410

Site Name Poker Lake Unit 18 BD Central Tank Battery	Site Type Bulk Storage and Separation Facility
Date Release Discovered 7/30/2019	API# (if applicable) 30-015-44899 (PLU 18 BD 101H nearby well)

A butterfly valve on the LACT unit failed. Fluid was released to lined containment and to the well pad. A vacuum truck recovered 5 barrels oil from the ground and 25 barrels from the containment. The LACT was repaired. Additional third party resources have been retained to assist with remediation.

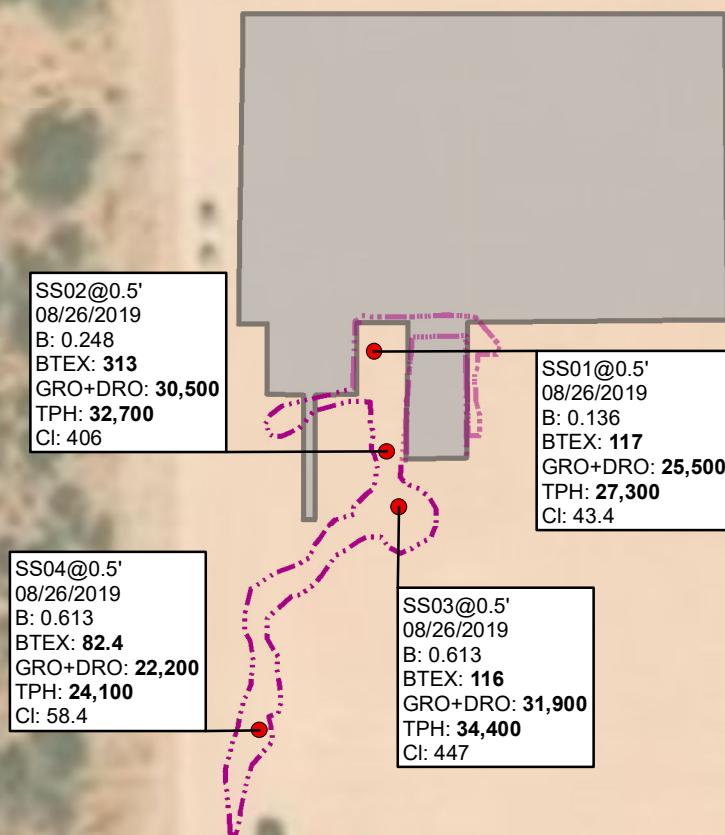
Boreholes were advanced via stainless steel hand auger at three locations within the release area. Boreholes BH01 through BH03 were advanced to depths of approximately three feet bgs. Delineation soil samples were collected from each borehole at depths ranging from approximately one foot to three feet bgs. Soil from the boreholes was field screened for volatile aromatic hydrocarbons and chloride utilizing a PID and Hach© chloride QuanTab© test strips, respectively. Field screening results and observations for each borehole were logged on lithologic/soil sampling logs, which are included in Attachment 2. The borehole and delineation soil sample locations are depicted on Figure 4.

- PRELIMINARY SOIL SAMPLE WITH CONCENTRATIONS EXCEEDING APPLICABLE CLOSURE CRITERIA
- RELEASE EXTENT
- PRODUCTION EQUIPMENT

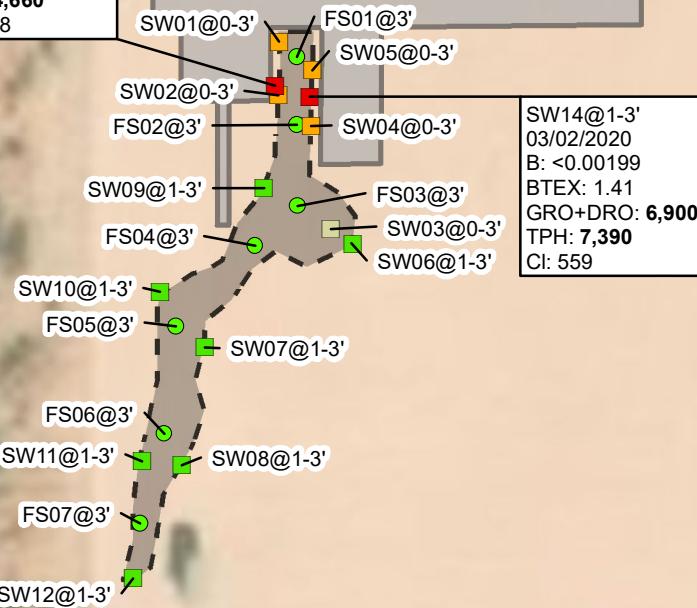
SW13@1-3'  
 03/02/2020  
 B: <0.00263  
 BTEX: 2.42  
 GRO+DRO: **4,380**  
 TPH: **4,660**  
 CI: 40.8

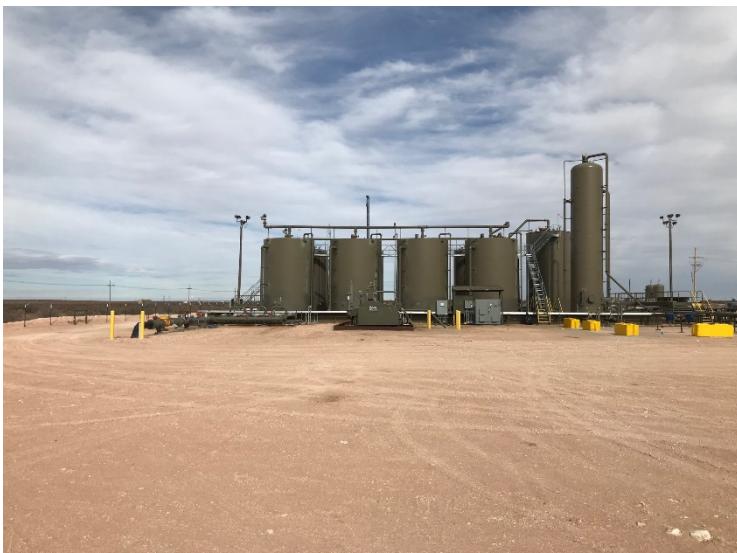
**Photograph 1:** View of Site and above ground equipment facing north.

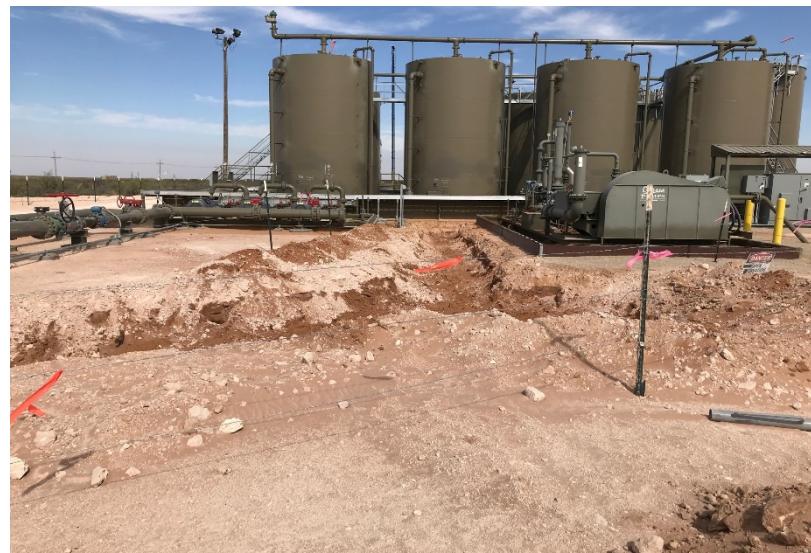
**Photograph 2:** View of excavation and production equipment facing north.

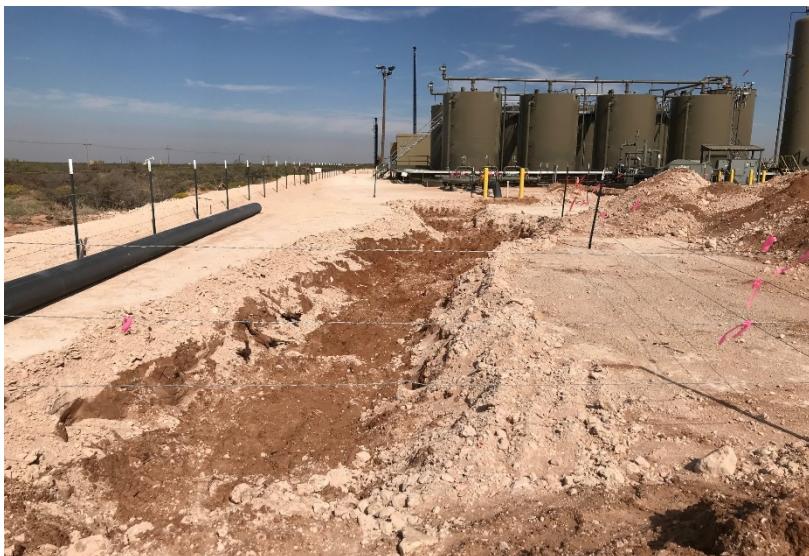
**Photograph 3:** View of southern end of excavation facing north.

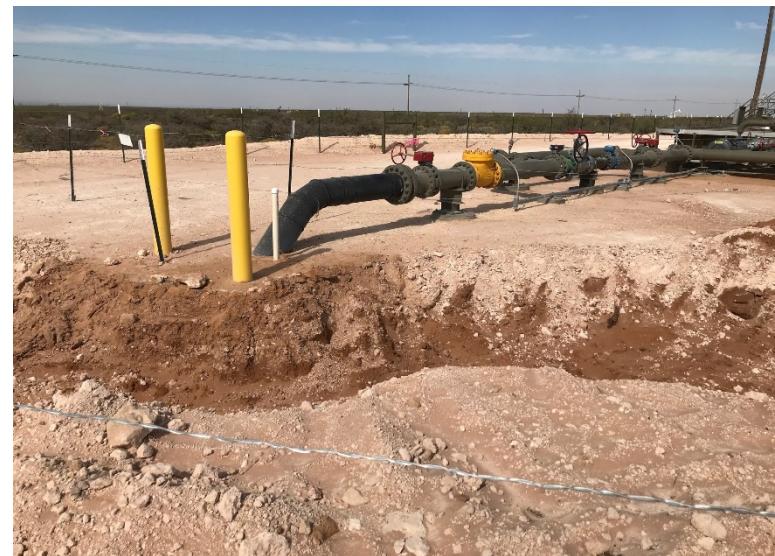
**Photograph 4:** View of above ground equipment and excavation facing northwest.

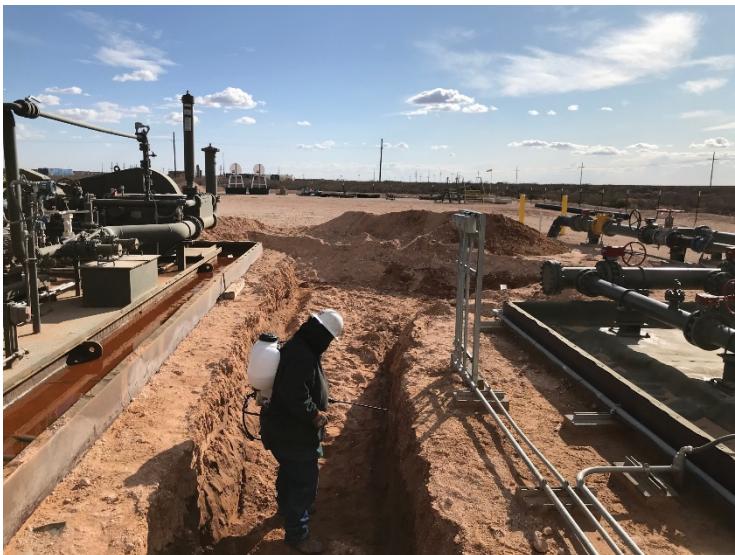
**Photograph 5:** MicroBlaze® application near soil samples SW01 and SW02.

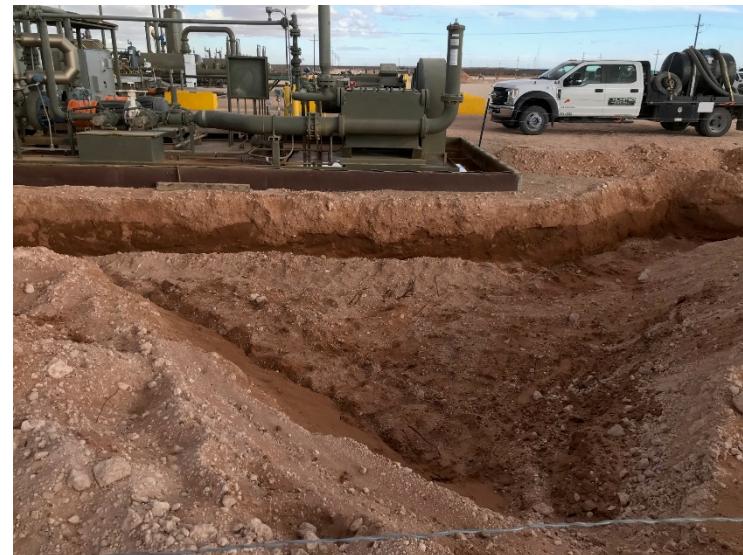
**Photograph 6:** View east of area near SW04 and production equipment.
