XTO Energy, Inc. Remediation Plan/Closure **Poker Lake Unit-CVX-JV-PB #008H** 03/16/2020

RE: Closure Request Poker Lake Unit-CVX-JV-PB #008H Remediation Permit Number 2RP-2661 Eddy County, New Mexico

LT Environmental, Inc. (LTE), on behalf of XTO Energy, Inc. (XTO), presents the following report detailing the soil sampling activities at the Poker Lake Unit (PLU)-CVX-JV-PB #008H well pad (Site) in Unit H, Section 32, Township 25 South, Range 31 East, in Eddy County, New Mexico (Figure 1). The purpose of the soil sampling activities was to assess impacts to soil after a contract crew improperly dismantled the frac tank containment while cleaning the frac tank and caused the release of 90 bbls of produced water onto the well pad. The release was discovered on December 12, 2014, and affected approximately 19,000 square feet of the caliche well pad. A vacuum truck was used to recover the free standing fluid; approximately 10 bbls of produced water were recovered. The former operator reported the release to the New Mexico Oil Conservation Division (NMOCD) on a Release Notification and Corrective Action Form C-141 on December 15, 2014, and was assigned Remediation Permit (RP) Number 2RP

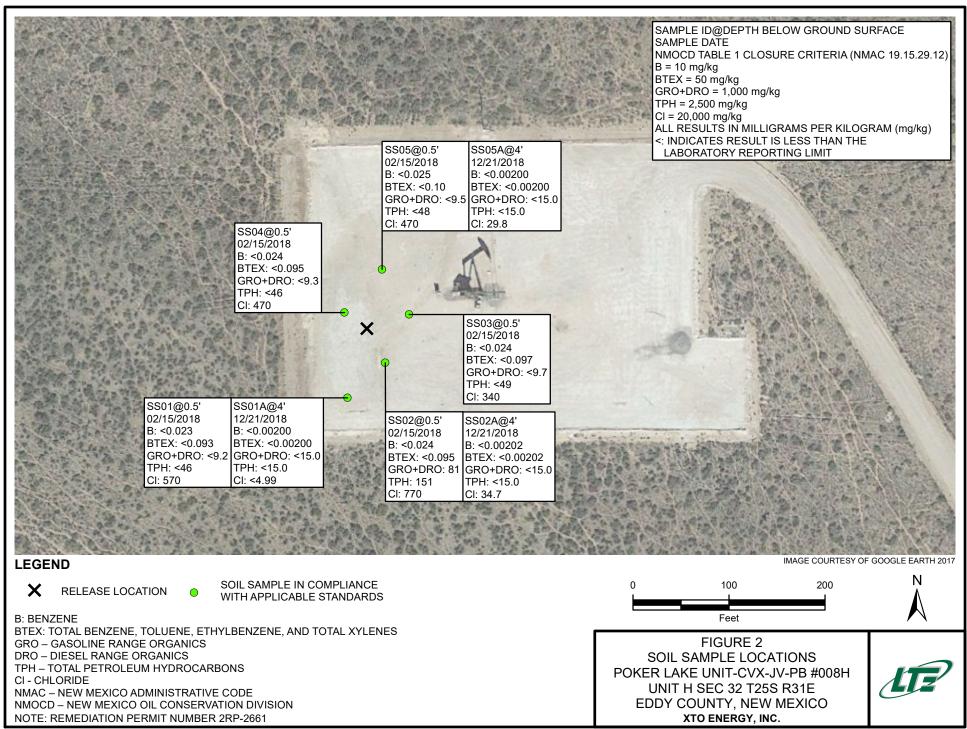
On February 15, 2018, an LTE scientist collected five preliminary soil samples (SS01 through SS05) within the release area to assess the lateral extent of soil impacts. The soil sample locations, depicted on Figure 2, were selected based on information provided on the initial Form C-141s and field observations. To eliminate the effects from weathering and natural degradation of contaminants at the ground surface, the soil samples were collected from each sample location at approximately 0.5 feet bgs. The soil samples were screened for volatile aromatic hydrocarbons and chlorides using a photo-ionization detector (PID) and Hach® chloride QuanTab® test strips. The soil samples were placed directly into pre-cleaned glass jars, labeled with the location, date, time, sampler, method of analysis, and immediately placed on ice. The soil samples were shipped at 4 degrees Celsius (°C) under strict chain-of-custody procedures to Hall Environmental Analysis Laboratory in Albuquerque, New Mexico, for analysis of BTEX by United States Environmental Protection Agency (USEPA) Method 8021B, TPH-GRO, TPH-DRO, and TPH-oil range organics (ORO) by USEPA Method 8015M/D, and chloride by USEPA Method 300.0.

On December 21, 2018, LTE personnel returned to the Site to assess the vertical extent of impacted soil in the release area. Potholes were advanced by backhoe to a depth of 4 feet bgs at three of the preliminary soil sample locations (SS01, SS02, and SS05). Soil samples SS01A, SS02A, and SS05A were collected from a depth of 4 feet bgs at the preliminary SS01, SS02, and SS05 soil sample locations. The soil samples were collected, handled, and analyzed as described above and submitted to Xenco Laboratories (Xenco) in Midland, Texas. The potholes were backfilled with the soil removed; no soil was removed from the site for disposal. The soil sample locations are depicted on Figure 2 and soil sample logs are included in Attachment 2.

Laboratory analytical results indicated that BTEX, TPH, and chloride concentrations were compliant with the NMOCD Table 1 closure criteria in soil samples SS01 through SS05 collected at 0.5 feet bgs, and soil samples SS01A, SS02A, and SS05A collected at 4 feet bgs. Based on the laboratory analytical results, no soil excavation was required. Laboratory analytical results are presented on Figure 2 and summarized in Table 1, and the complete laboratory analytical reports are included as Attachment 3.

Soil samples SS01 through SS05, SS01A, SS02A, and SS05A were collected within the release area to determine if any impacted soil remained in place as a result of the historical release. Laboratory analytical results indicated that BTEX, TPH, and chloride concentrations were compliant with the NMOCD Table 1 closure criteria in all soil samples. Initial response efforts and natural degradation have mitigated impacts at the Site. XTO requests no further action for this release. An updated NMOCD Form C-141 is included as Attachment 1. A photographic log of the Site is included as Attachment 4.
