Incident ID	NCH1903363086
District RP	1RP-5318
Facility ID	
Application ID	pCH1903363384

Site Assessment/Characterization

State of New Mexico
Oil Conservation Division

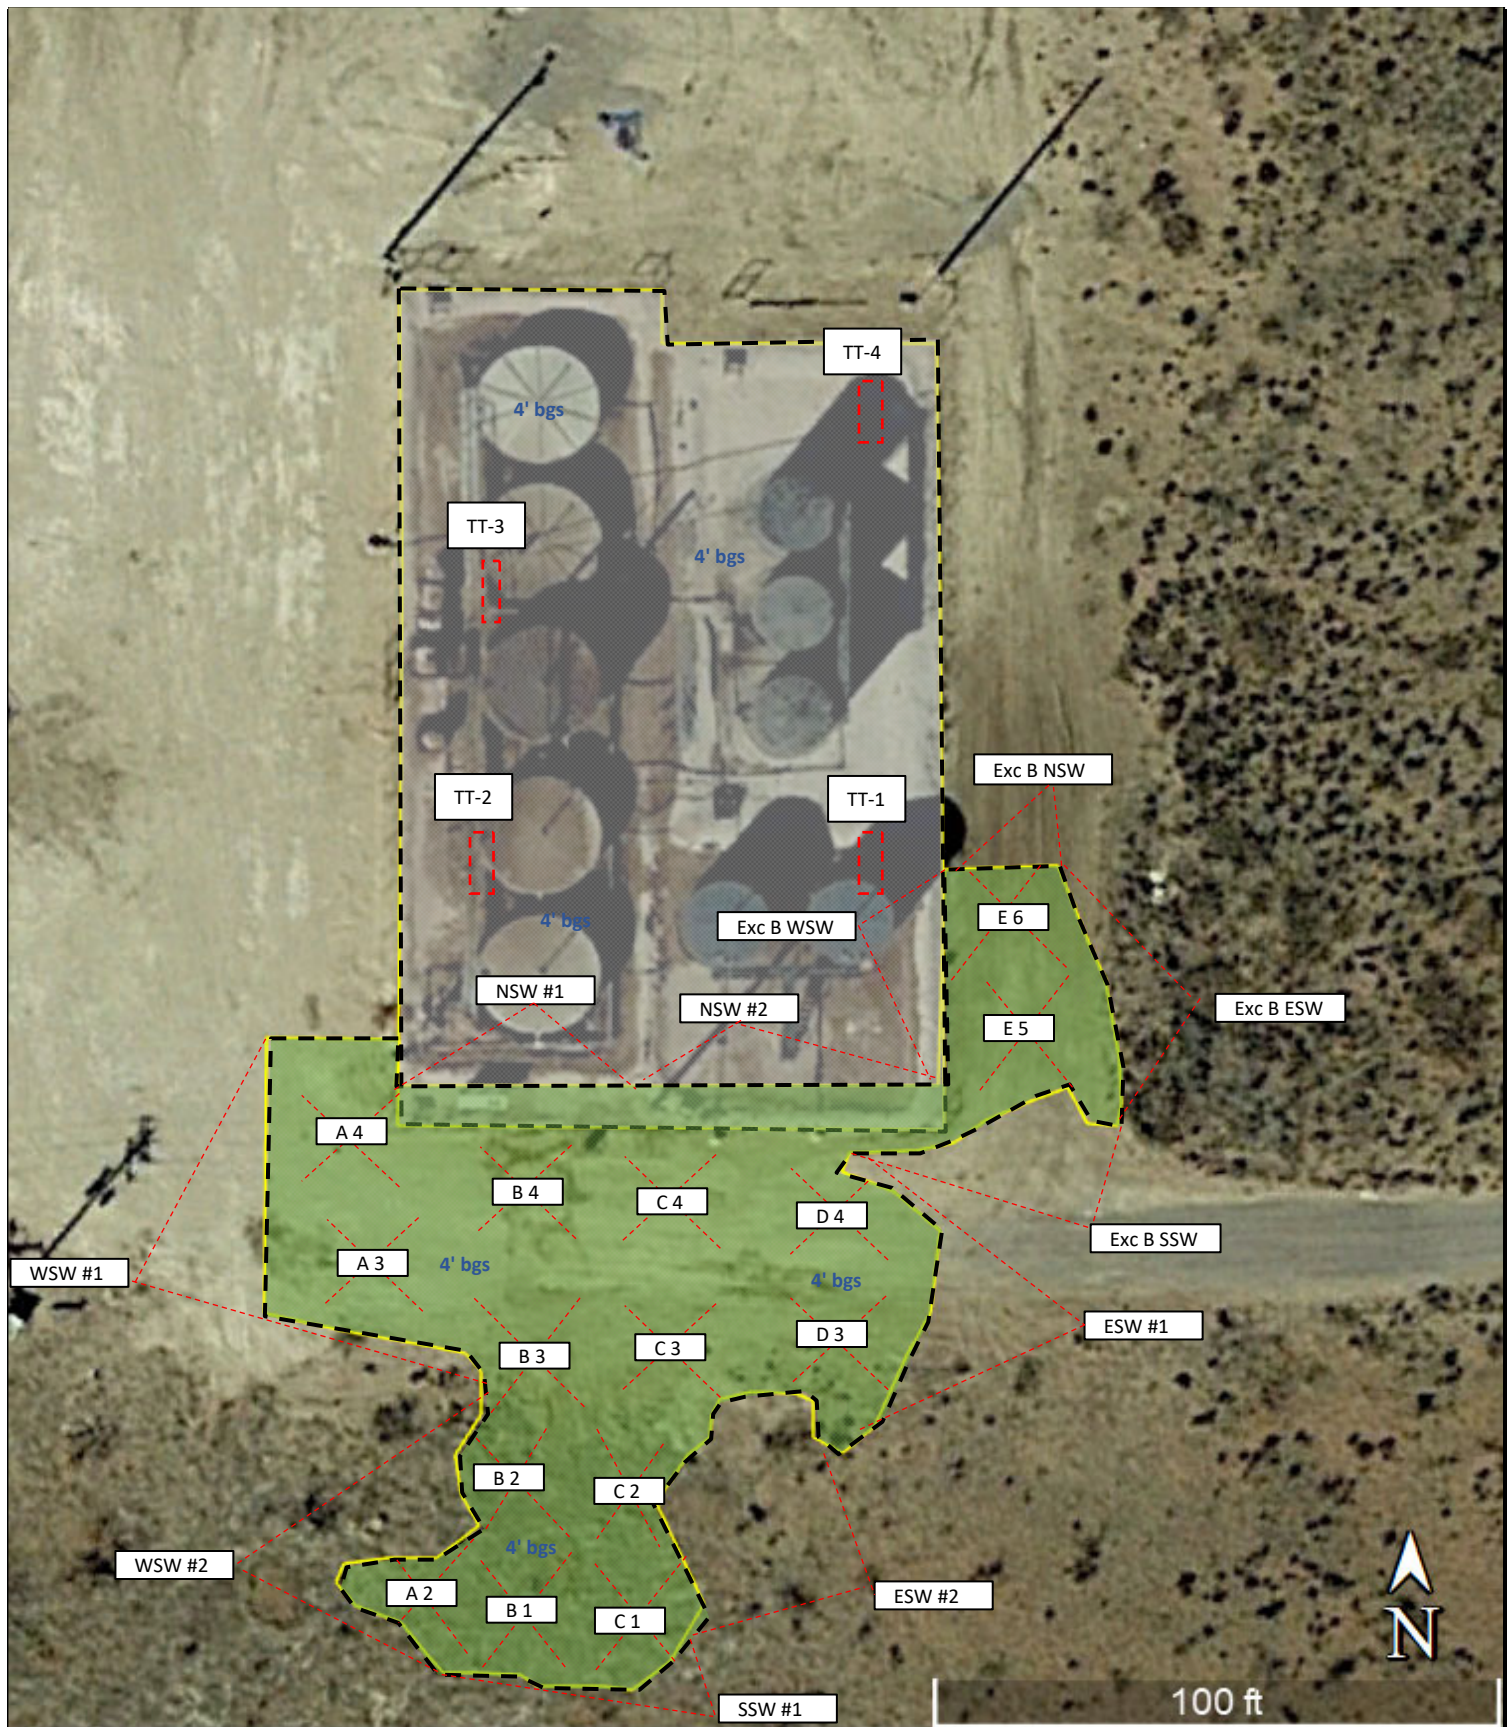
Figure 3

Site and Sample Location Map

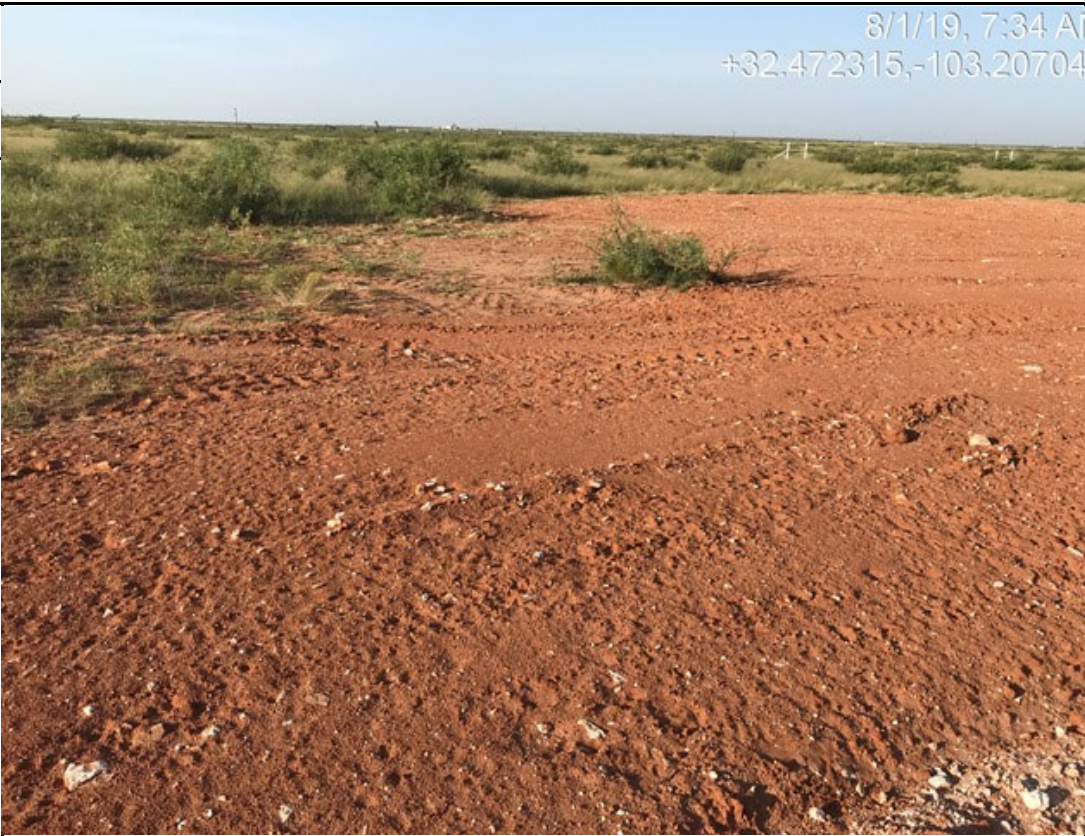
Photo Number: 5

Photo Direction: South	
Photo Description: View of the affected area outside the salt water disposal containment after backfilling activities.
