Subject: Liner Inspection and Closure Report
Cotton Draw Unit 172H
Eddy County, New Mexico

Devon Energy Production Company (Devon) (Client) retained HRL Compliance Solutions, Inc. (HRL) to conduct a liner inspection and prepare this closure report for the release at the Cotton Draw Unit 172H well pad (Site). The Site is located in Eddy County, New Mexico (Figure 1).

**Subject: Liner Inspection and Closure Report
Cotton Draw Unit 172H
Eddy County, New Mexico**

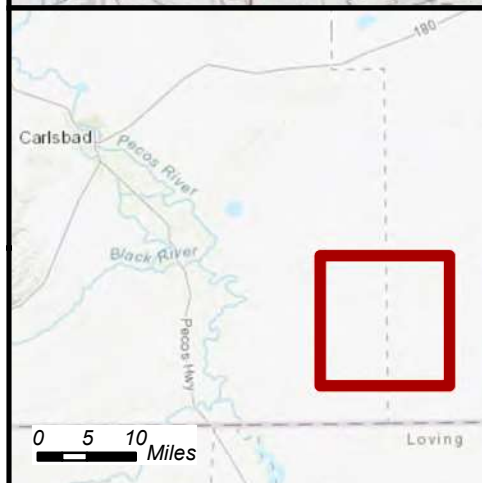
Figure 2: Depth to Groundwater Map

Based on research from the New Mexico Office of the State Engineer (NMOSE) and United States Geological Survey (USGS), depth to groundwater is estimated to be between 155 and 429 feet below ground surface (bgs) (Figure 2).

Well Number	Water Level Below Ground Surface (ft)	Distance from Source (mi)
C02250	390	4.23
C03639	365	2.72
C04256	340	5.48
C02440	155	5.85
C03891	429	5.90

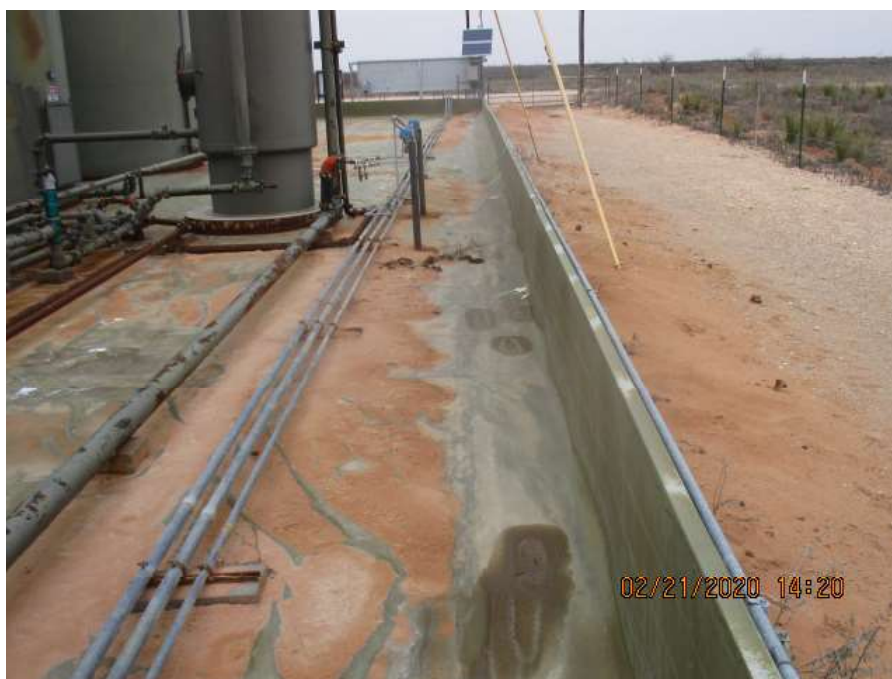
View of sediment buildup within lined secondary containment

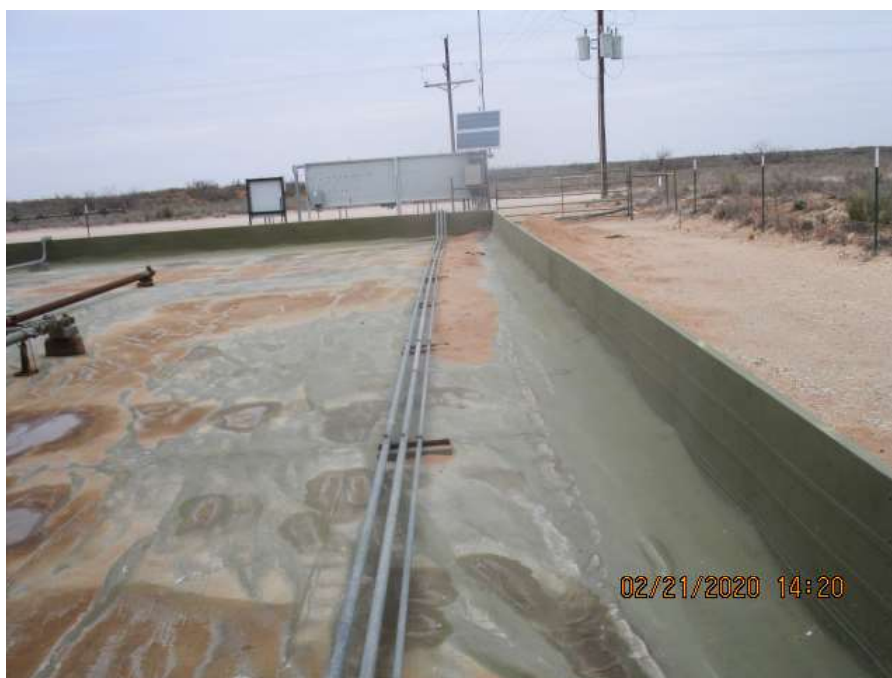
On February 21, 2020, after the released fluid was removed, HRL conducted an inspection to evaluate the integrity of the liner (Attachment B, Photographs). No tears or holes were observed in the liner and the liner was retaining precipitation. Based on this inspection, HRL has determined that the liner remains intact and had the ability to contain the release (Attachment C, Liner Inspection Field Form).

View of sediment and minor pooling within lined secondary containment

The August 13, 2019 release of 10 barrels of produced water at the Site remained within the lined containment area. HRL has determined that the liner integrity remains intact and had the ability to contain the release; therefore, additional characterization of the soil and/or groundwater at the Site is not necessary. HRL recommends closure of this release.

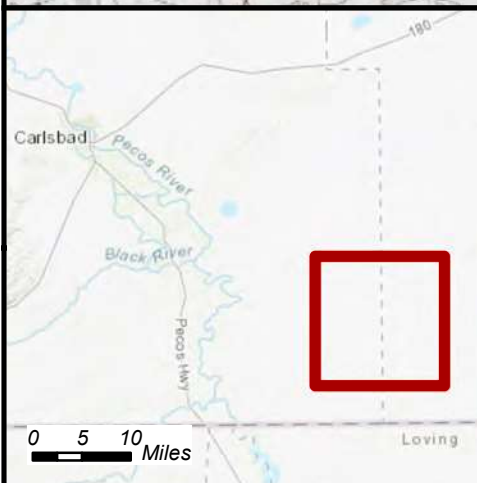
Figure 2: Depth to Groundwater Map

Based on research from the New Mexico Office of the State Engineer (NMOSE) and United States Geological Survey (USGS), depth to groundwater is estimated to be between 155 and 429 feet below ground surface (bgs) (Figure 2).

Well Number	Water Level Below Ground Surface (ft)	Distance from Source (mi)
C02250	390	4.23
C03639	365	2.72
C04256	340	5.47
C02440	155	5.85
C03891	429	5.90

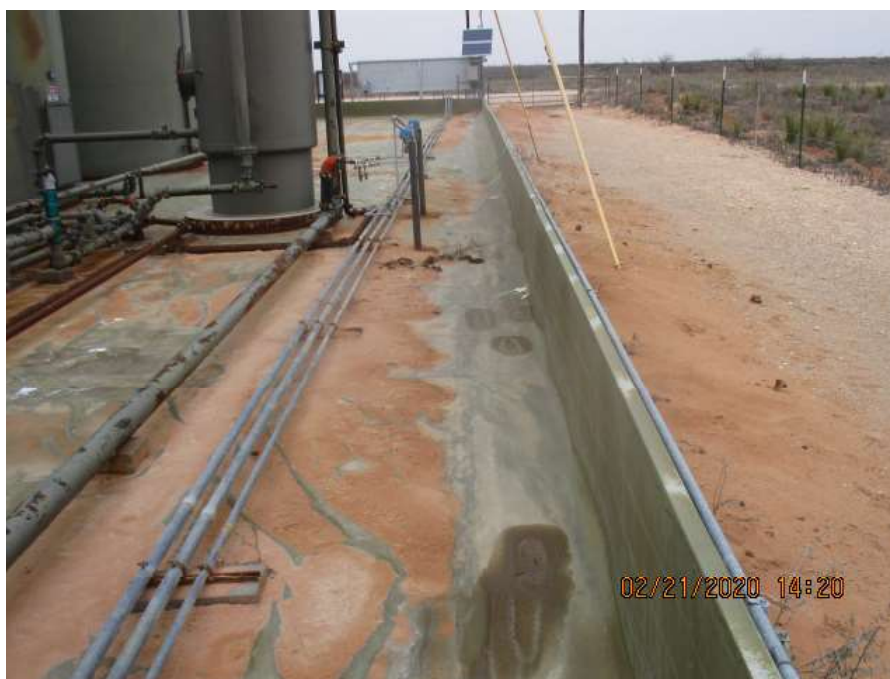
View of sediment buildup within lined secondary containment

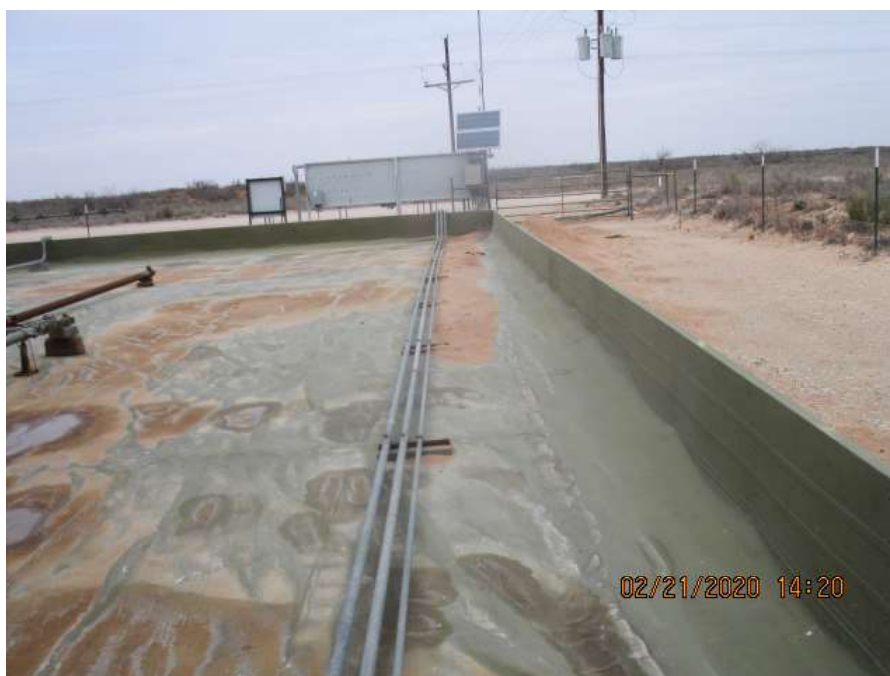
On February 21, 2020, after the released fluid was removed, HRL conducted an inspection to evaluate the integrity of the liner (Attachment B, Photographs). No tears or holes were observed in the liner and the liner was retaining precipitation. Based on this inspection, HRL has determined that the liner remains intact and had the ability to contain the release (Attachment C, Liner Inspection Field Form).

View of sediment and minor pooling within lined secondary containment

The January 7, 2016 release of 15 barrels of produced water and 10 barrels of oil at the Site remained within the lined containment area. HRL has determined that the liner integrity remains intact and had the ability to contain the release; therefore, additional characterization of the soil and/or groundwater at the Site is not necessary. HRL recommends closure of this release.
