**RE: Closure Request  
Nash 042 Tank Battery  
Remediation Permit Number 2RP-4823  
Eddy County, New Mexico**

LT Environmental, Inc. (LTE), on behalf of XTO Energy, Inc. (XTO), presents the following Closure Request detailing site assessment, soil sampling, and excavation activities at the Nash 042 Tank Battery (Site) in Unit E, Section 18, Township 23 South, Range 30 East, in Eddy County, New Mexico (Figure 1). The purpose of the site assessment, soil sampling, and excavation activities was to address impacts to soil after a release of crude oil and produced water at the Site.

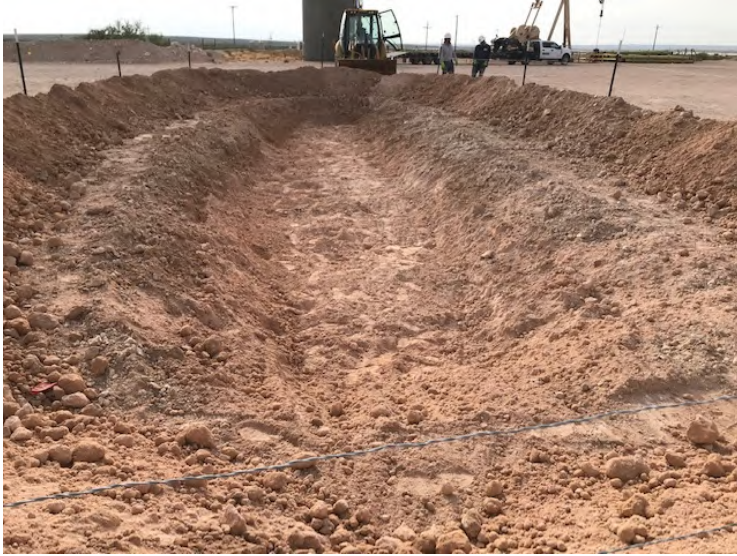
**Photograph 1:** West facing view of open excavation north of the tanks.

Impacted soil was excavated from the release area as indicated by field screening activities and laboratory analytical results for the preliminary and delineation soil samples. To direct excavation activities, LTE screened soil for volatile aromatic hydrocarbons and chloride utilizing a PID and Hach® chloride QuanTab® test strips, respectively. Impacted soil was excavated to a depth ranging from 2 feet to 4.5 feet bgs, in the areas around preliminary soil sample SS01 and delineation soil sample PH05A. Following removal of impacted soil, LTE collected 5-point composite soil samples every 200 square feet from the sidewalls and floors of the excavations. The 5-point composite samples were collected by depositing five aliquots of soil into a 1-gallon, resealable plastic bag and homogenizing the samples by thoroughly mixing. Composite soil samples SW01 through SW03 were collected from the sidewalls of the excavations from depths ranging from the ground surface to 4.5 feet bgs. Composite soil samples FS01 through FS03 were collected from the floor of the excavations from depths ranging from 2 feet to 4.5 feet bgs. The excavation extents and excavation soil sample locations are depicted on Figure 4.

The combined excavations measured approximately 710 square feet in area and were completed to depths ranging from 2 feet to 4.5 feet bgs. A total of approximately 80 cubic yards of impacted soil were removed from the excavations. The impacted soil was transported and properly disposed of at the R360 Landfill located in Hobbs, New Mexico.

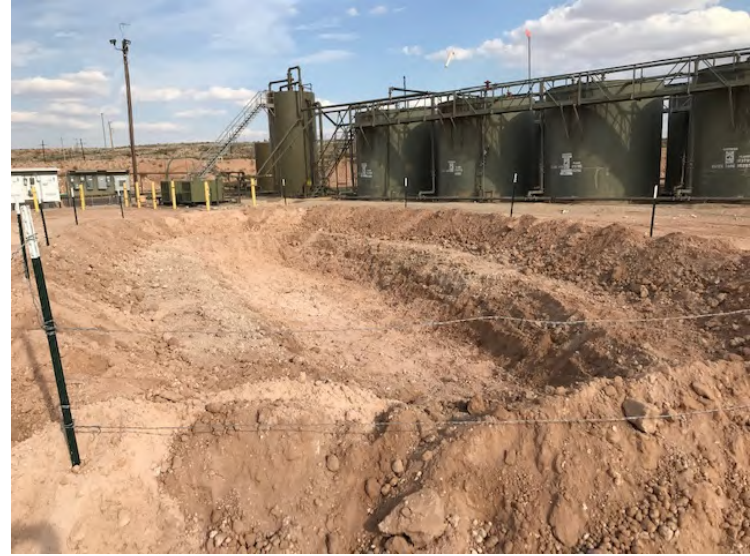
**Photograph 2:** East facing view of open excavation north of the tanks.

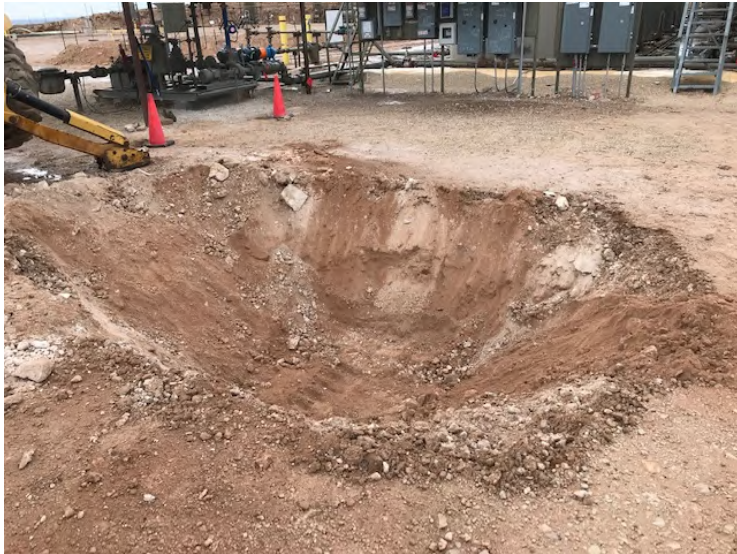
**Photograph 3:** East facing view of open excavation west of the tanks.

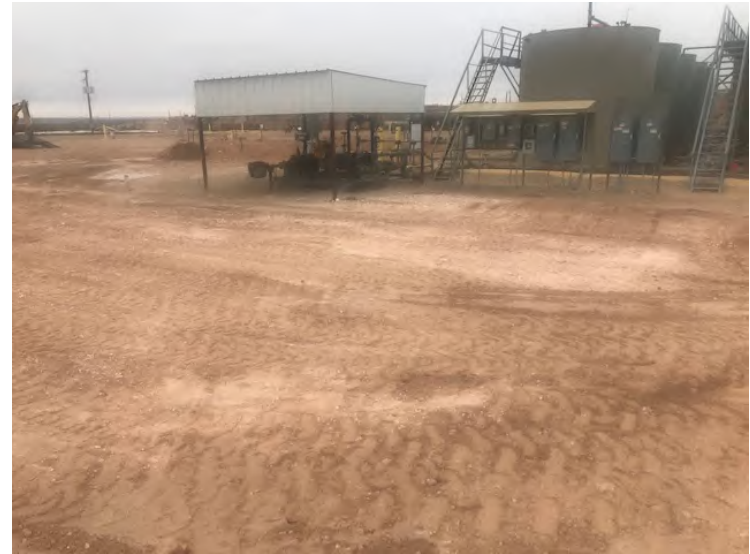
**Photograph 4:** East facing view of the backfilled excavation.
