**SOIL BORING AND SAMPLE  
LOCATIONS MAP**  
HARVEST MIDSTREAM  
TRUNK S RELEASE LOCATION  
INCIDENT NUMBER: NCS1931842879  
RELEASE ID: 373888  
NE¼ SE¼, SEC. 7, T25N, R3W  
RIO ARriba COUNTY, NEW MEXICO  
N36.41180, W107.18085

HARVEST MIDSTREAM  
TRUNK S RELEASE LOCATION  
INCIDENT NUMBER: NCS1931842879  
RELEASE ID: 373888  
NE¼ SE¼, SEC. 7, T25N, R3W  
RIO ARriba COUNTY, NEW MEXICO  
N36.41180, W107.18085

GEOLOGIC CROSS SECTION  
AND CHLORIDES

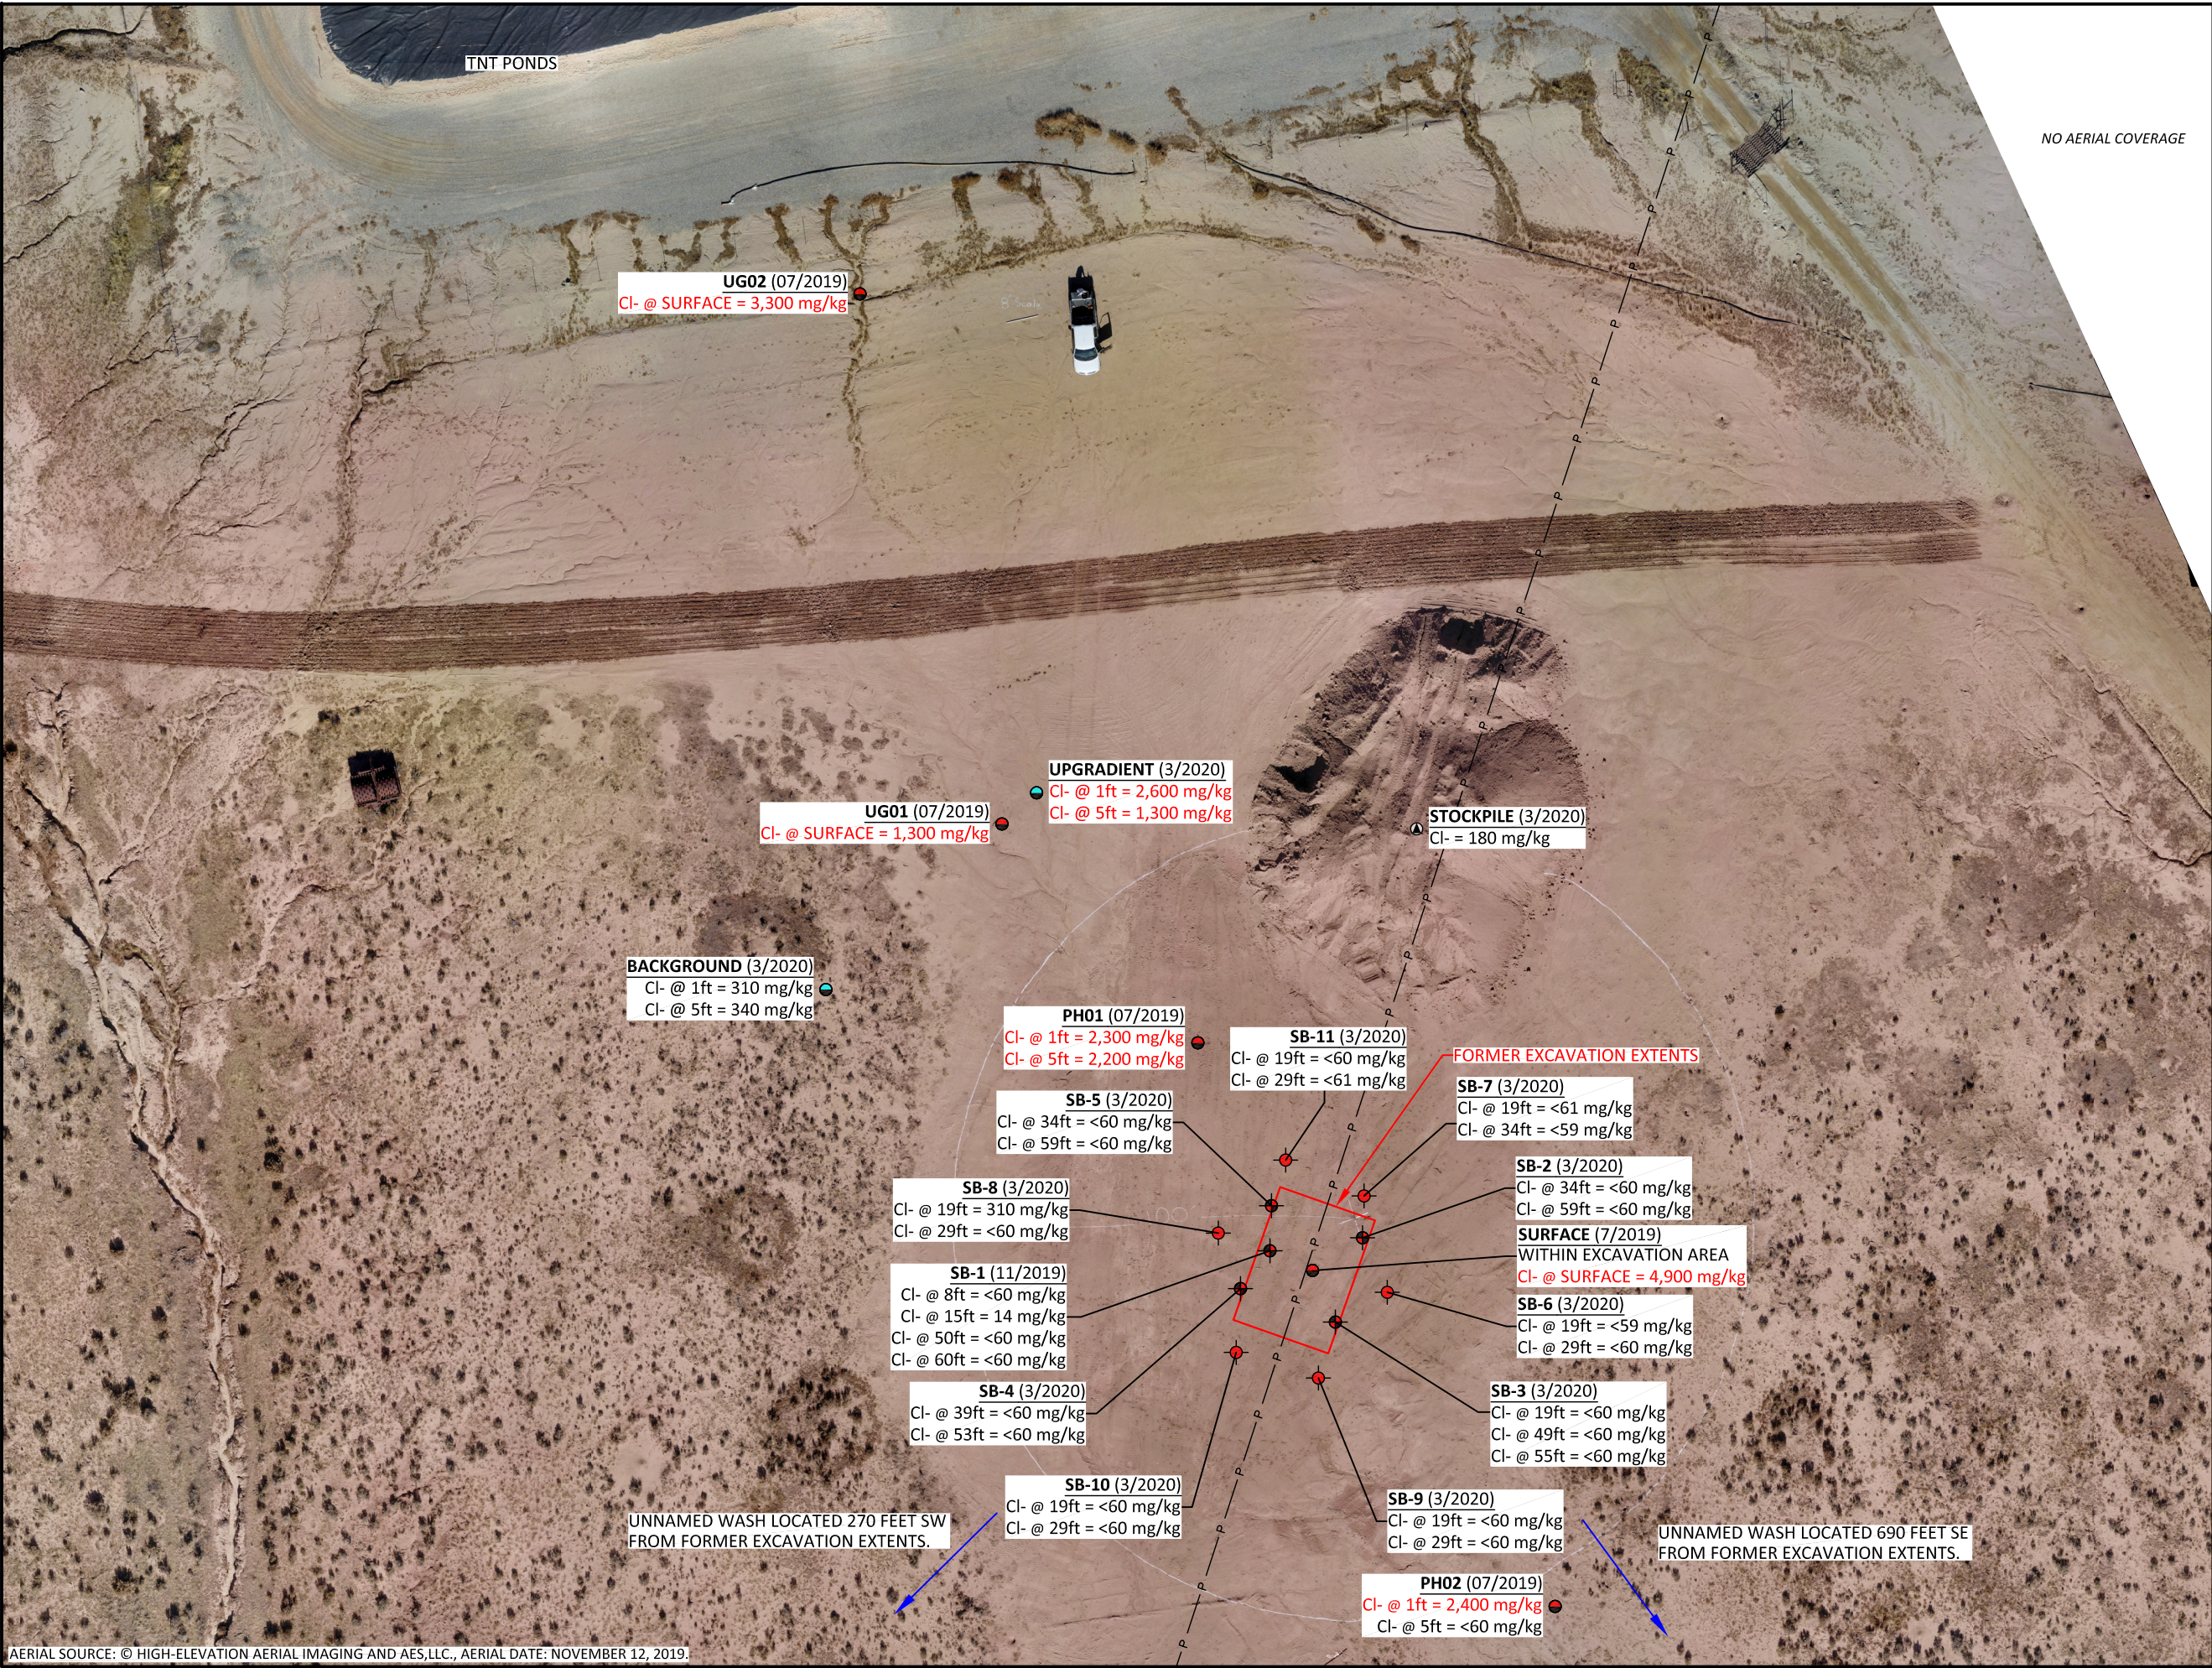
FIGURE 3A

SOIL BORING AND SAMPLE  
LOCATIONS MAP - CHLORIDES

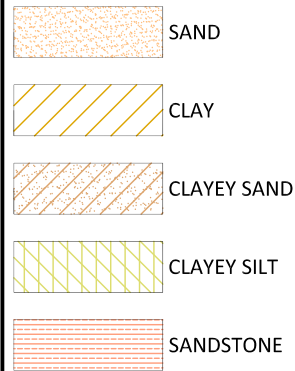
FIGURE 4A

FIELD CHLORIDE mg/L (ppm)  
(LAB CHLORIDE) mg/kg (ppm)  
NOTE: ALL RESULTS TABULATED IN TABLE 1.  
SAMPLES ANALYZED PER EPA METHOD 300.0.

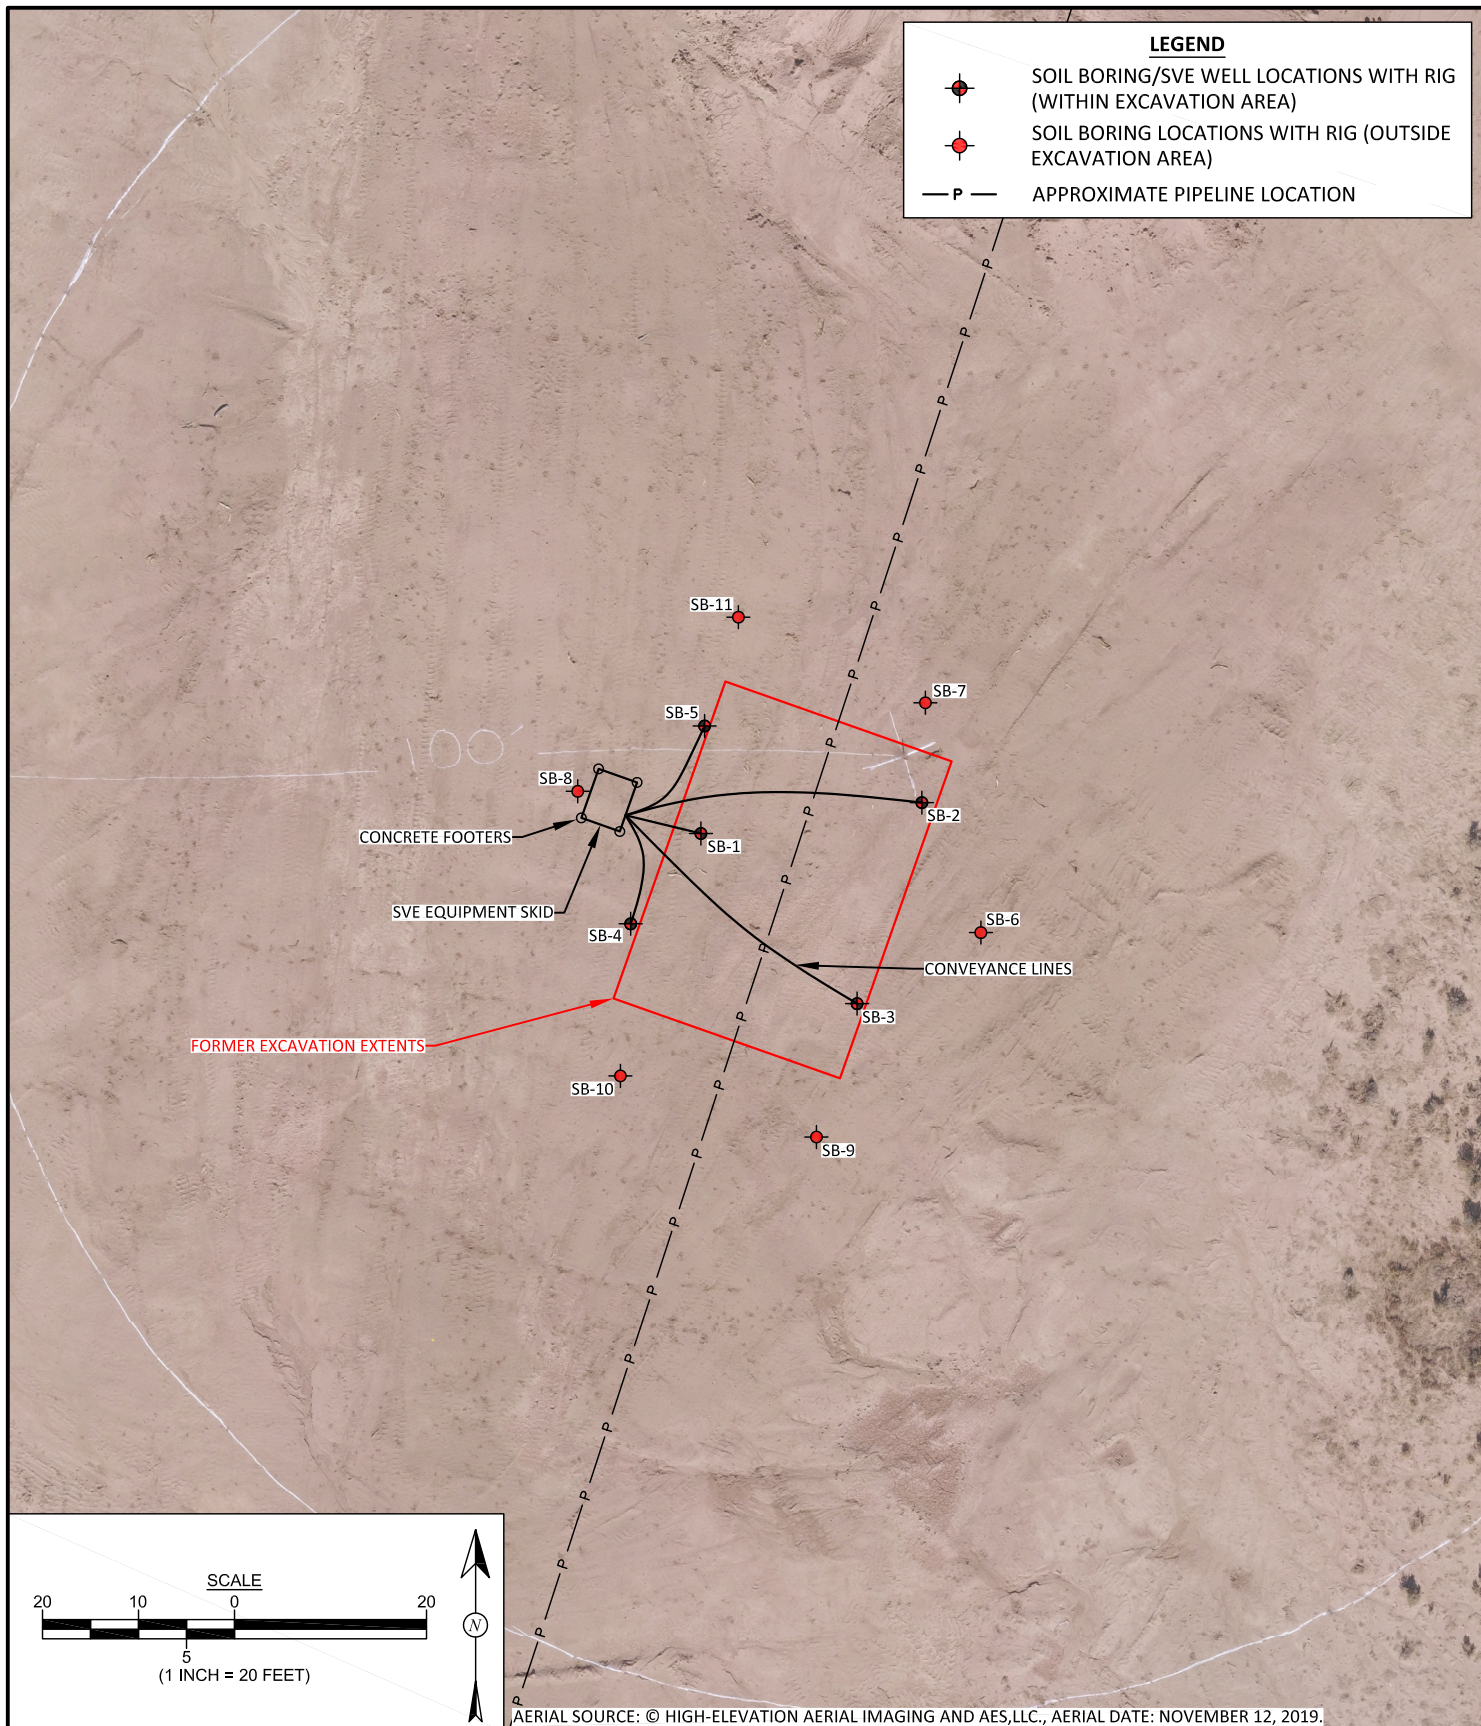
| <p><b>animas environmental services</b><br/>Farmington, NM • Durango, CO<br/>animasenvironmental.com</p> | <b>DRAWN BY:</b><br>C. Lameman | <b>DATE DRAWN:</b><br>April 23, 2020 | <p><b>FIGURE 5</b></p> <p><b>PROPOSED SITE REMEDIATION LAYOUT</b><br/>HARVEST MIDSTREAM<br/>TRUNK S RELEASE LOCATION<br/>INCIDENT NUMBER: NCS1931842879<br/>RELEASE ID: 373888<br/>NE¼ SE¼, SEC. 7, T25N, R3W<br/>RIO ARriba COUNTY, NEW MEXICO<br/>N36.41180, W107.18085</p> |
