NCS2003549670 Closure Report Ike's Recycling Containment #1

**Prepared for
Ameredev Operating, LLC
Austin, Texas**

**Prepared by
R.T. Hicks Consultants, Ltd.
Albuquerque, New Mexico**

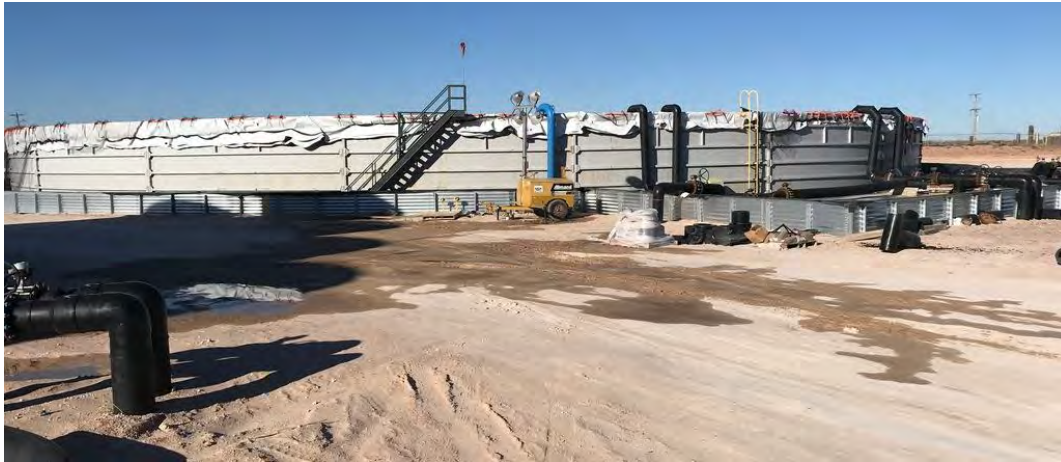
The release occurred on 12/18/2019 at 14:00 hours on surface owned by Washington Crossing Field Serv. LLC (Amerdev). The cause of the release was due to a valve on a water transport truck that became disconnected while filling an Above Ground Recycling Containment.

Figure 1: Release extent viewing north toward recycling AST. A secondary containment is visible photo right. Date/Time: 2019-12-18 15:36:42. GPS: 32.0203528 N , 103.2607889 W

Twenty-one and one-half (21.5) barrels of produced water was released and none was recovered. Excavation of the release began on December 19, 2019. Excavated material was transported to an approved disposal facility.

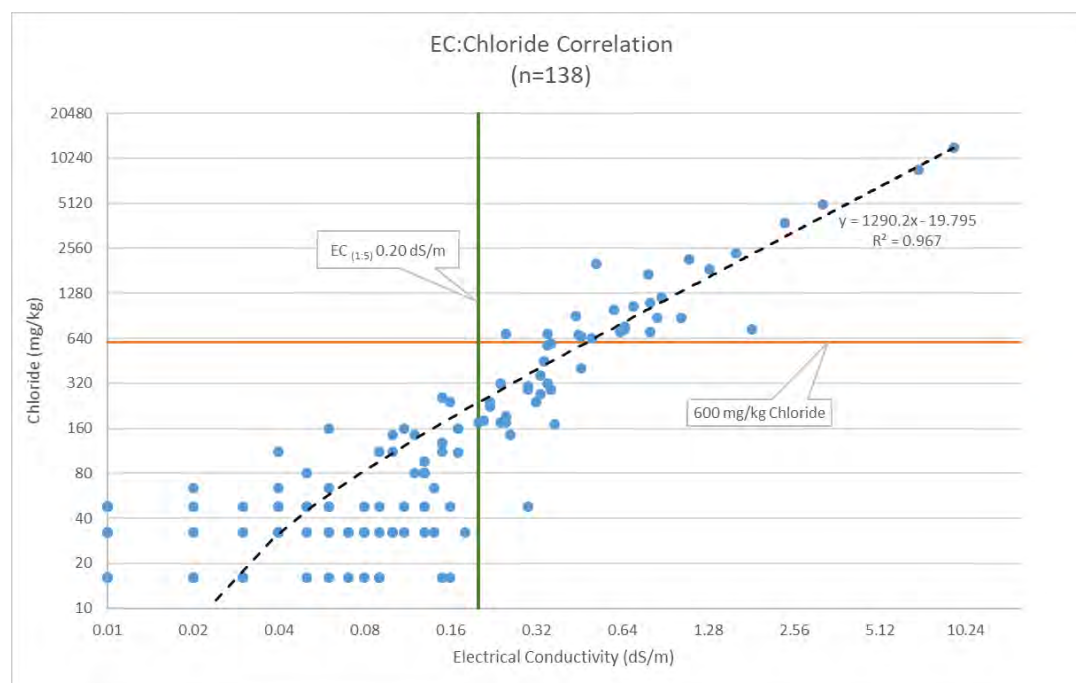
As shown below (Figure 2), EC < 0.2 dS/m correlates with a chloride concentration < 600 mg/kg.

Figure 2: Electrical Conductivity to Chloride correlation. Data collected by R.T. Hicks Consultants containing 138 sample points (n=138). Root Mean Square = 0.97.

Excavation of the base and walls continued until field screening of electrical conductivity (EC) was between 0.2 and 0.3 dS/m. EC readings were measured using a saturated paste in a 1-part soil to 5-parts distilled water solution (EC_{1:5}). A Hanna DiST 4 EC Tester was used to record measurements.

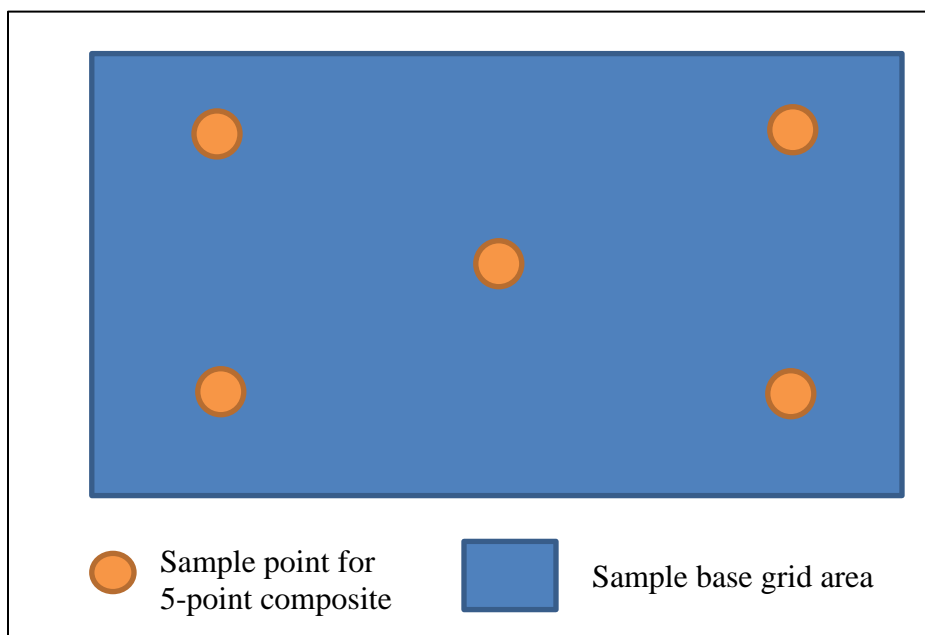
Plate 2a shows the sample grid for base samples. A 5-point composite sample was collected from each grid for confirmation sampling. Five-point composite sample points were evenly spaced within each sample grid to obtain a representative sample of the area (Figure 3, below example).

Figure 3: Example of 5-point sample grid for composite sampling.

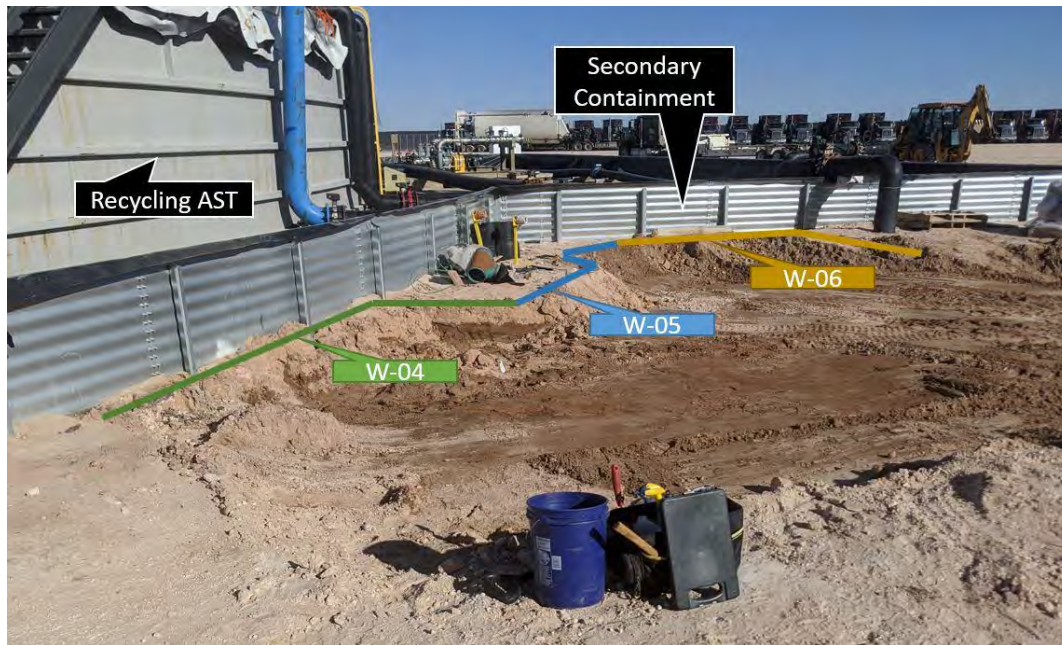
Walls W-04 and W-05 are along the recycling AST's south wall. Wall W-06 is along a secondary containment (Figure 4, below). Chloride concentrations at the walls from the surface to excavation base depth (1.5 to 2 feet) exceeds 19.15.29 Table 1 Closure Criteria for chloride. Remediation beyond the current extent of the walls would cause a major facility deconstruction per 19.15.29.12.C(2):

Figure 4: Photo of wall deferral locations along recycling and secondary containments.
Date/Time: 2019-12-20 13:54:43. GPS: 32.0205694 N , 103.2609444 W

Therefore, we ask NMOCD for deferment of these three areas. Final remediation and reclamation of these three areas shall take place in accordance with 19.15.29.12 and 19.15.29.13 NMAC after the production equipment is decommissioned and is no longer used for oil and gas operations.

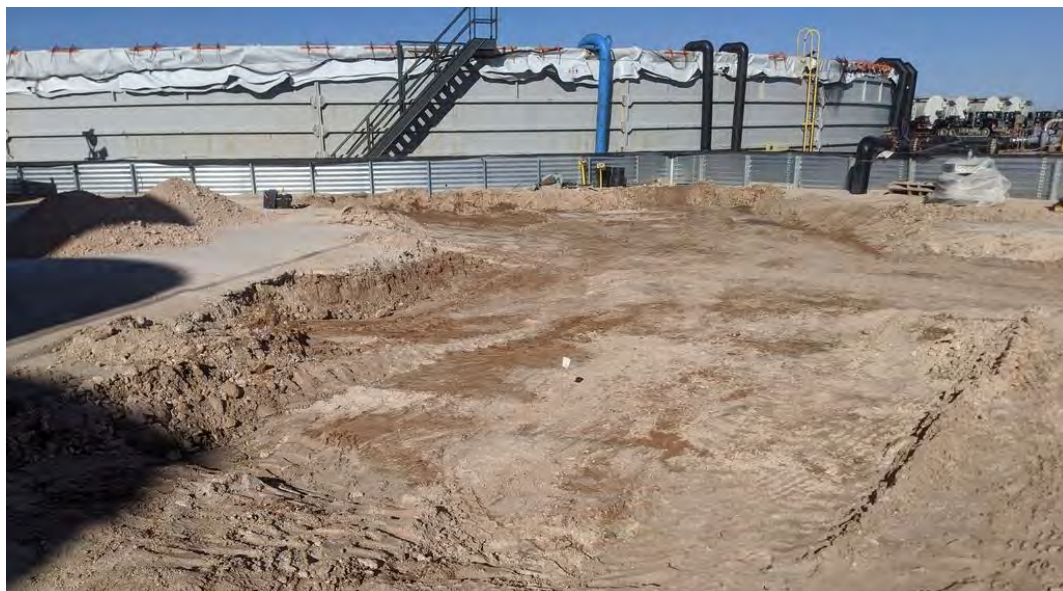
Below is photo documentation of excavation prior to backfilling (Figures 5 & 6).

Figure 5: Photograph of excavation viewing north prior to backfilling. Date: 2019-12-20 13:53:30. GPS: 32.0205694 N , 103.2609444 W

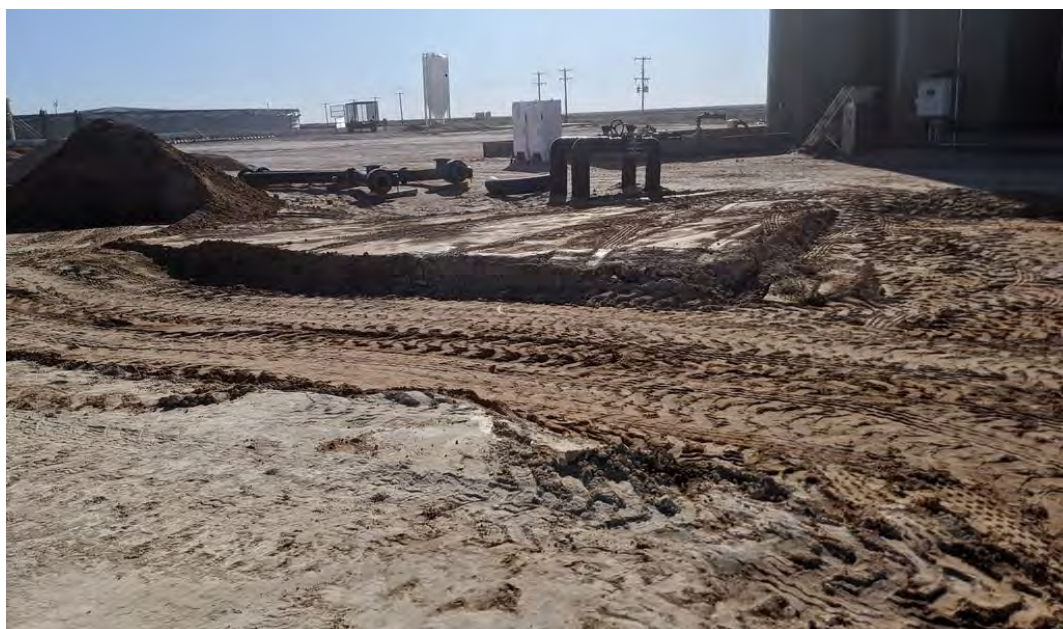
Figure 6: Photograph of excavation viewing southwest prior to backfilling. Date: 2019-12-20 13:55:22. GPS: 32.0205694 N , 103.2609444 W.

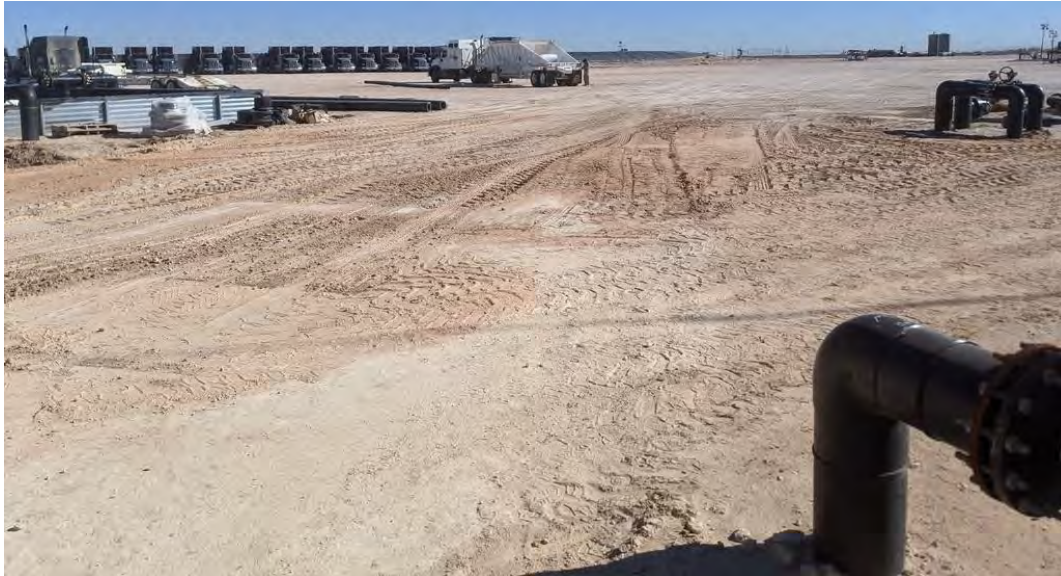
Below is photo documentation of excavation after backfilling (Figure 7).

Figure 7: Photo of backfill and restoration of active production pad. Photo is viewing southeast from wall W-02 where the wall crosses a pipeline. Date: 2019-12-21 12:45:00. GPS: 32.0205667 N , 103.2611111 W
