Remediation and Closure Report

Weems #001 Battery
Eddy County, New Mexico
API # 30-015-24827

Subject: **Remediation and Closure Report**
Weems #001 Battery
Eddy County, NM
API # 30-015-24827

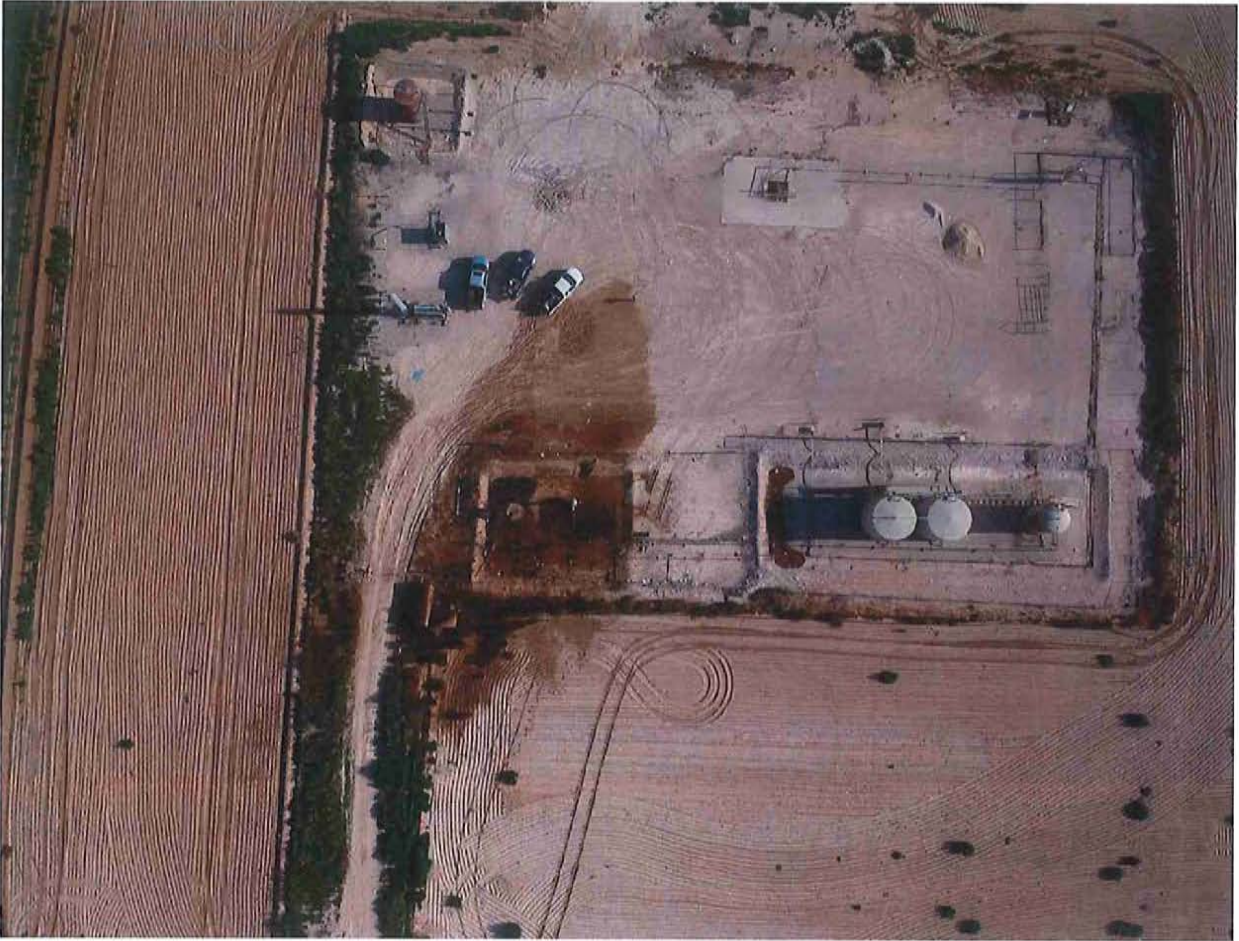
Figure 1: Initial Site Assessment Photograph

On July 29, 2019, 81 barrels (bbls) of crude oil (63 of which were recovered) and 92 bbls of produced water (72 bbls recovered) were released when a heater treater over pressured and ruptured. An initial C-141 was submitted on July 30, 2019 and is provided in [Appendix III](#). No RP or Incident Number has been issued to date by NMOCD.
