#### **Remediation and Deferrel Closure Report**

Union 35 A Federal Battery  
Eddy County, NM  
API# 30-015-24689  
\*2RP-2854, \*2RP-4481, \*2RP-5507

Subject: **Remediation and Deferrel Closure Report**  
Union 35 A Federal Battery  
API# 30-015-24689  
\*2RP-2854, \*2RP-4481, \*2RP-5507

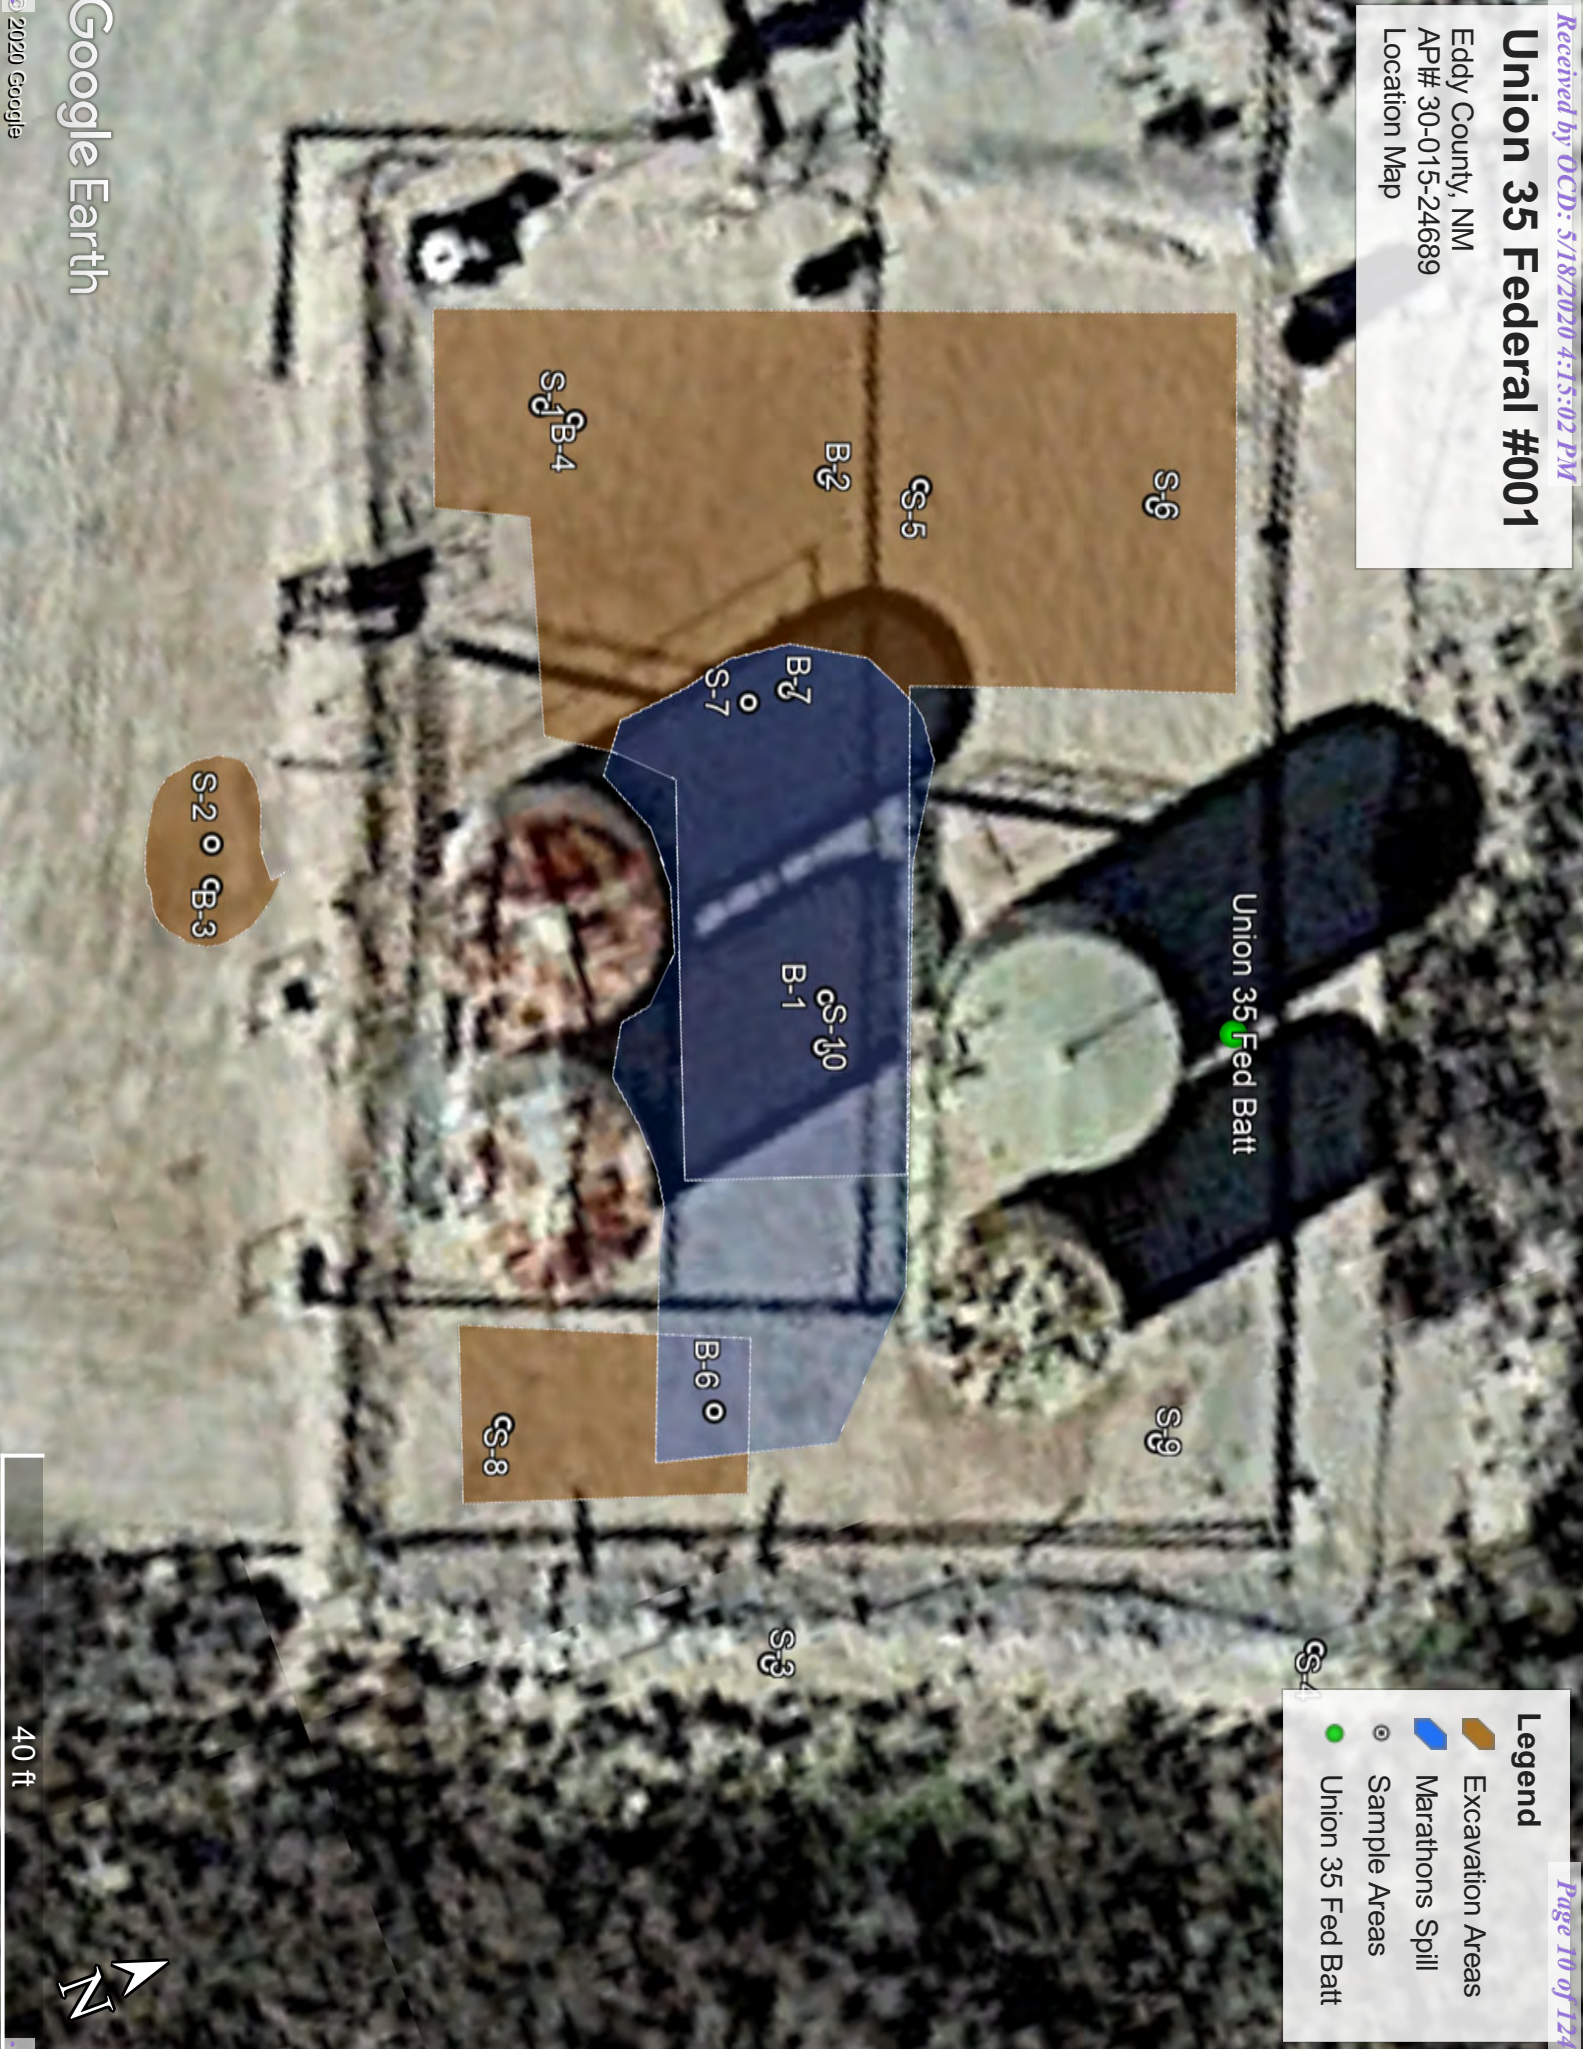
## Legend

- Excavation Areas
- Marathons Spill
- Sample Areas
- Union 35 Fed Batt

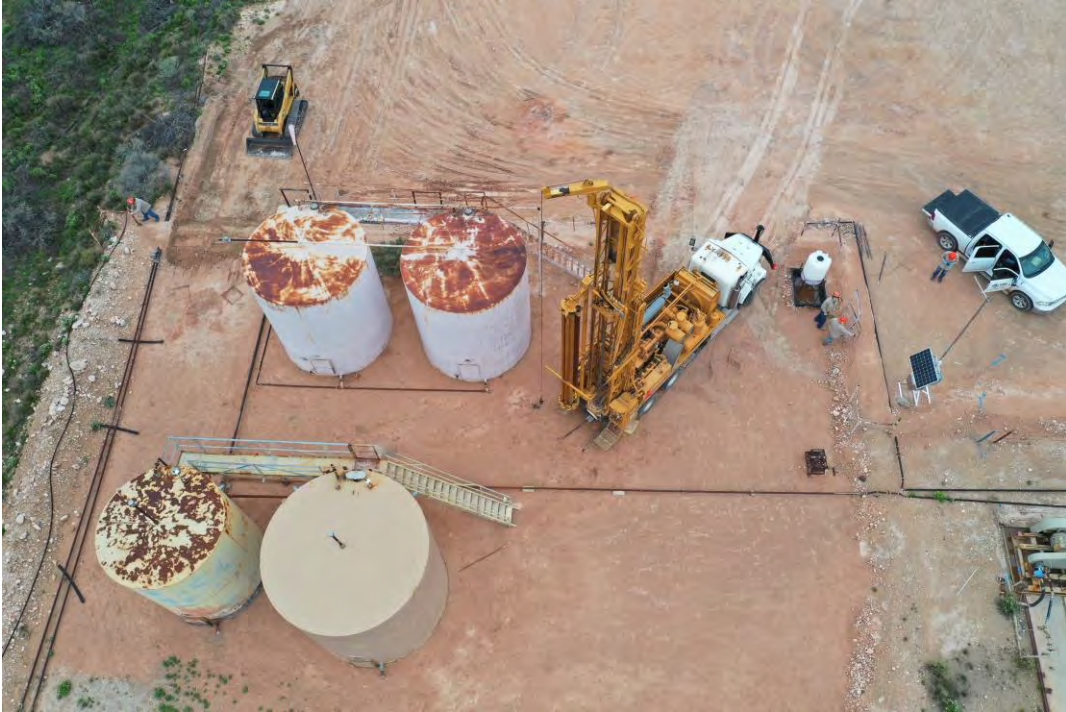
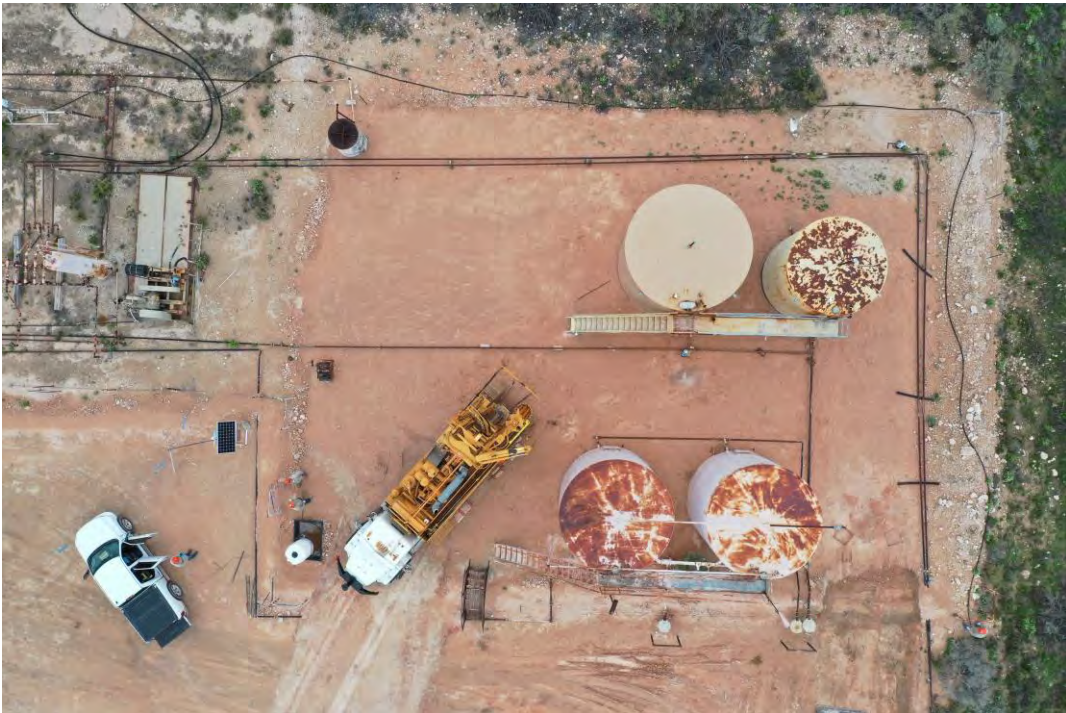
## Boring Samples

On March 17, 2020, Talon personnel returned to the site with an air rotary drill rig to vertically delineate the extent of the contamination within accessible areas. The results of our sampling event can be found in the following data table.
