Closure Report

SRO State Com #010

API #: 30-015-38072

RP#: 2RP-5041

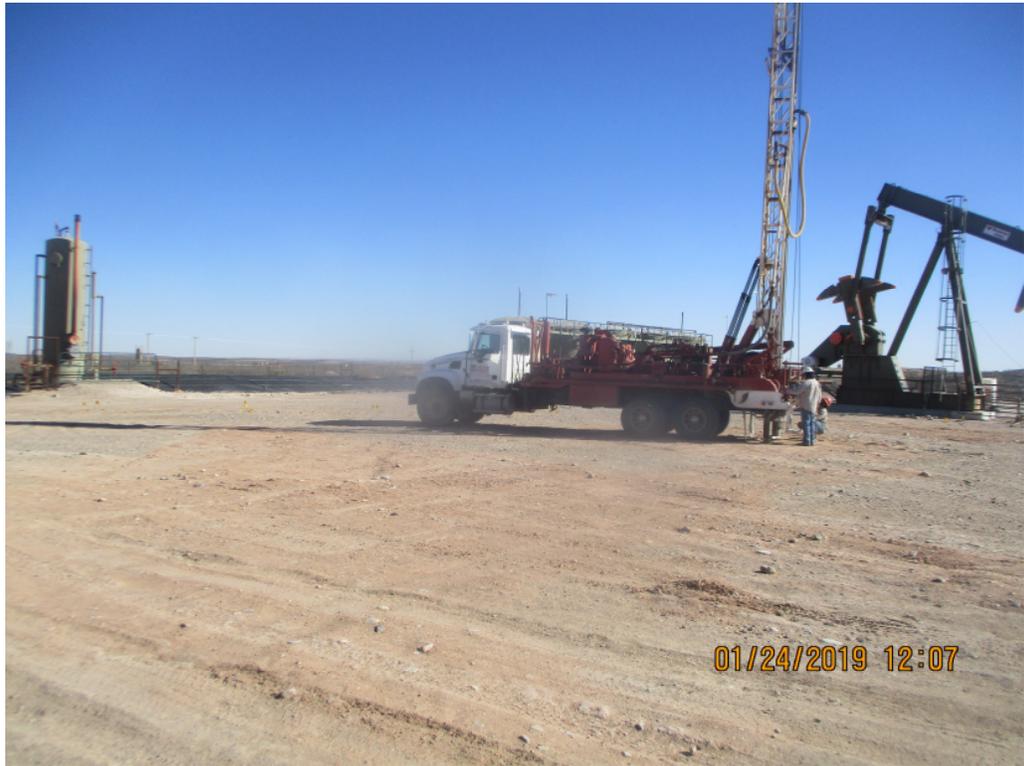
Area of BH-1 – View to Northeast

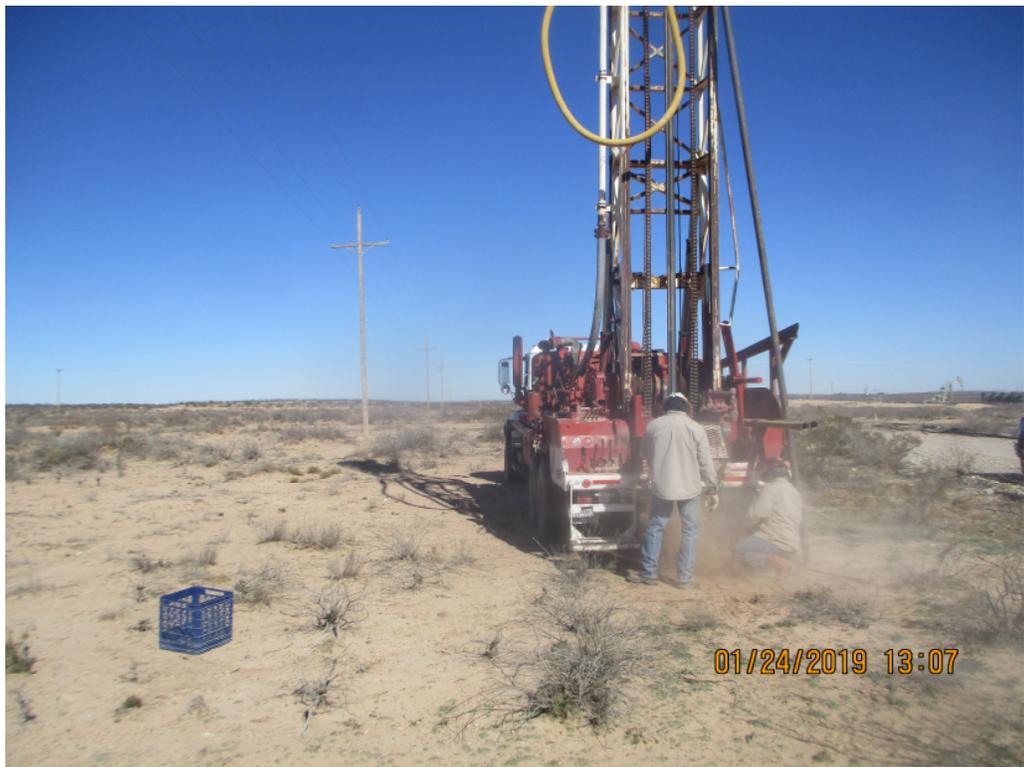
Area of Background – View North
