M&M Excavating, Inc. (MMX) has prepared this Remediation Closure Report for Devon Energy Production Company that describes the remediation of a release of liquids associated with the Thistle Unit #111H well (facility on C141s) but occurred at the Thistle Unit 22 CTB #2. The site is in Unit A, Section 22, Township 23S, Range 33E, Latitude 32.2968168, Longitude -103.5537133, Lea County, New Mexico, on State land. Figure 1 provides the vicinity and site location on an USGS 7.5-minute quadrangle map.

<b>Release Information and Closure Criteria</b>			
Name	Thistle Unit #111H/Thistle Unit 22 CTB #2		
API Number	30-015-44418		
Incident Number	1RP-5364 & 1RP-5428		
Source of Release	Heater Treater		
Released Material	Crude Oil	Released Volume	290 BBLS
Recovered Volume	290 BBLS	Net Release	0 BBLS
NMOCD Closure Criteria	>100 feet to groundwater

Regional Vicinity & Wellhead Protection Map  
 Thistle Unit #111H - Devon Energy  
 Sec 33 T23S R33E Lea County, New Mexico

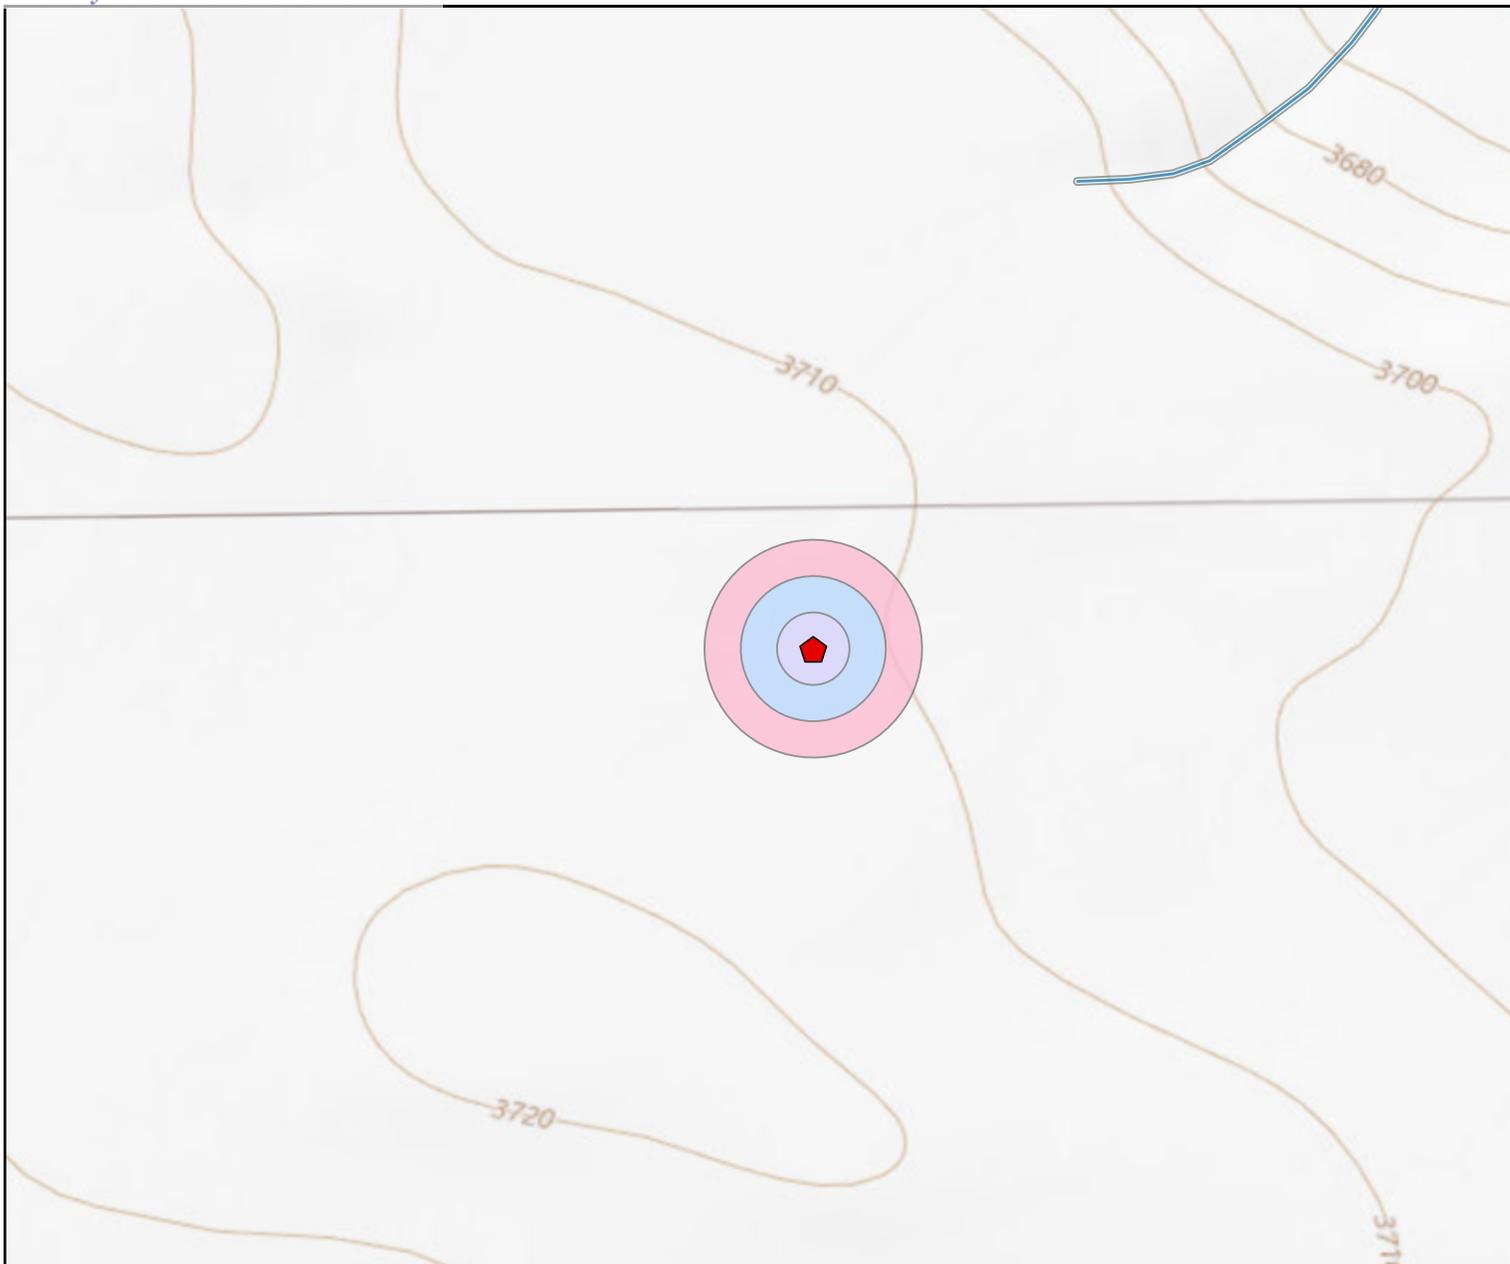
Figure 2

Surface Water Protection Map  
 Thistle Unit #111H - Devon Energy  
 Sec 22 T23S R33E Lea County, New Mexico

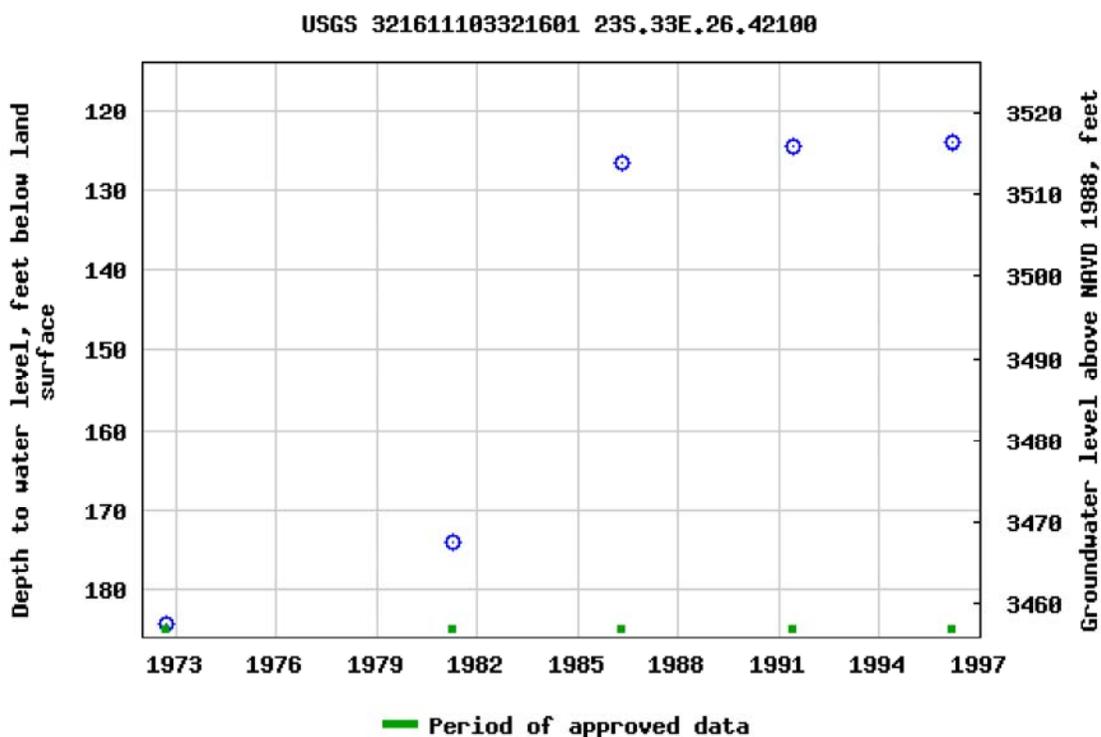
### USGS 321611103321601 23S.33E.26.42100

The depth of the well is 190 feet below land surface.

Breaks in the plot represent a gap of at least one year between field measurements.

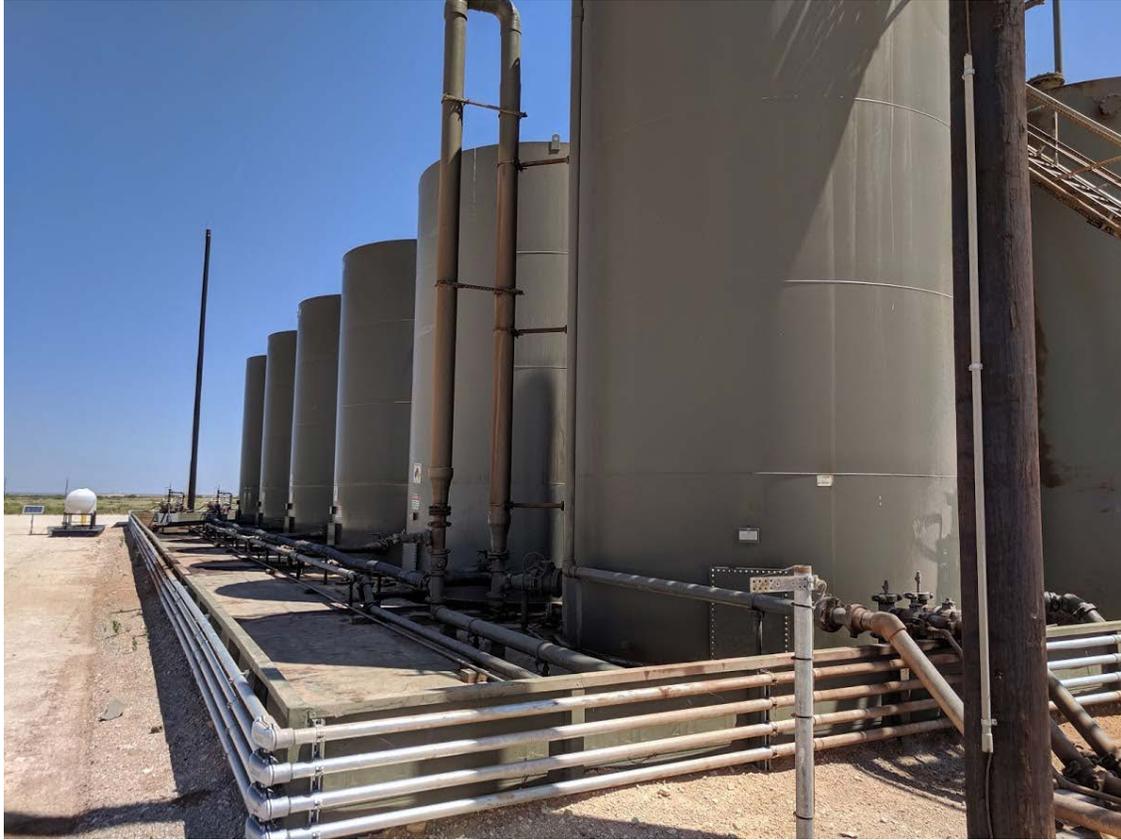
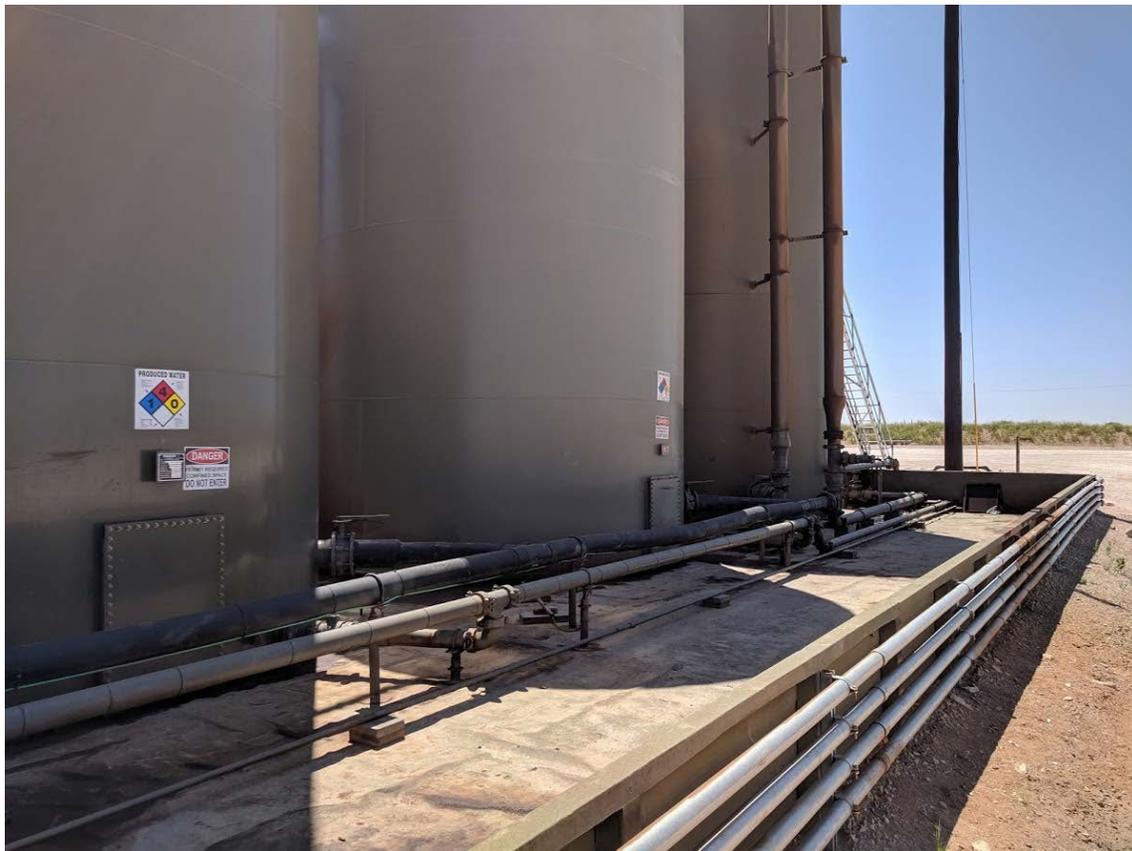
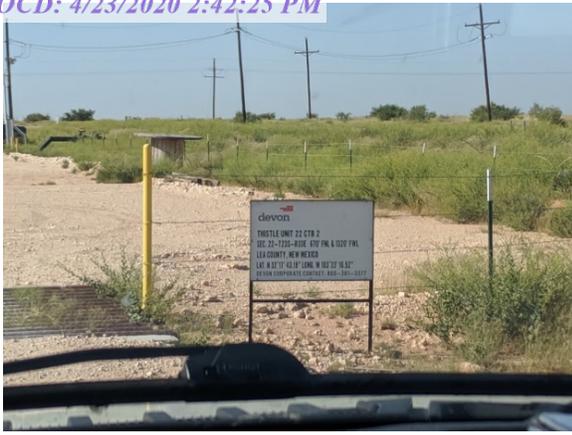
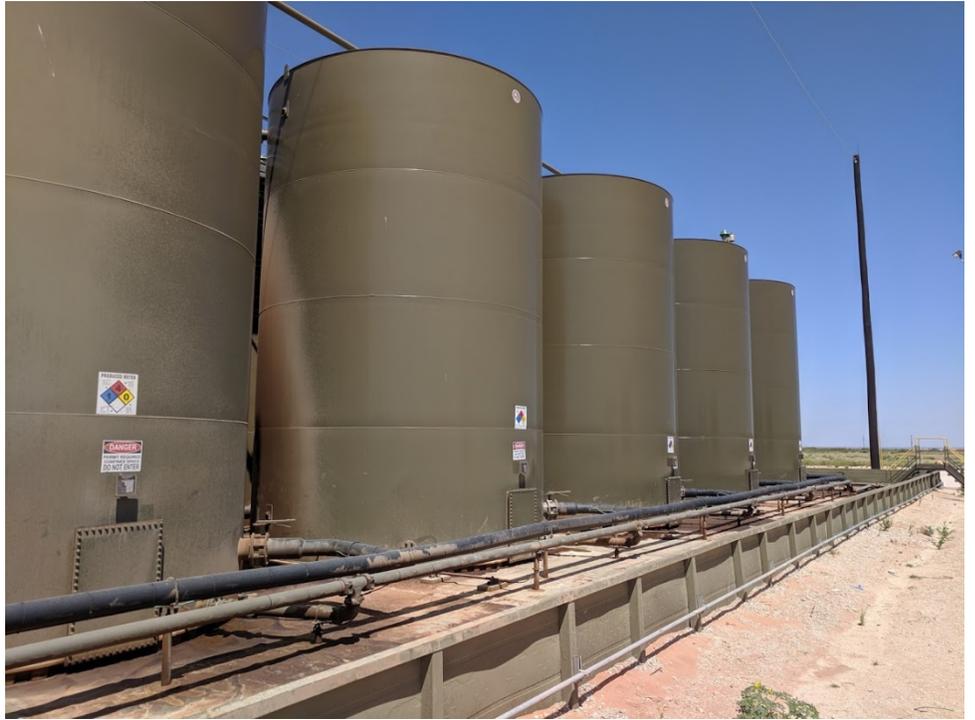
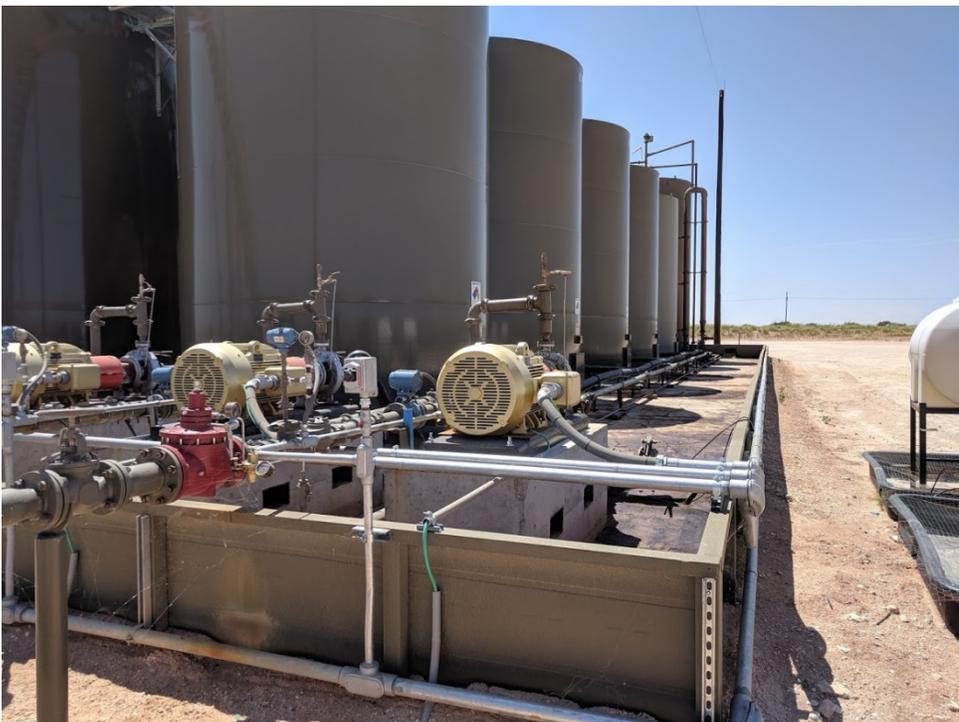
## Appendix C Liner Inspection Photo Log

At the request of Devon Energy, MMX power-washed the containment after the release and conducted a liner integrity inspection per requirements of 19.15.29.11.A(5)(a) NMAC. Notice was given to the state on August 18, 2019 that the inspection was to occur on August 23, 2019. After a thorough a visual inspection of the liner within the containment, the liner appeared to be intact and had the ability to contain the leak in question. A photo log documenting the inspection conducted by MMX is included in Appendix C.

Liner Inspection Photos Taken August 23, 2019

On behalf of Devon Energy, MMX recommends no further action and requests closure for the releases associated with 1RP-5364 and 1RP-5428.
