SUBJECT: Remediation Closure Report for the QPQASU Tank Battery #1 Release (1RP-5122), Lea County, New Mexico

On behalf of Mewbourne Oil Company, Souder, Miller & Associates (SMA) has prepared this Remediation Closure Report that describes the remediation of a release of liquids related to oil and gas production activities at the QPQASU Tank Battery #1 site. The site is in Unit M, Section 23, Township 18S, Range 32E, Lea County, New Mexico, on Federal land. Figure 1 illustrates the vicinity and site location on an USGS 7.5-minute quadrangle map.

QPQASU Tank Battery 31 Remediation Closure Report (1RP-5122)  
February 26, 2019

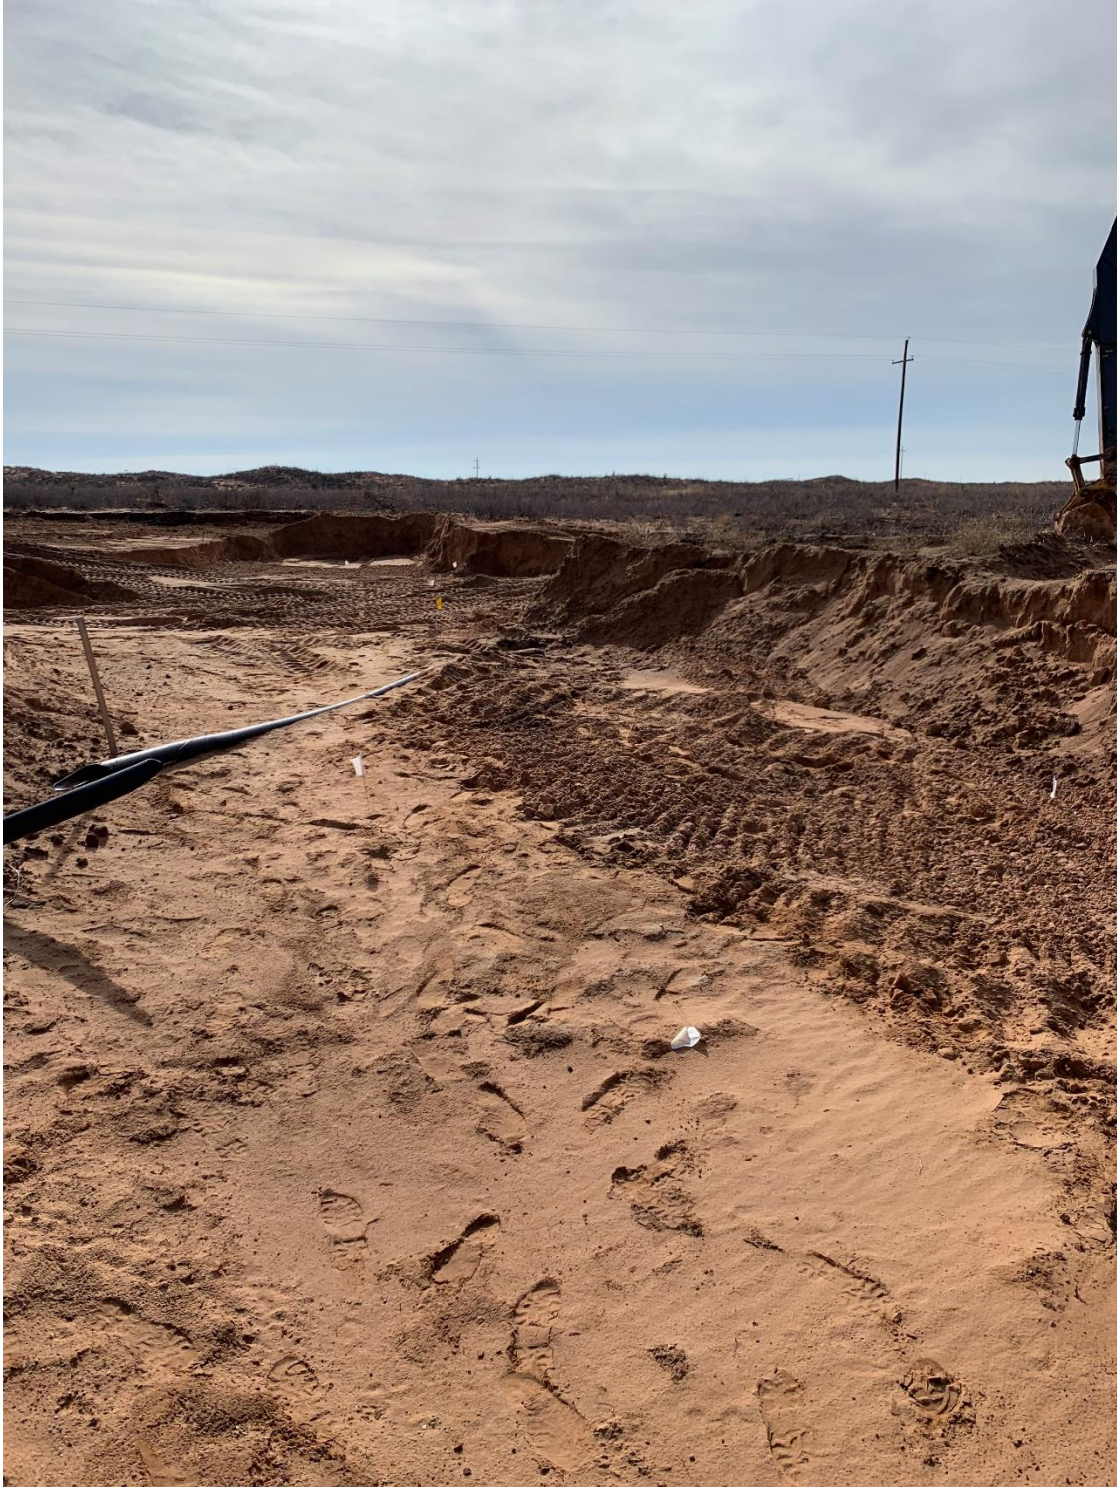
Photo 1: Standing at BH6 looking Southwest.

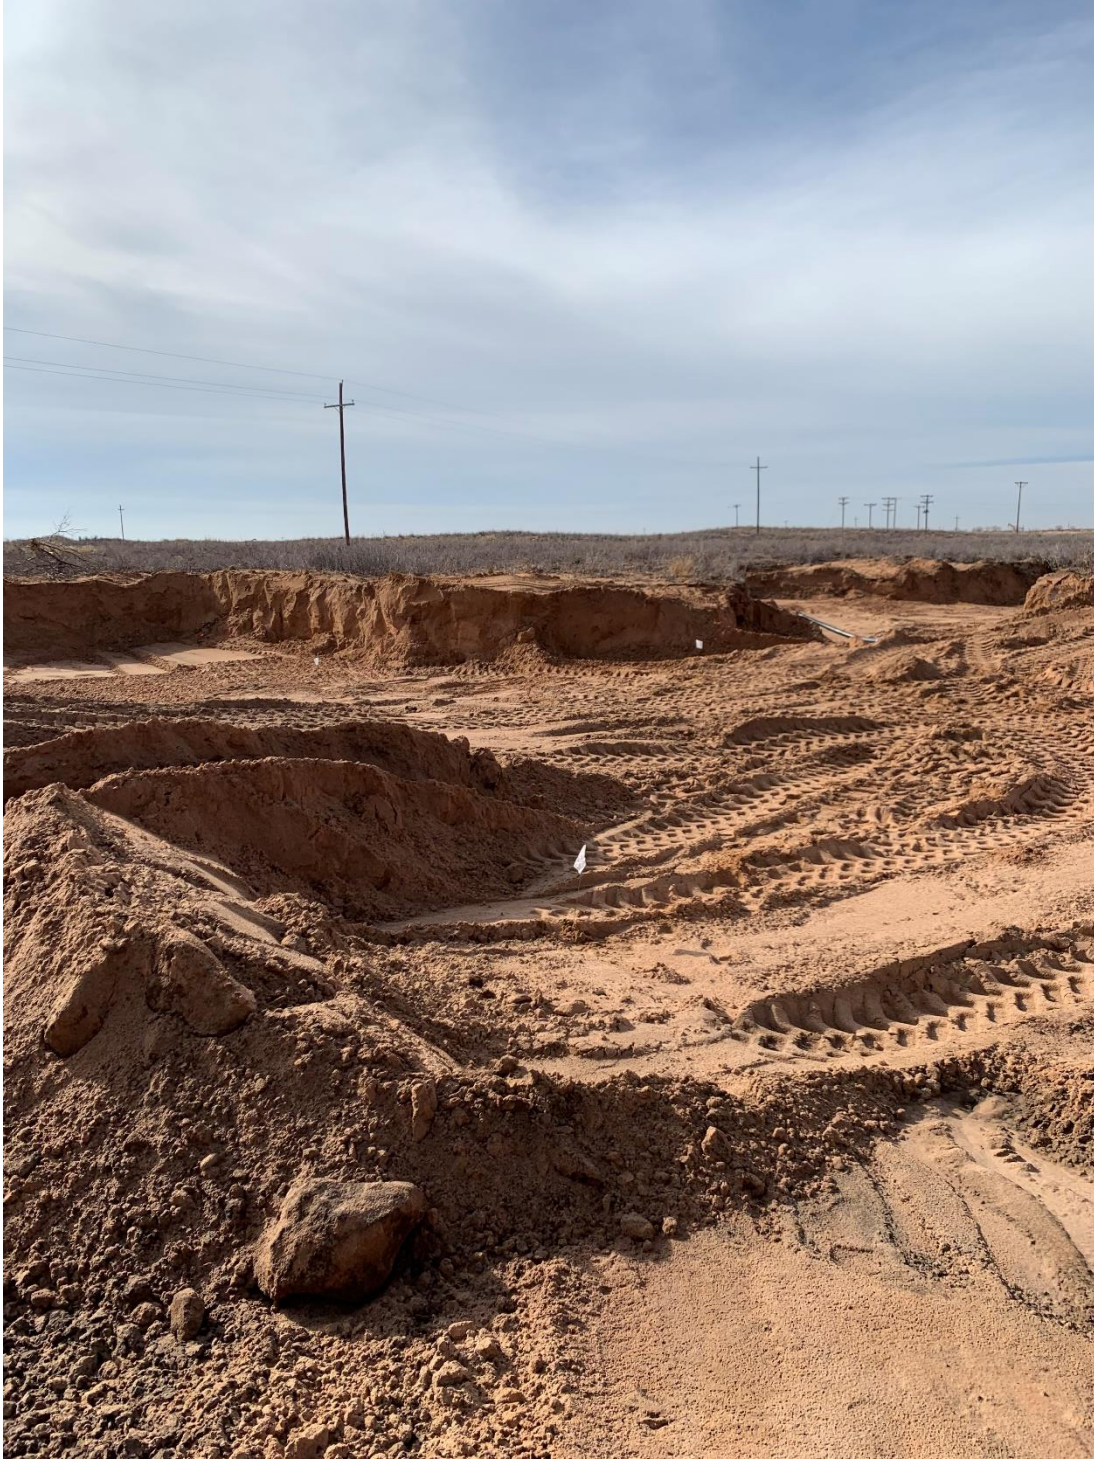
Photo 2: At BH2 looking Southeast.

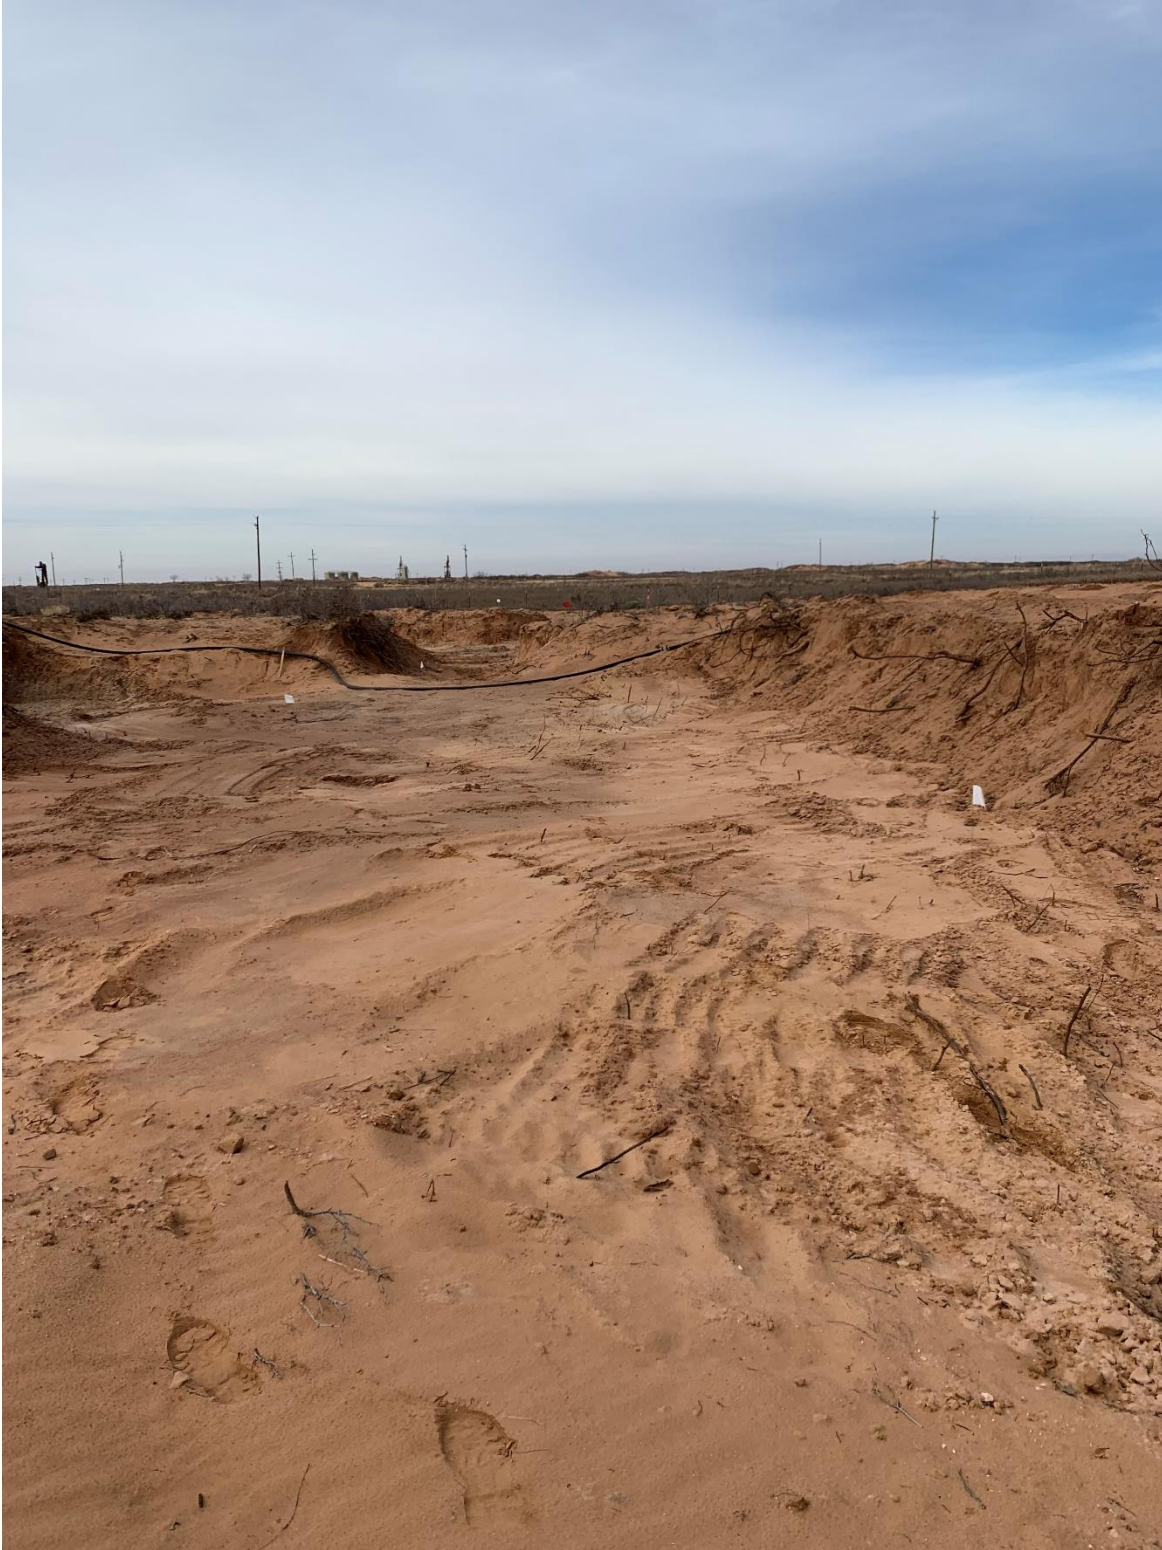
Photo 3: Standing at BH 1 looking West.

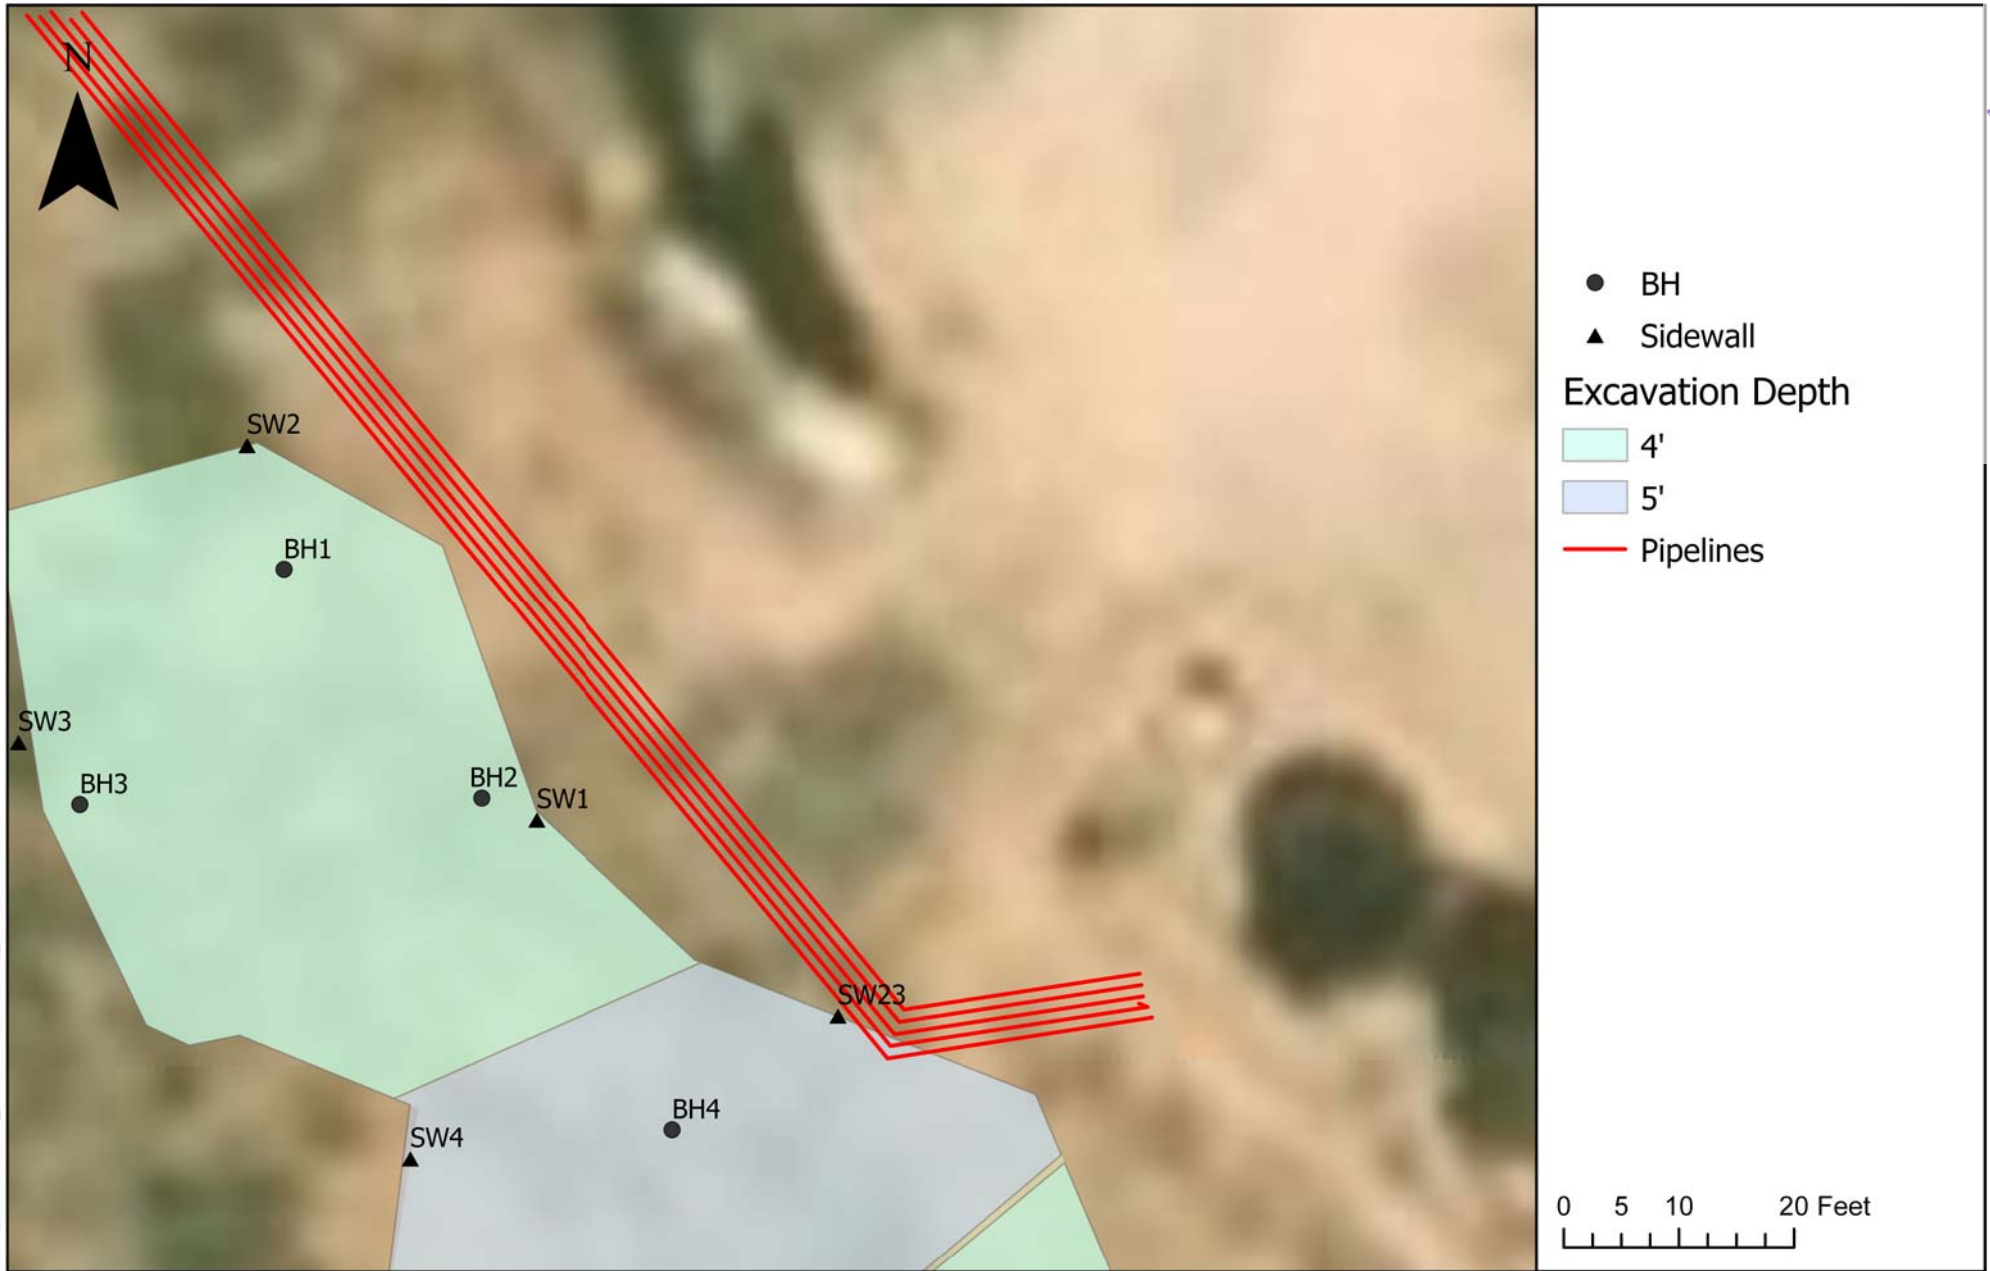
Figure 3

Site and Sample location Map  
QPQASU Tank Battery #1-Mewbourne
