RE: Closure Request

Shocker 32 State Com #3H Battery Remediation Permit Number 2RP-5136

Eddy County, New Mexico

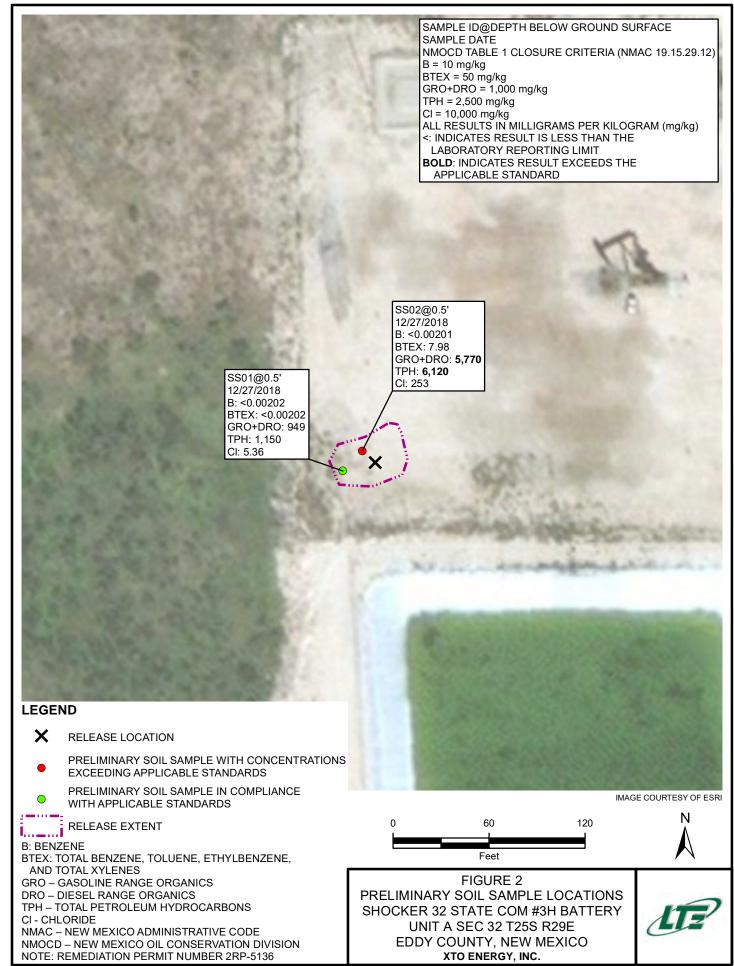
Figure 2 Preliminary Soil Sample Locations
Figure 3 Delineation Soil Sample Locations
Figure 4 Excavation Soil Sample Locations

On December 27, 2018, LTE personnel inspected the Site to evaluate the release extent. Surface hydrocarbon staining was observed in the release area on the well pad. The release extent was mapped using a handheld Global Positing System (GPS) unit and is depicted on Figure 2. LTE personnel collected two preliminary soil samples (SS01 and SS02) within the release area from a depth of 0.5 feet bgs to assess the lateral extent of soil impacts. The soil samples were screened for volatile aromatic hydrocarbons and chloride using a photo-ionization detector (PID) and Hach® chloride QuanTab® test strips. The soil samples were placed directly into pre-cleaned glass jars, labeled with the location, date, time, sampler, method of analysis, and immediately placed on ice. The soil samples were shipped at 4 degrees Celsius (°C) under strict chain-of-custody procedures to Xenco Laboratories (Xenco) in Midland, Texas, for analysis of BTEX by United States Environmental Protection Agency (USEPA) Method 8021B, TPH-GRO, TPH-DRO, and TPH-oil range organics (ORO) by USEPA Method 8015M/D, and chloride by USEPA Method 300.0.

Laboratory analytical results for soil sample SS01 indicated that BTEX, GRO/DRO, TPH, and chloride concentrations were compliant with the NMOCD Table 1 closure criteria. Laboratory analytical results for soil sample SS02 indicated that GRO/DRO and TPH concentrations exceeded the NMOCD Table 1 closure criteria. Laboratory analytical results are presented on Figure 2 and summarized in Table 1 and the laboratory analytical report is included in Attachment 2. Based on the SS02 soil sample analytical results, excavation of impacted soil was required.

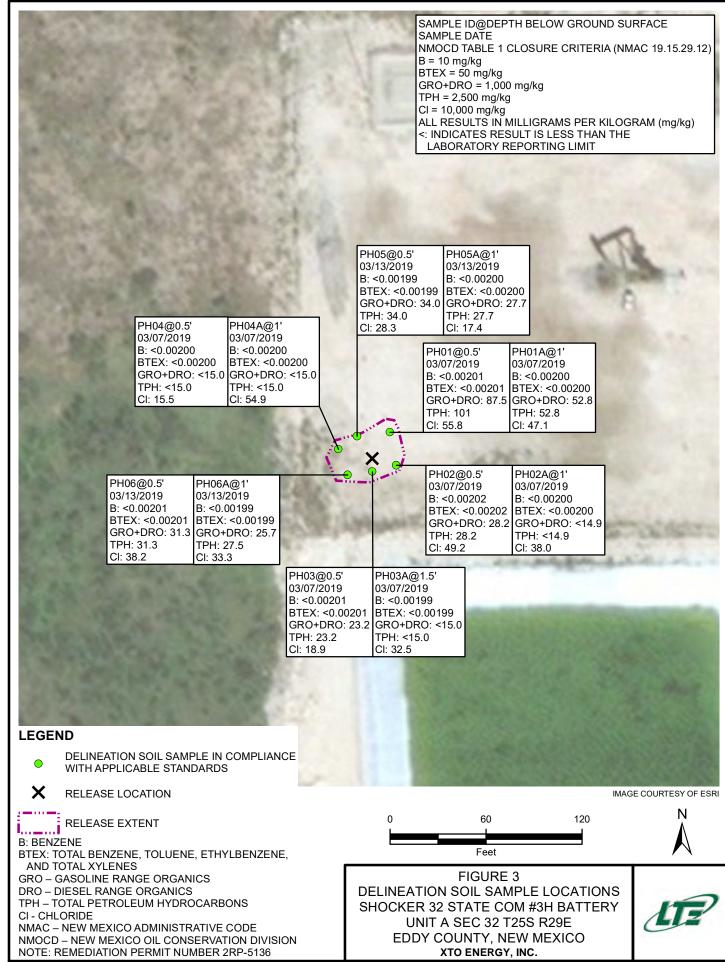
On March 7 and March 13, 2019, six potholes (PH01 through PH06) were advanced in the release area using a backhoe to delineate the lateral and vertical extent of impacted soil. Soil was field screened in each pothole using a PID and Hach® chloride QuanTab® test strips. Two soil samples

were collected from each pothole, PH01 through PH06. Soil samples were collected from depths of 0.5 feet and 1 foot bgs from potholes PH01, PH02, and PH04 through PH06 and soil samples were collected from depths of 0.5 feet and 1.5 feet bgs from pothole PH03. The pothole soil sample locations and depths are presented on Figure 3 and soil sample logs are included as Attachment 3.

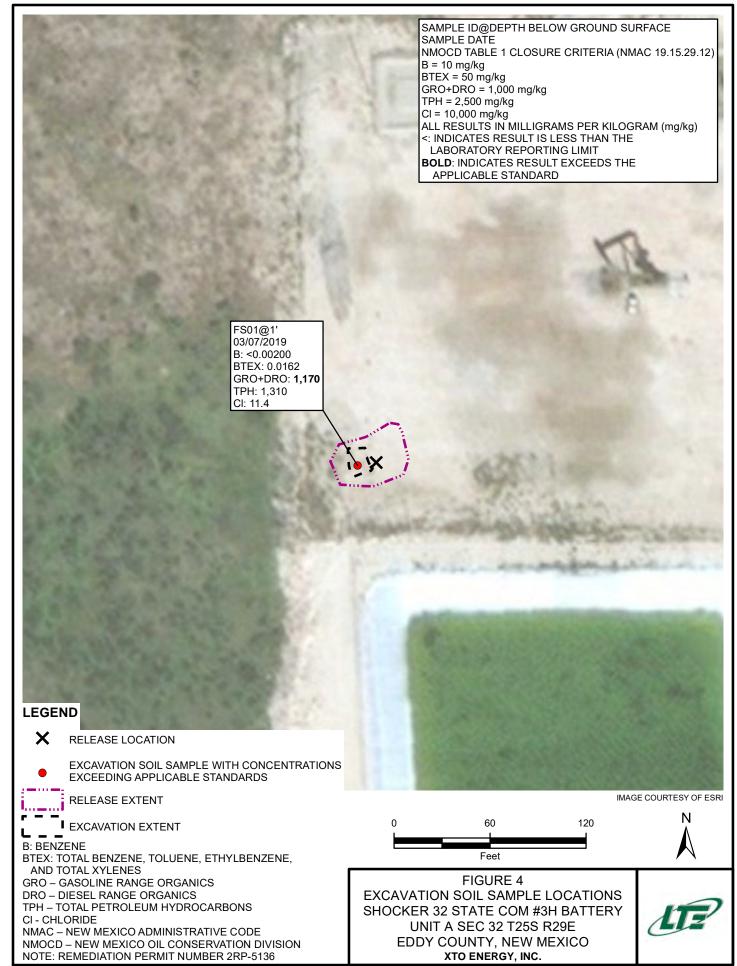
On March 7, 2019, impacted soil was excavated to a depth of 1 foot bgs in the area around preliminary soil sample SS02. Following removal of impacted soil, LTE collected a 5-point composite soil sample (FS01) from the floor of the excavation from a depth of 1 foot bgs. The 5-point composite sample was collected by depositing 5 aliquots of soil into a 1-gallon, resealable plastic bag and homogenizing the sample by thoroughly mixing. The excavation measured approximately 200 square feet in area and was completed to a depth of 1 foot bgs. Based on the shallow depth of the excavation, composite sample FS01 was representative of the sidewalls and floor of the excavation. The soil sample location and horizontal extent of the excavation are presented on Figure 4. The pothole and excavation soil samples were collected, handled, and analyzed as described above and submitted to Xenco in Midland, Texas.

Laboratory analytical results indicated that BTEX, GRO/DRO, TPH, and chloride concentrations were compliant with the NMOCD Table 1 closure criteria in preliminary soil sample SS01 and all soil samples collected from potholes PH01 through PH06. Based on the laboratory analytical results, no excavation was required in these areas. Laboratory analytical results indicated that GRO/DRO and TPH concentrations exceeded the NMOCD Table 1 closure criteria in preliminary soil sample SS02. Impacted soil was excavated in the area around preliminary soil sample SS02 and laboratory analytical results for the subsequent excavation soil sample FS01 indicated that GRO/DRO concentrations continued to exceed the NMOCD Table 1 closure criteria.

Further excavation of impacted soil was limited by the active flare stack and pipelines. XTO safety policy restricts soil disturbing activities to a 2 foot radius of any on-site process equipment. This XTO safety policy is established to protect workers and to reduce the likelihood of compromising the foundation of the process equipment. This policy was enforced where impacted soil was identified within 2 feet of the active flare stack and pipelines. Laboratory analytical results are summarized in Table 1 and the complete laboratory analytical reports are included as Attachment 2.

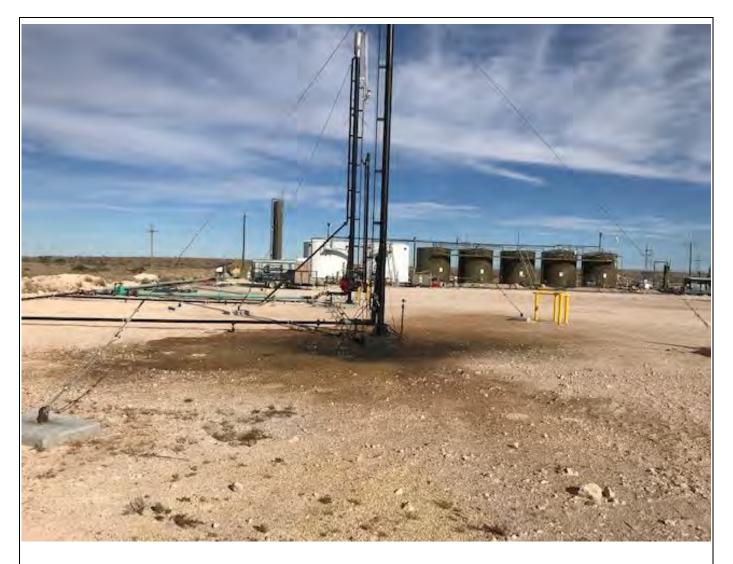
Lab Sample Id: 609962-002 Date Collected: 12.27.18 09.35 Sample Depth: 0.5 ft

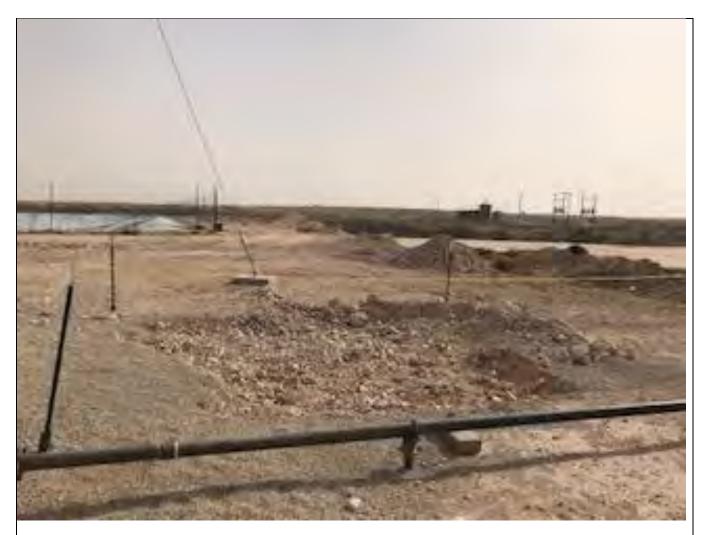
Approximately 8 cubic yards of impacted soil were removed from the excavation. The impacted soil will be transported and properly disposed of at the R360 Red Bluff Landfill Facility, in Orla, Texas.

Analyst: SCM Date Prep: 01.03.19 08.15 Basis: Wet Weight

XTO requests to backfill the existing excavation and complete remediation during any future major well pad construction/alteration or final plugging and abandonment, whichever occurs first. LTE and XTO do not believe deferment will result in imminent risk to human health, the environment, or groundwater. Free-standing fluids were recovered during initial response activities and no saturated soil remains in place. The impacted soil remaining in place in the southwest corner of the pad is delineated vertically and laterally by soil samples collected from potholes PH01 through PH06.

Initial response efforts and excavation of impacted soil have mitigated impacts at this Site. XTO requests no further action for release number 2RP-5136. Upon approval of this closure request, XTO will backfill the excavation with material purchased locally and recontour the Site to match pre-existing site conditions. An updated NMOCD Form C-141 is included as Attachment 1. A photographic log of the Site is included as Attachment 4.
