Dagger State Unit 3 (DSU 3 02062020)
Characterization, Remediation & Closure Report

Prepared for
Advance Energy Partners Hat Mesa LLC
Houston, Texas

Prepared by
R.T. Hicks Consultants, Ltd.
Albuquerque, New Mexico

Site Name: Dagger State Unit #003	Site Type: Produced water transfer line
Date Release Discovered: 02/06/2020	API# 30-025-36595

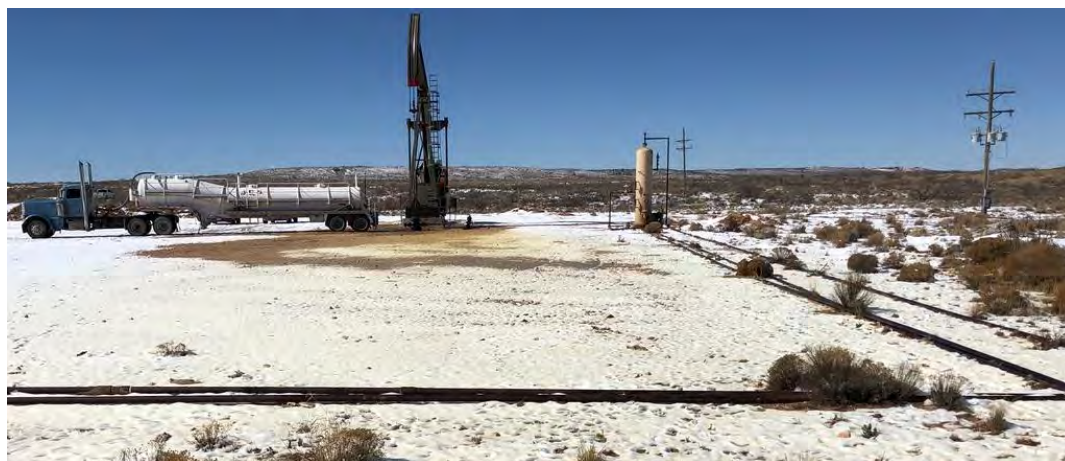
Figure 1: Photograph viewing west from the east edge of the production pad. The release extent is visible as outlined by the melted snow (photo center). Date/Time: 02/06/2020. GPS: 32.4624139 N, 103.6146778 W.

The release occurred on February 06, 2020, resulting from failure of the wellhead stuffing box. The release included produced water and crude oil. The area of saturation and pooling areas remained on the active production pad (Plate 1 and Figure 1). The release consisted of 17 barrels; 11 barrels were recovered. The majority of the release was recovered from within the wellhead cellar.

The production pad was scraped within the release area on February 10th. Excavation of impacted soil caused by the release began on February 24, 2020. Excavated material was transported to an approved disposal facility.

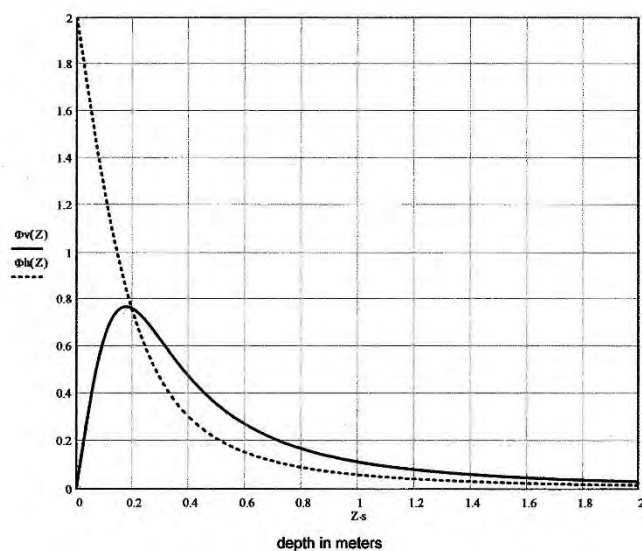
Figure 2a: 0.5-meter coil separation. Relative sensitivity with depth. Dashed line horizontal dipole mode. Solid line vertical dipole mode.

The difference in sensitivity ranges in the two coil configurations and dipole modes is important; the horizontal dipole mode will be relatively sensitive to variations near surface whereas the vertical dipole mode will be insensitive near the surface and sensitive at greater depths. This difference in sensitivity allows for a quick method for determining whether the near surface soil is more conductive (higher chloride concentration) than soils at depth, where

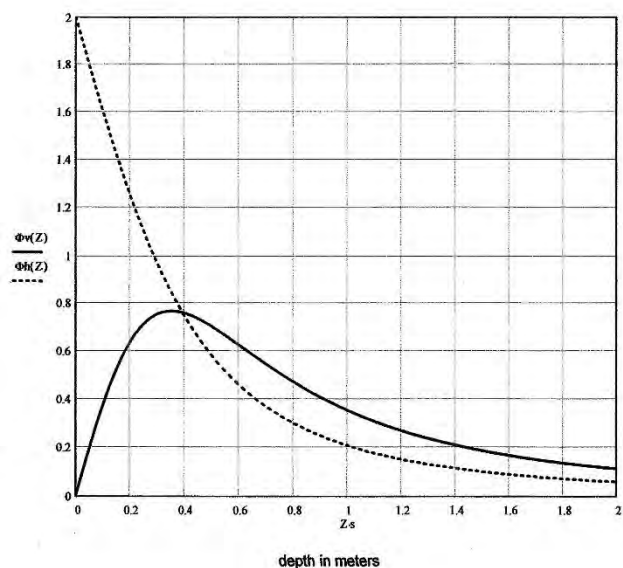
Figure 2b: 1.0-meter coil separation. Relative sensitivity with depth. Dashed line horizontal dipole mode. Solid line vertical dipole mode.

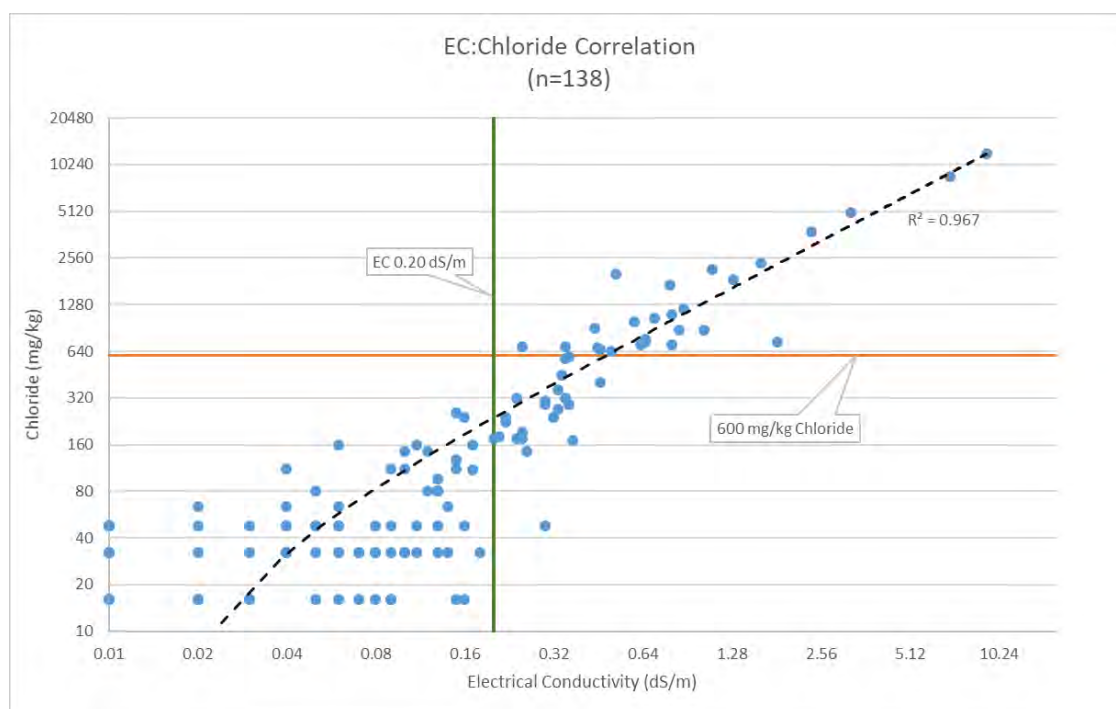
Figure 3: EC_{1:5} vs Chloride. Soil samples with an EC_{1:5} < 0.2 dS/m are likely to exhibit chloride concentrations below 600 mg/kg.

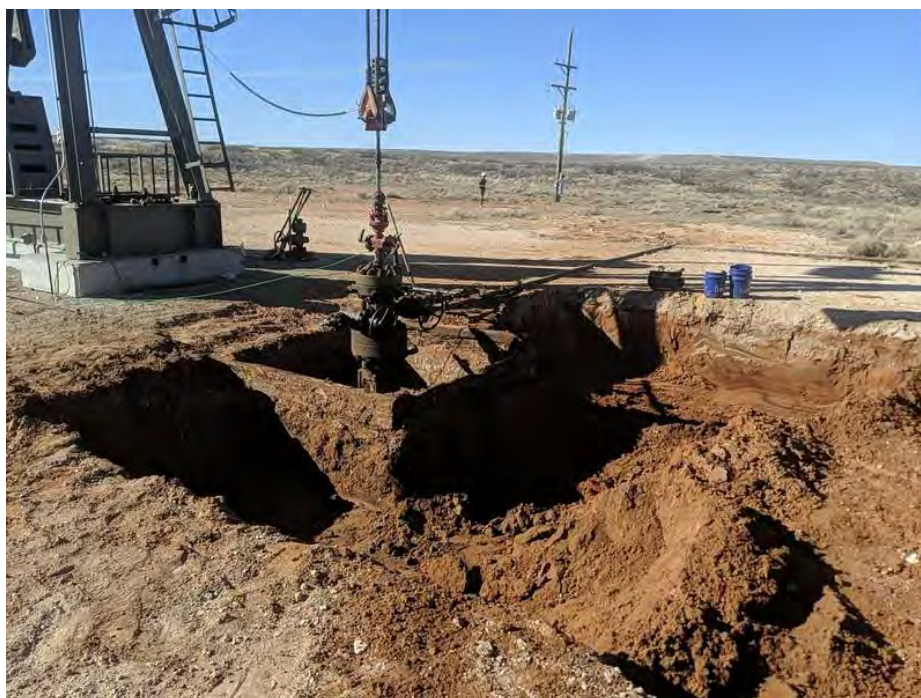
Excavation of the base and walls in the upper 4-feet continued until field screening of electrical conductivity (EC_{1.5}) was less than 0.2 to 0.3 dS/m (Figure 4). As shown previously in Figure 3, EC < 0.2 dS/m correlates with a chloride concentration <600 mg/kg.

Figure 4: Field screening for electrical conductivity (EC) during excavation.
Date 02/24/2020. GPS: 32.4623308 N, 103.6152389 W

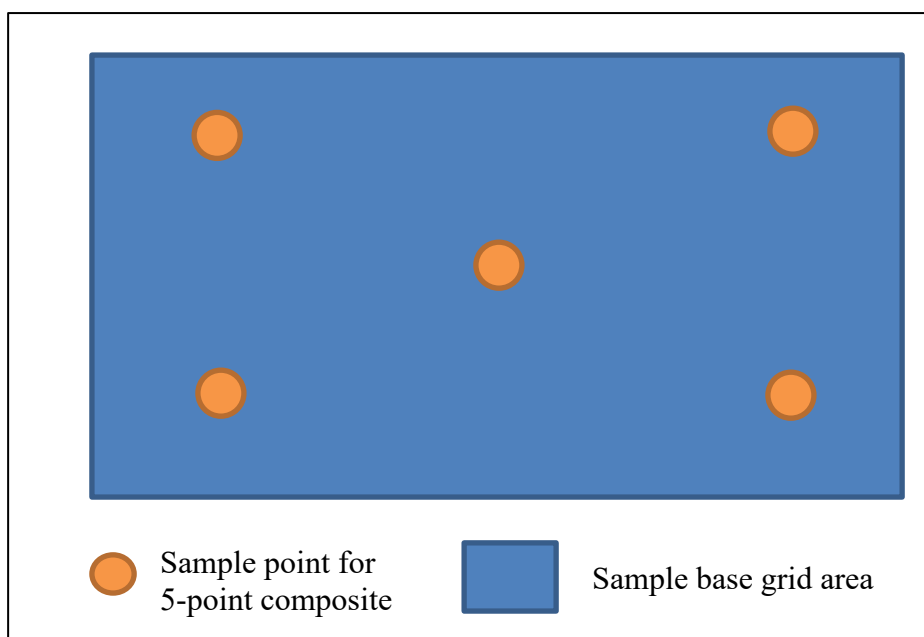
Plate 14 shows the sampling diagram for base samples. A 5-point composite sample was collected from each grid for confirmation sampling. Five-point composite sample points were evenly spaced within each sample grid to obtain a representative sample of the area (Figure 5, below example).

Figure 5: Example of 5-point sample grid for composite sampling.

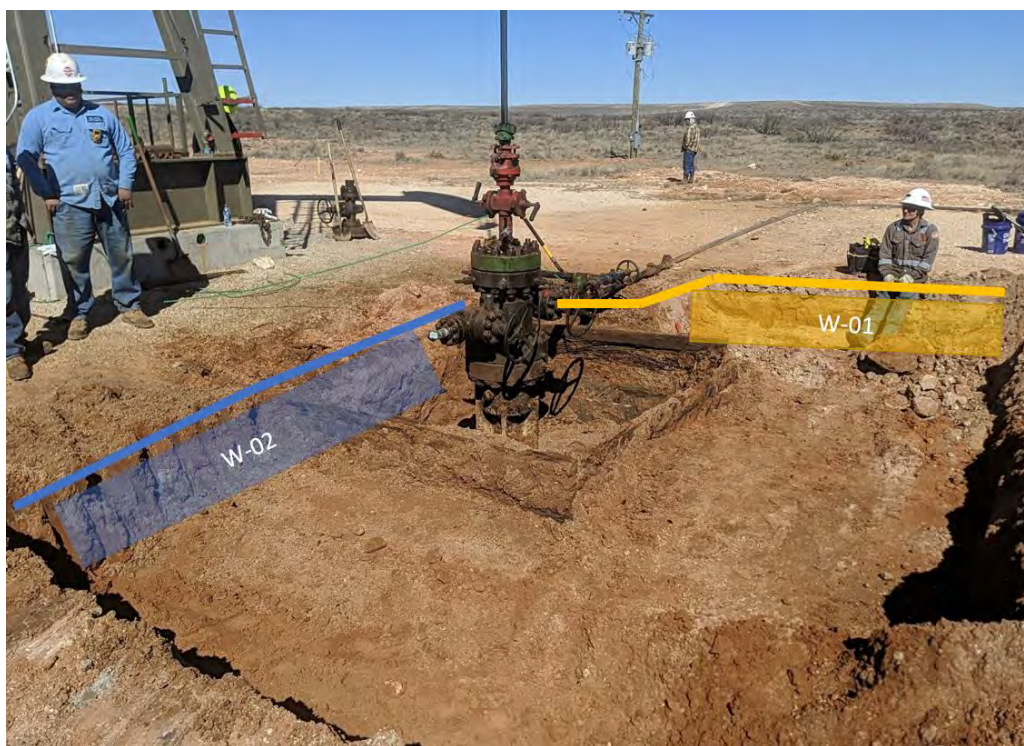
The wellhead cellar base and Wall W-02 (Figure 6) is located around production equipment (wellhead and pump jack). Therefore, we ask NMOCD for deferment of these areas.

Figure 6: Photograph of wellhead and pump jack (production equipment), viewing northwest along base sample grid B-01. Wall grid extents are shown by the blue and yellow lines that are subject of deferment. Date/Time: 02/24/2020. GPS: 32.4623628 N,103.6152844 W.

Final remediation and reclamation shall take place in accordance with 19.15.29.12 and 19.15.29.13 NMAC after production equipment is decommissioned and is no longer used for oil and gas operations.

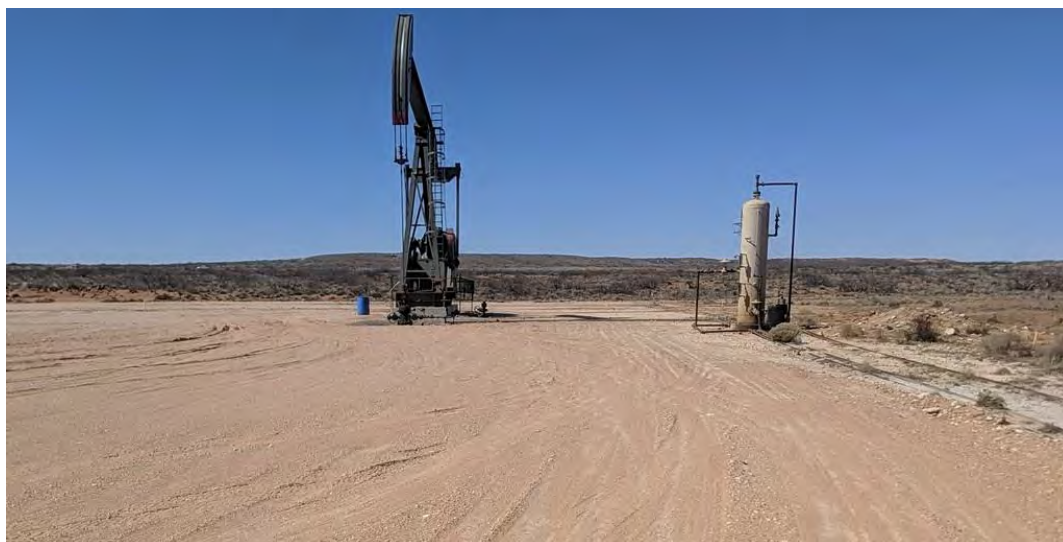
Excavated material was transported to an approved disposal facility. Clean backfill material was purchased from Merchant Livestock under a surface use agreement. Figure 7 shows the restored surface.

Figure 7: Restored production pad. Date: 02/28/2020 GPS: 32.4624347 N,103.6149031 W

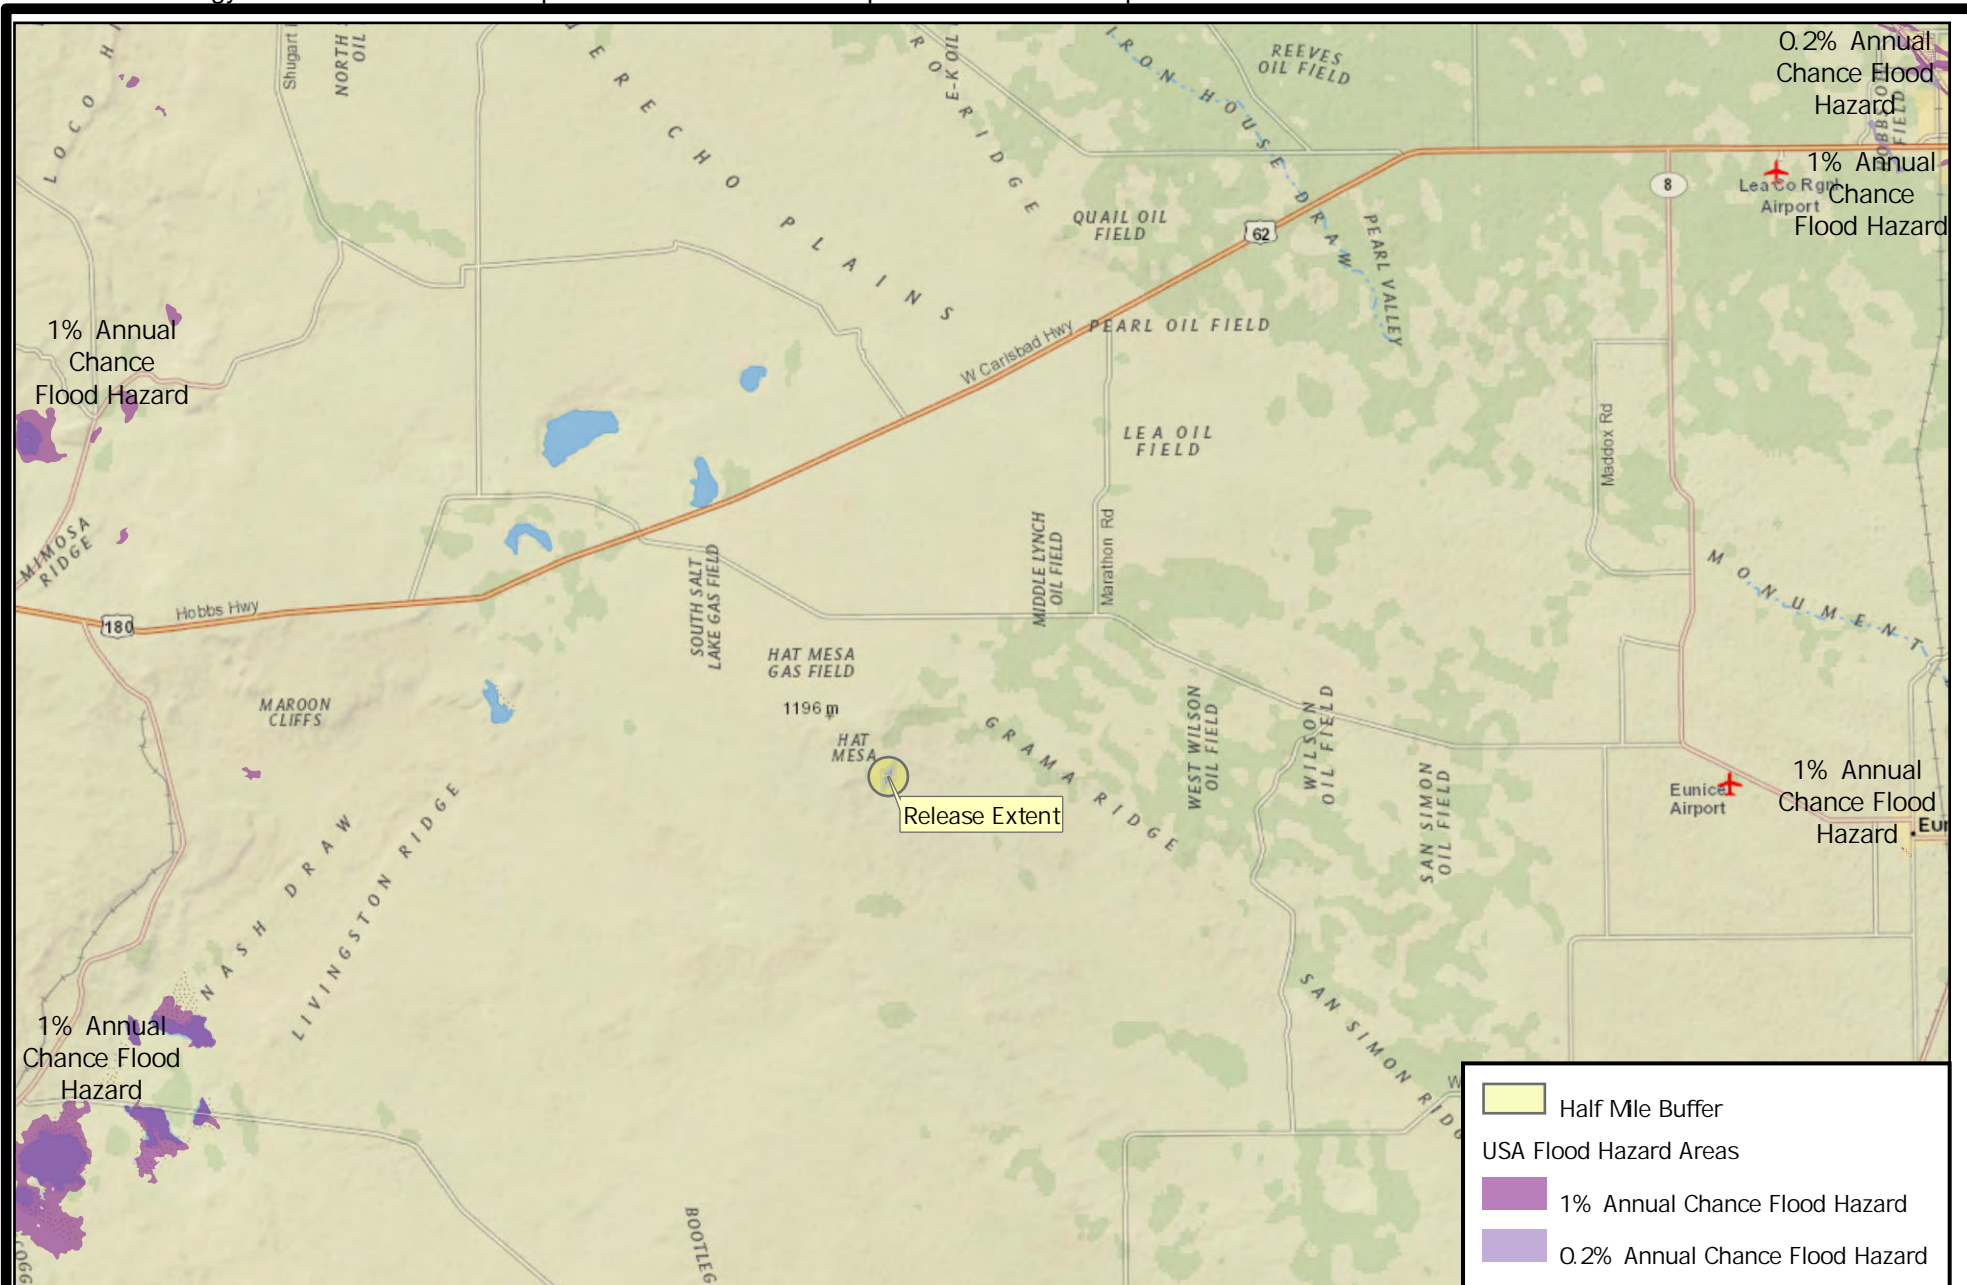
Plate 13
04/07/2020

Flood Hazards (FEMA)
Advance Energy Partners Hat Mesa
DSU 3 02062020
