Site Name	PLU 15 TWR PLU C1 FRAC Pond	Site Type	Well Location
Date Release Discovered	11/19/2019	API# (if applicable)	30-015-29847 (Poker Lake 139)

**RE: Closure Request  
PLU 15 TWR PLU C1 FRAC Pond  
Incident Number NCE2002857417  
Eddy County, New Mexico**

LT Environmental, Inc. (LTE), on behalf of XTO Energy, Inc. (XTO), presents the following Closure Request detailing site assessment and soil sampling activities at the PLU TWR PLU C1 Frac Pond (Site) in Unit J, Section 24, Township 24 South, Range 30 East, in Eddy County, New Mexico (Figure 1). The purpose of the site assessment and soil sampling activities was to confirm the presence or absence of impacts to soil following the release of mixed recycled and fresh water at the Site. Based on field observations, field screening, and laboratory analytical results from soil sampling activities, XTO is submitting this Closure Request and requesting no further action (NFA) for Incident Number NCE2002857417.

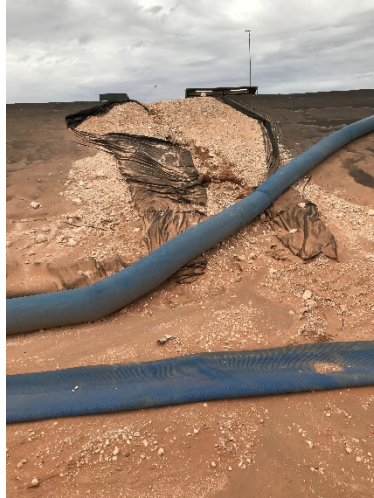
**Photograph 1:** View of hole in containment lining on east side of Frac Pond.

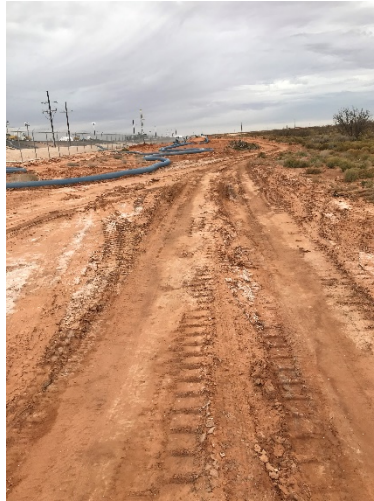
**Photograph 2:** View north of off-pad spill extent.

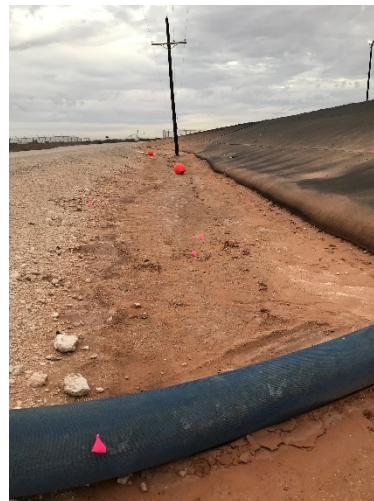
**Photograph 3:** View of on-pad spill extent facing south.

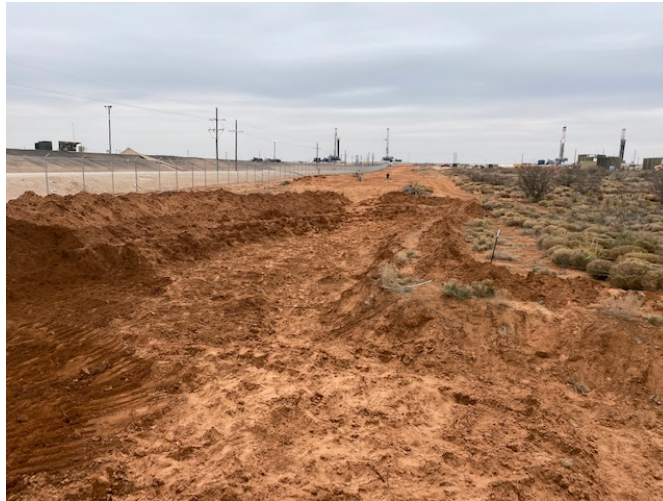
**Photograph 4:** View of northern half of off-pad excavation facing north.

Excavation of waste-containing soil was completed between January 22 and January 24, 2020. To direct excavation activities, LTE screened soil for volatile aromatic hydrocarbons and chloride. Following removal of waste containing soil in the pasture, LTE collected 5-point composite soil samples every 200 square feet from the sidewalls and floor of the excavation. The 5-point composite samples were collected by depositing five aliquots of soil into a 1-gallon, resealable plastic bag and homogenizing the samples by thoroughly mixing. Composite soil samples SW01 through SW13 were collected from the sidewalls of the excavation from depths ranging from ground surface to approximately 4 feet bgs. Composite soil samples FS01 through FS17 were collected from the floor of the excavation at depths ranging from approximately 1 foot to 4 feet bgs. The excavation soil samples were collected, handled and analyzed for chloride as described above and submitted to Xenco in Carlsbad, New Mexico. Photographic documentation was conducted during the Site visit. Photographs are included in Attachment 1.

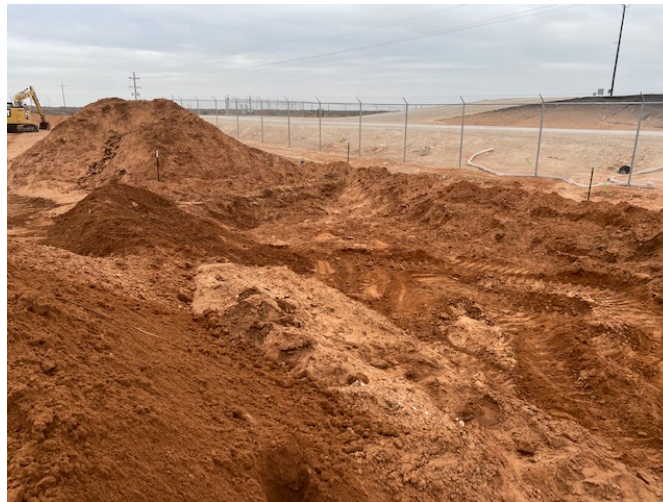
**Photograph 5:** View of southern half of off-pad excavation facing southwest.

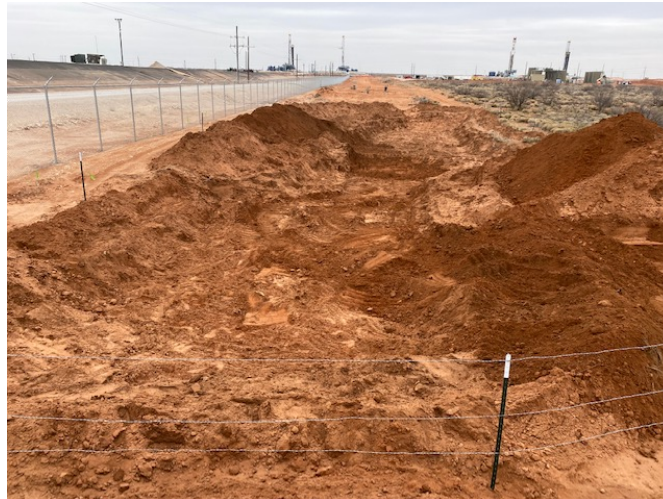
**Photograph 6:** View of off-pad excavation from the southernmost point.
