## Release Notification

Based on laboratory analytical results and field activities conducted to date, Etech recommends COG Operating, LLC provide copies of this Remediation Summary and Deferral Request to the appropriate agencies and request partial closure be granted to the Red Raider BKS St. #001 Site.

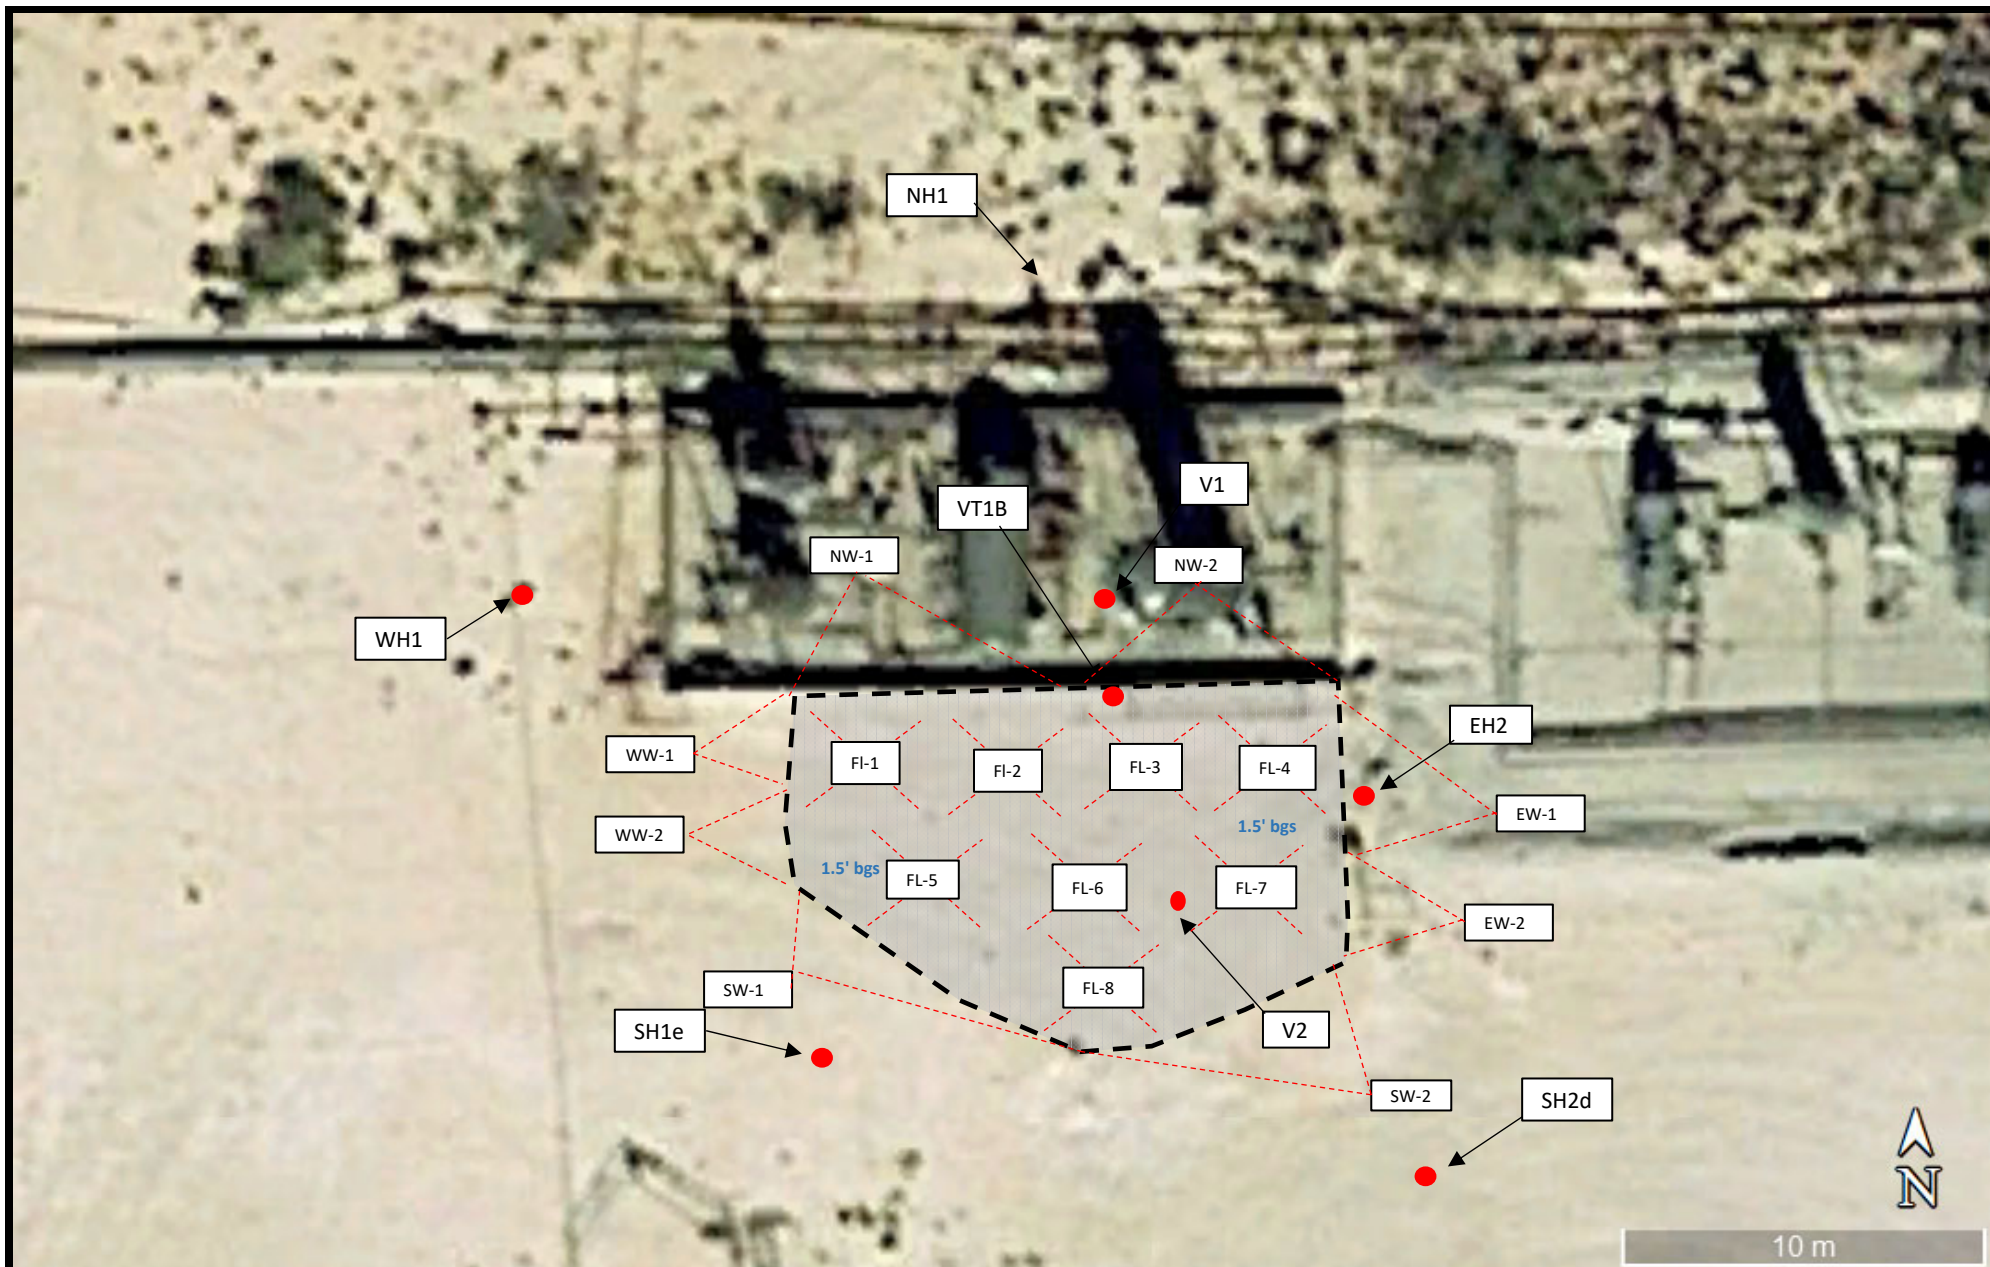
### **Figure 3**

### **Site and Sample Location Map**

- Delineation Sample Point
- SW-2 Confirmation Sample Location
- Excavated Area

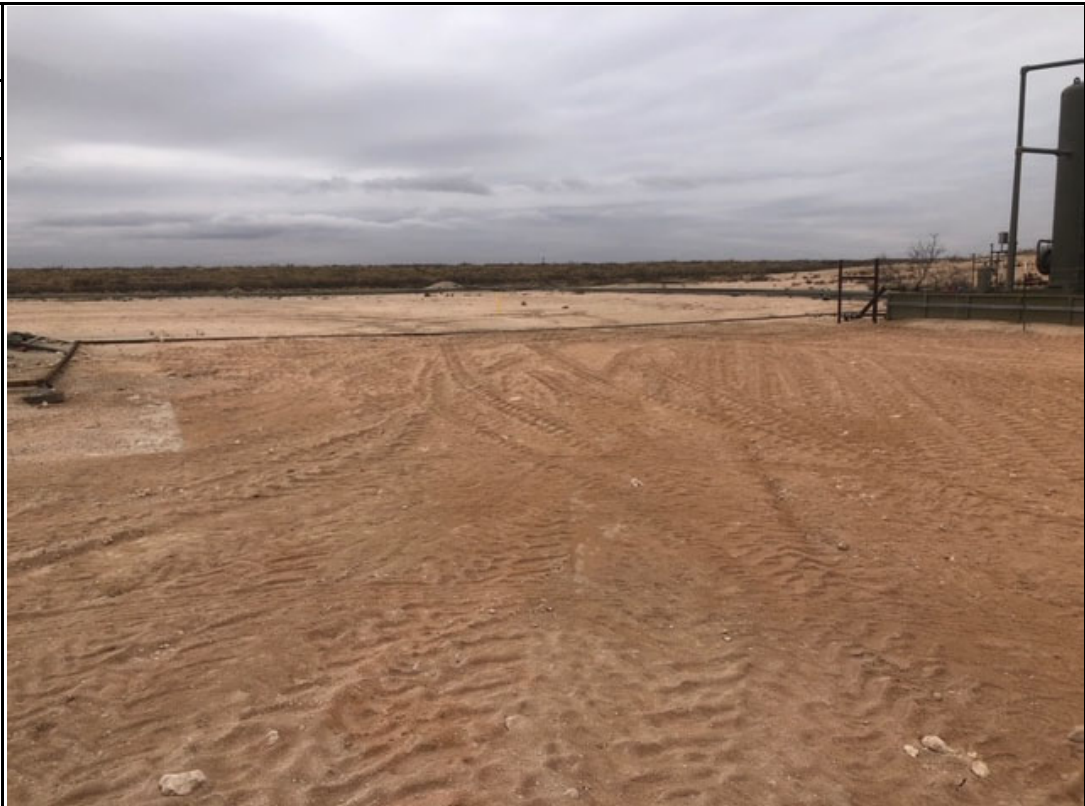
<b>Photo Number:</b> 6

<b>Photo Direction:</b> West	
<b>Photo Description:</b> View of the affected area after remediation activities.
