Release Notification

Site Name	Poker Lake Unit 213 SWD	Site Type	SWD
Date Release Discovered	01-28-20	API# (if applicable)	30-015-33859 (Poker Lake Unit #213)

**RE: Closure Request
Poker Lake Unit 213 SWD
Incident Number: NRM2004446696
Eddy County, New Mexico**

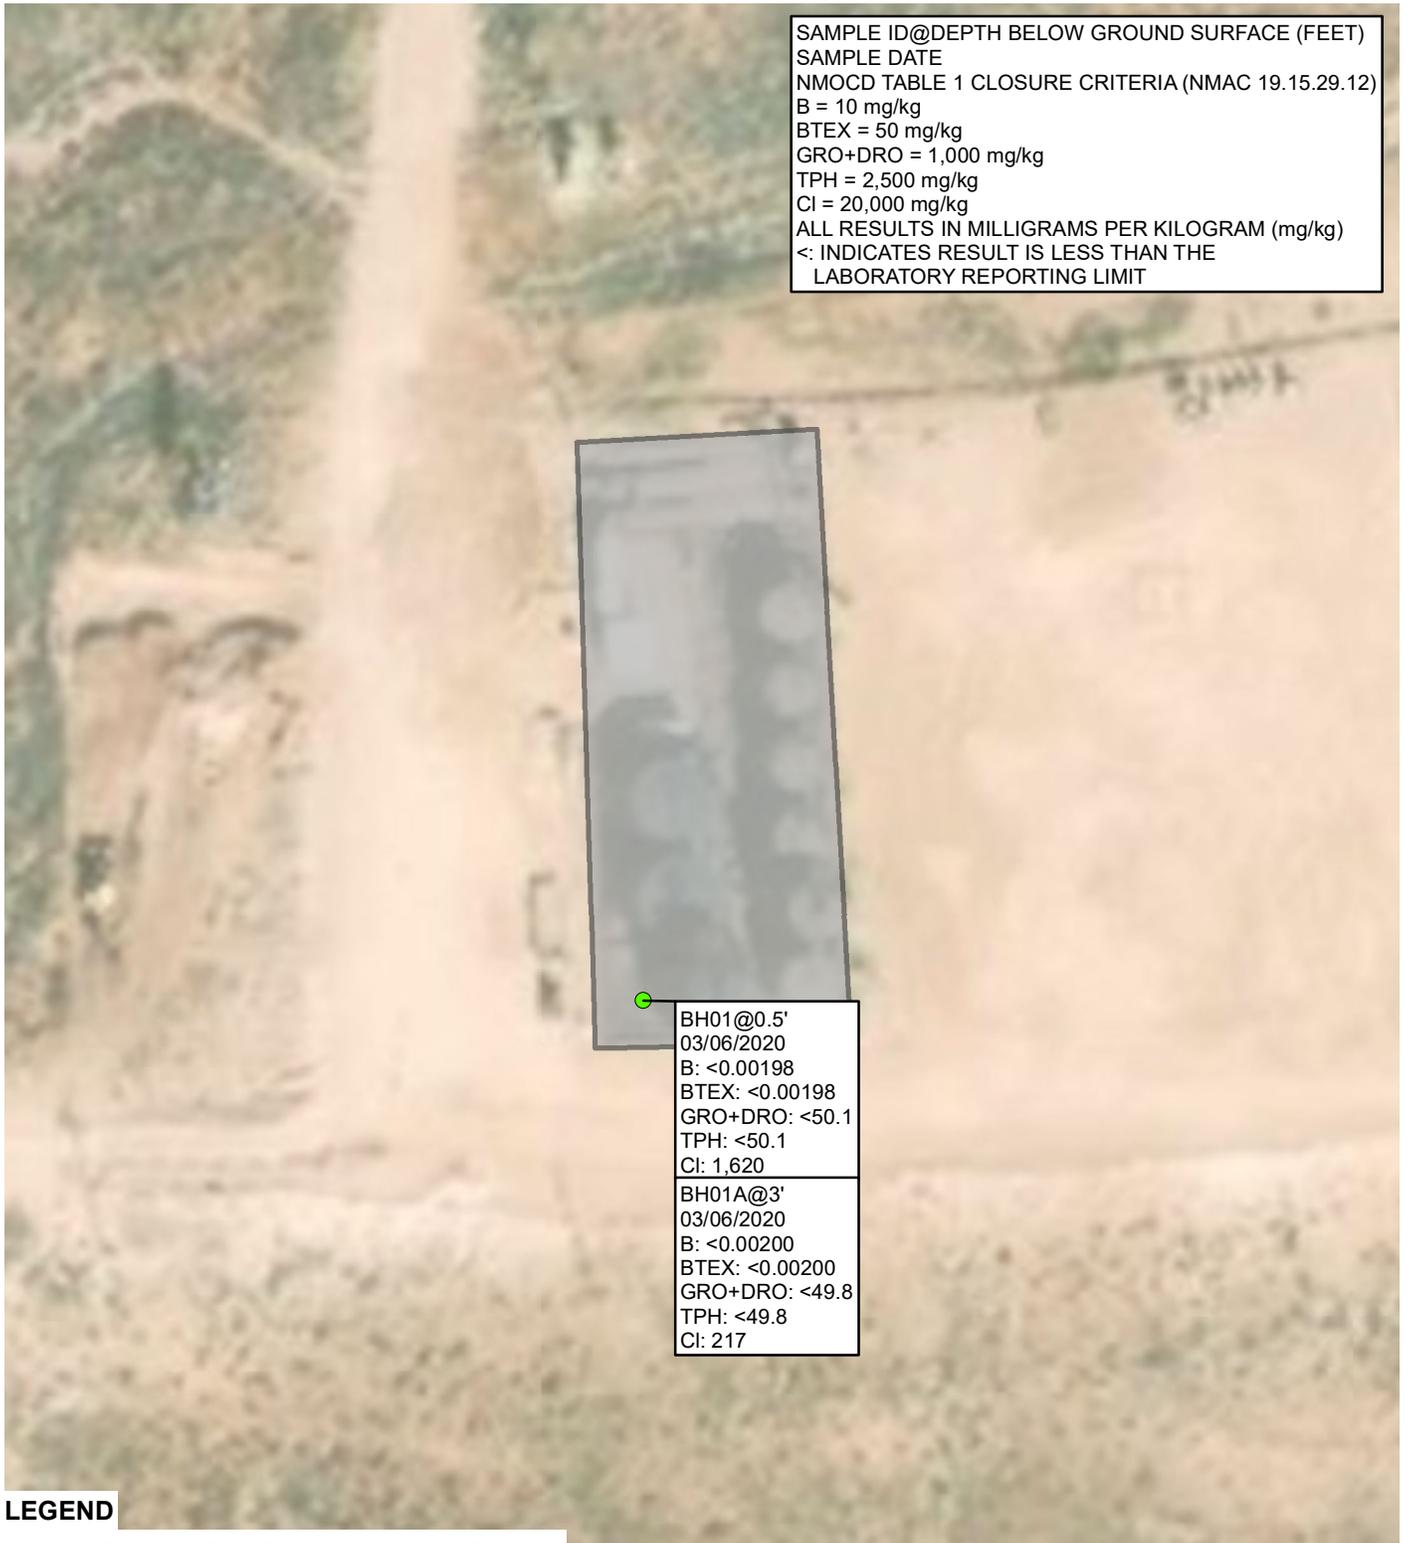
FIGURE 2
 DELINEATION SOIL SAMPLE LOCATIONS
 POKER LAKE UNIT 213 SWD
 UNIT P SEC 18 T24S R30E
 EDDY COUNTY, NEW MEXICO
XTO ENERGY, INC.

is depicted on Figure 2. Photographic documentation was conducted during the Site visit. The photographic log is included in Attachment 2.

BH01A@0.5'
 03/06/2020
 B: <0.00198
 BTEX: <0.00198
 GRO+DRO: <50.1
 TPH: <50.1
 Cl: 1,620

BH01A@3'
 03/06/2020
 B: <0.00200
 BTEX: <0.00200
 GRO+DRO: <49.8
 TPH: <49.8
 Cl: 217

Following the failed liner integrity inspection, LTE personnel advanced one borehole in the location of the hole in the compromised liner. Delineation soil samples BH01 and BH01A were collected from within the lined tank battery containment at depths of approximately 0.5 feet and 3 feet bgs to assess for the presence or absence of soil impacts as a result of the January 28, 2020 produced water release. Laboratory analytical results indicated benzene, BTEX, TPH-GRO and TPH-DRO, TPH, and chloride concentrations were compliant with the Closure Criteria in soil samples BH01 and BH01A. The liner was subsequently repaired. As such, XTO respectfully requests NFA for Incident Number NRM2004446696.

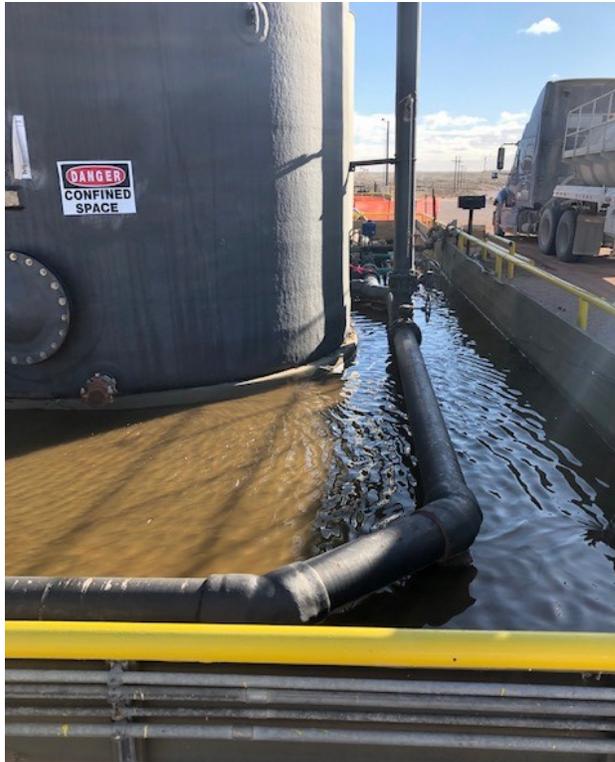
On January 28, 2020, an 8-inch fiberglass line separated, resulting in the release of 140 barrels (bbls) of produced water inside a poly-lined tank battery containment. A vacuum truck was immediately dispatched to the Site to recover freestanding fluids, of which approximately 140 bbls of produced water were recovered. XTO reported the release to the New Mexico Oil Conservation Division (NMOCD) on a Release Notification and Corrective Action Form C-141 (Form C-141) on February 11, 2020. A 48-hour advance notice of liner inspection was provided via email to NMOCD District 2 and, upon inspection, the liner was determined to be insufficient.

Photograph 1: View of release collecting inside liner.

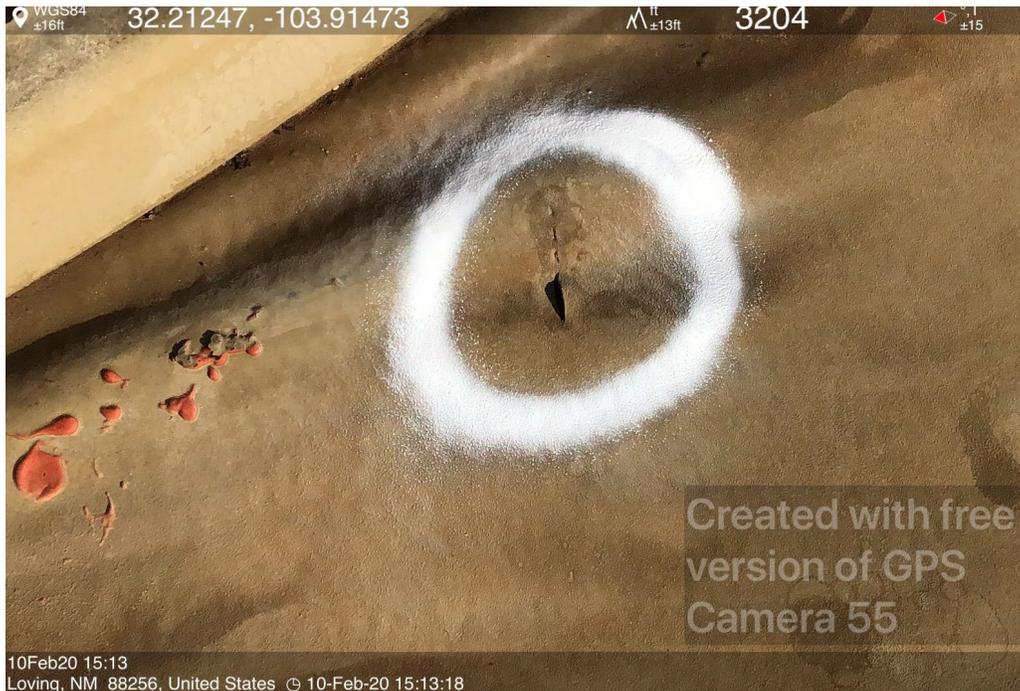
On March 6, 2020, LTE evaluated the release based on information provided on the Form C-141 and visual observations. LTE personnel advanced a borehole via hand-auger at one location within the tank battery containment, located on the southwest edge of the caliche well pad. Site assessment activities and vertical delineation soil sampling was completed at the location of the tear in the liner found during the liner integrity inspection conducted by XTO. Two soil samples were collected at approximately 0.5 feet and 3 feet bgs (BH01 and BH01A, respectively). Soil from the discrete borehole soil samples was field screened for volatile aromatic hydrocarbons and chloride utilizing a calibrated photo-ionization detector (PID) and Hach® chloride QuanTab® test strips, respectively. Field screening results and observations for each sample were documented on a lithologic/soil sampling log and are included as Attachment 1. The borehole was backfilled with the soil removed and XTO repaired the liner. The borehole delineation soil sample location

Photograph 2: View of delineation soil sample BH01 location.
