SITE CHARACTERIZATION AND CLOSURE REPORT

DEVON ENERGY CORPORATION
IRONHOUSE 19 STATE COM #001H
LEA COUNTY, NEW MEXICO
UNIT LETTER "N", SECTION 19, TOWNSHIP 18 SOUTH, RANGE 35 EAST
LATITUDE 32.7266121° N, LONGITUDE 103.499527° W
API NUMBER: 30-025-40676
1RP – 5374

SEPTEMBER 2019

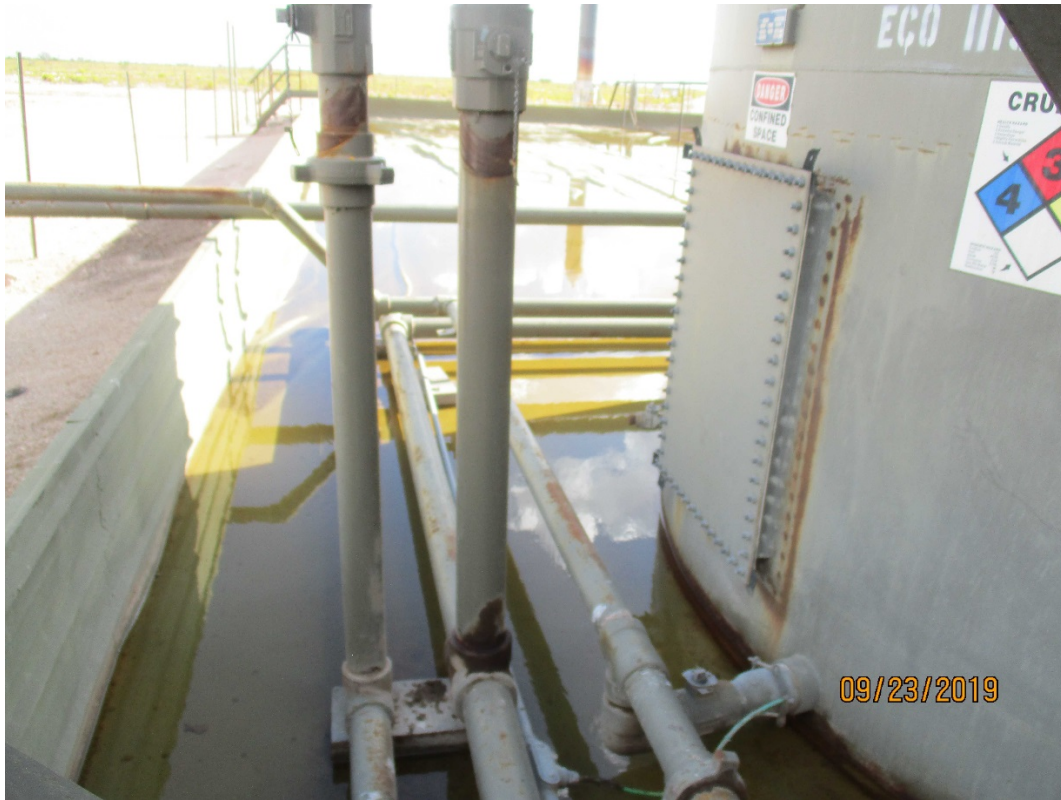
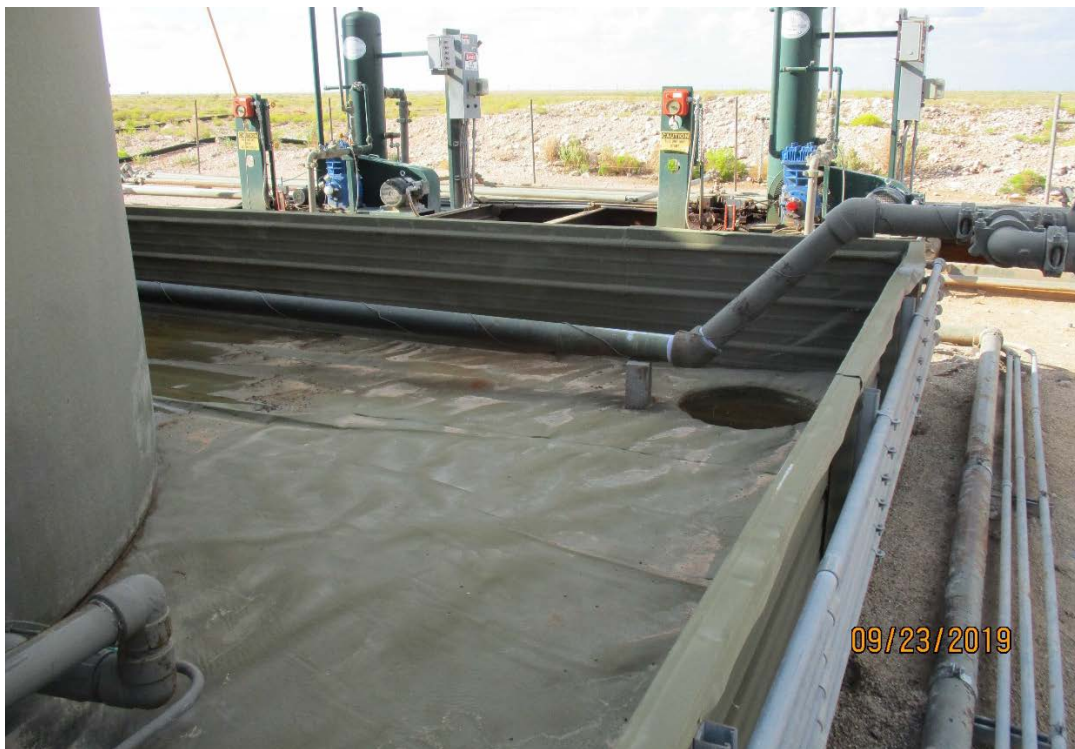
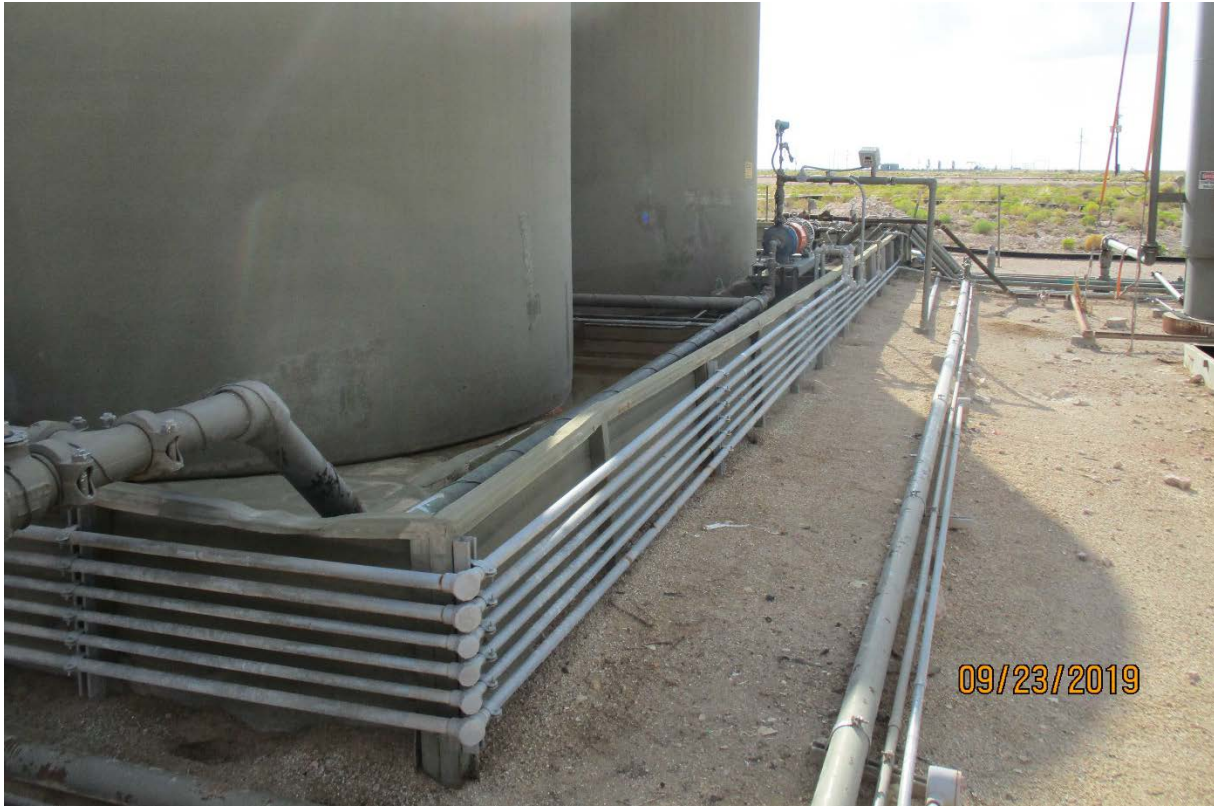
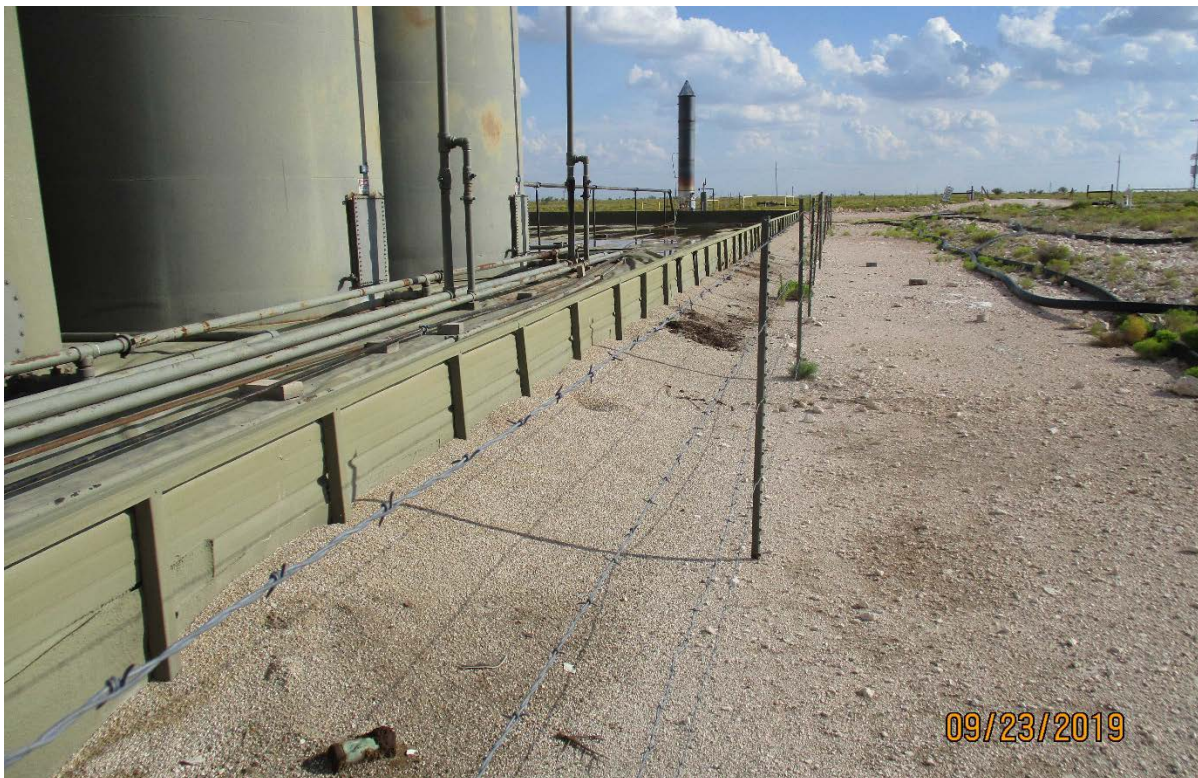
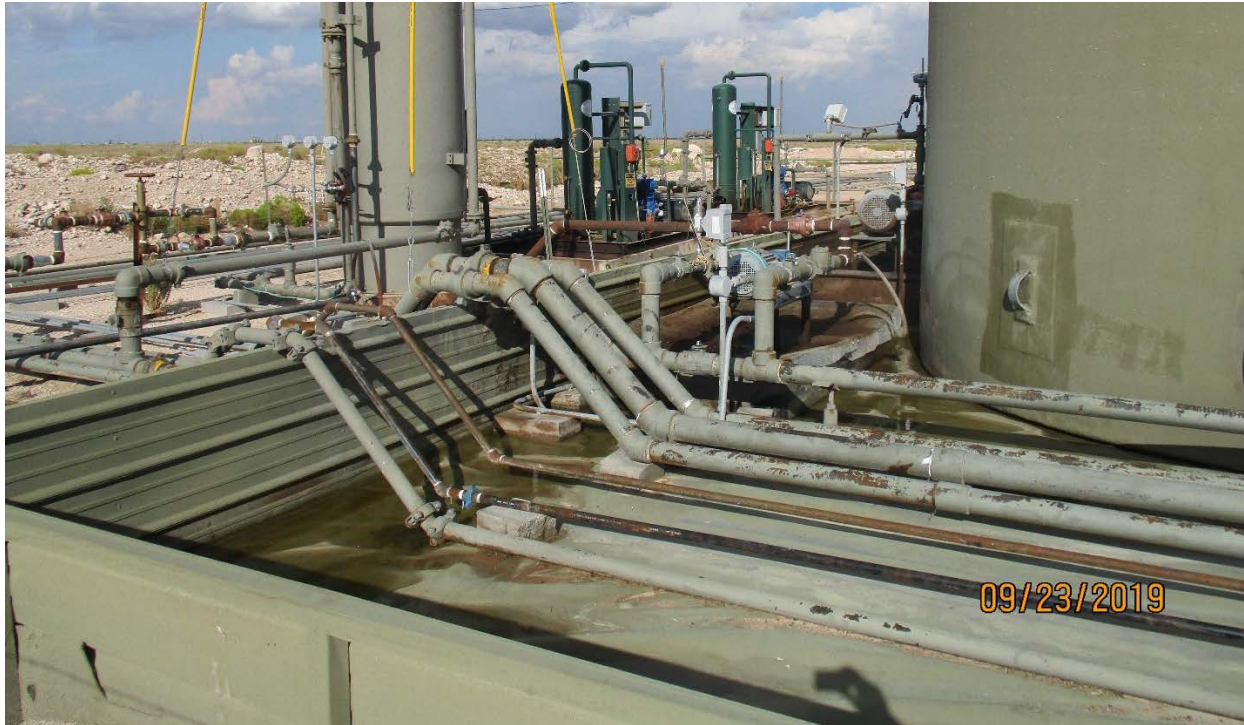
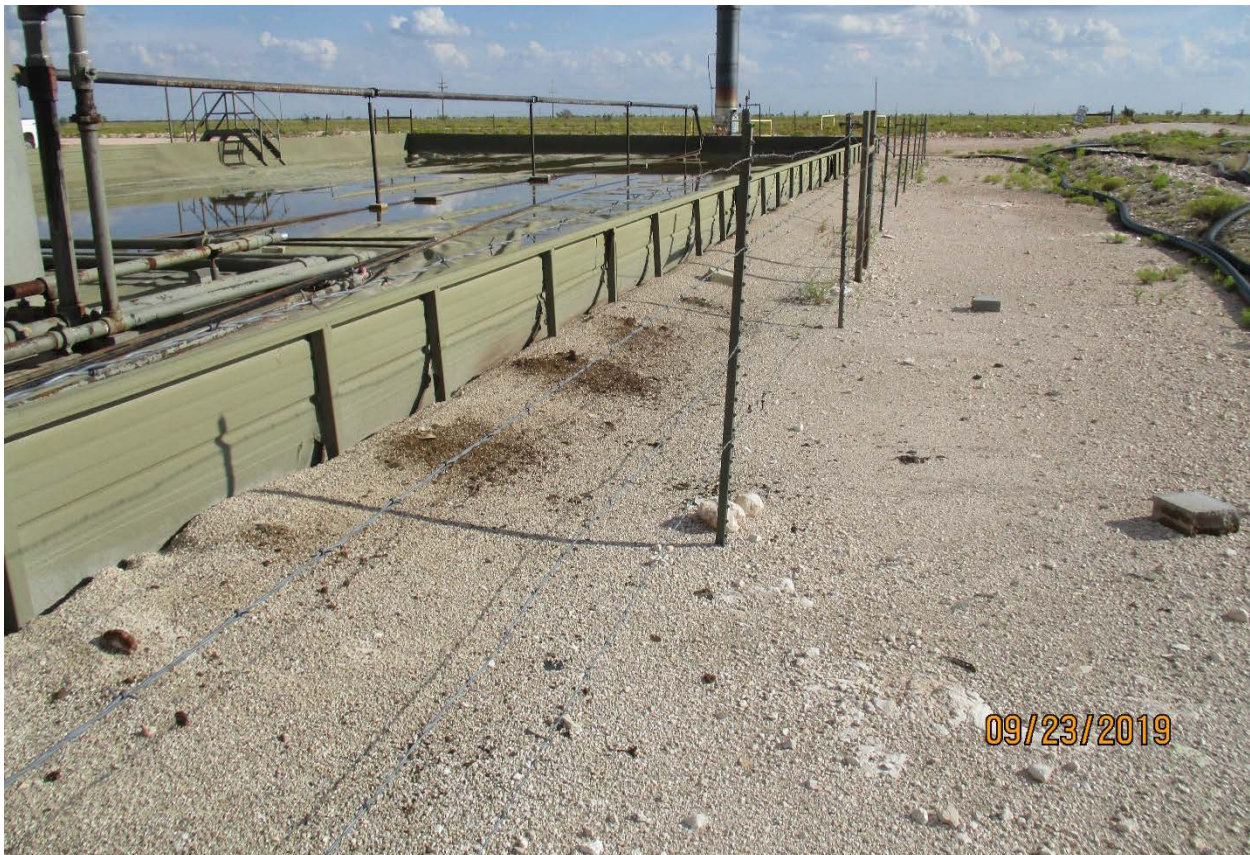
Appendix C: Photographs

HRL conducted a visual liner inspection on September 23, 2019. Following appropriate notice to the NM OCD District I office, the liner was visually inspected for cracks, tears, cuts, and other signs of damage to verify that the liner remained intact and had the ability to contain the release, as required by Subparagraph (a) of Paragraph (5) of Subsection A of 19.15.29.11 NMAC.

The site assessment and liner inspection conducted on September 23, 2019 was conducted under NM OCD guidance found in Subparagraph (a) of Paragraph (5) of Subsection A in 19.15.29.11 NMAC. The inspection confirmed that the spill of February 9, 2019 was contained within the secondary containment and it revealed no damage or integrity issues with the secondary containment liner. Standing rainwater was present in portions of the secondary containment, indicating that the liner integrity was intact. No crude oil was present in the lined secondary containment area at the time of the inspection and there were no indications of adverse conditions on or near the remainder of the site.

Given the location of the spill, the producer's immediate removal of free liquids from the secondary containment following the release, and based on the success of the liner verification, HRL recommends no additional remediation action to address this release. The presence of any contaminants of concern at the site resulting from the above-referenced release are wholly contained within the lined secondary containment and cannot migrate off site. There are no anticipated risks to human, ecological, or hydrological receptors at the Ironhouse 19 location.
