## **Pronghorn SWD #001 Closure Report**

**API No. 30-025-32735  
1RP-5723  
Release Date: 09/13/2019**

**U/L B, Section 24, Township 19S, Range 32E  
Lea County**

**SUBJECT:      Closure Request for Spur Energy Partners – Pronghorn SWD #001  
API No. 30-025-32735  
1RP-5723  
U/L B, Section 24, Township 19S, Range 32E  
Lea County**

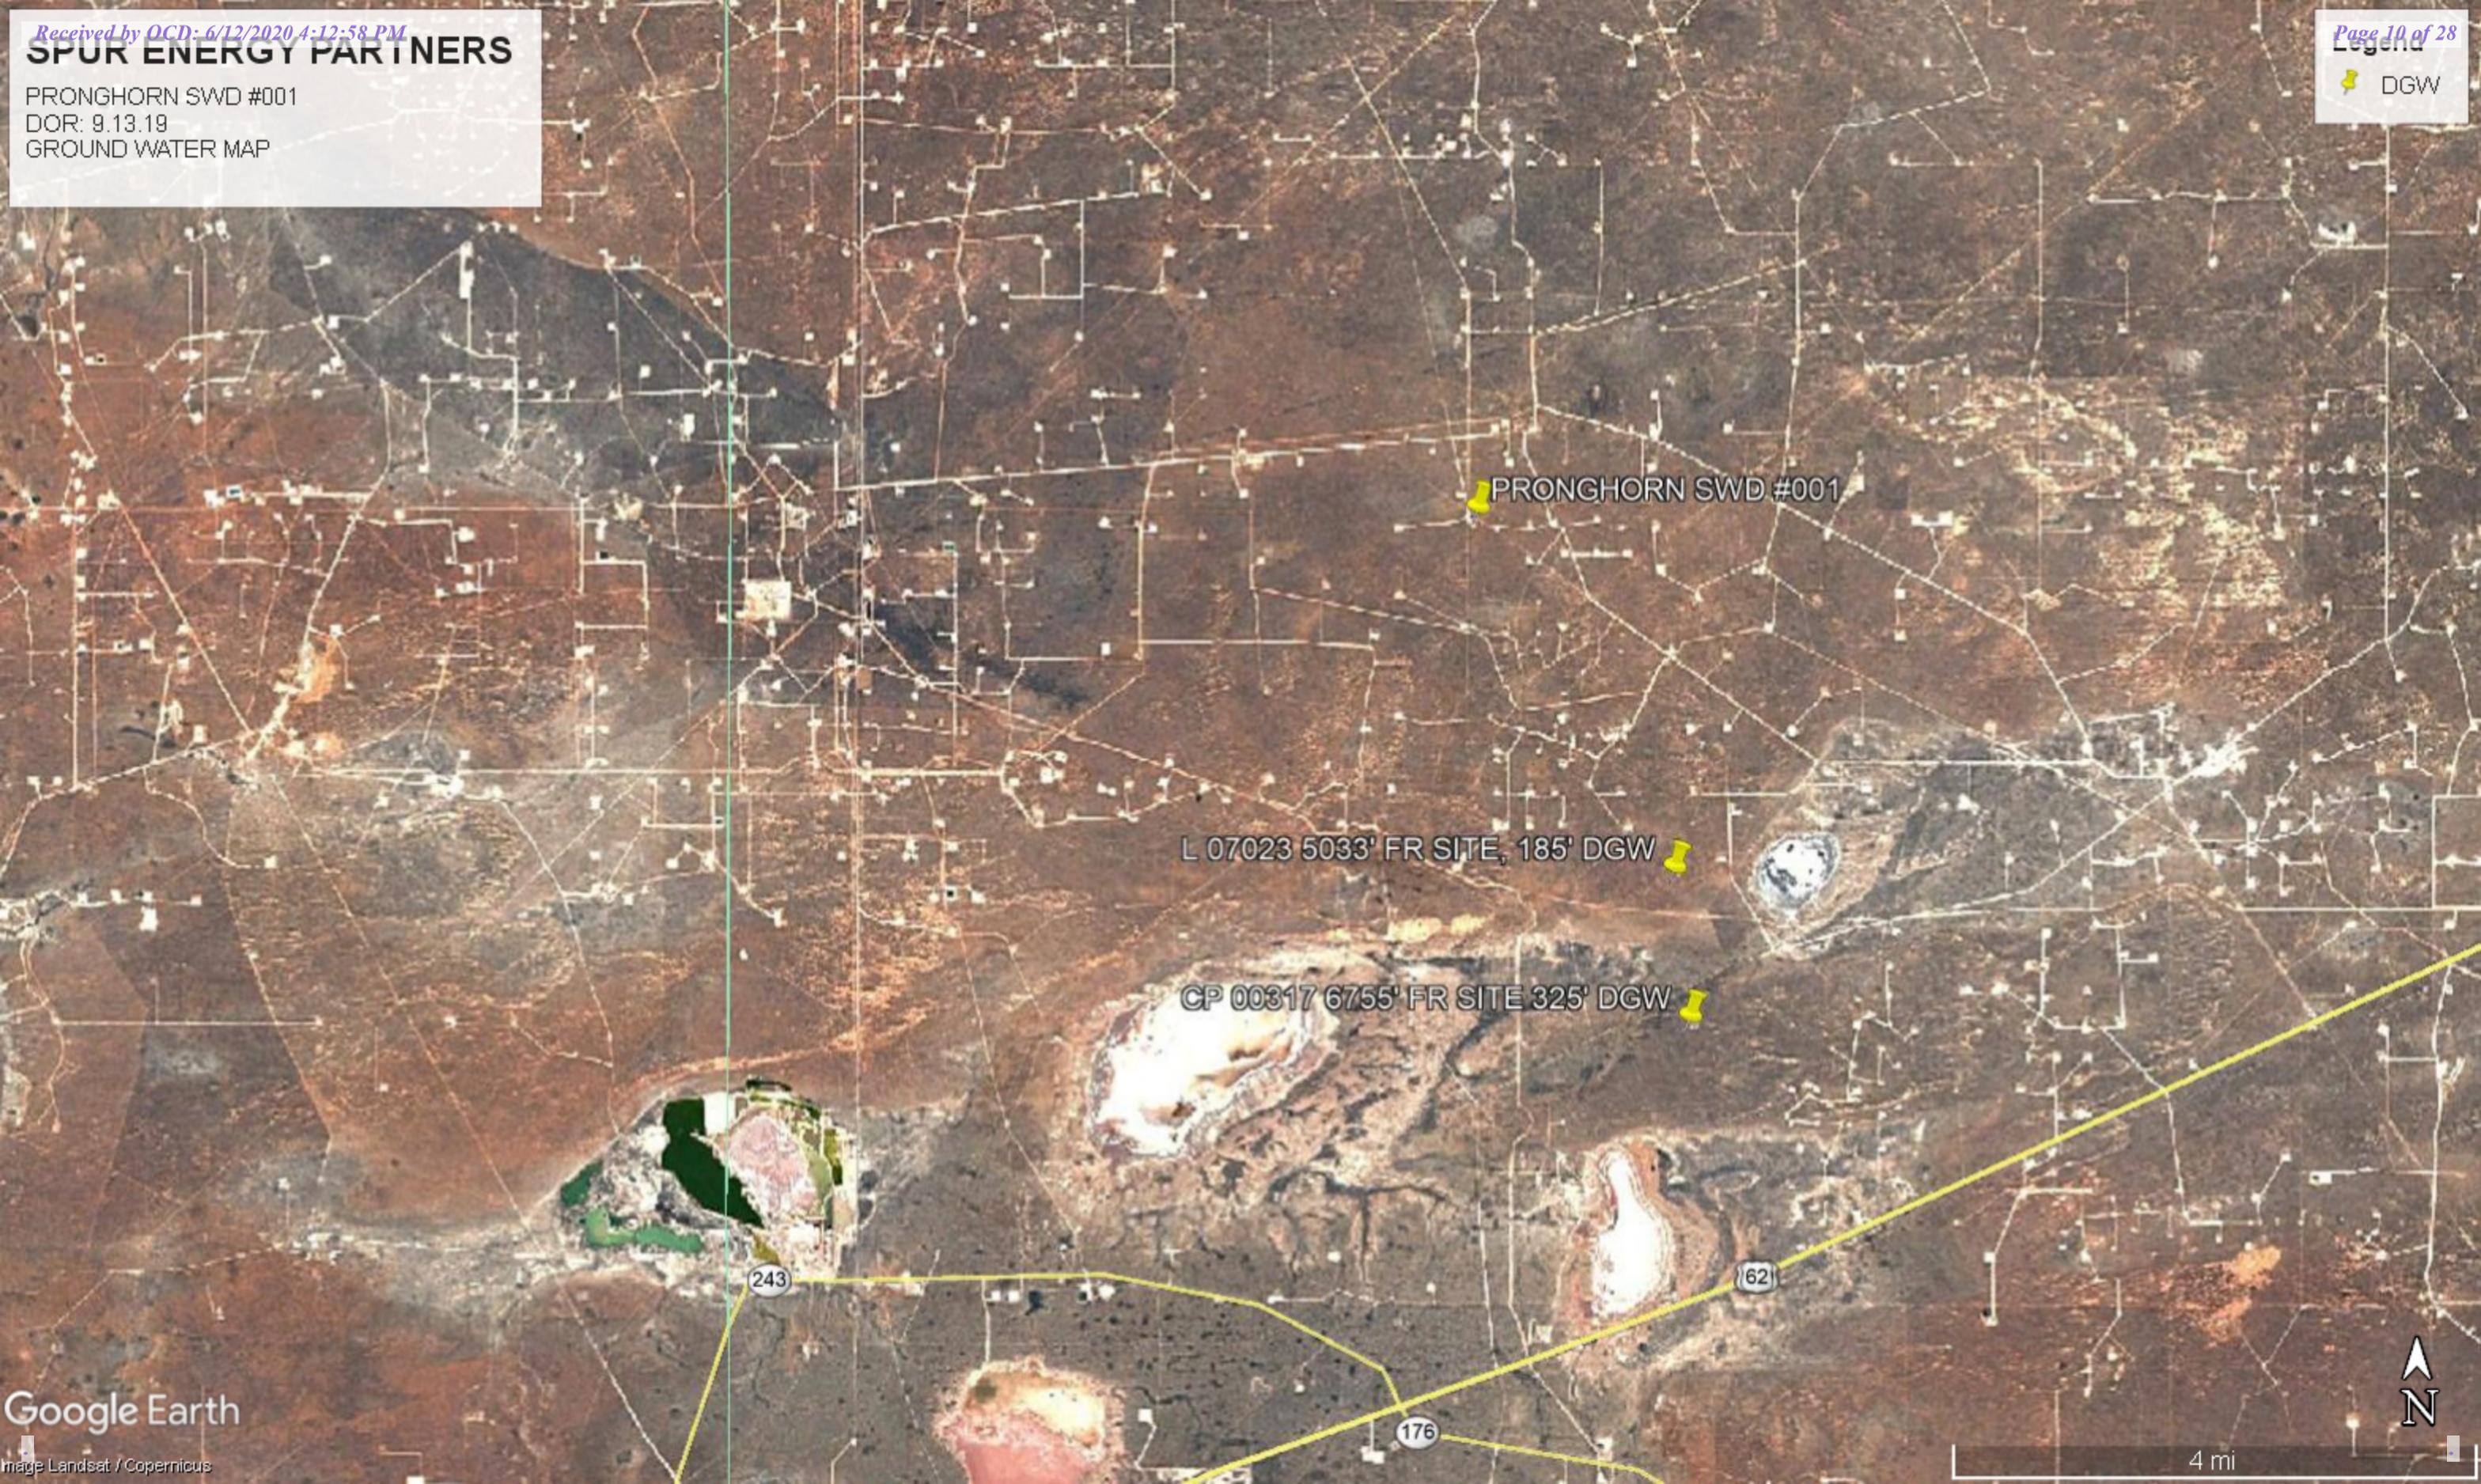
PRONGHORN SWD #001  
DOR: 9.13.19  
GROUND WATER MAP

ESS has conducted a groundwater study of this area. It has been determined that according to the New Mexico Office of the State Engineer that closest well to the site is 5,033' with water depth of 185'bgs (below ground surface). The well is listed below:

L 07023 is 5,033' from the site with water depth at 185'bgs.

The Closure Criteria for Soils Impacted by a Release is shown below, based on ground water of 185'bgs the site falls into the >100' depth category. Please see the groundwater data and map attached.

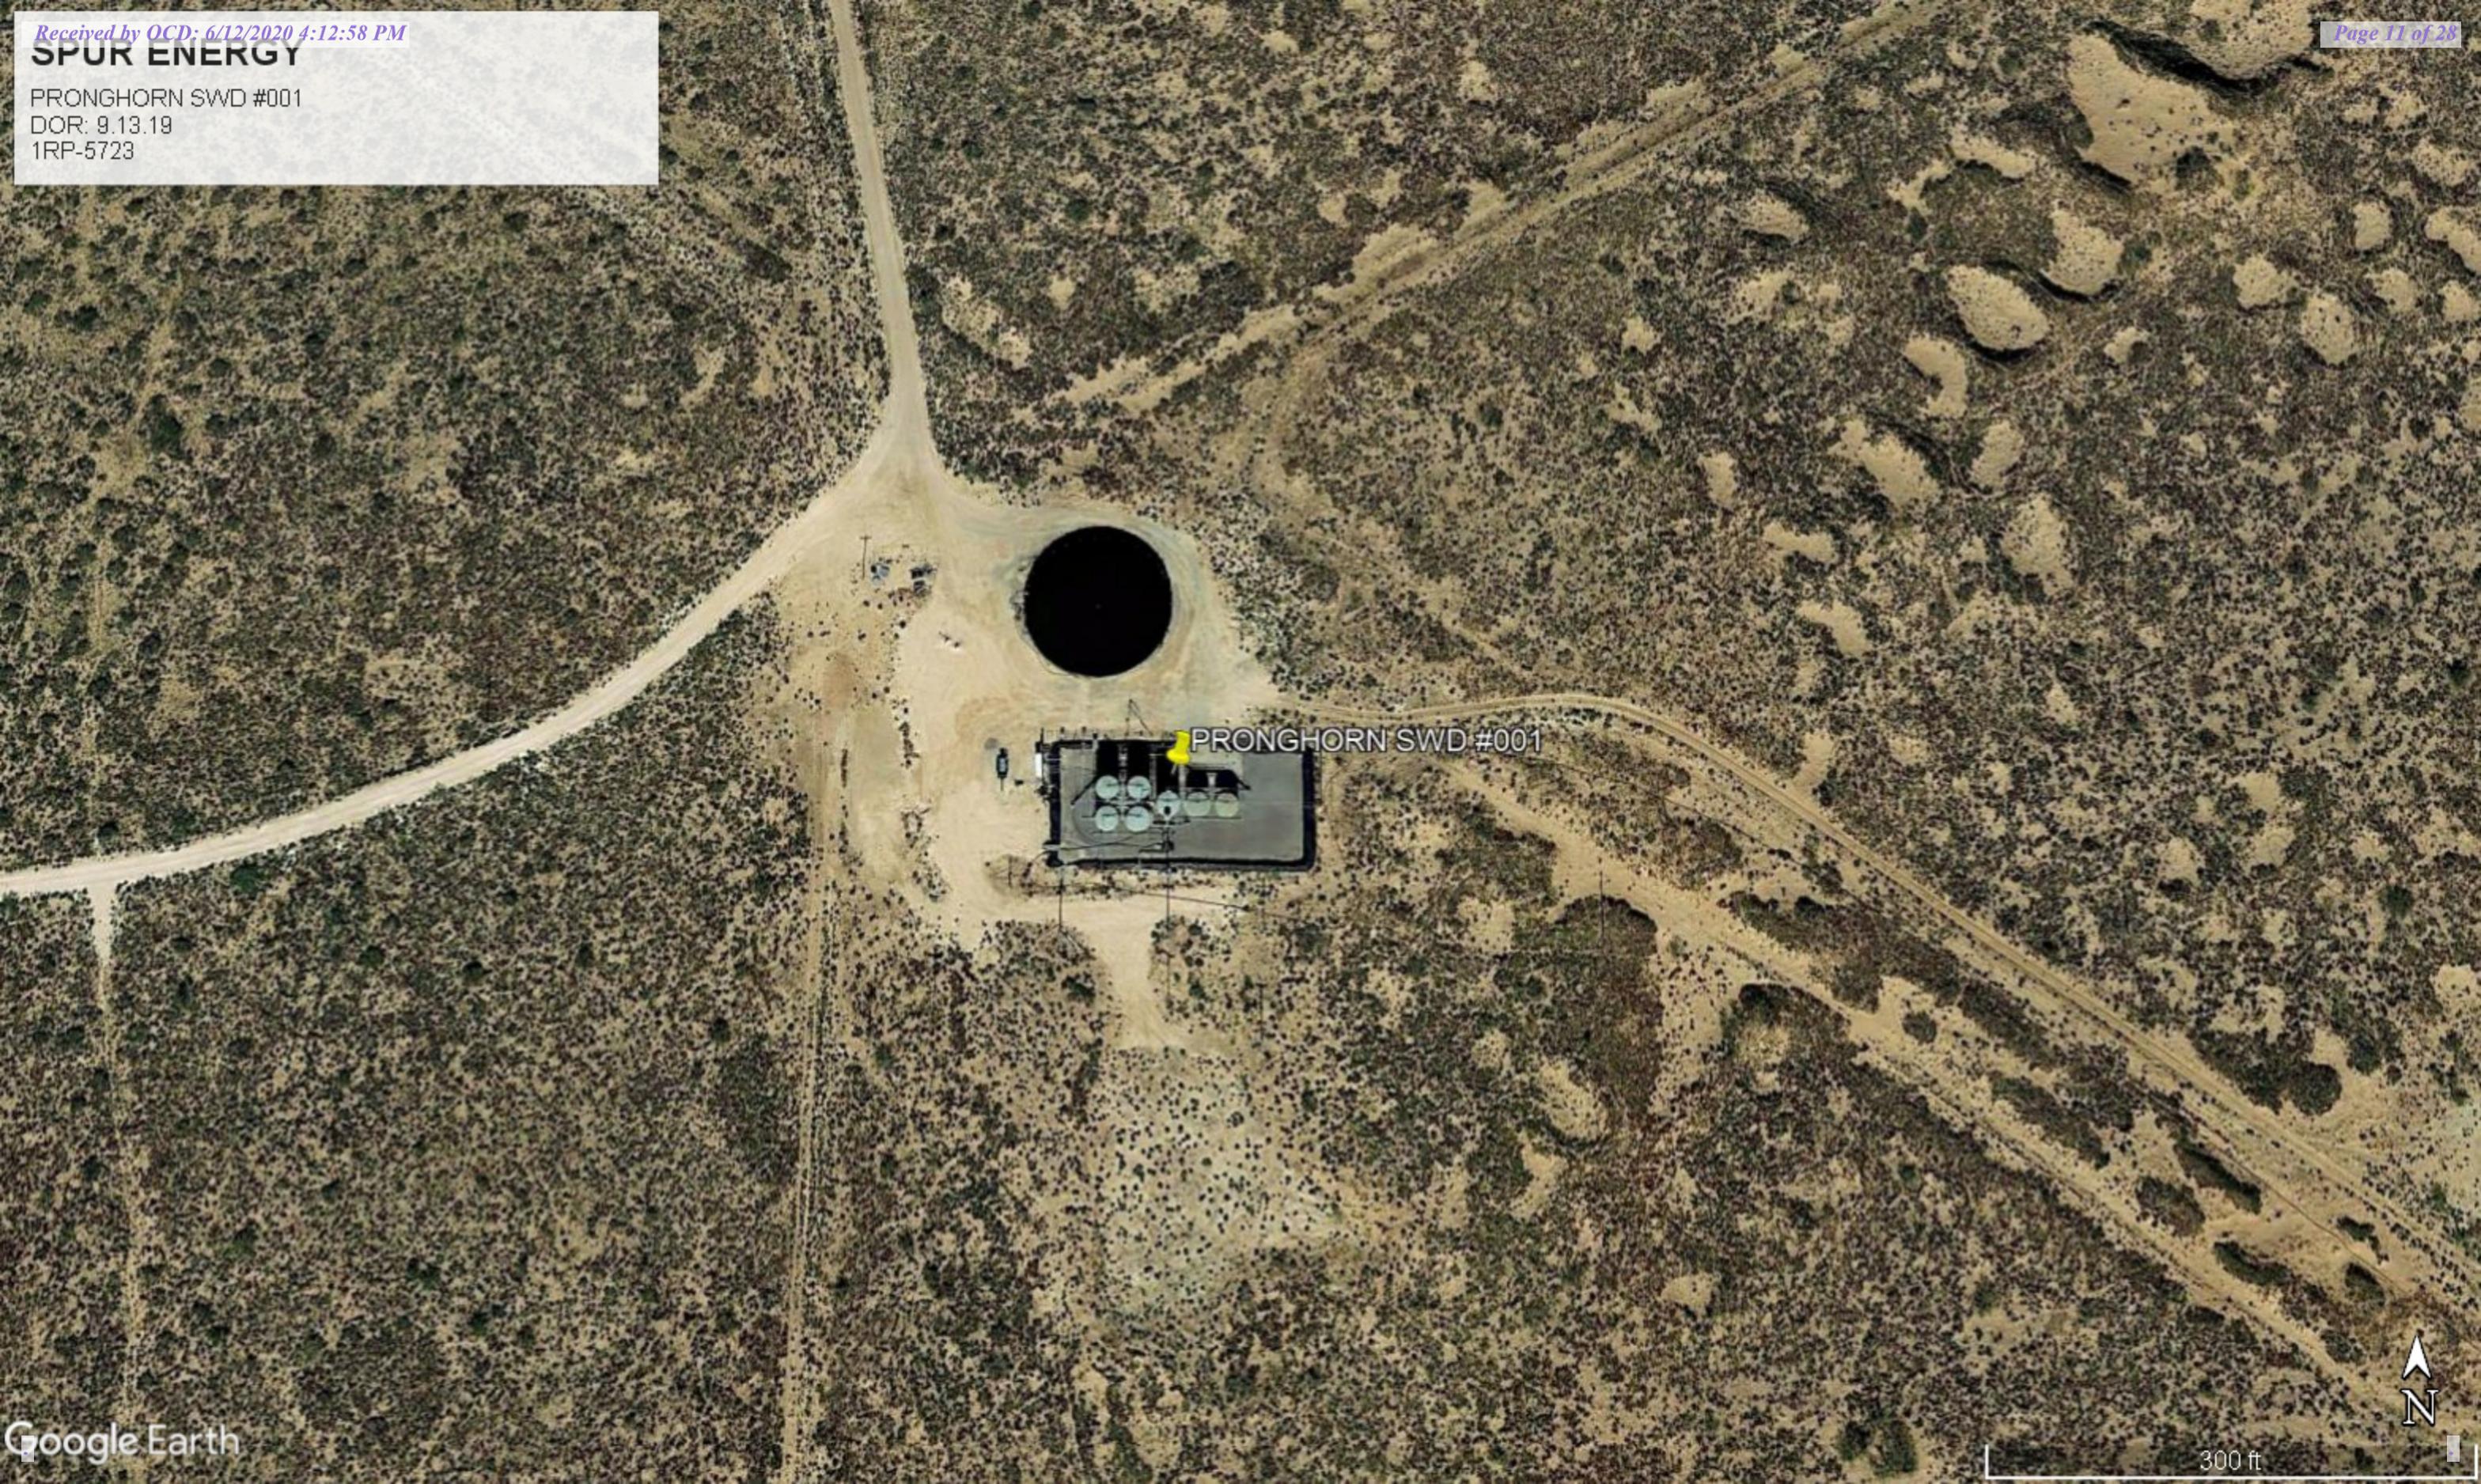
PRONGHORN SWD #001  
DOR: 9.13.19  
1RP-5723

The check valve was replaced. The release was in the lined facility. Approximately 15bbbls of produced water was released. A vacuum truck was dispatched to the facility with an unknown volume recovered. The approved corresponding C-141 for the release is attached. The approximate area of impact was 11,924 sq. ft.

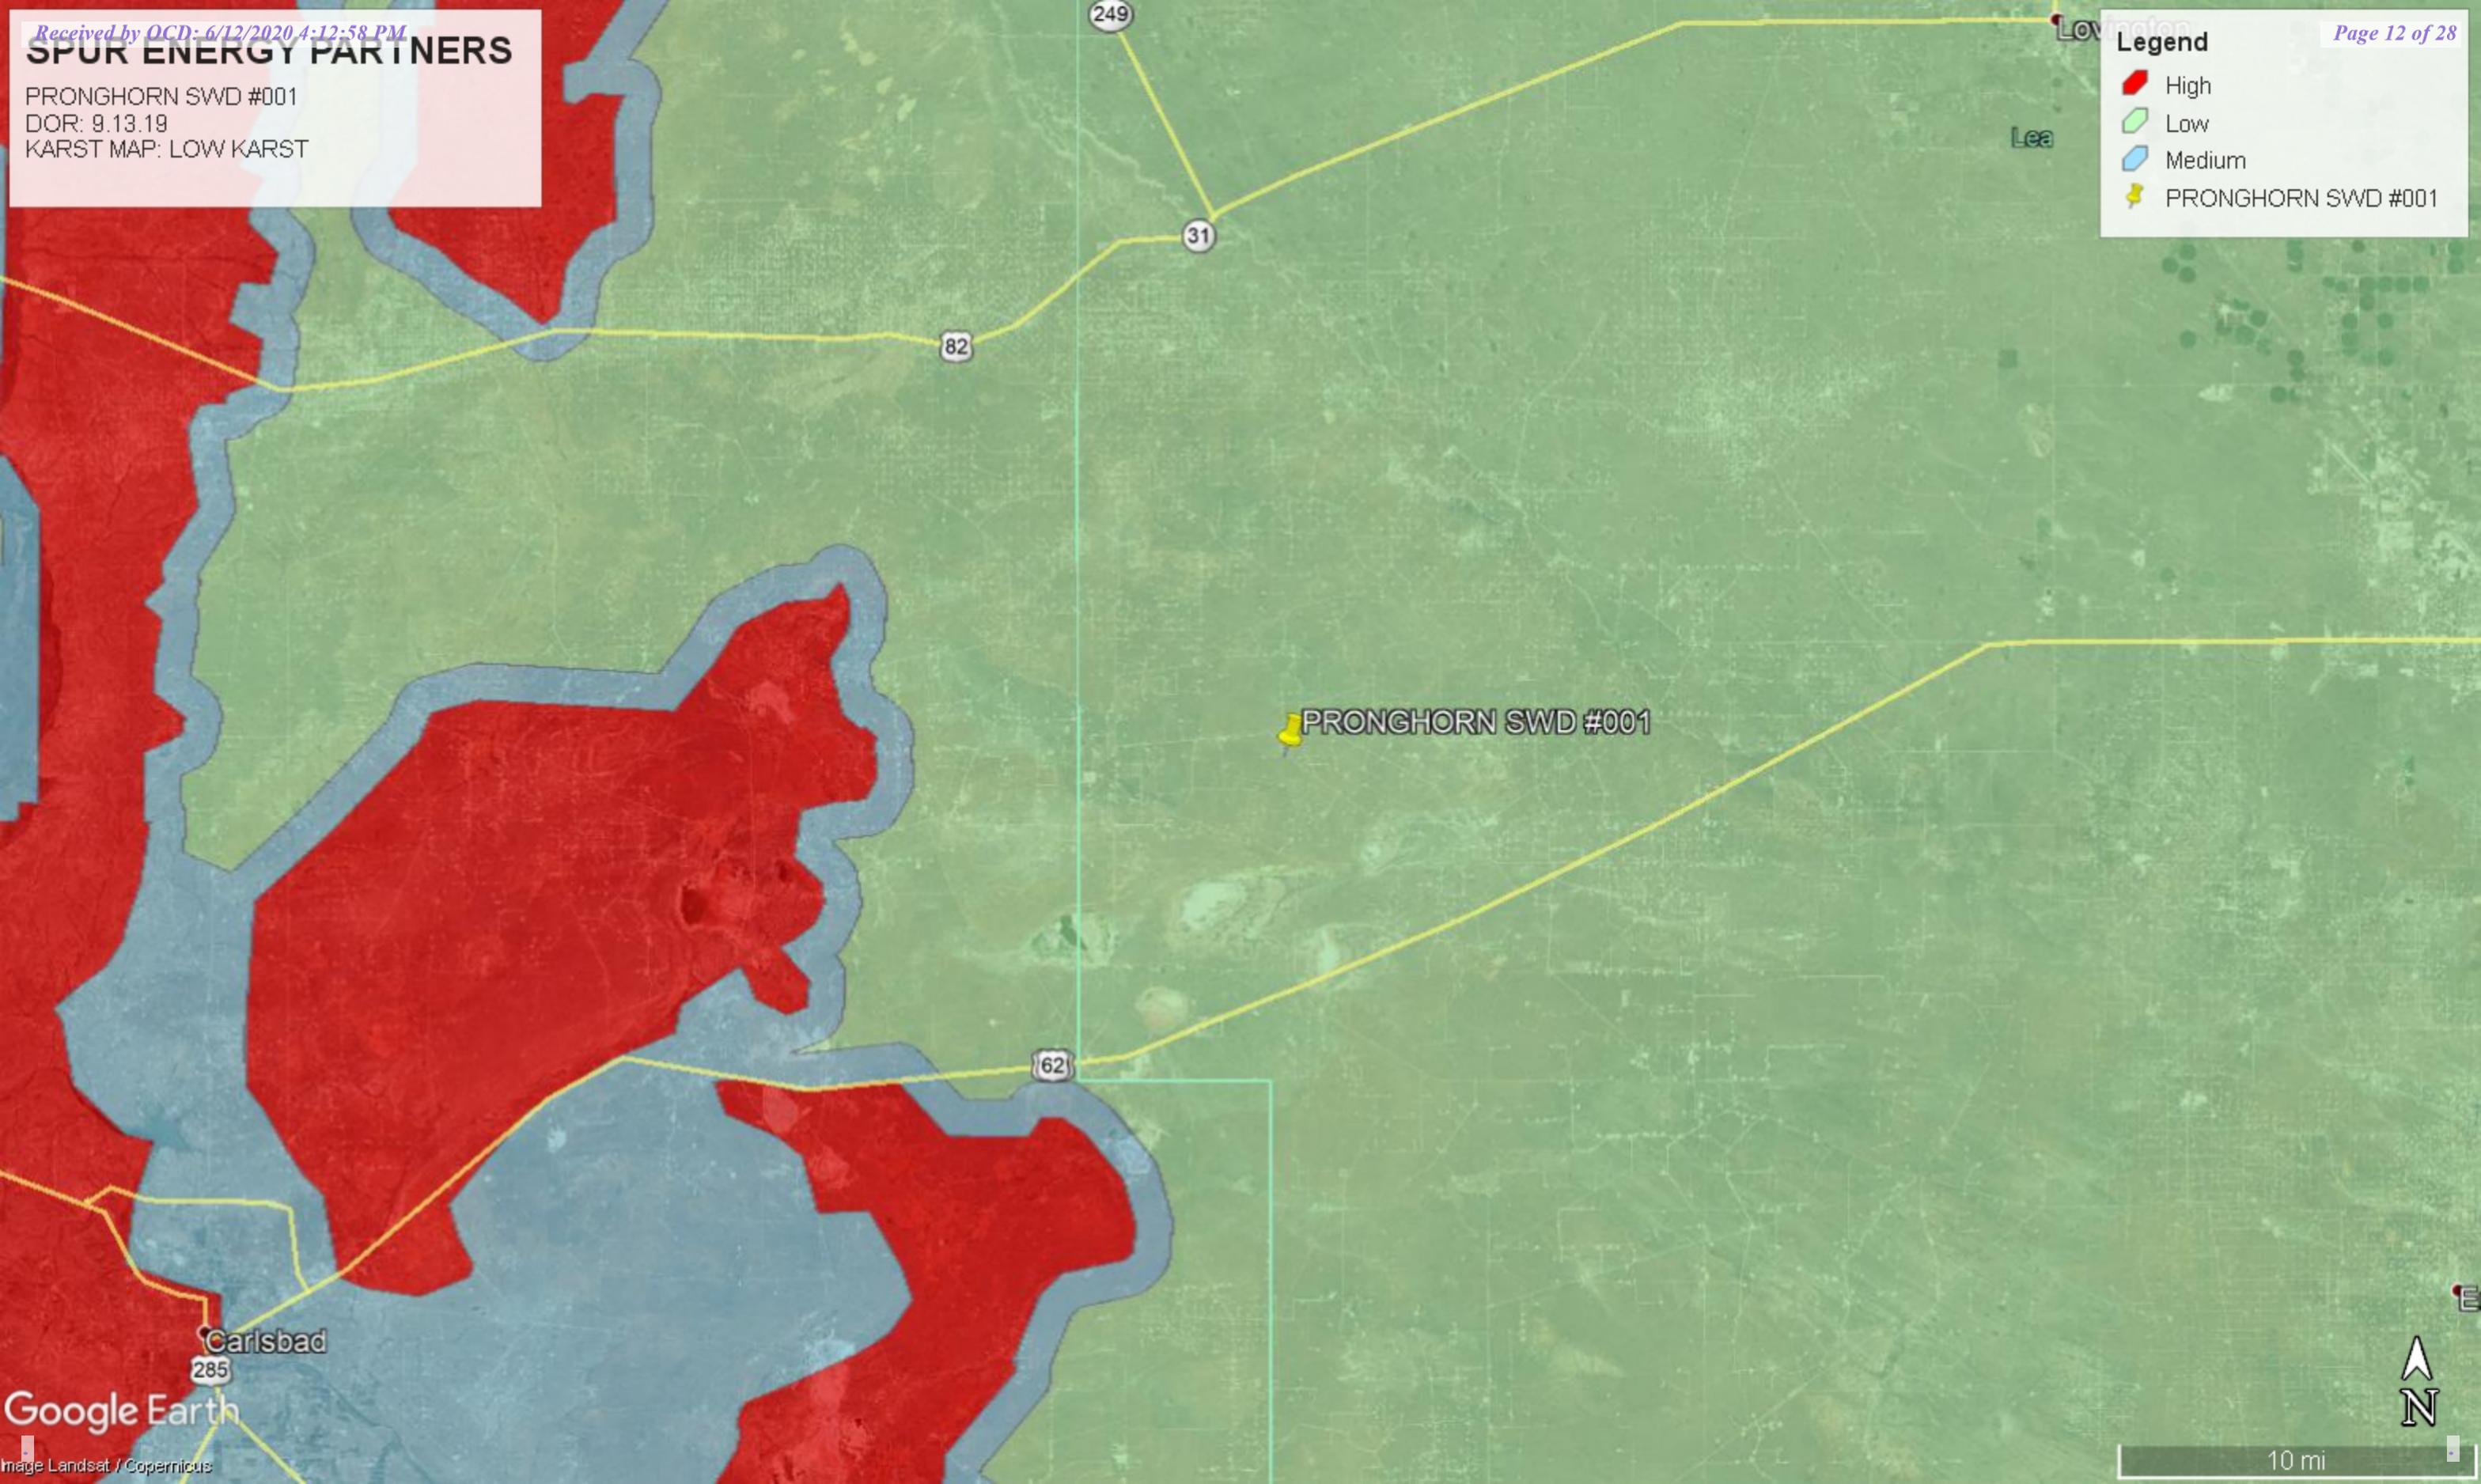
PRONGHORN SWD #001  
DOR: 9.13.19  
KARST MAP: LOW KARST

The Karst Mapping Data found for this site shows the site is located inside the low area marked in green. Please see the attached Karst Map.
