Release Notification

Site Name San Juan 28-7 Unit 183M	Site Type Well Site
Date Release Discovered 01/15/2019	API# (if applicable) 30-039-25660

Re: Site Characterization Report and Remedial Action Plan
San Juan 28-7 No. 183M
Hilcorp Energy Company
Rio Arriba County, New Mexico
OCD Incident No.: nCS1901627746

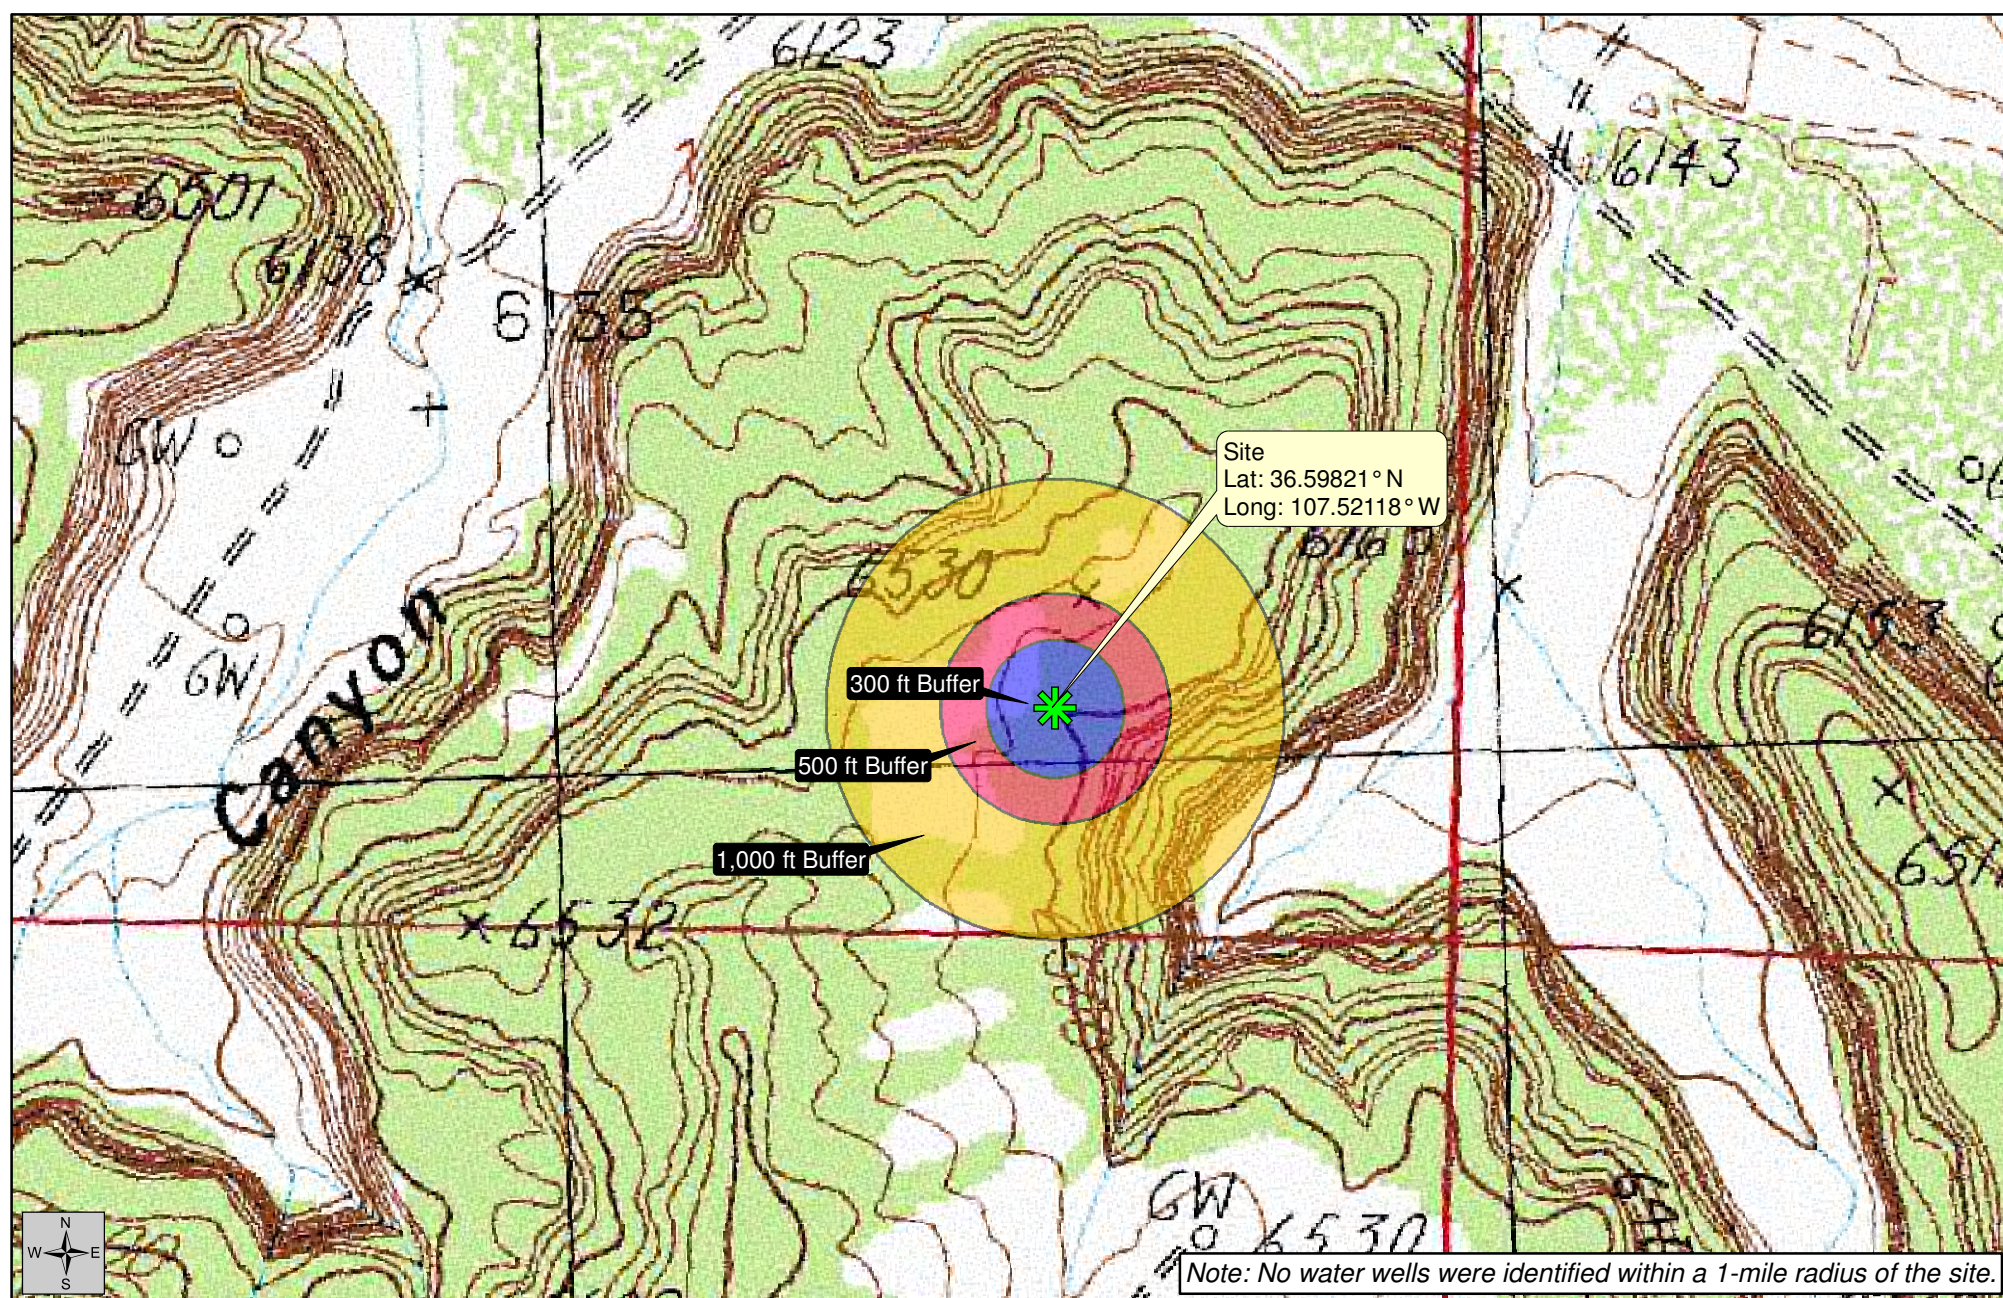
Figure 3
Buffer Map

- Site
- 1,000 ft Buffer
- 500 ft Buffer
- 300 ft Buffer
