Release Notification

Site Name: John Charles 2	Site Type: Wellsite
Date Release Discovered: 7/29/2020	API# (if applicable) 30-045-06480

John Charles 2 Narrative**7/29/2020**

Enduring Resources, LLC
BGT Closure Report
John Charles 2
30-045-0648

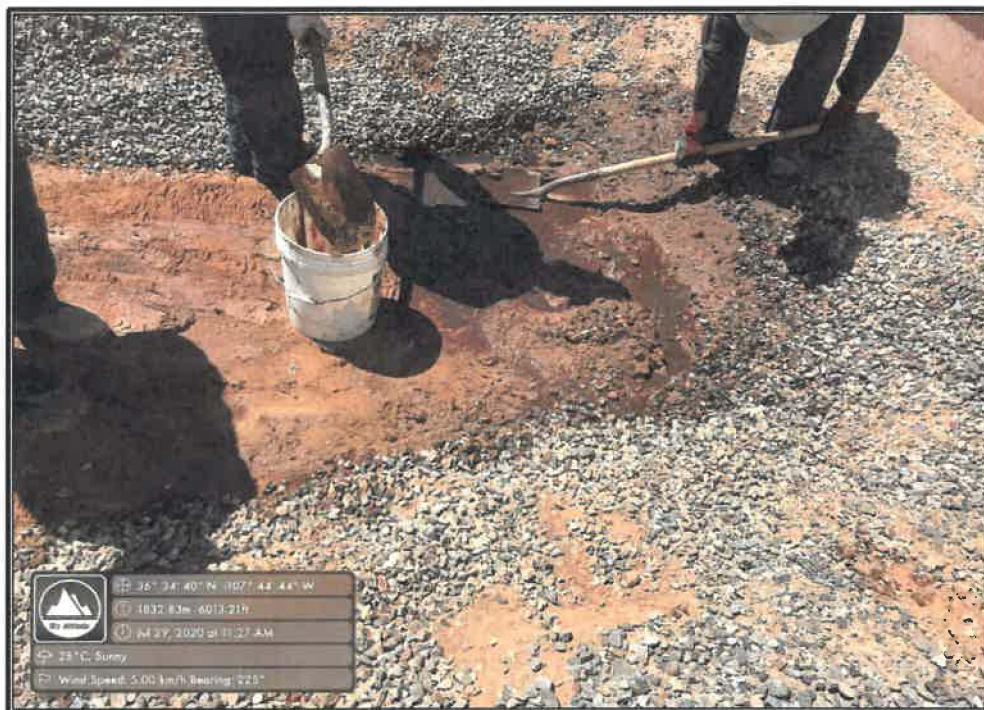
PHOTO 1: Visual Confirmation of Release Occurring During BGT Removal

On 7/29/2020, BGT closure activities were performed at this location. During the removal of the BGT, some fluids in the BGT spilled into the depression where the BGT was pulled out of, confirming a release for this location. Sample results on 7/29/2020 indicated additional excavation was needed, and on 8/3/2020, closure sampling was performed, with all samples returning results below the Table I standards for this location. A Remediation Narrative is attached to this report for reference.

BGT Activities occurred at the John Charles 2 due to an unpermitted BGT. During removal of the BGT, a small amount of liquid inside the BGT spilled from the BGT, into the area where the BGT formerly was located, see *Photo Page*. Approximately 6" of soil was excavated from the spill area and removed for disposal at Envirotech's Landfarm. A closure composite sample was collected in the bottom of the former BGT location, see attached *Table I Analytical Results* and the *Sampling Map*.

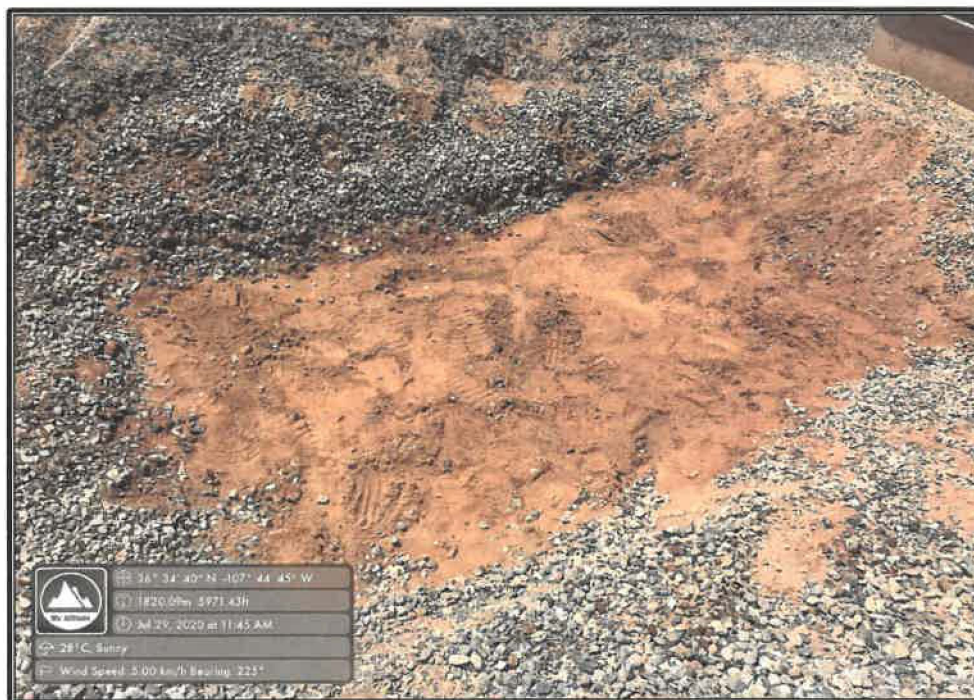
PHOTO 2: Former BGT Location after Removal and Excavation of 6" (7/29/2020)

Sample results indicated that TPH levels above the Table I standards of 100 ppm were present. Additional excavation is required. Notification of additional sampling requirements were submitted via email to the NMOCD, BLM and FIMO; see attached *Notification Email*. Additional sampling to occur on 8/3/2020.

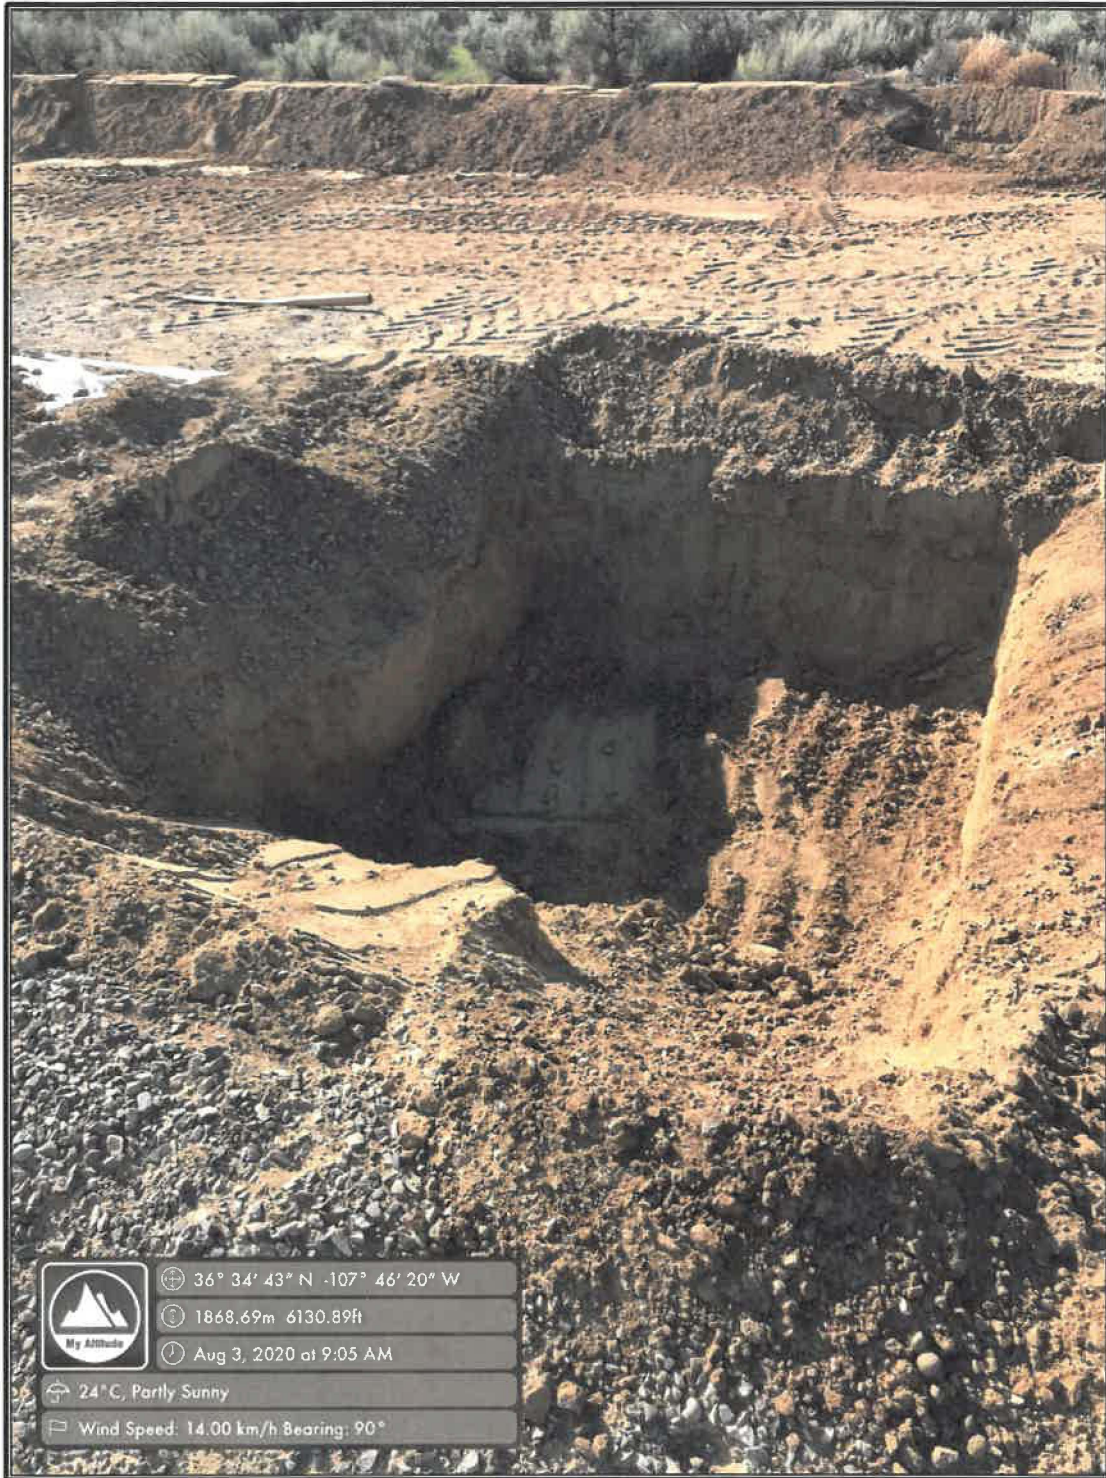
PHOTO 3: Former BGT Location after Additional Excavation during Closure Sampling (8/3/2020)

Additional excavation was performed, excavating the former BGT area to extents of 8' x 5' x 2' deep. Impacted soil sent to Envirotech for disposal.

Additional sampling performed on the excavated area. One (1) composite sample was collected from the bottom of the excavation, and one (1) composite sample was collected of the four (4) walls of the excavation. These samples were submitted to Envirotech for analysis.

Both samples returned results below the Table I Standards for this location; see attached *Analytical Results* and *Sampling Map*.

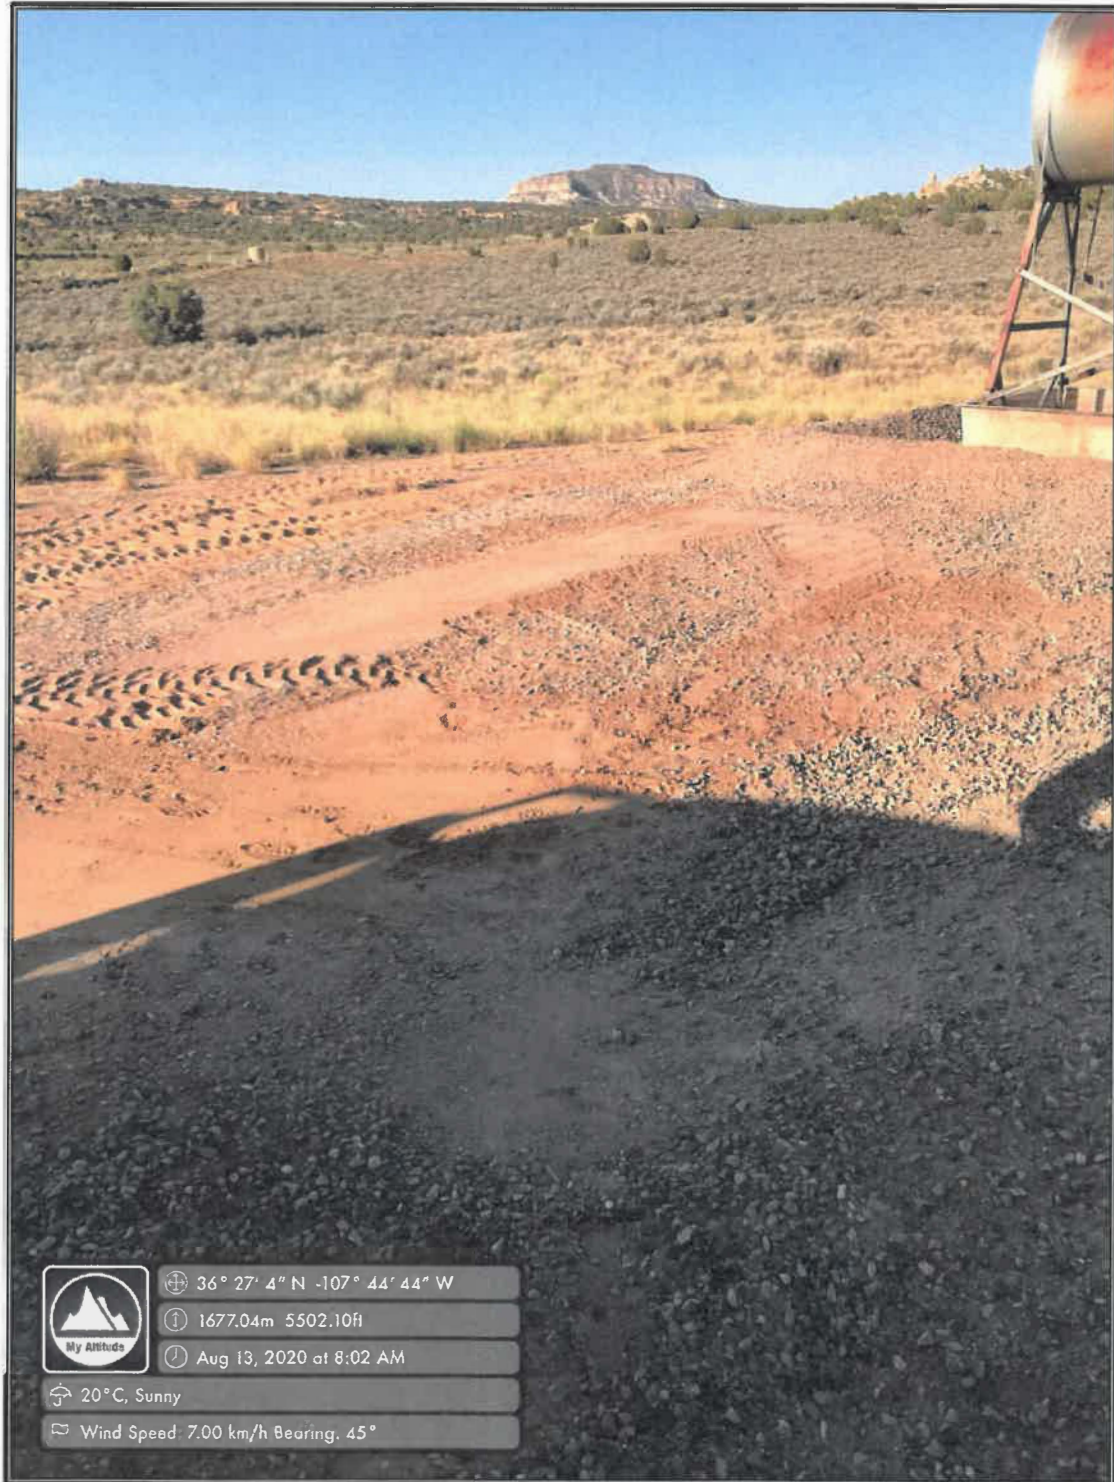
PHOTO 4: BGT Area after Backfill

Backfill activities occurred at the location.

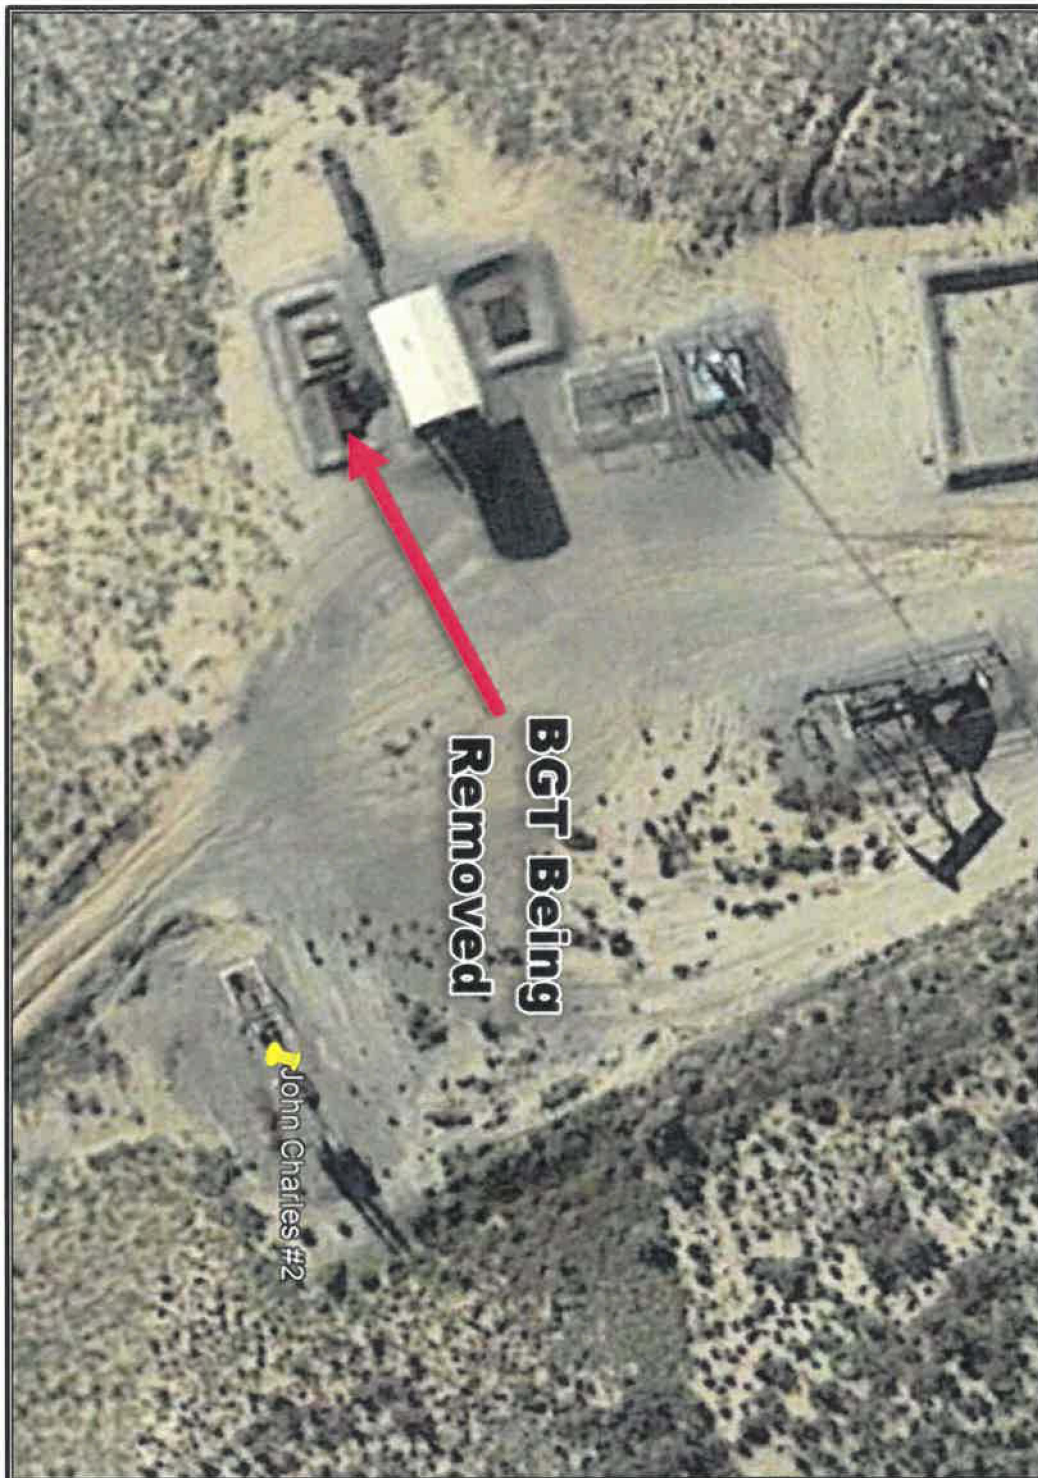
PHOTO 5: Aerial Photo of BGT Location
