**Re: Site Assessment Summary and Remediation Plan
Natural Gas Gathering Line #11117 Leak Location 2**
GPS: Latitude 32.297758 Longitude -104.255832
UL "P", Sec. 14, T23S, R26E
Eddy County, NM
NMOCD Ref. No. NRM2016954249

Tasman Geosciences, Inc. (Tasman), on behalf of DCP Operating Company, LP (DCP), has prepared this Site Assessment Summary and Remediation Plan for the condensate and natural gas Release Site known as the Natural Gas Gathering Line #11117 Leak Location 2. Details of the release are summarized below:

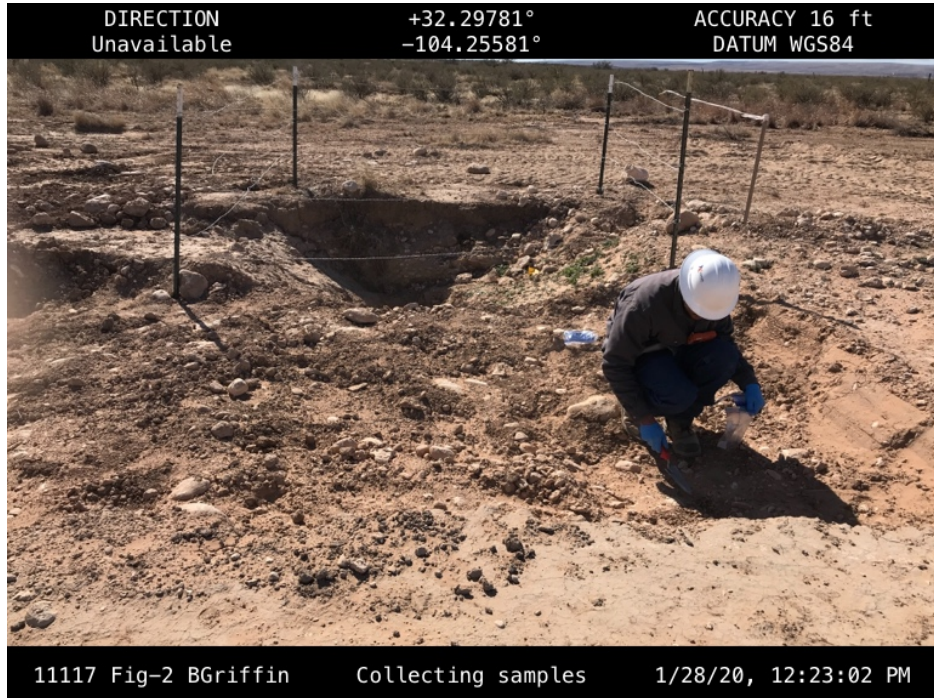
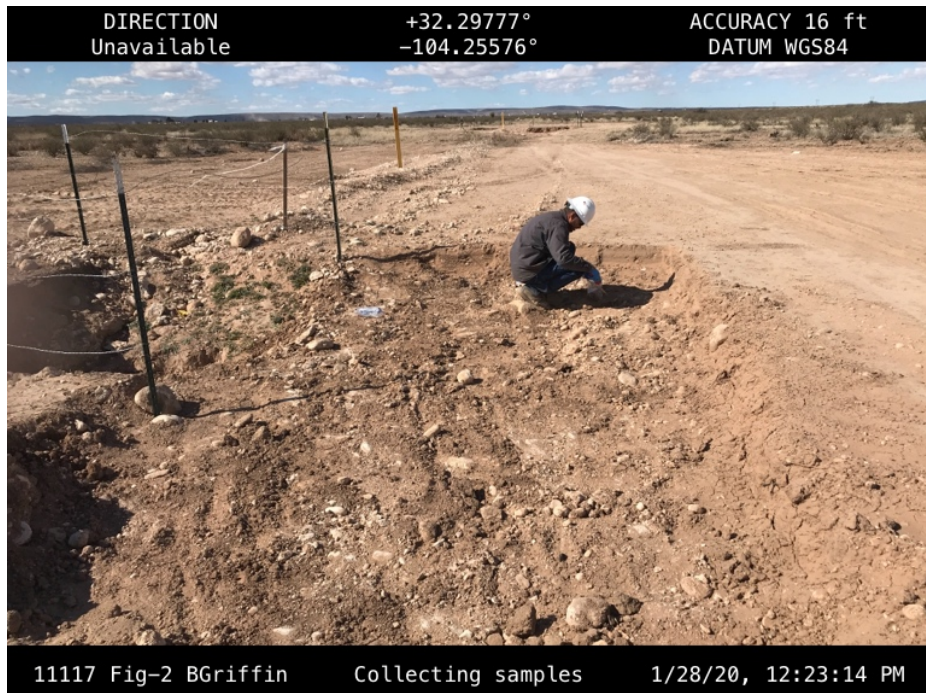
Collecting Bottom Comp Samples
