Release Notification

Site Name Florance 18R Pipeline	Site Type Natural Gas Pipeline
Date Release Discovered 8/14/2020	API# (if applicable)

RE: CLOSURE REPORT
Florance 18R Pipeline Excavation Clearance
NE¼ SE¼, Section 11, T30N, R9W
San Juan County, New Mexico

Florance 18R Pipeline Excavation Clearance Report

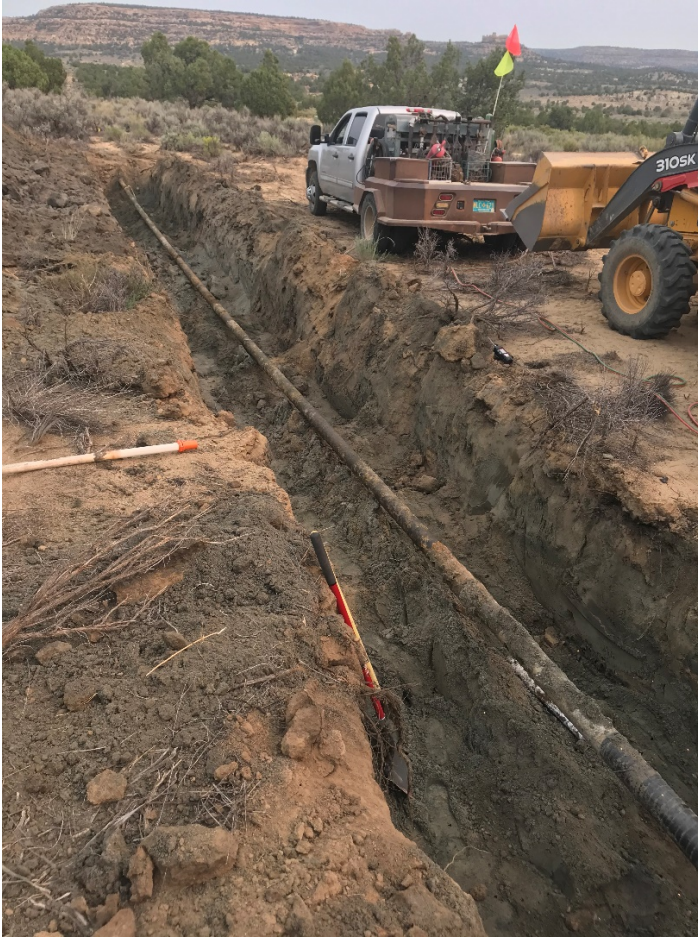
Photo 1: Excavation Around 4-Inch Pipe.

the line was blocked in and depressurized. Gas loss was reported at 3.80 Mcf with no liquids. On August 19, 2020, Harvest personnel dug out the 4-inch pipeline and discovered a 1/4-inch x 1/8-inch hole present. Soil staining and an odor were present. Approximately 84 ft of pipe was replaced and 500 to 600 yards of historic contaminated soil were excavated. Line repairs are complete. Cory Smith of NMOCD was informed of the release on September 4, 2020, via email.

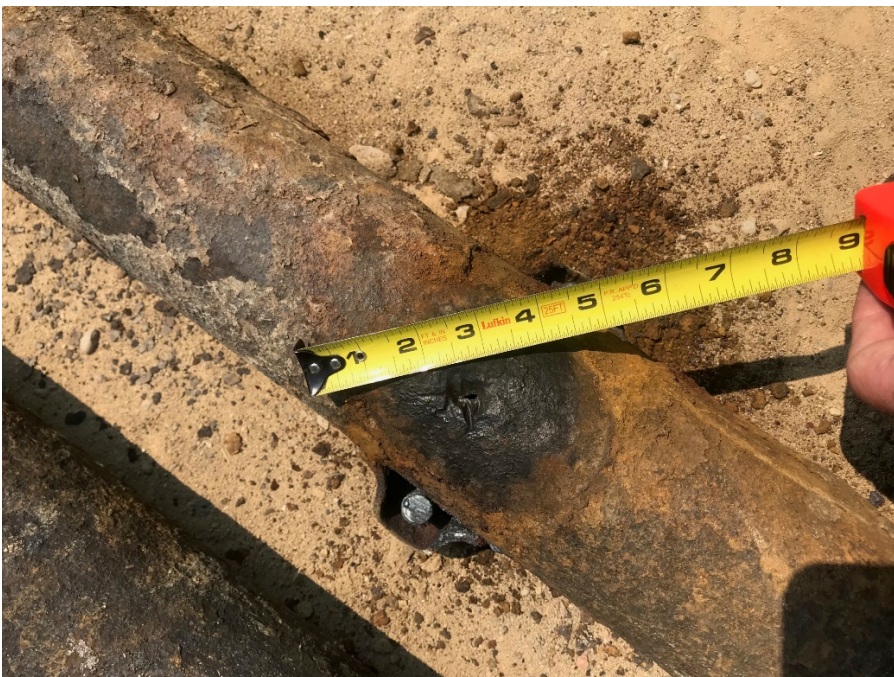
Photo 2: Hole in 4-inch pipe.

Leak was below-ground and has been repaired.

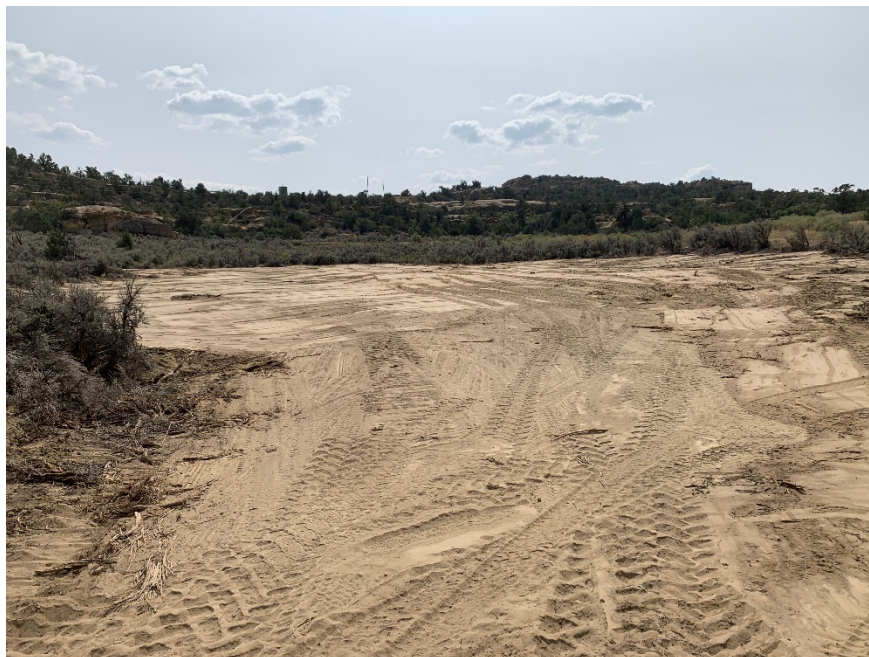
Photo 3: Site after final backfill.

Harvest completed excavation and final clearance of natural gas contamination at the Florance 18R Pipeline in September 2020. Laboratory analytical results reported benzene, total BTEX, TPH (as GRO/DRO/MRO), and chloride concentrations in all samples as below applicable NMOCD action levels. The excavation has been backfilled with clean soil. No further action is recommended at this time.
