**Re: Central Vacuum Unit No. 199 Well Site  
Case No. 1RP-3808  
2019 Work Plan  
Lea County, New Mexico**

# 2018 Site Assessment Report

Central Vacuum Unit 199 (RP-3808)

Lea County, New Mexico

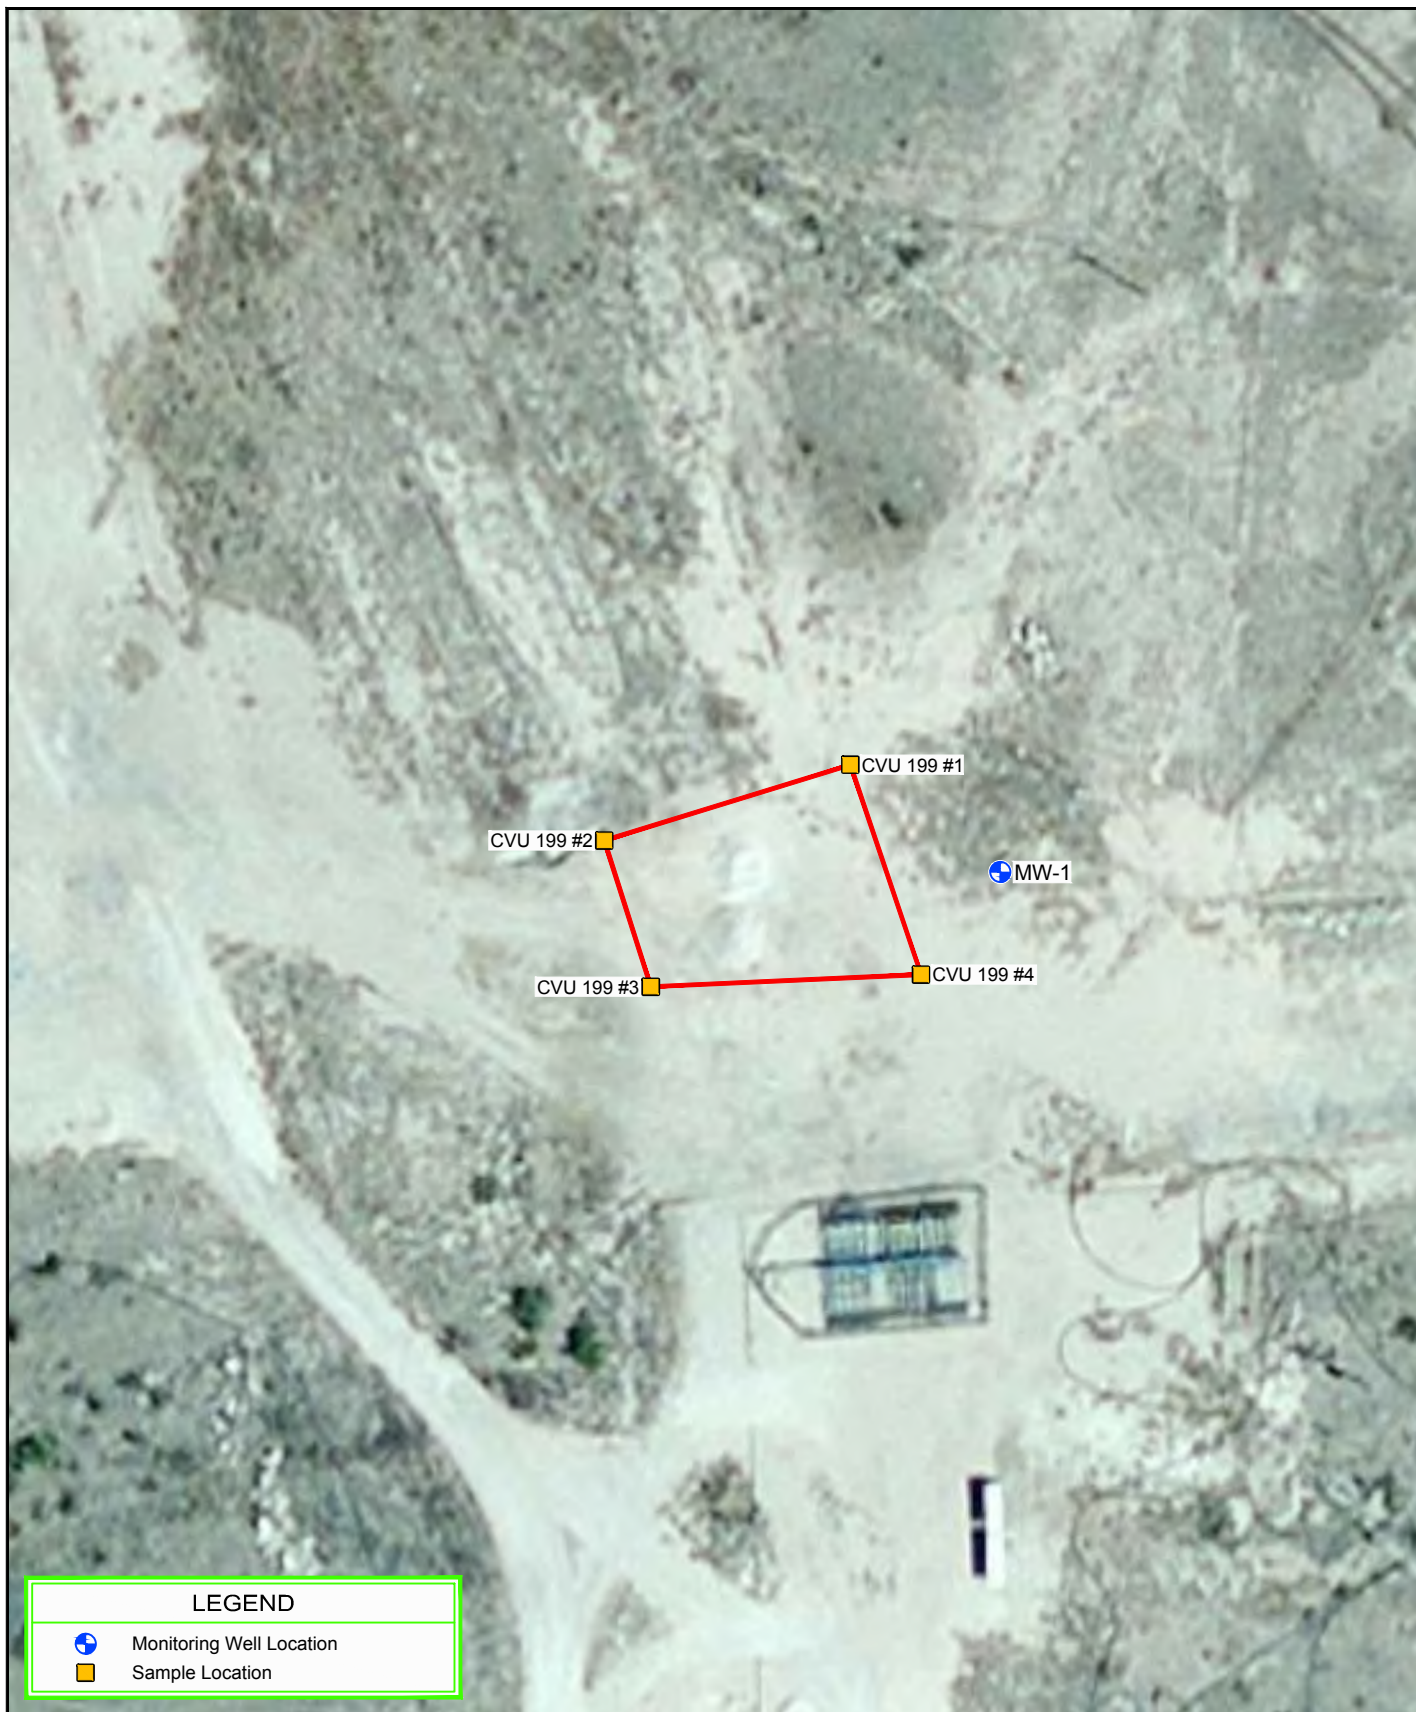
FIGURE 3

| Figure 3 | Site Details Map |

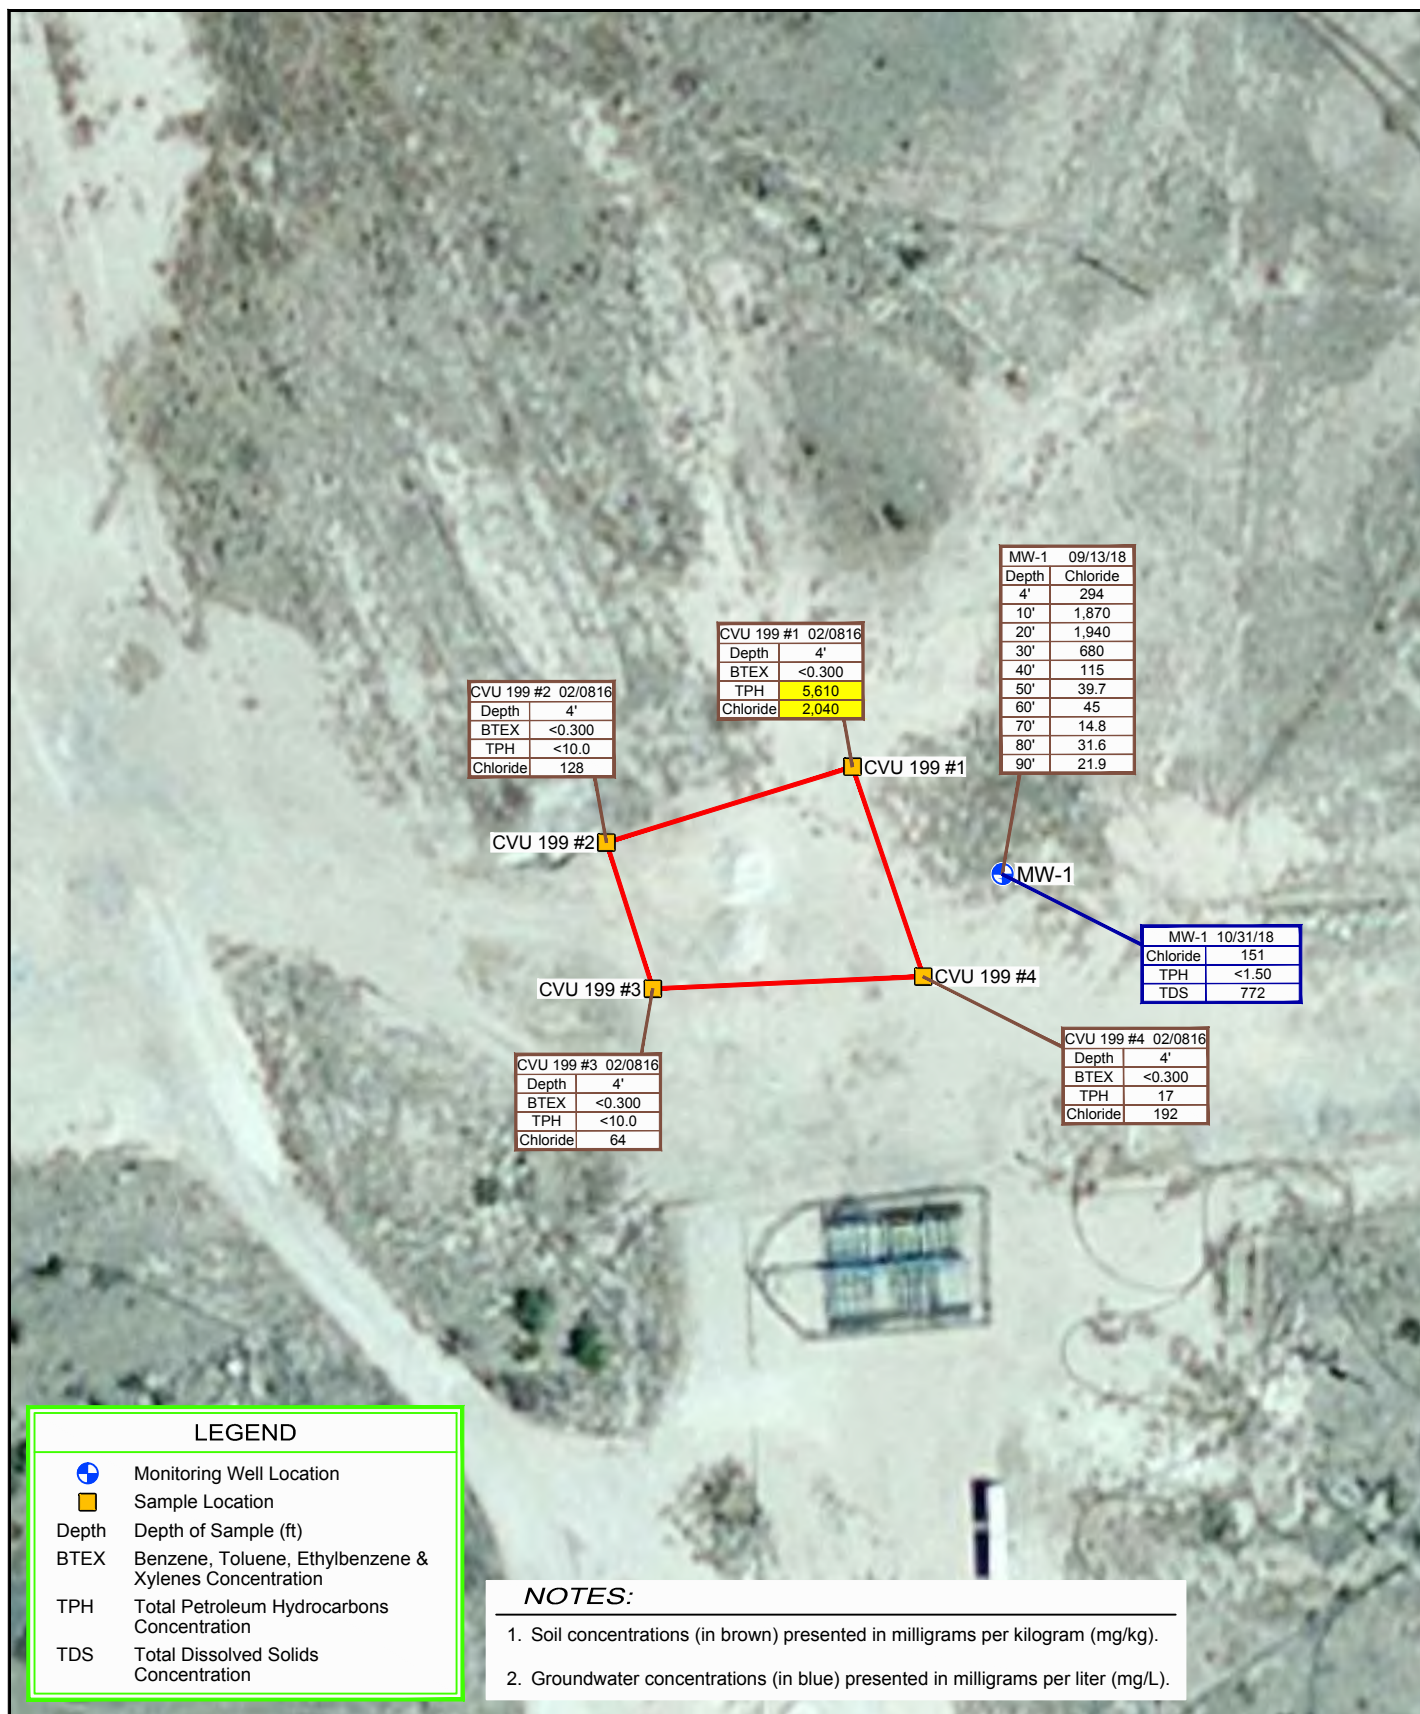
| Figure 4 | Site Details and Analytical Results Map |

A soil analytical summary of results is presented in Table 1. A Site Details and Analytical Results Map is presented as Figure 4.

Given the significant amount of buried and surface lines on and surrounding the Site, any excavation activities in these areas will be extremely dangerous and are not advisable. GHD recommends that any future remediation at the Site be deferred until the lines are no longer in service and have been plugged and abandoned. In addition, based on the groundwater analytical data, it appears that groundwater has not been impacted at the site. Therefore GHD recommends MW-1 be plugged and abandoned.

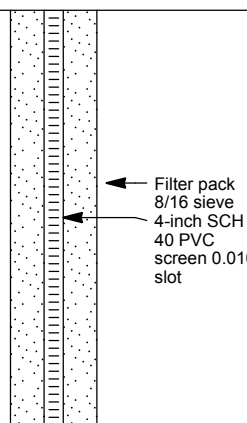
General well specifications for MW-1 include 4-inch diameter PVC casing with PVC screen from approximately 95 to 130 feet bgs. A gravel pack was installed in the annulus of the borehole from bottom up to 2-feet above the screen depth. A 2 to 3-feet bentonite seal was installed above the gravel pack in the well. The well was grouted with a bentonite/cement slurry from the top of the bentonite seal to the ground surface. The well was then finished at the surface with stickup well protectors set in an approximate 4 foot by 4 foot concrete pad. The total depth and construction of the well was based on the professional judgment of the GHD geologist in coordination with CEMC personnel.

The well construction diagram and the State Well Report are provided in Appendix A.
